**Etteridge to Boat of Garten  
Electricity Rationalisation:  
New Overhead Line  
Southern Section (Etteridge to Ruthven)**

**Archaeological Recording  
Report No. 3062**

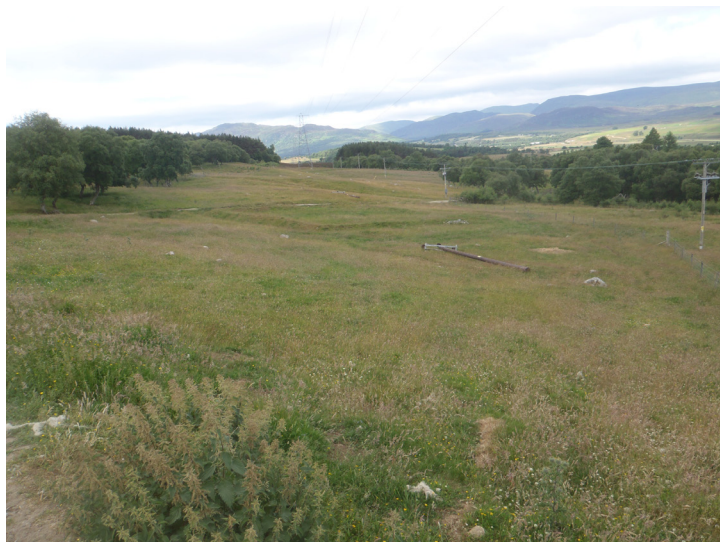
Fig. 3 - Location of pole 3 pre-excitation

Pole 3 (Figs. 3-6) was placed inside of a 3-sided enclosure with access open on the northern side. Agreed mitigation was that the pole could be placed in the centre of the enclosure as micro-siting outside of the enclosure was unfeasible. Access and egress for construction machinery was agreed to be through the open northern side of the enclosure and subsequently following a modern fence line to and from the access track. Plant movements and excavations were conducted under the supervision of the archaeologist.

A pit measuring 1m by 1.5m by 1.8m deep was dug to accommodate the pole under archaeological supervision. No buried archaeological features or deposits were identified and the upstanding archaeological features remained unaffected.

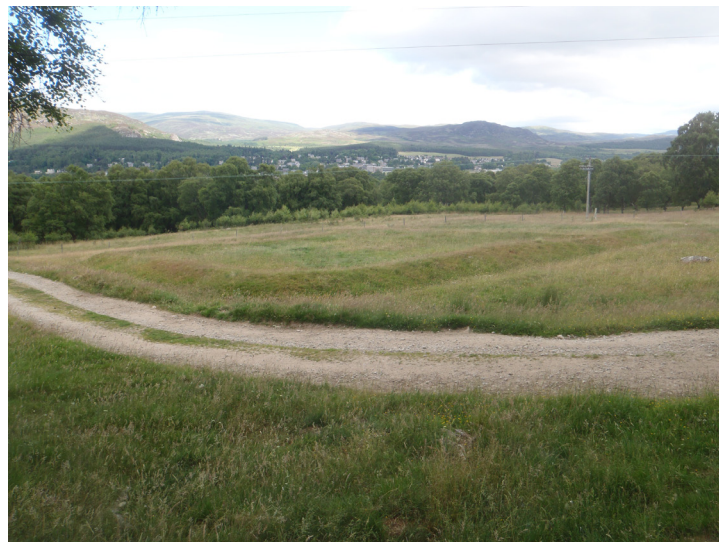
Fig. 4 - Site g

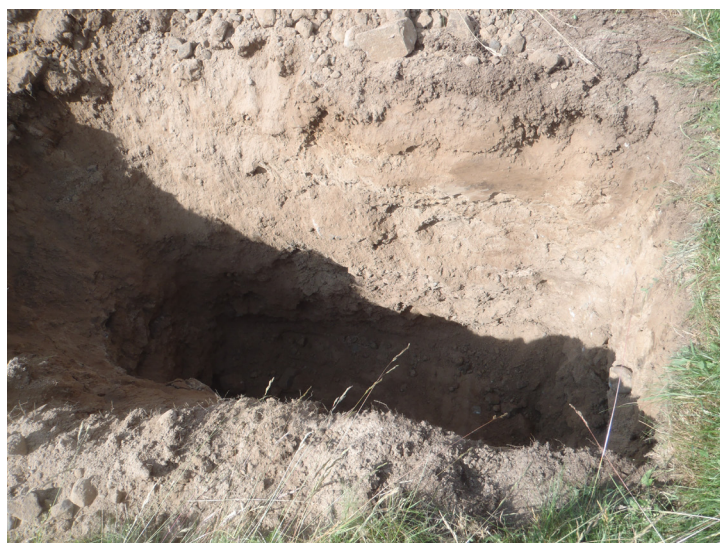
Fig. 5 - Excavation for pole 3

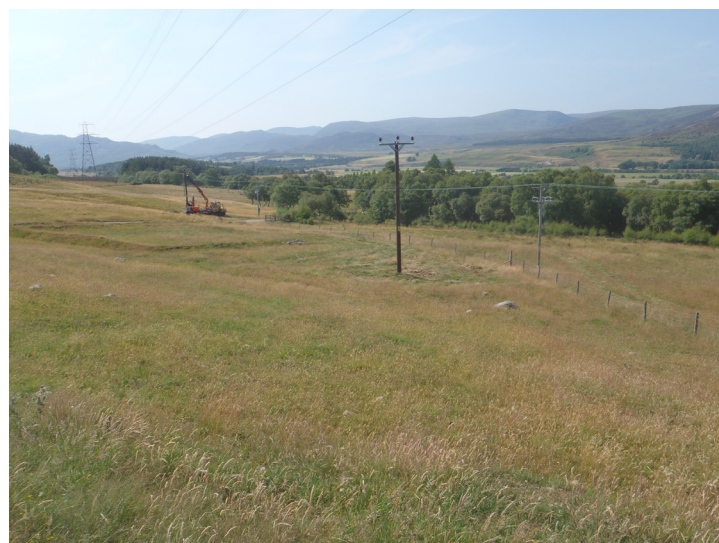
Fig. 6 - Location of pole 3 erected within Site g

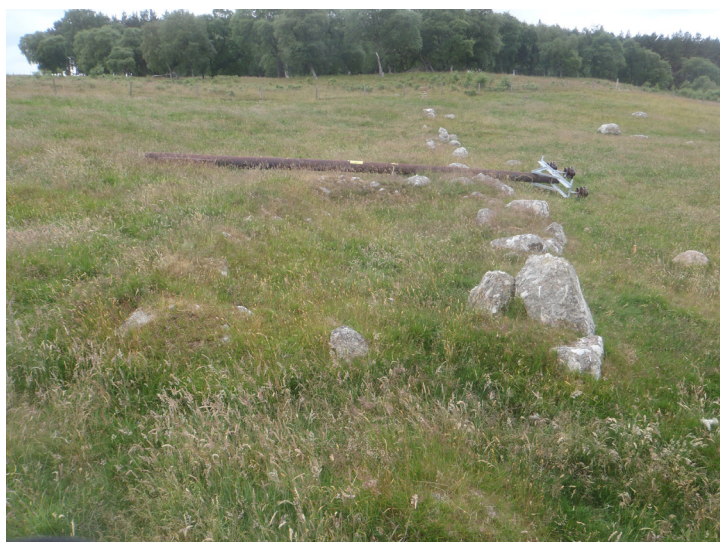
Fig. 7 - Location of pole 5 pre-excitation, Site s

Pole 5 (Figs 7-9) was originally sited just 0.5m from an upstanding archaeological feature. It was agreed that the pole would be micrositied to take the new position 3m to the north away from the affected archaeological feature and associated field boundary.

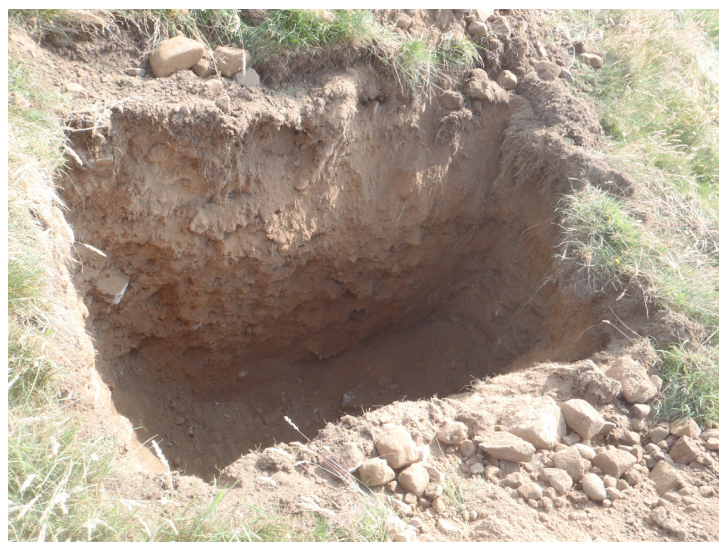
Fig. 8 - Excavation for pole 5

A pit measuring 1m by 1.5m by 1.8m deep was dug to accommodate the new pole under archaeological supervision (Fig. 8). No buried archaeological features or deposits were identified and the upstanding archaeological feature remained unaffected.

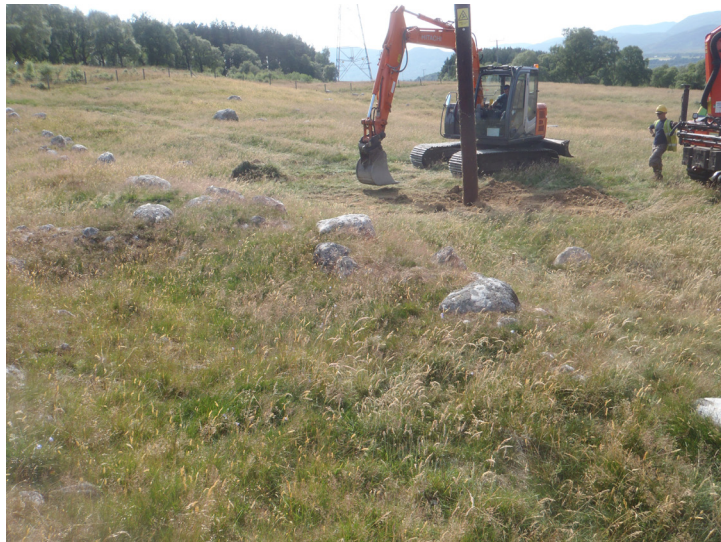
Fig. 9 - Location of pole 5 adjacent to Site s

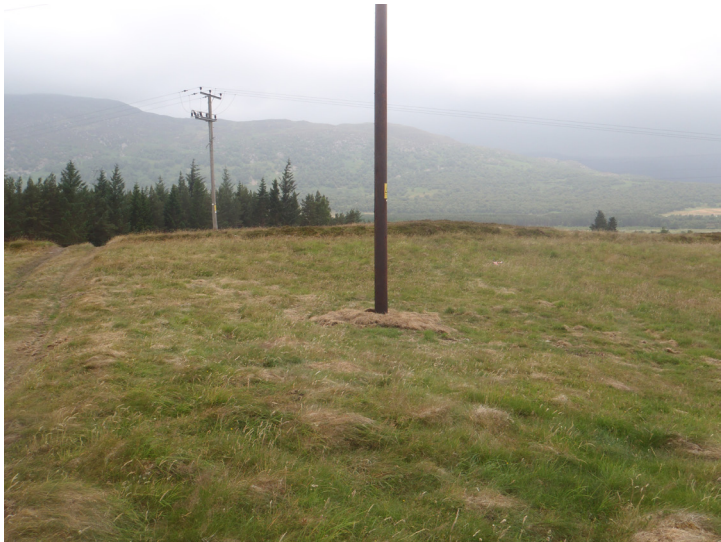
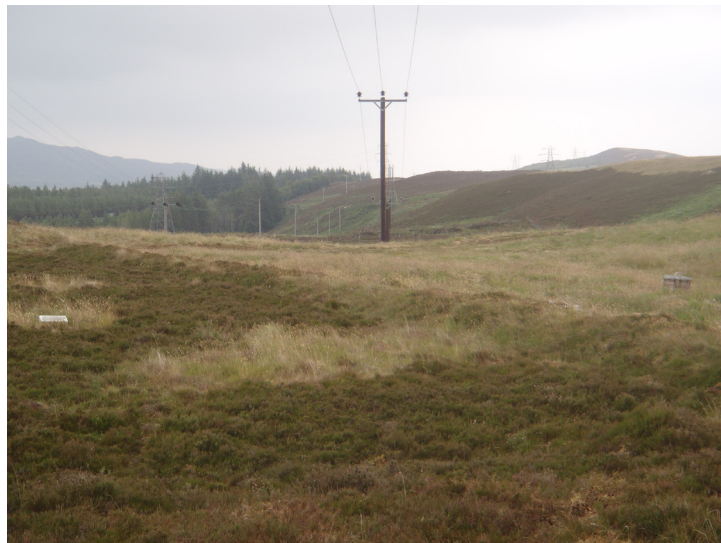
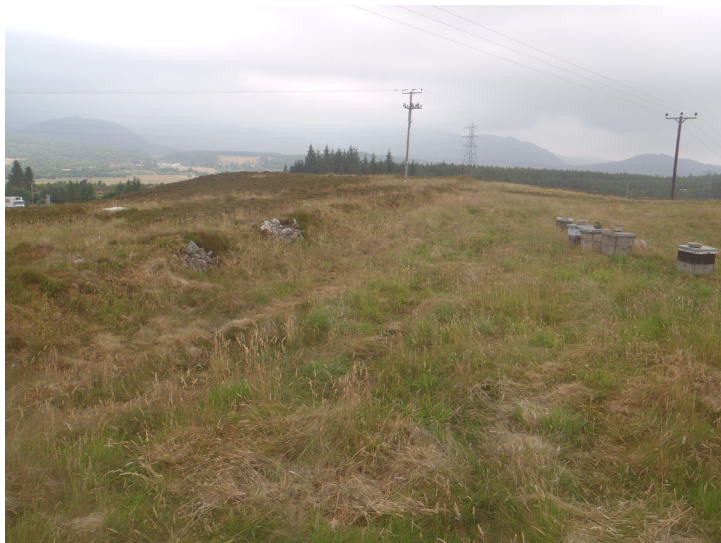
Fig. 10 - Location of pole 79 at Site m

Fig. 11 - Location of pole 80 at Site m

Fig. 12 - Location of pole 81 at Site m

Poles 79-81 (Fig. 10-12) did not directly affect any archaeology although they were sited close to some field boundaries (Site m) but beyond the 10m buffer. Plant movement was controlled to avoid any upstanding archaeology and mitigation was put in place to use existing farm tracks where possible.

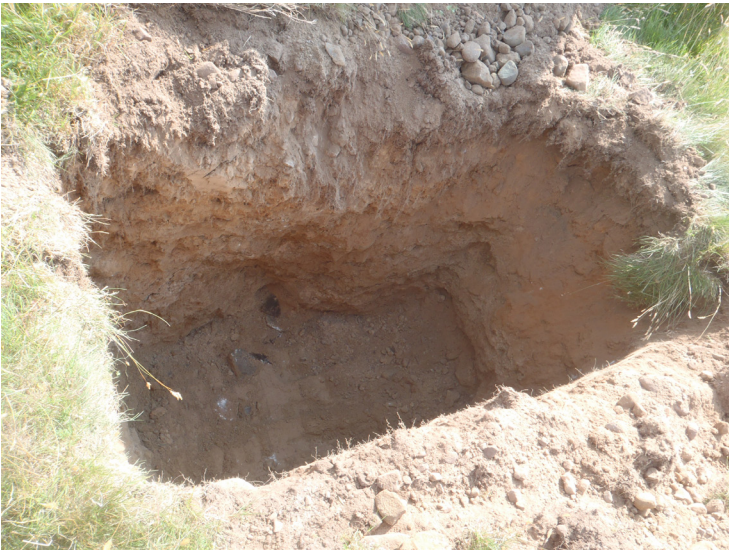
Fig. 13 - Excavation for pole 4

Site 38 was demarcated prior to the installation of Pole 4. A pit measuring 1m by 1.5m by 1.8m deep was excavated to accommodate the pole (Fig. 13). No buried archaeological features or deposits were identified and the upstanding archaeological features remained unaffected.

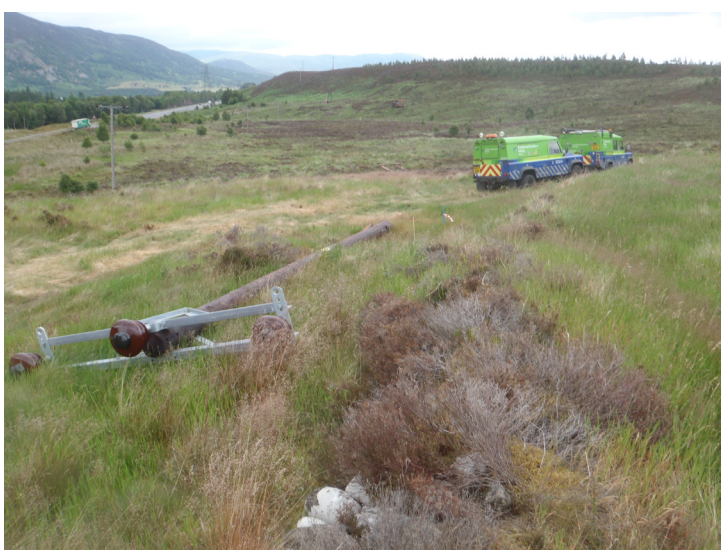
Fig. 14 - Location of pole 124 at Site 14, pre-excavation

Pole 124 (Fig. 14) could not be microsited more than 3m away from upstanding archaeological features and was monitored under a watching brief. A pit was excavated measuring 1m by 2m by 1.8m deep to accommodate the pole (Figs 15, 16, 18). Plant movement was controlled to avoid any upstanding archaeology. No buried archaeological features or deposits were identified and the upstanding archaeological features remained unaffected.

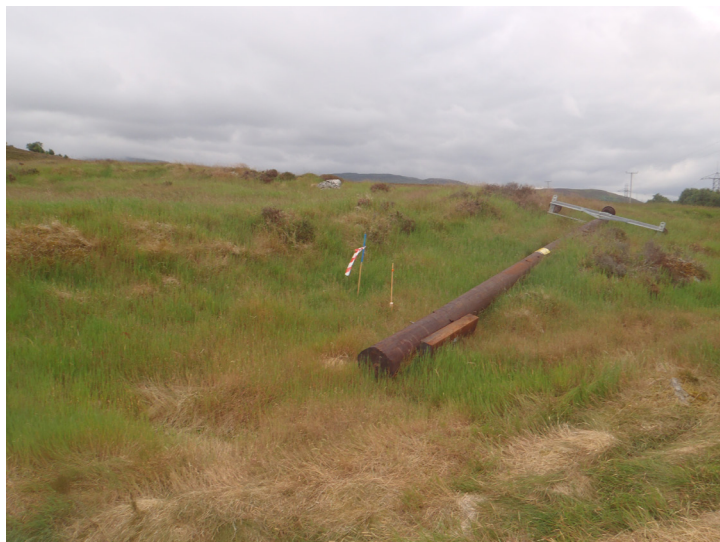
Fig. 15 - Mitigation at pole 124 at Site 14

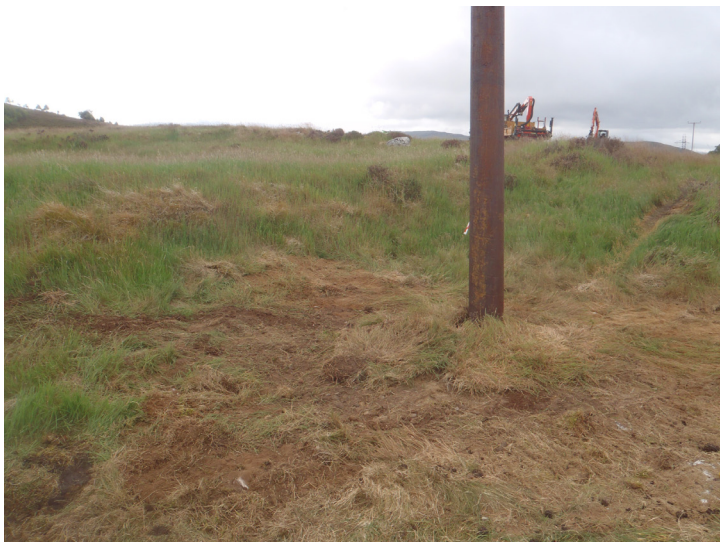
Fig. 16 - Location of erected pole 124 at Site 14

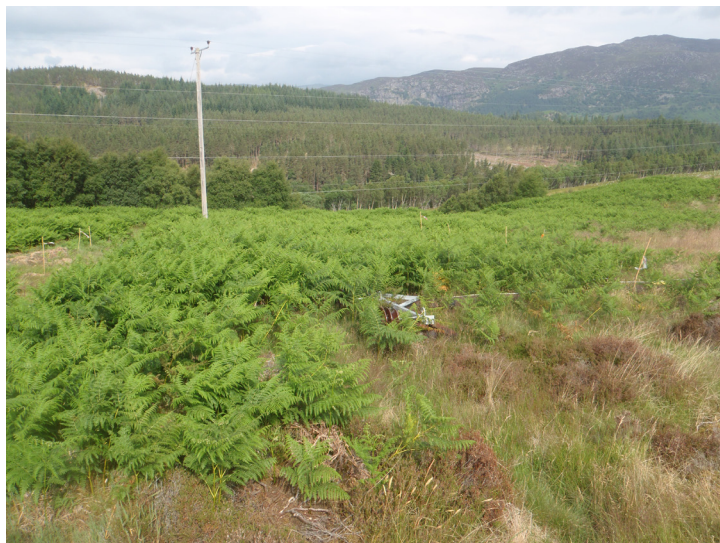
Fig. 17 - Location of pole 126 at Site 14 pre-excavation

Pole 126 required mitigation due to its proximity to an enclosure (Fig. 17). This was microsited 1.5m away from the feature to move it outside an already demarcated buffer of 10m. A pit measuring 1m by 1.5m by 1.8m deep was excavated to accommodate the pole (Fig. 19). Pole 126 also required Stays to be put in for stability. These were excavated under watching brief conditions and did not affect any upstanding archaeological remains as they were positioned parallel to the enclosure bank. No buried archaeological features or deposits were identified and the upstanding archaeological features remained unaffected.

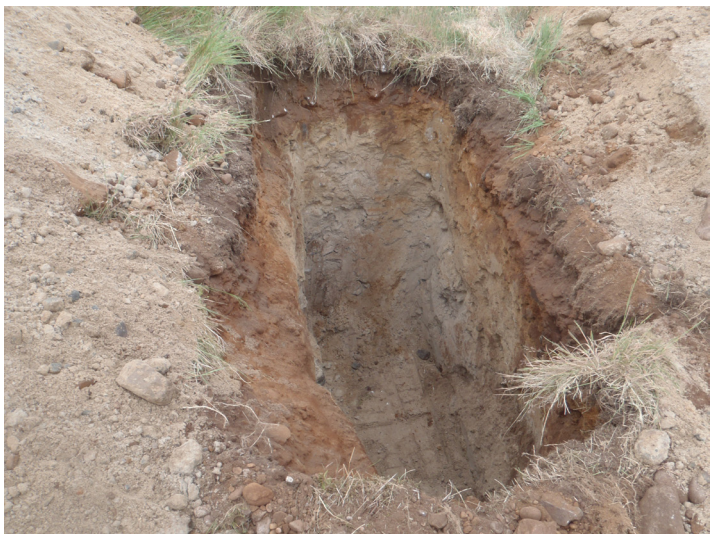
Fig. 18 - Excavation for pole 124

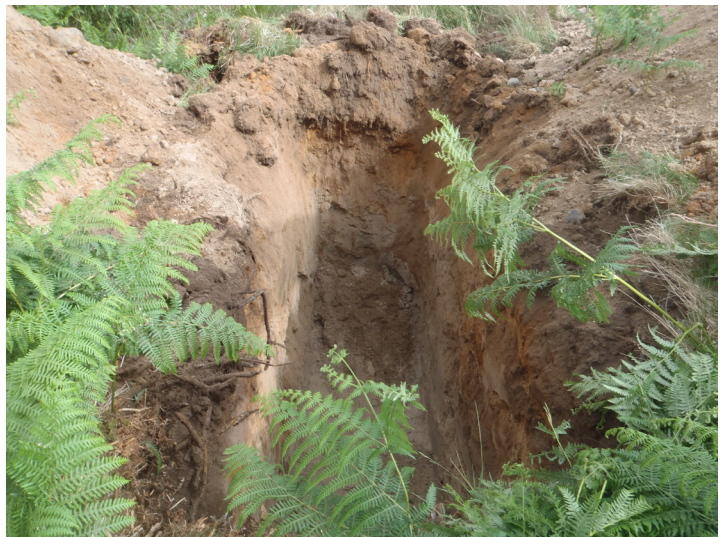
Fig. 19 - Excavation for pole 126

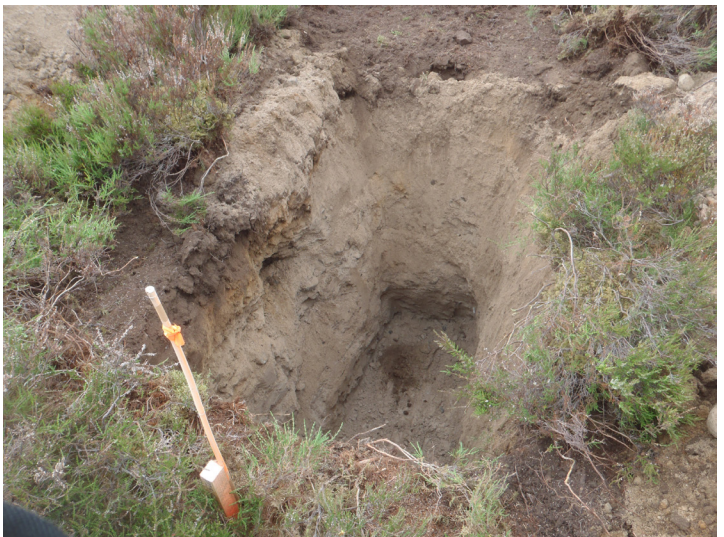
Fig. 20 - Excavation for pole 125

Pole 125 was monitored under a watching brief. A pit measuring 1m by 1.5m by 1.8m deep was excavated to accommodate the pole (Fig. 20). Plant movement along the access route to the pole was controlled to avoid any upstanding archaeology. No buried archaeological features or deposits were identified and the upstanding archaeological features remained unaffected.
