## CASTLE ROY

### NETHY BRIDGE

## ARCHAEOLOGICAL EVALUATION

SITE CODE: NCR 13  
REPORT CODE: FAS2013 534 NCR500  
NGR: NJ 0065 2192

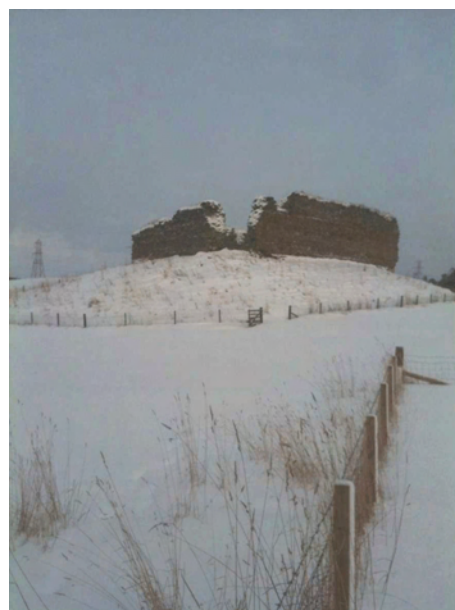
**Plate 1** Castle Roy looking north during evaluation

Castle Roy is situated beside the B970 on the northern outskirts of the village of Nethy Bridge, approximately 5 miles southwest of Grantown on Spey in the Highlands of Scotland (NGR: NJ 0065 2192). The castle ruin occupies a small hill or mound overlooking the Spey valley (Figure 1; Plate 1). Castle Roy is a Scheduled Monument (952 NJ 006219).

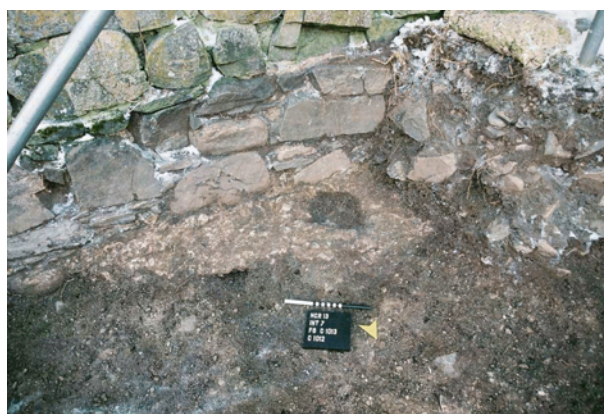
**Plate 2** C1012 showing F6 pre-excavation (scale 0.30m)

The northwestern end of C1011 was notably flecked with lime mortar and removal against the southwest corner revealed a small area of hard lime mortar surface assigned C1012 (Figure 3). A small post-socket was identified within C1012 and assigned F6 (Plate 2). Excavation of F6 identified a small sub-square depression within the surface of C1012. The sides and base of the depression were smooth and did not penetrate below the lime mortar indicating the post was set into C1012 while still wet. The full extent of C1012 had not survived and may have been lost to disturbance or robbing. The flecks of lime mortar within C1011, confined to the northwestern end of Intervention 7, might indicate the original extent of C1012 and the footprint of a building adjacent to structural features within the adjacent curtain wall.

Structural evidence within Intervention 7 consisted of evidence for a timber building which may have been furnished with a solid lime mortar floor surface which survived as a small remnant close to the southwest corner of the castle interior (C1012). The laying down of C1012 was contemporaneous with the positioning of the squared post represented by F6 and as C1012 overlay subsoil both features may belong to the early occupation of the castle. As well as F6 the stone plinth F7 forms further evidence for the presence of a timer-framed building in this position and the mortar flecking observed wihtin C1011 may represent the stance of a building aligned NE-SW along the northwestern interior of the castle.

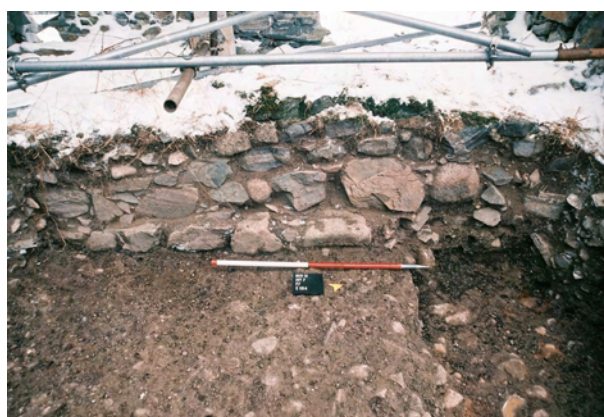
**Plate 3** F7 C1014 (scale 1.0m)

Further structural evidence was identified within the northwest wall of the castle and took the form of a small stepped plinth above the wall foundation (Plate 3). The feature was assigned F7 and consisted of a single course of stone rubble projecting from the main elevation by c.0.22m forming a small plinth which was visible for 1.7m and could be seen to continue beyond a small baulk which supported adjacent scaffolding (C1014). The feature may have provided support for timber framing for a building in this position.

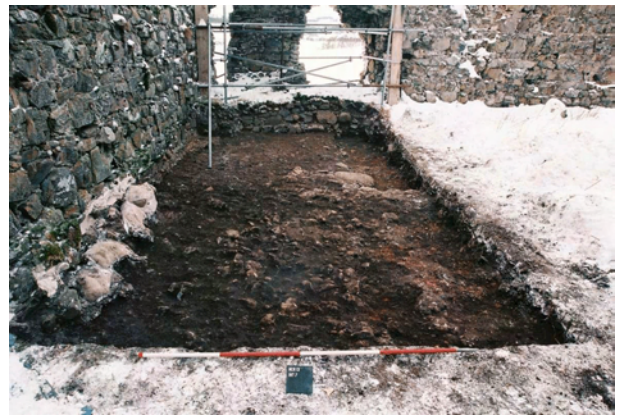
**Plate 4** Intervention 7 looking northwest (scale 2.0m)

in the northeastern corner of Intervention 7 where it was proved to 0.40m BGL and was found to be firmly compacted and sterile (Plate 4).

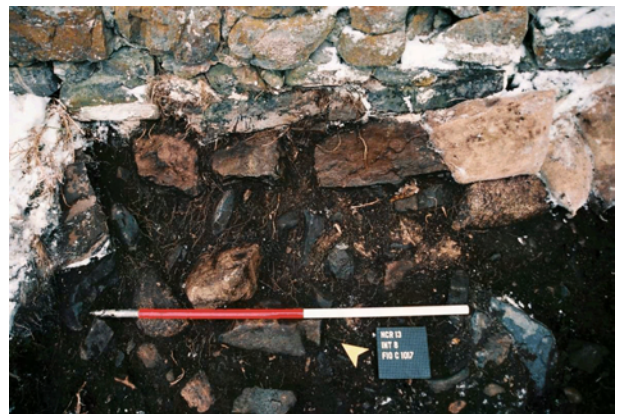
**Plate 5** F10 C1017 (scale 1.0m)

C1011 abutted the internal walls of the castle and its removal revealed three features (Figure 4). Two were integral with the northeast wall of the castle and represent two lengths of projecting stonework. That to the west was assigned F10 and consisted of a short length of stone plinth measuring 1.0m formed by three level stones projecting from the main elevation (C1017)(Plate 5). A distance of 4.0m to the southeast a further similar feature was identified and assigned F9. F9 consisted of a group of five level stones projecting from the main northeast elevation and coursing through beneath the southeast wall of the castle (C1016)(Plate 6). Together these features represent further evidence for the location of buildings adjacent to the southeast corner of the castle interior. They are likely to have functioned in the same way as F7 within Intervention 7 and may represent seatings for timber-framed structures in this position.

Intervention 8 provided further evidence for a building in the northeast corner of the castle interior perhaps extending along the south east wall. Little of the form and function of the building can be gleaned although evidence for the positioning of a timber-frame is provided by F9 and F10, and is corroborated by the recovery of structural ironwork. While the form and function of F8 could not be easily surmised within the evaluation area the feature may relate to the occupation of the castle and is further evidence for the presence of features buried at shallow depth.

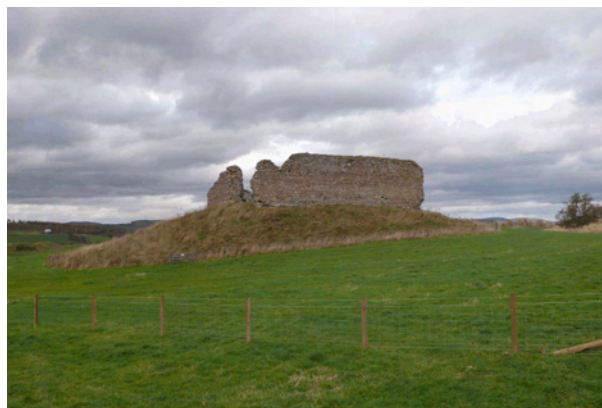
**Plate 1** Castle Roy looking north

Castle Roy is situated beside the B970 on the northern outskirts of the village of Nethy Bridge, approximately 5 miles to the southwest of Grantown on Spey in the Highlands of Scotland (NGR: NJ 0065 2192; Plate 1). The castle ruin occupies a small hill or mound overlooking the Spey river valley. Castle Roy is a Scheduled Monument and a Listed Building.

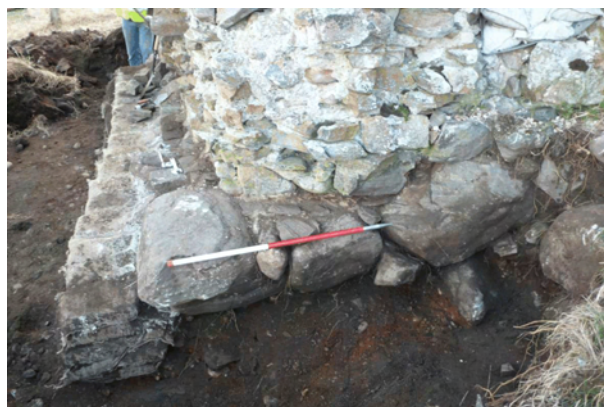
The foundations of the curtain wall are clearly in poor condition having been undermined and eroded during ongoing natural deterioration of the monument. The foundations are to be repaired using limecrete-filled sandbags and the exposed make-up re-grouted. Superficial excavation of turf and topsoil at the base of the exterior of the curtain wall is required to enable these repairs. The aim of the archaeological watching brief is to supervise these excavations in order to minimise below ground intervention, and in the event that archaeological strata are contacted, to preserve them by record.

**Plate 2** Foundations of northwest tower following consolidation (scale 1.0m)

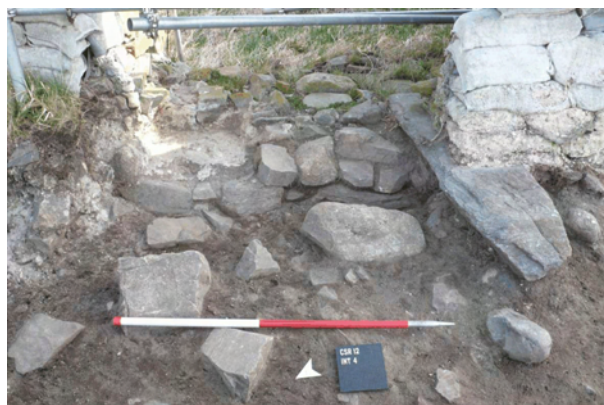
More recent archaeological work at the site necessitated by the ongoing programme of emergency repairs has consisted of a pre-intervention photographic survey along with topographic survey of the site and the mound and measured survey of the extant fabric. In addition the archaeological monitoring of two test pits to investigate the stability of the castle mound and buried foundations of the surviving fabric was undertaken. This phase of work determined that the mound is a natural geological feature. Subsequently, underpinning of the northwest tower was undertaken under archaeological supervision (Plate 2). An evaluation trench was also excavated in order to explore the original form of a garderobe turret to inform repair solutions; the trench achieved the plan and arrangement of the turret (Plate 3).

**Plate 3** Evaluation trench showing the remains of foundations of garderobe turret (scale 1.0m)
