A Survey of Kildonan Township

2011

Kildonan, Little Loch Broom

Kildonan Township
Kildonan, Dundonnell
Centred on NH 0782 9097

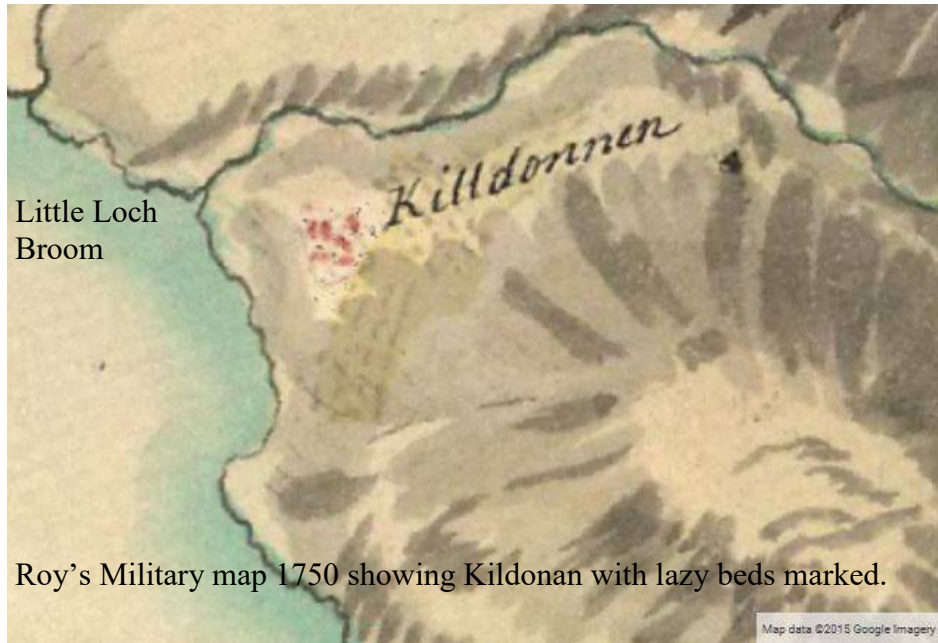
Roy's Military map 1750 showing Kildonan with lazy beds marked.

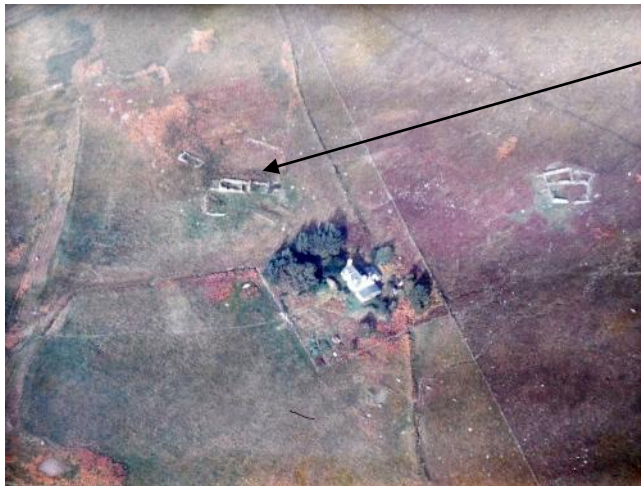
Ruin of original house shown on old aerial photo before it became overgrown with brambles.

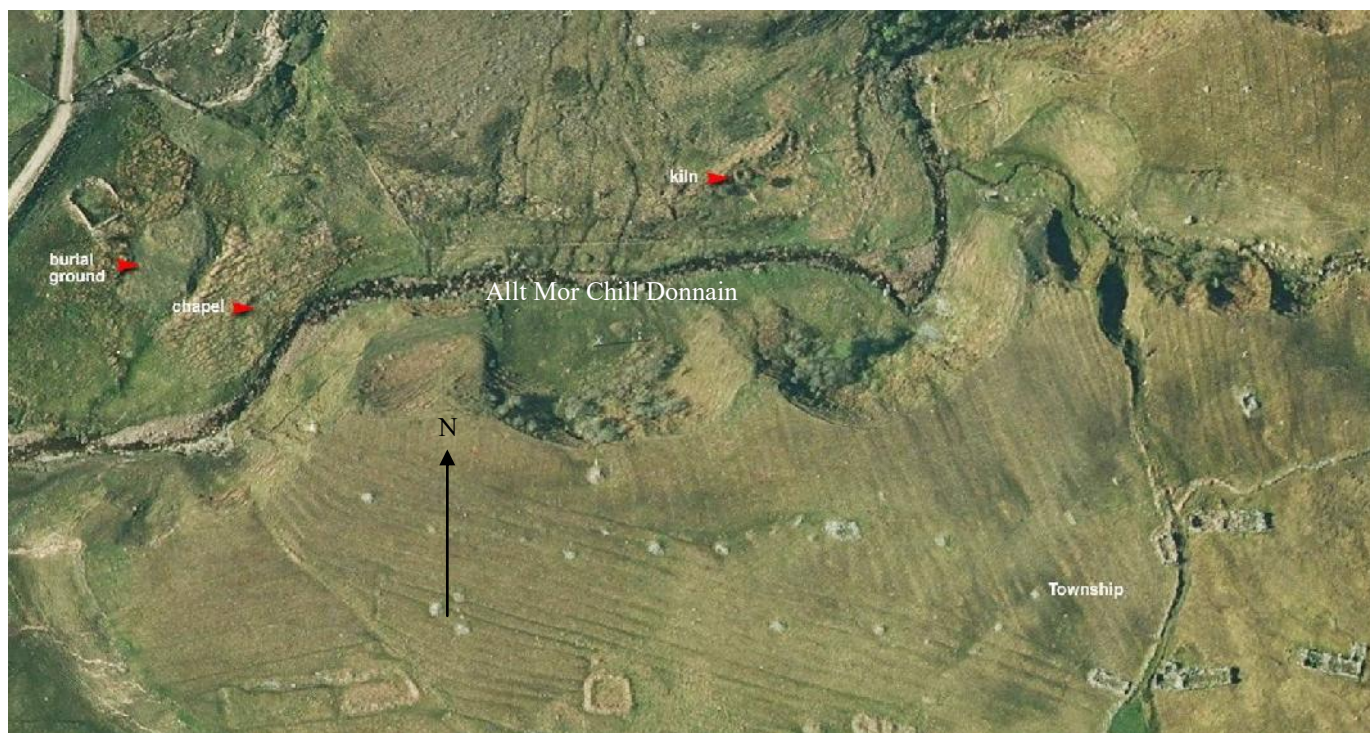
The 1st OS shows all the buildings within the township to be unroofed, however the shepherds house and byre by the shore are both roofed along with the two farmhouses.

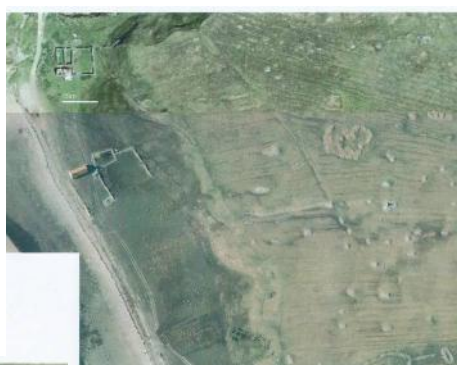
Aerial showing the site of the two shore buildings in relation to the township on the upper slope.

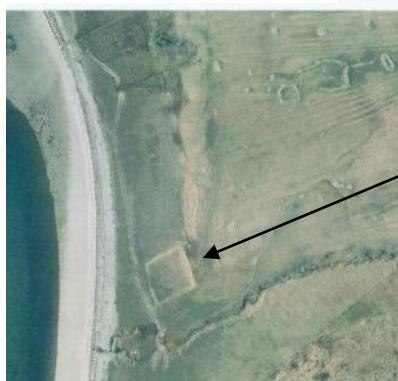
Aerial showing The Square of Cromartie to the S of the shore buildings

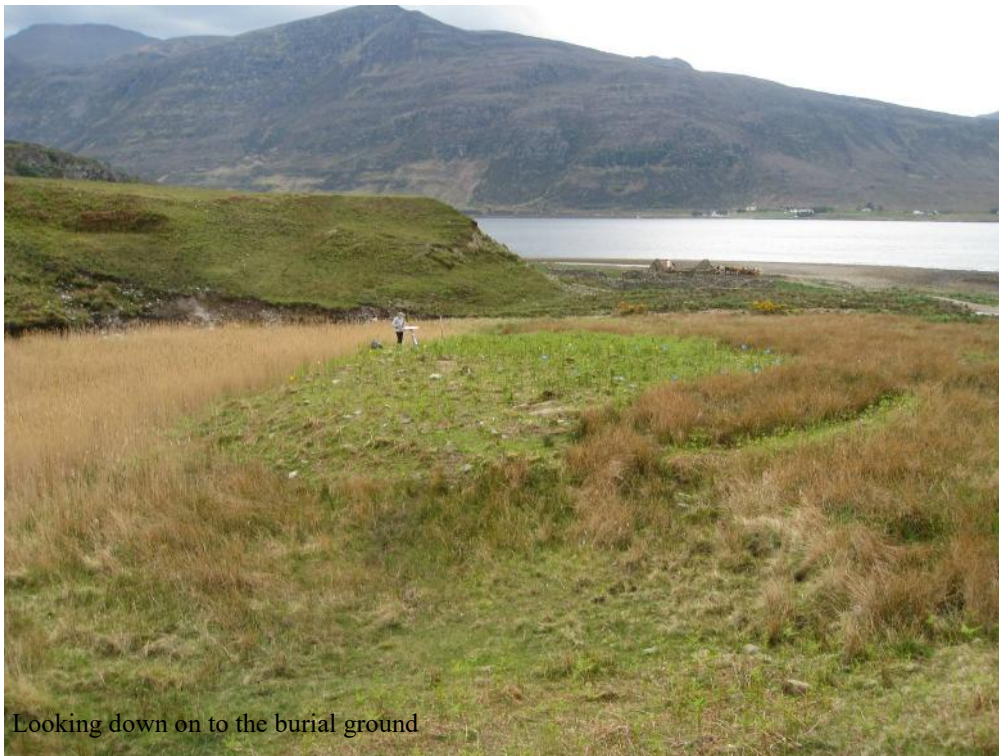
Looking down on to the burial ground

The area is named after the Irish priest/monk Donan (Donnainn)who was martyred on Eigg in AD617 and later made a saint.. He was reputed to have had a monastic cell here and the graveyard and footings of the adjacent possible chapel are associated with him.

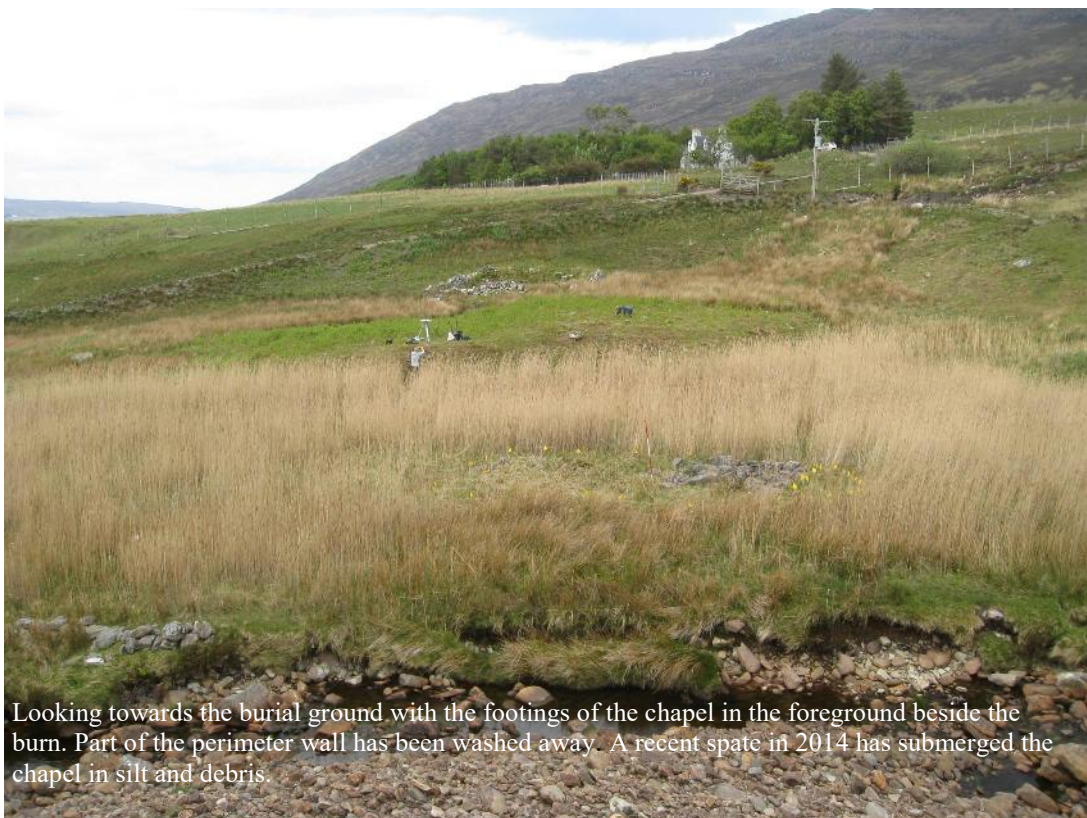
Looking towards the burial ground with the footings of the chapel in the foreground beside the burn. Part of the perimeter wall has been washed away. A recent spate in 2014 has submerged the chapel in silt and debris.

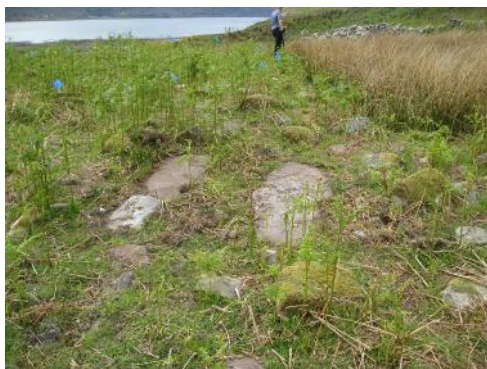
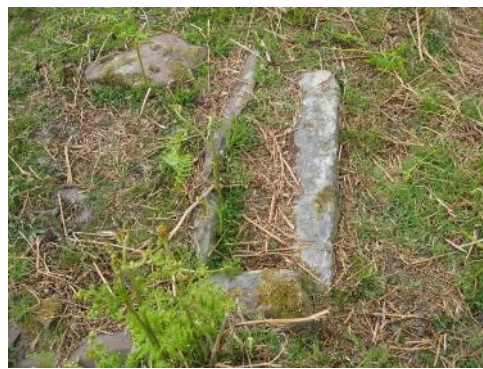
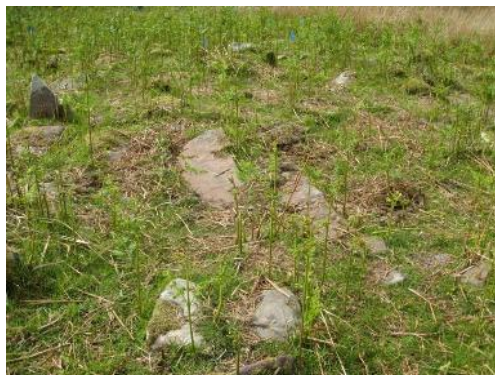
Some of the grave slabs

More grave slabs and markers.

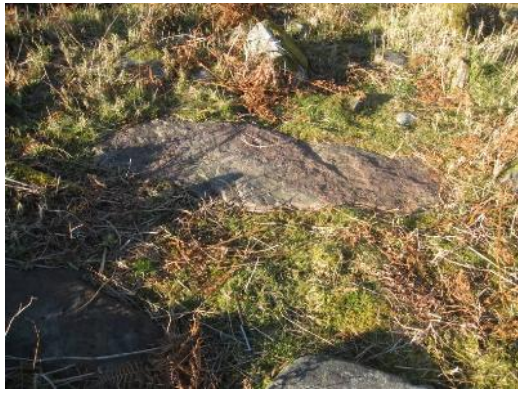
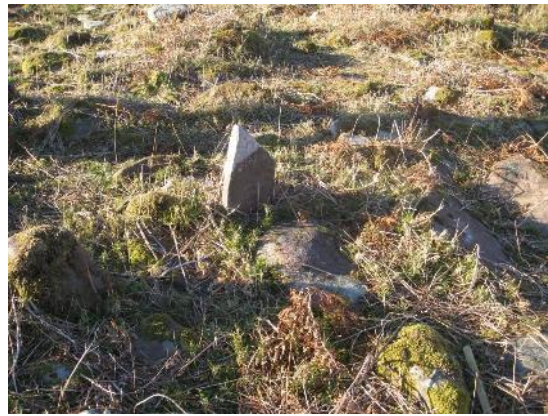
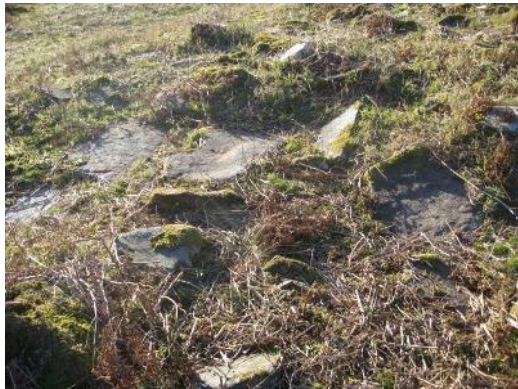
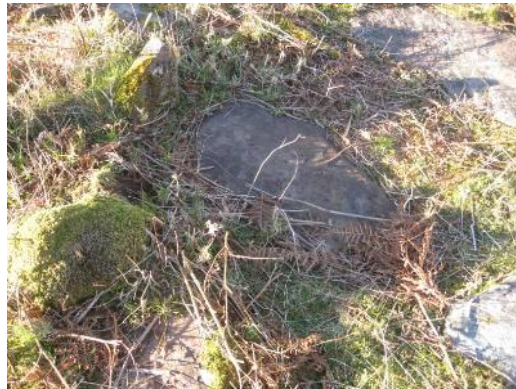
The outline of walls and a mound of stones are all that remains on the chapel site. It is in serious danger of being washed away as the bank of the burn erodes in spates.

Following our survey we were concerned at the damage being done by cattle to the burial ground so with permission and help from Dundonnell estate we have fenced off both the burial ground and the chapel. Access is by gate or stile.

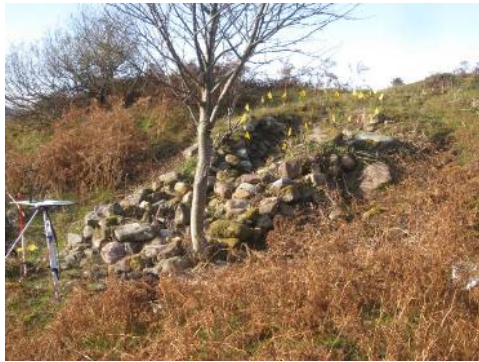
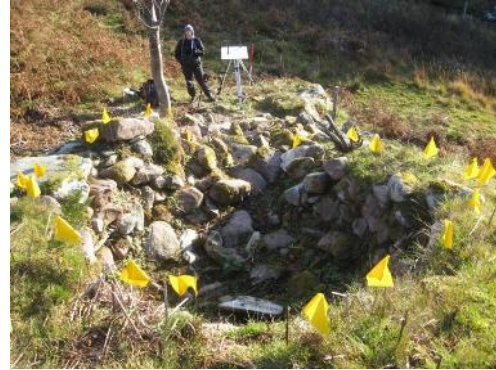
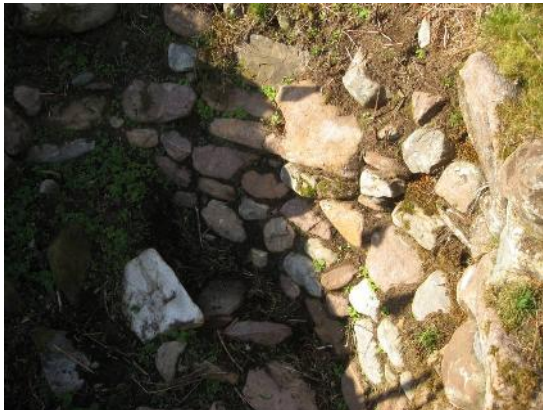
The kiln structure.

Lime deposits and burnt stones

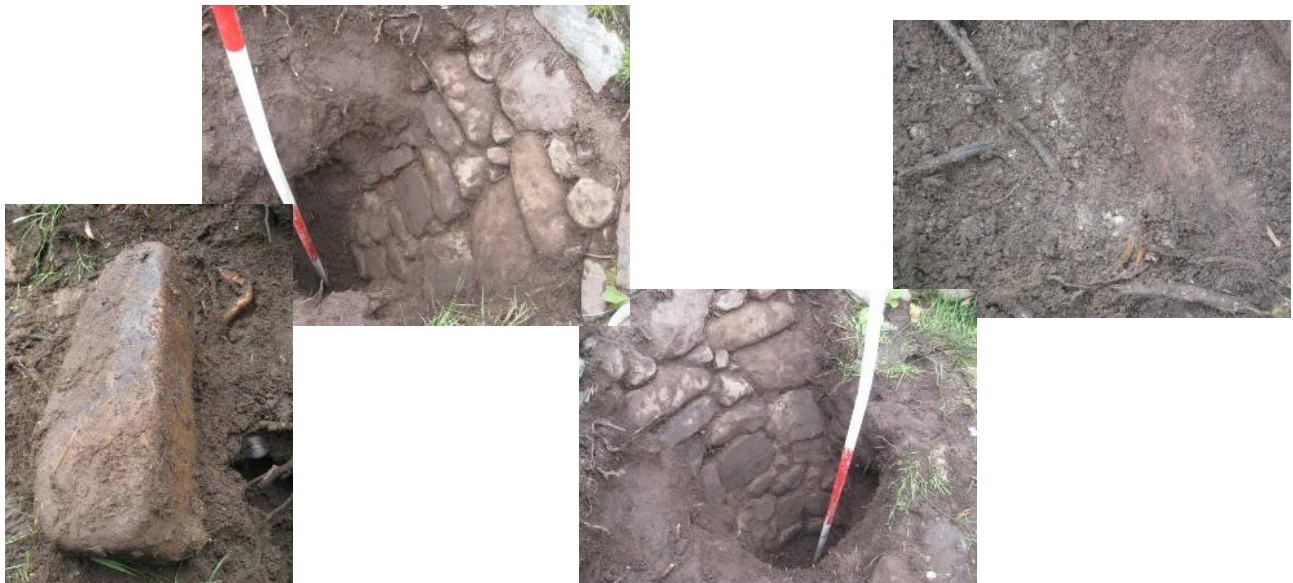
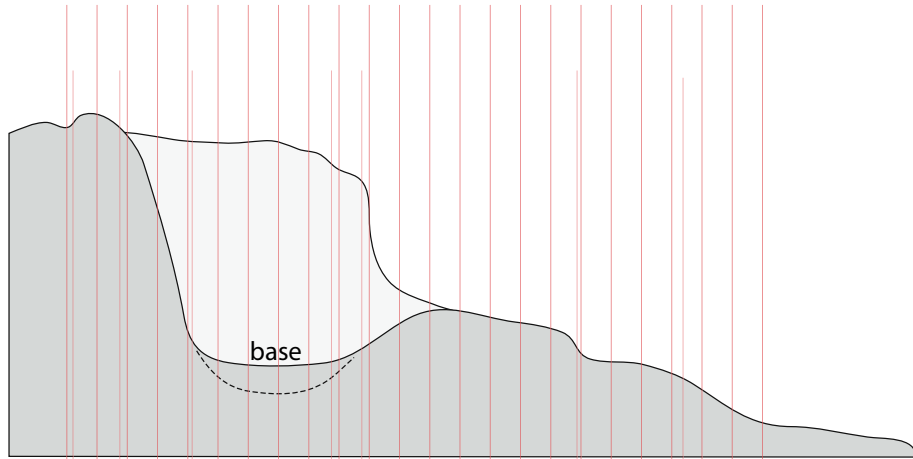
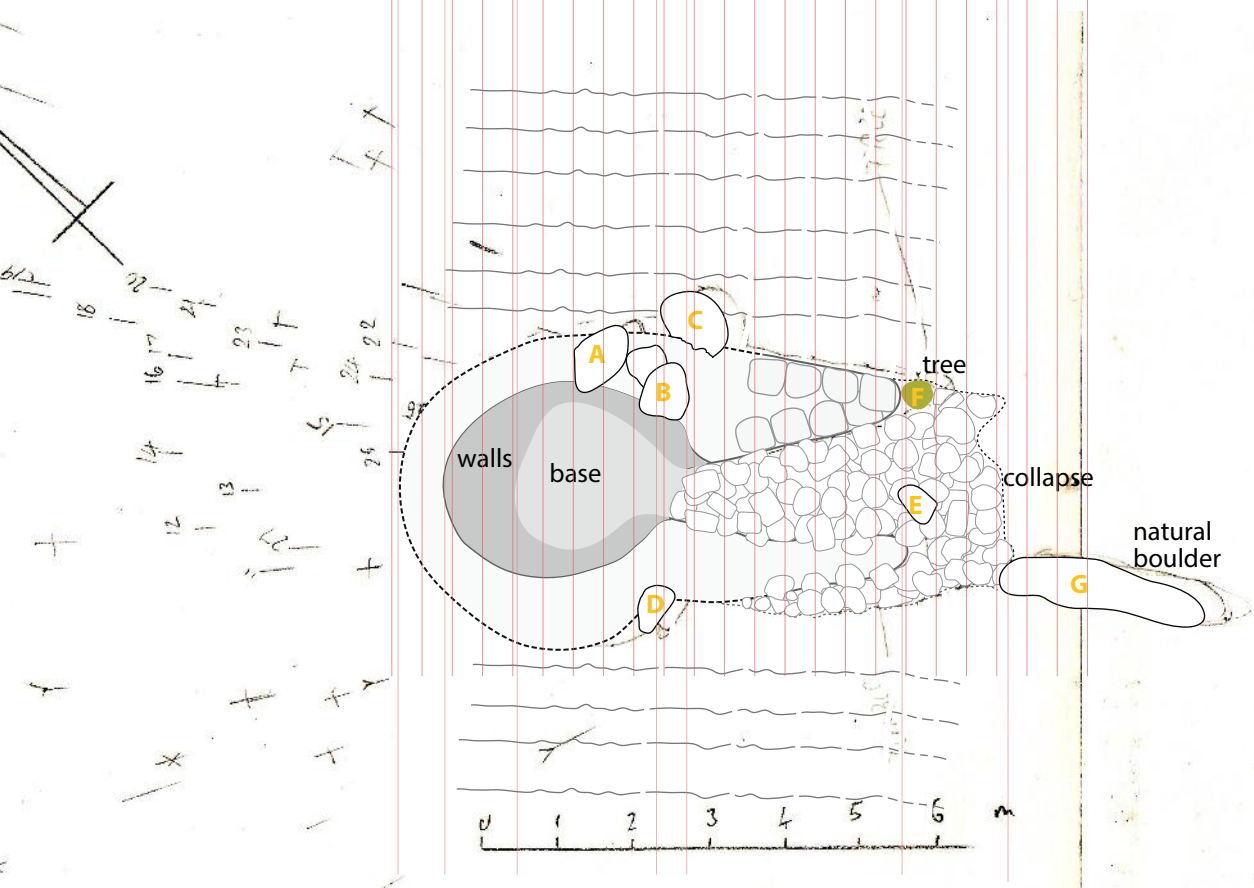
Lime Kiln

Having cleared away the main tumble and plane tabled the structure (see plan), we continued to clear away the debris in one corner of the bowl and found obvious deposits of lime and heat affected stones.

Kildonan, Little Loch Broom
 NH 07991 90986 (elevation 15m)
 Surveyed 05.11.11
 A.MacInnes, M.Buchanan, J.Buchanan

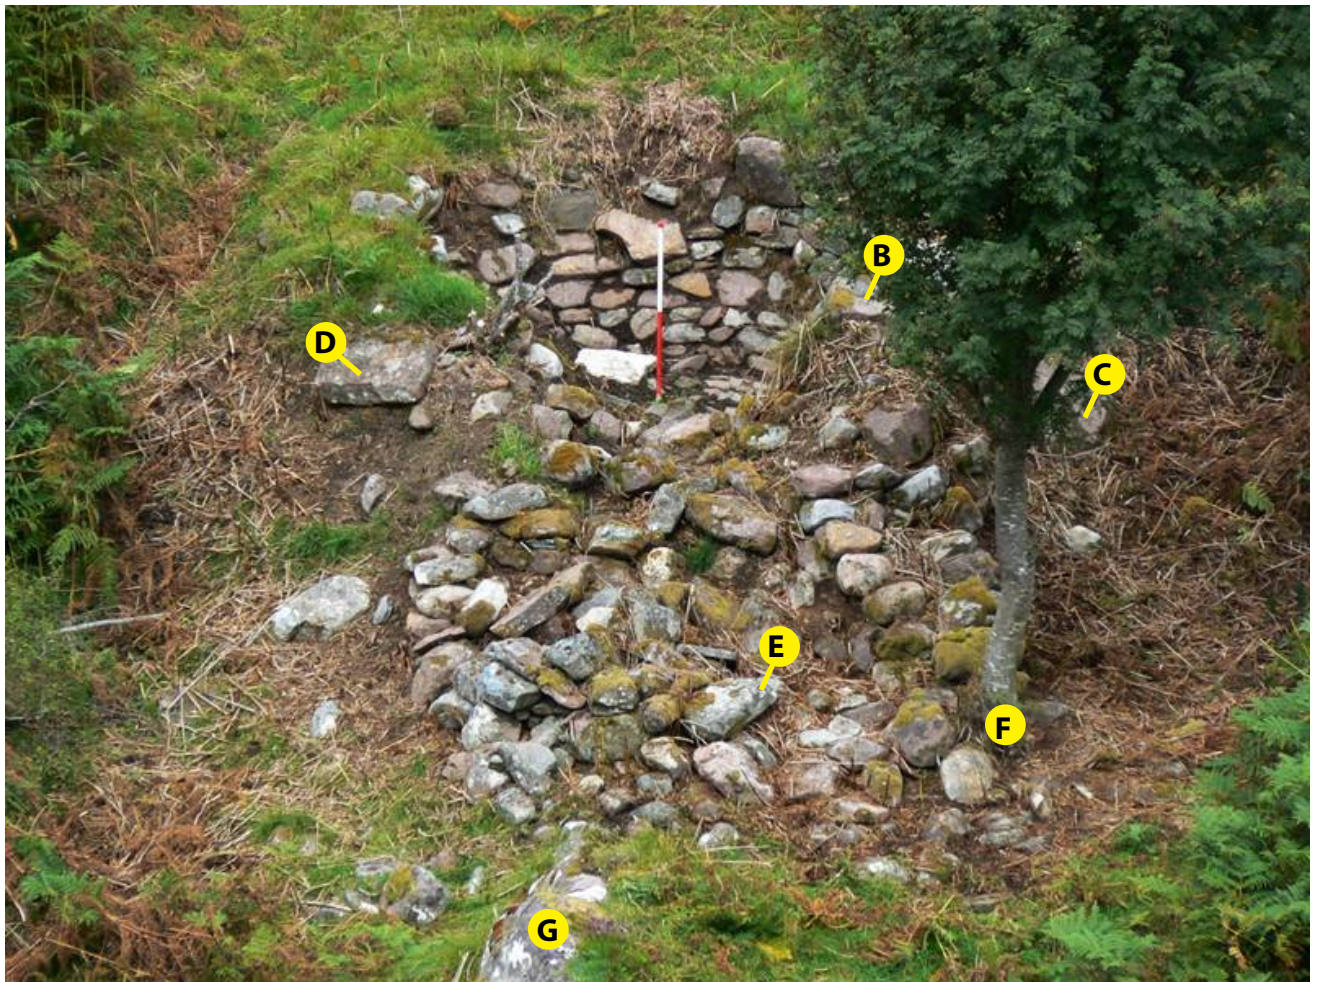
We have also found further up the burn on the same side as the township a smaller corn drying kiln situated at NH 08257 90912 elevation 36m. It is very overgrown but the structure is intact.

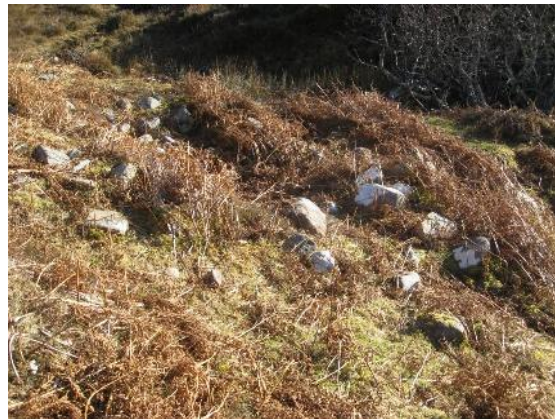
Adjacent to this is a possible older corn drying kiln situated at NH 08273 90916 elevation 34m

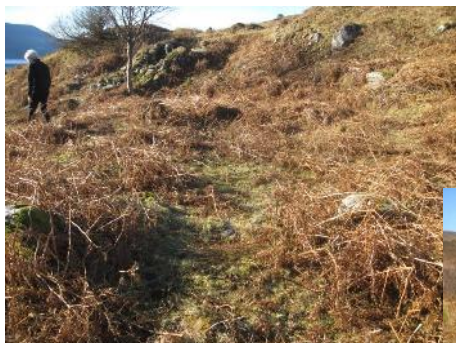
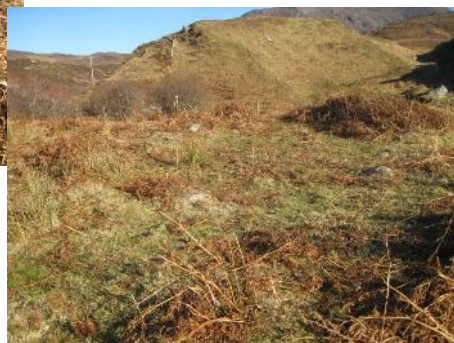
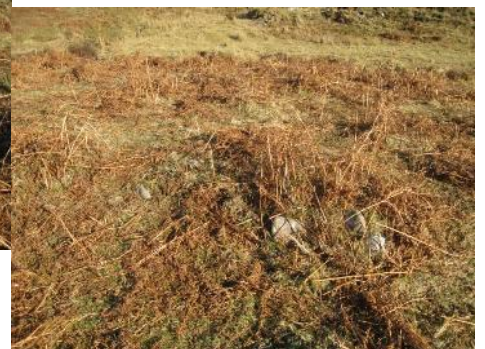
Beside the lime kiln are the footings of 3 buildings mentioned in previous walkover surveys.

NH 08004 90988 elevation 10m measuring 3 x 5m

NH 08016 90995 elevation 15m measuring 3 x 5m

NH 08034 90980 elevation 12m measuring 2 x 4m

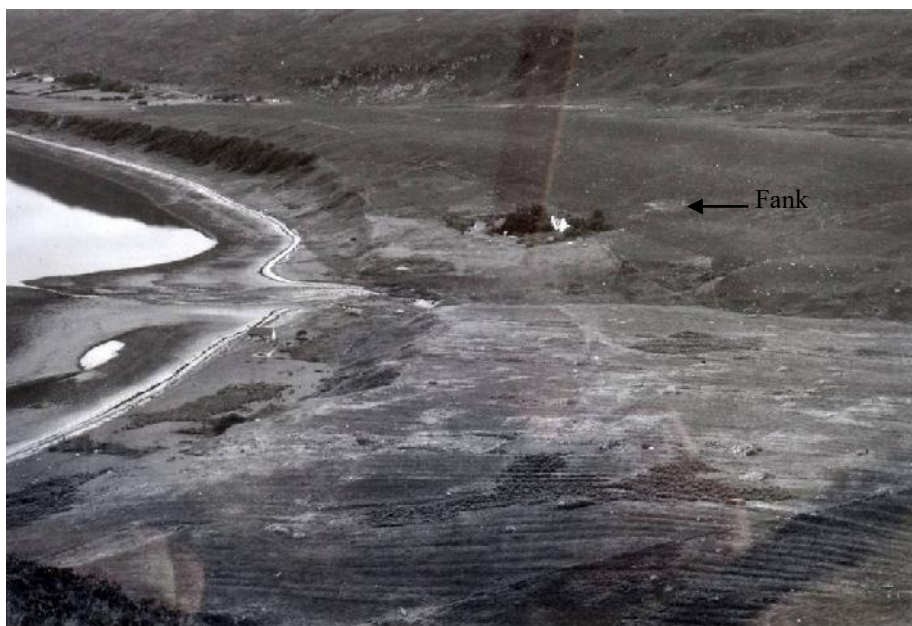
An old photo showing Kildonan House in relation to the township.

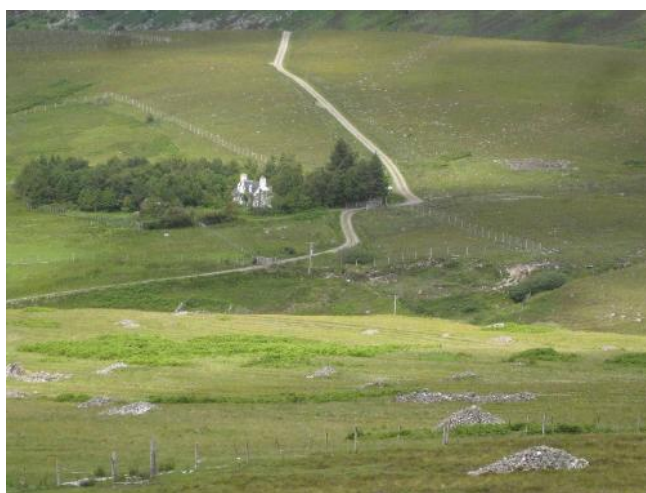
Kildonan House today showing the new track that runs down the hillside from the road above.

The house lies on a SW facing slope above Little Loch Broom. The structure is still roofed but damage unless repaired will lead to deterioration of the house. It has remained unoccupied since 1996. The 1st OS shows both the present house built in 1851 and the earlier house as roofed. It is not known if the earlier house post dates the township, being built when the sheep farm was established, but its construction of dressed stone unlike the ruins within the township, suggests this.

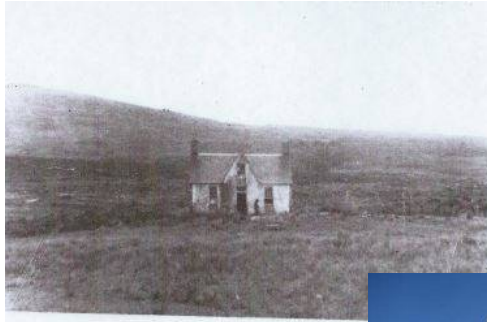
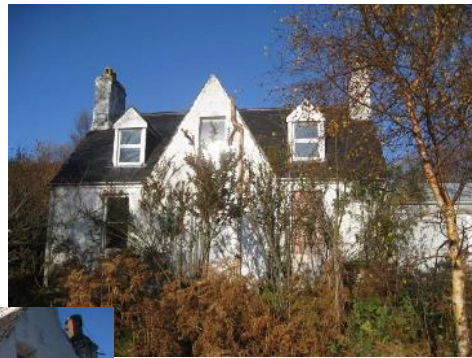
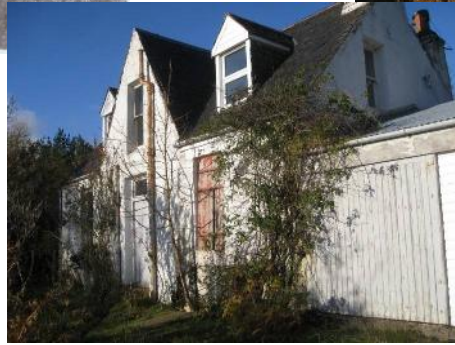
Kildonan house as it is at present, in comparison to 1932.

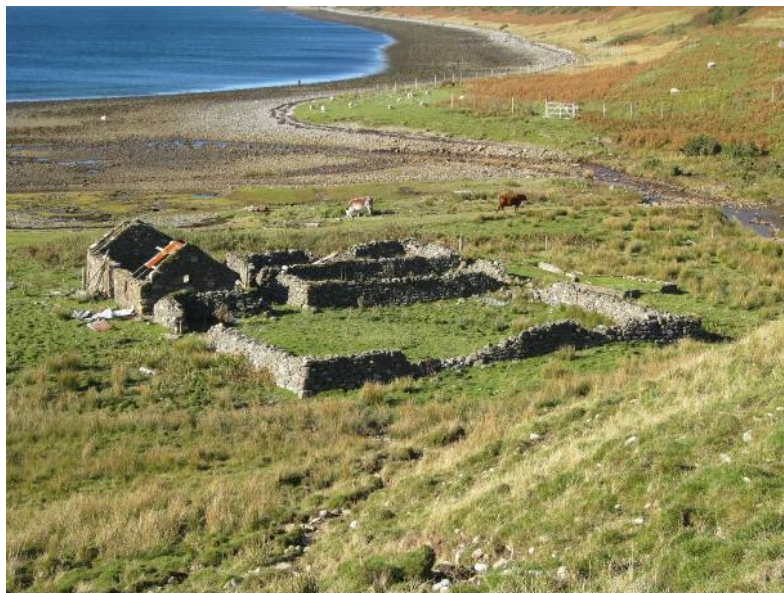
The ‘Byre’

The 'byre' is now unroofed with only remnants of corrugated iron roof left. However the walls remain upstanding (see plan). To the front there is a doorway and one window, and in the rear wall an opposing door. The E. gable wall has a small window.

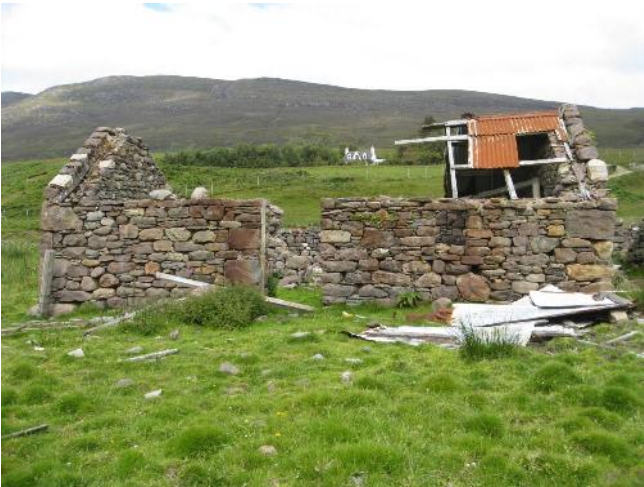
The walls are constructed with dressed stone which has been layered, and around the doorway and at the corners of the building are larger dressed stones. There is snecking between the larger stones to make it wind and watertight.

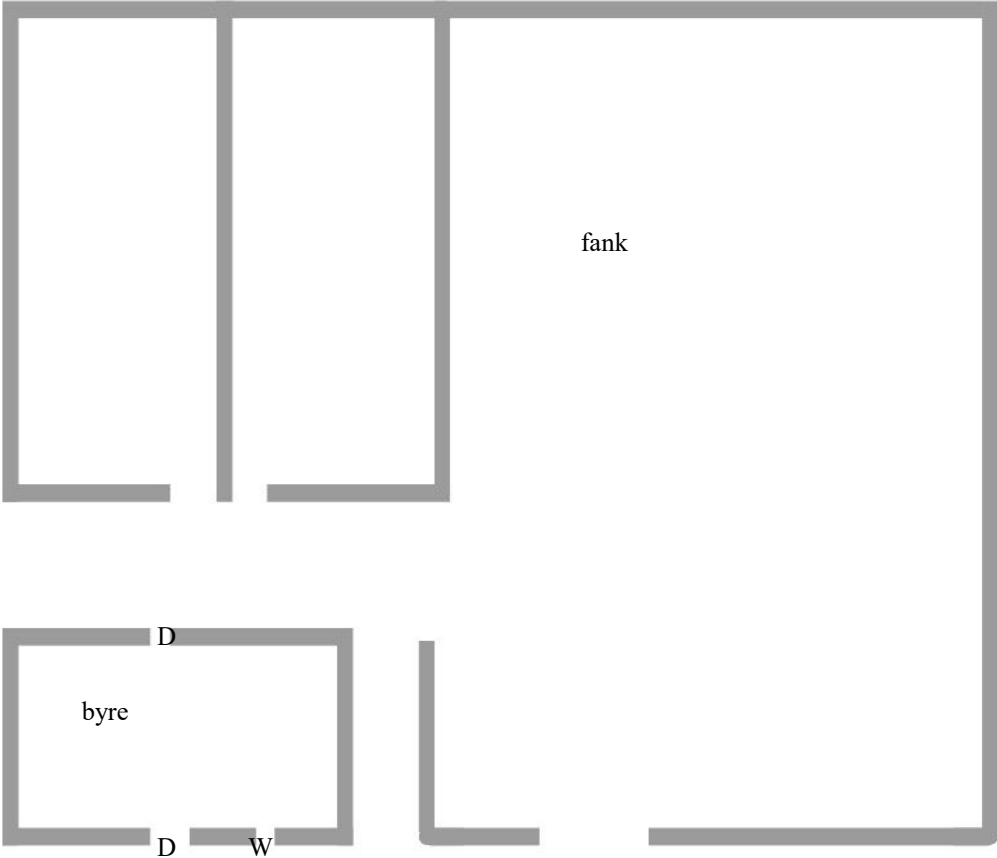
Kildonan Byre, Fank & Dip

The walls of the surrounding sheepfold are still largely intact, and are neatly constructed with layered dressed and chosen stone. (see plan) The dipper also remains in good condition.

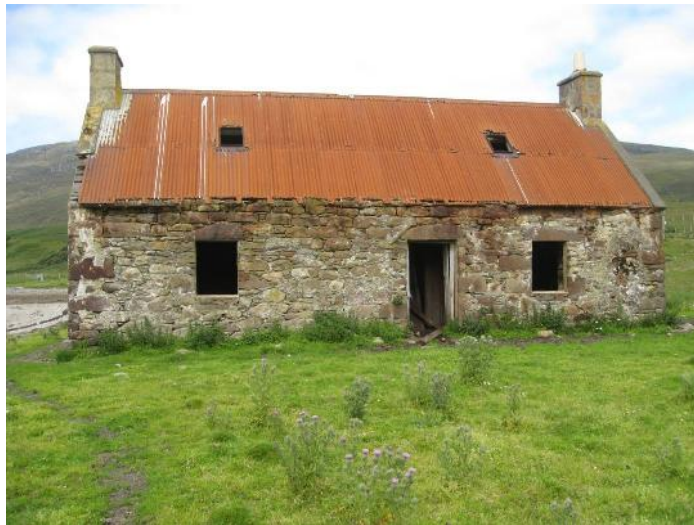
This building is still roofed with corrugated iron which has two skylights to the front elevation, and one to the rear.

The walls are constructed with layered dressed stone that has had some harling over them. This is now breaking off. To the front there is a doorway with two windows and to the rear one small window. There is a chimney at each gable. Above the doorway and windows there are large lintel stones.

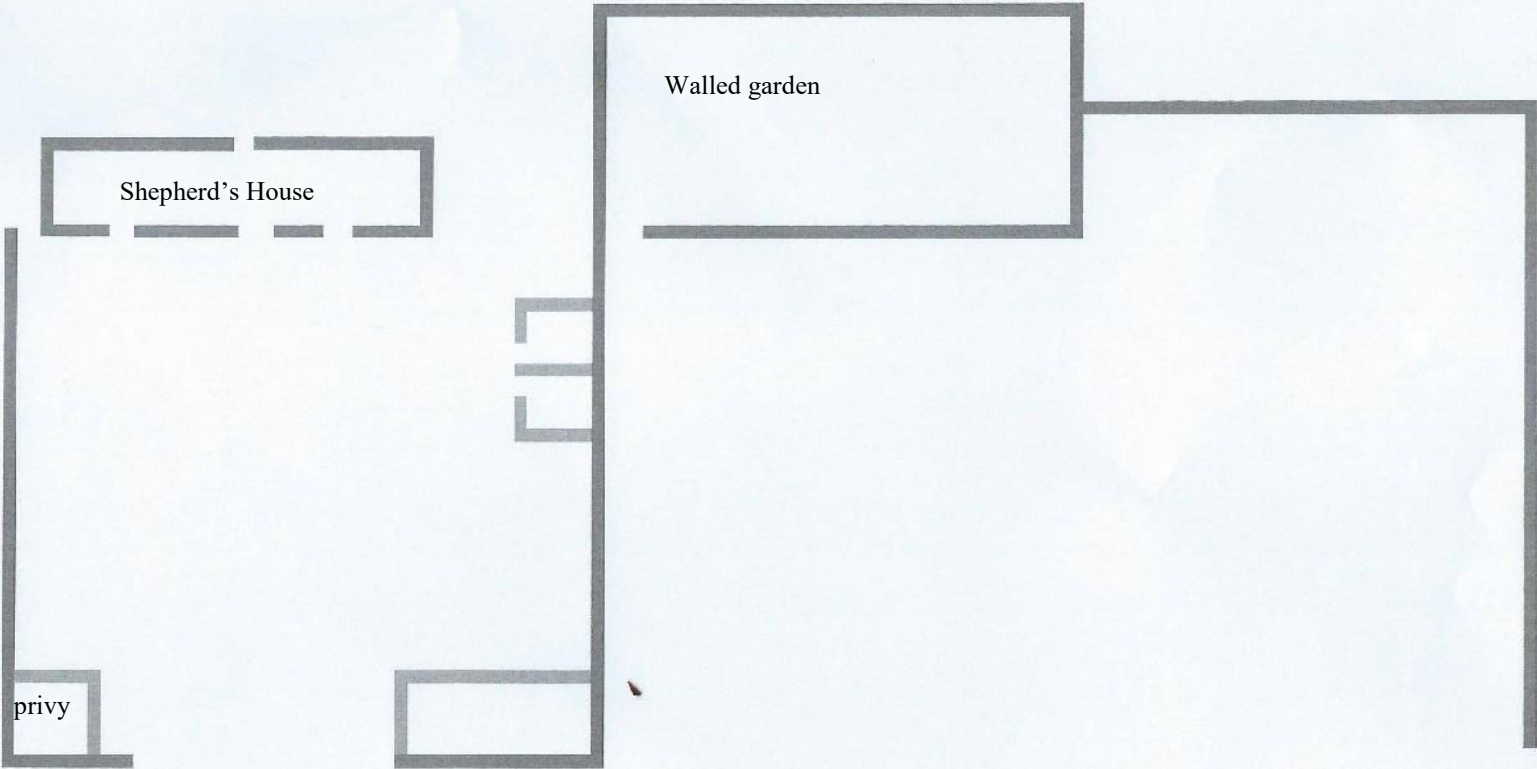
Kildonan Shepherd's House & Enclosure

Within the building the two fireplaces and floor of the upper rooms can be seen. It was too dangerous to attempt to see into the upper floor.

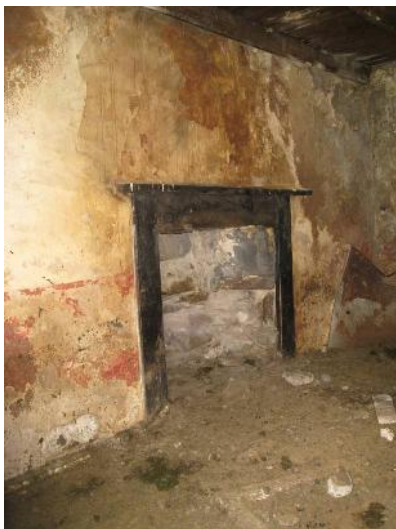
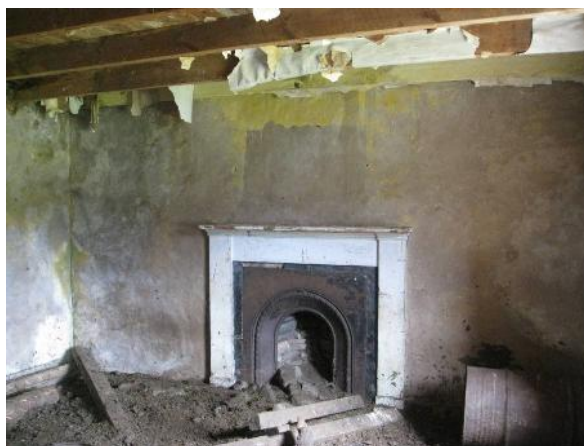
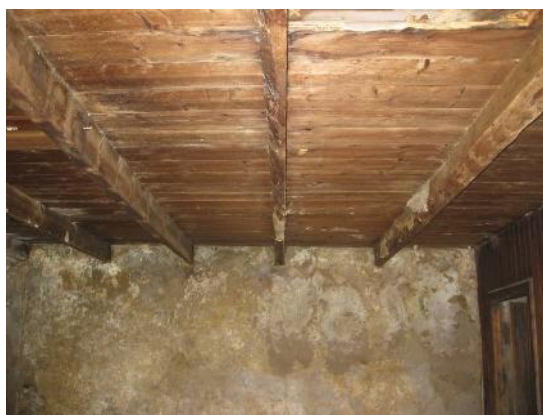
As can be seen the walls were whitewashed.

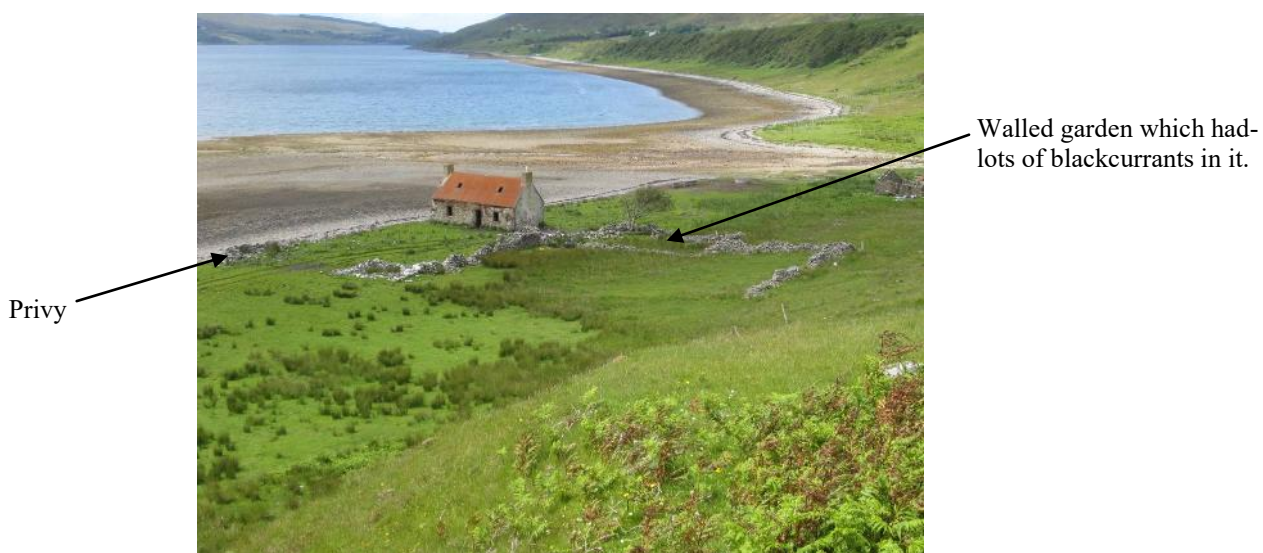
The building is surrounded by the remains of an enclosure marked on the 1st OS. Local knowledge indicates the later use of part of the enclosure. The ruins of various outhouses remain (see plan) There was no evidence of the well marked on the 1st OS map.

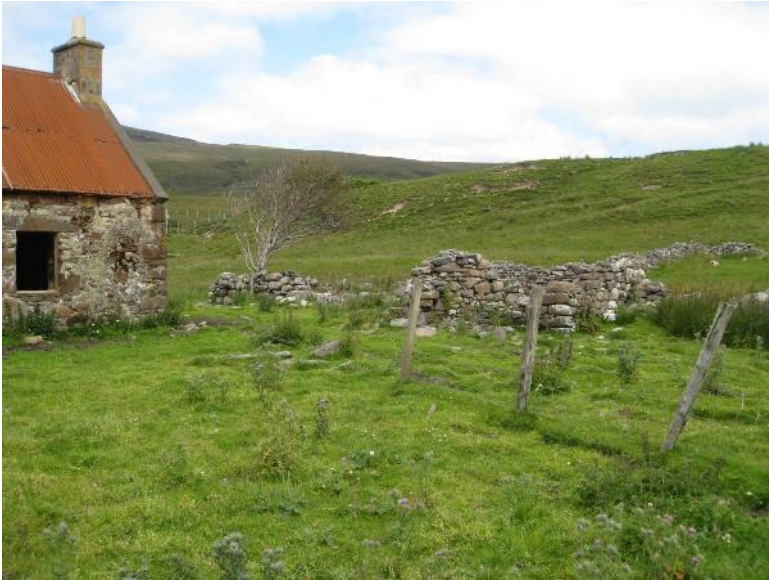
The walled garden as marked on the 1st OS

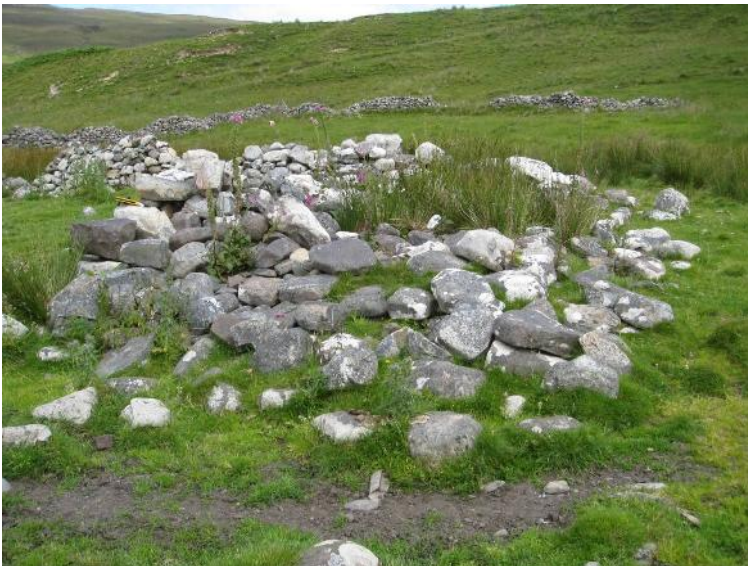
The ruins of the two outbuildings also shown as roofed on the 1st OS.

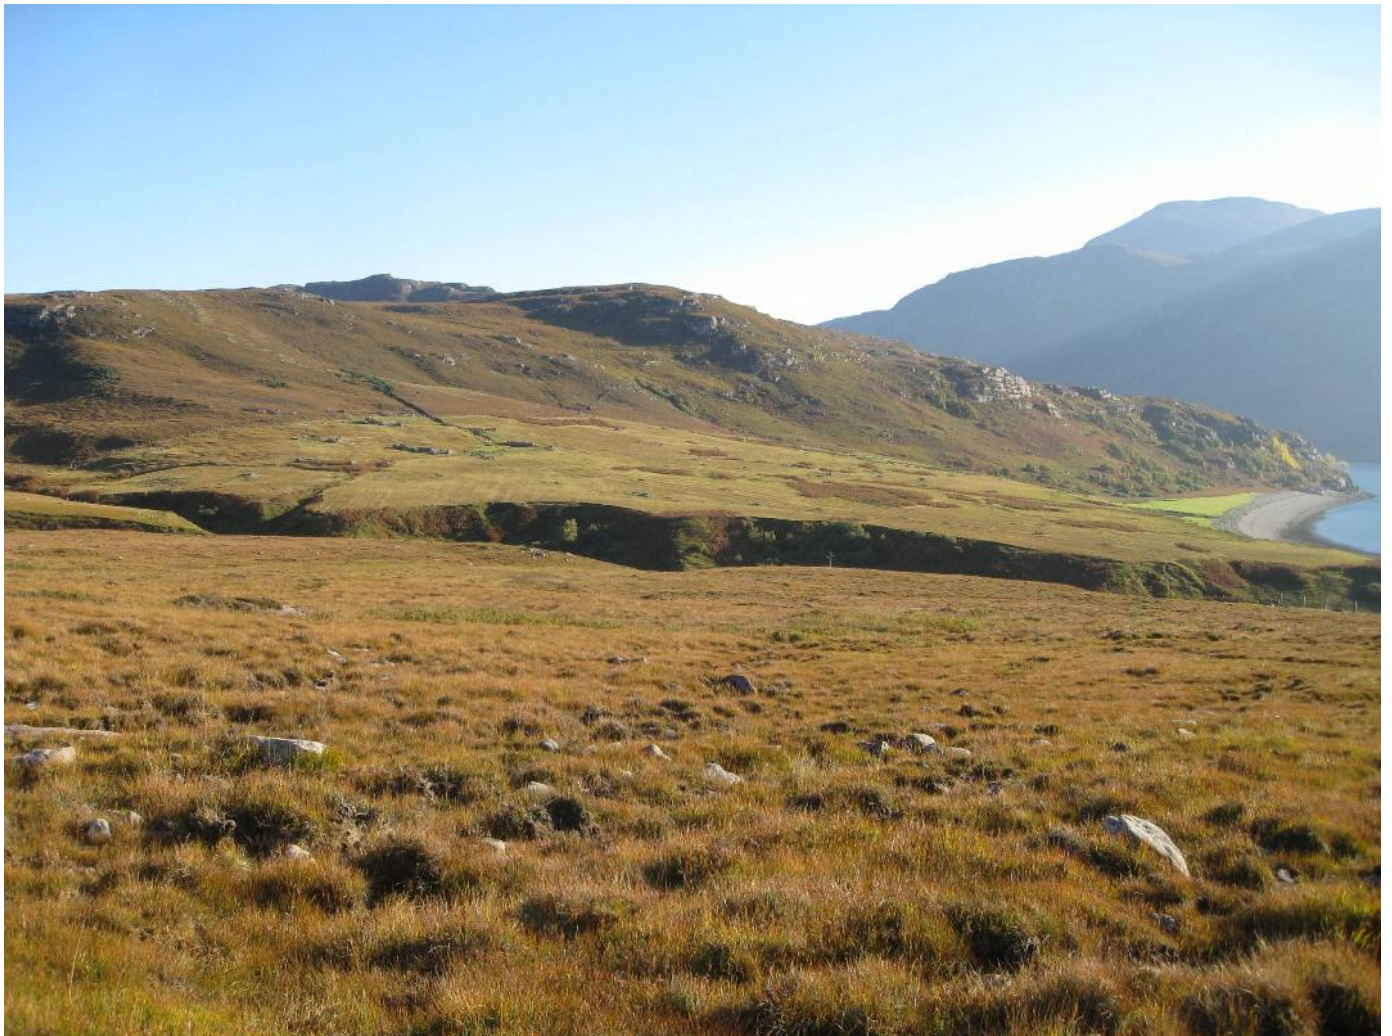
Looking South across the moor to the Township. The steep sides of the Allt Mor Chill-Donnain can be seen.

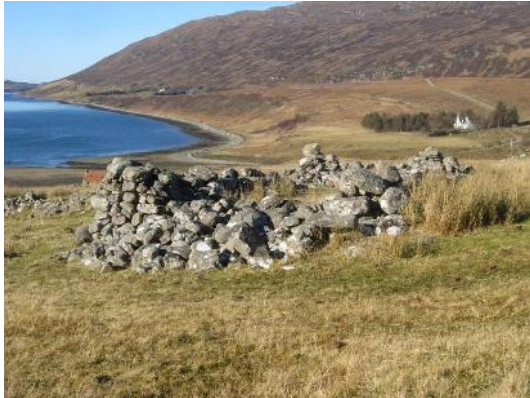
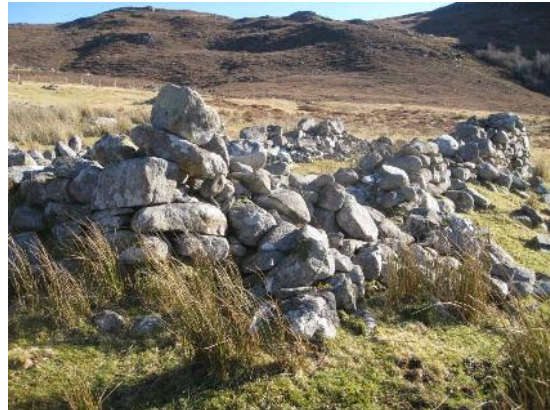
1. Footings of building measuring 4.10 x 9.7m. NH 08035 90666 elevation 46m The walls are constructed with undressed boulders with the remaining walls averaging 0.6m in width to a maximum height of 1.2m. There is a door opening in the S. facing wall which is down slope and beyond this a narrow terrace is built up. No evidence of any windows.

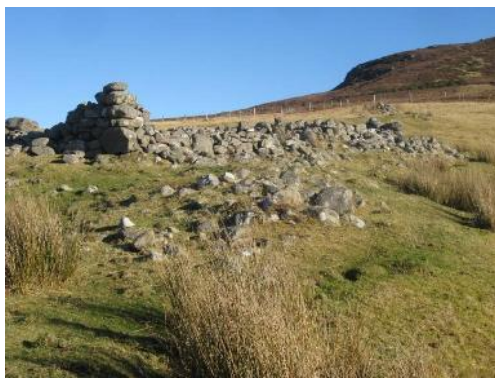
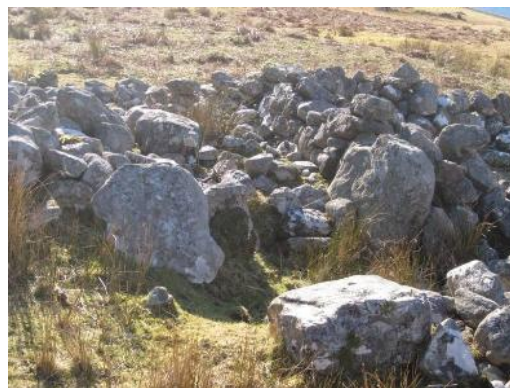
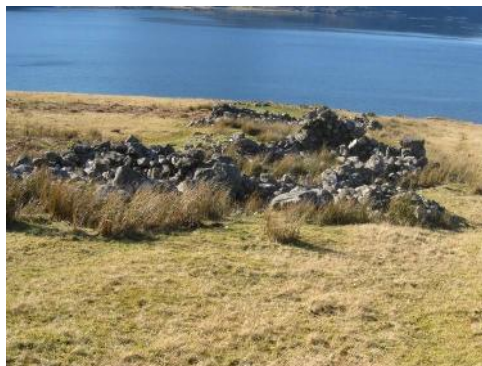
2. Footings of building adjacent to and upslope from building 1. NH08063 90673 elevation 47m. The building measures 12.5 x 4.8m with an inner dividing wall at 9.4m. There is a door opening on the N. facing wall with two large upright stones marking a possible entrance to the smaller section of the building, a probable byre. The walls are constructed with undressed boulders with an average width of 0.7m to a maximum remaining height of 1.3m on the gable end. The inner dividing wall has a width of 0.5m.

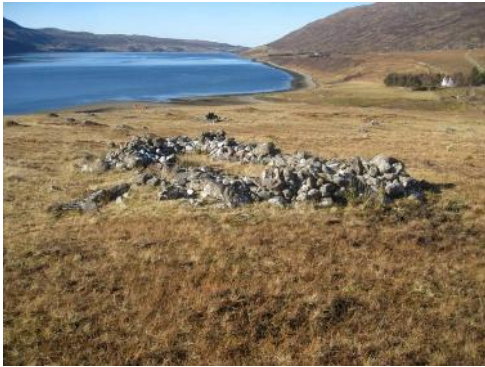
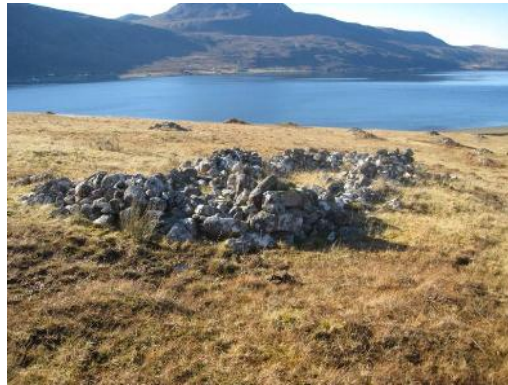
3. The footings of a building measuring 11.10 to 4.40m. NH 08074 90747 elevation 45m. The building is constructed with undressed boulders to a maximum remaining height of 0.5m and a width of 0.6m. There is a door opening in the S. facing wall but no evidence of any windows.

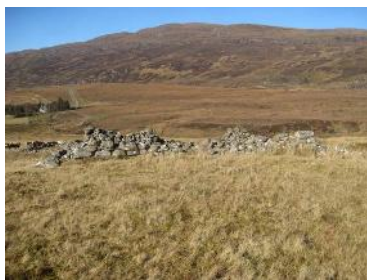
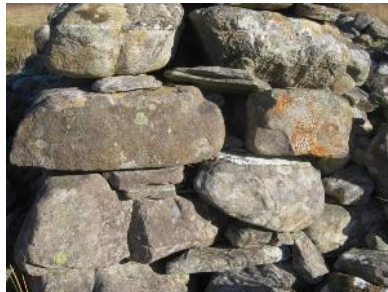
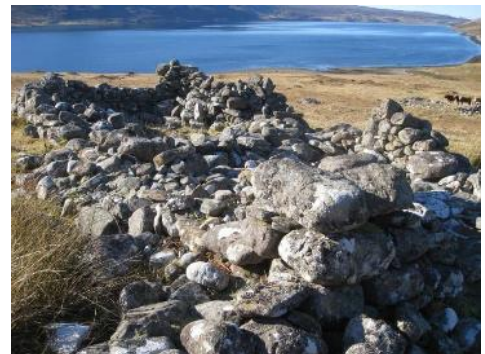
4. The ruin of a building measuring 8.0 x 3.8m. NH 08122 90794 elevation 52m. The building is mainly constructed with undressed boulders with some chosen stones with some layering. It has an inner dividing wall at 4.6 m along the S. wall with evidence of a door opening on this wall. There is no evidence of any windows. The walls, including the dividing wall, average 0.5m in width to a remaining maximum height of 1.0m.

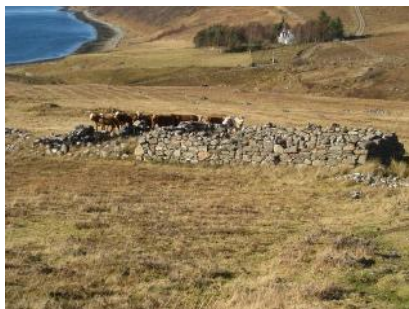
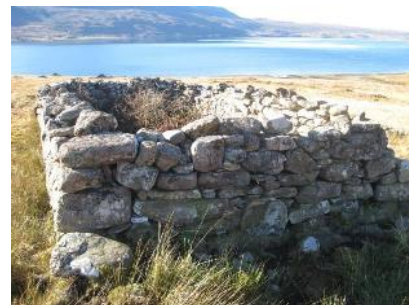
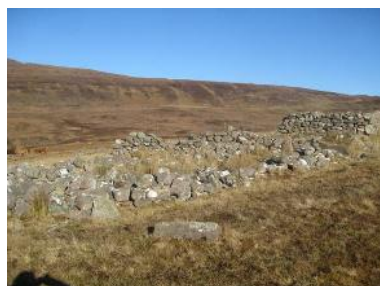
5. The ruin of a house with adjacent sectioned barn/byre. NH 08089 90815 elevation 48m. The house is constructed with layered chosen stones with a dividing wall and doorway, no visible windows, and measures 14.4 x 4.5m. The barn/byre is constructed with boulders, has 3 sections with one measuring 4.0 x 8.9m, no visible doorway, and at right angles to this the other two sections totalling 10.0 x 6.6m with two visible doorways. Attached to this section is a field wall leading off in a N. direction.

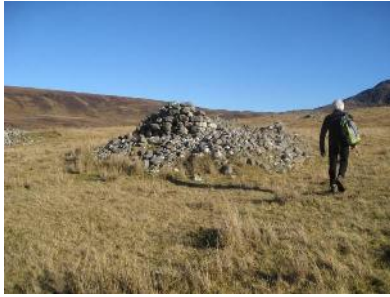
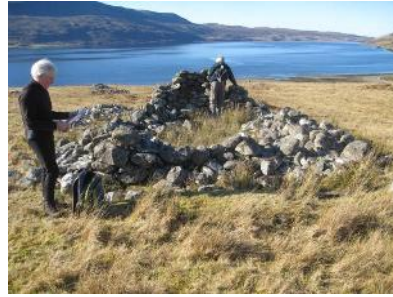
6. Ruin of building measuring 6.5 x 3.7m. NH 07997 90771 elevation 31m. The walls are constructed with undressed boulders to a maximum height on the W. gable of 1.3m with an average width of 0.5m. There is a door opening on the S. facing wall but no remaining evidence of any windows.

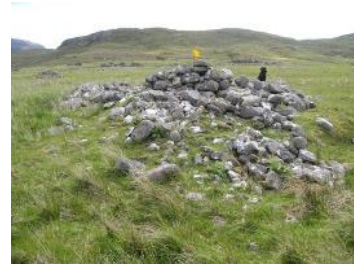
7. Ruin of building measuring 7.4 x 4.3m. NH 08024 90888 elevation 3.2m. The walls are constructed with undressed boulders to a maximum height of 0.8m on the W. gable wall with an average width of 0.6m. There is a door opening on the S. facing wall but no remaining evidence of any windows.
