A Survey of Kildonan Township

2011

Kildonan, Little Loch Broom

Kildonan Township
Kildonan, Dundonnell
Centred on NH 0782 9097

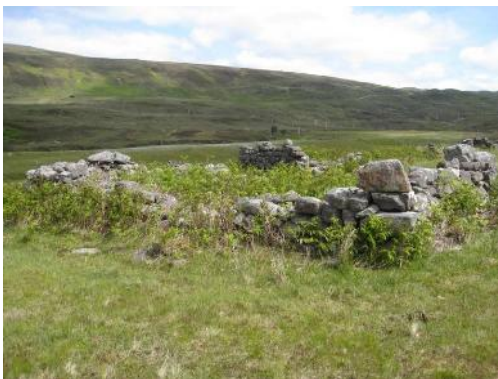
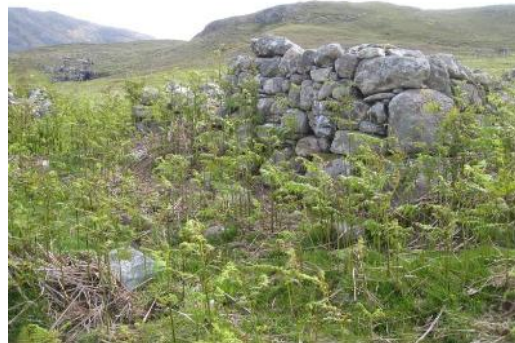
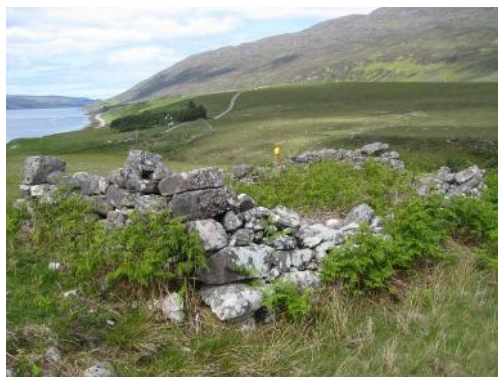
8. Ruin of building measuring 8.1 x 5.4m. NH 08104 90885 elevation 34m. The walls are constructed with undressed boulders with large boulders at the base of the walls. The walls stand to a maximum height of 1.1m and an average width of 0.7m. There is a door opening on the E. facing wall but no evidence of any windows. A platform of stones 2m in width runs along the external side of the NE gable wall, and a stone dyke leads away from the SE corner of the building.

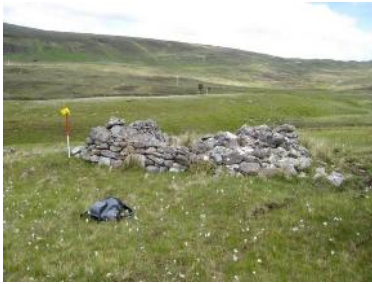
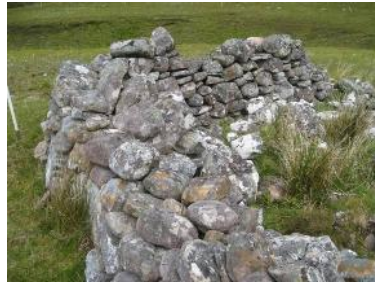
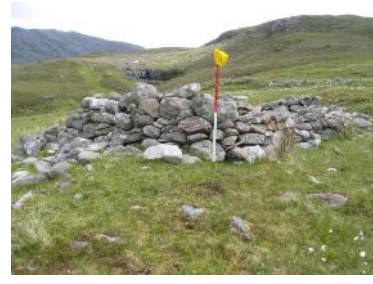
9. Ruin of building measuring 4.4 x 3.3m. NH 08127 90921 elevation 33m. The walls are constructed with undressed boulders to a maximum remaining height of 0.7m and an average width of 0.7m. There is a door opening in the NE corner of the building but no remaining evidence of any windows. An external platform of stones 2m in width runs the width of the N. gable wall.

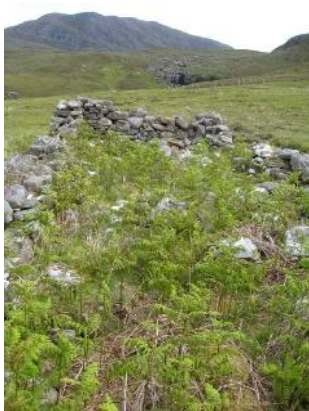
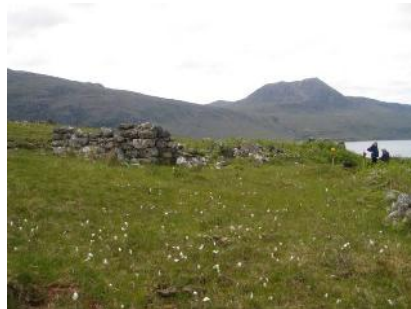
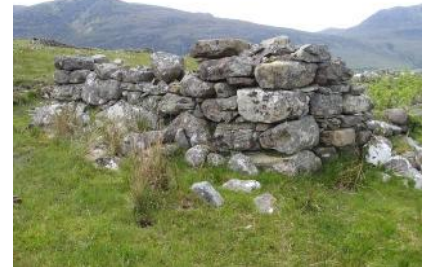
10. Ruin of a building measuring 19.9 x 4.6m. NH 08124 90891 elevation 36m. The walls are constructed with chosen flat boulders with some layering and rise to a maximum remaining height of 1.3m with an average width of 0.7m. The ruin has a dividing wall at 8.2m along its length with a width of 0.9m. This wall is only 4m long centrally placed thus leaving a gap at either end for access between the compartments. The only external door opening is on the N. facing wall, with no evidence of any windows. To the S. side of the building there is an external ditch running the full length and to the N. side there is a midden.

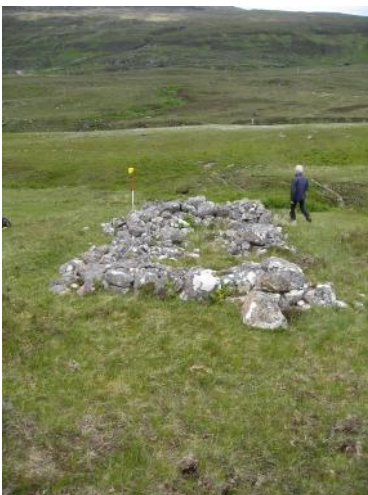
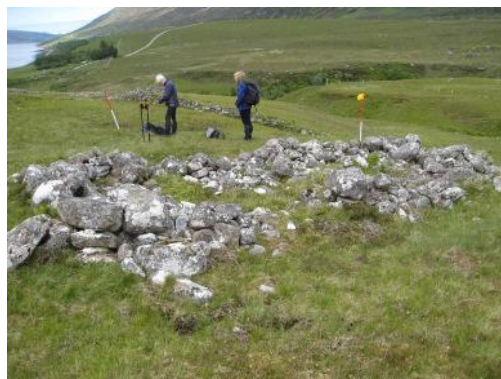
11. Ruin of a building measuring 7.5 x 3.3m. NH 08188 90893 elevation 45m. The walls are constructed with undressed boulders to a maximum remaining height of 0.5m with an average width of 0.7m. There is a door opening on the E. Wall but no remaining evidence of any windows.

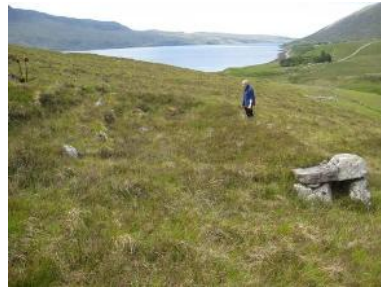
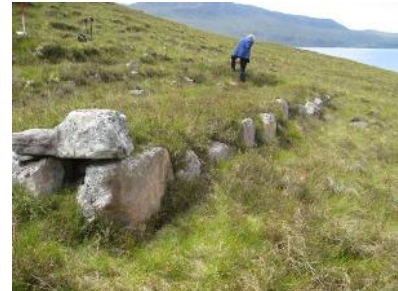
12. Grass covered footings of a building measuring 9.8 x 4.5m. NH 08262 90852 elevation 55m. There is a base of large boulders with a well defined edge remaining to a height of 0.7m with a width of 0.9m. Within the building there are the remains of a drain leading to the door opening on the N. downslope wall. Externally a ditch runs along the E. And S. uphill walls.

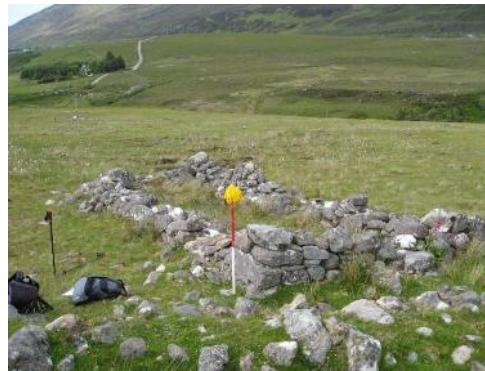
13. Ruin of a building measuring 9.3 x 3.3m. NH 08096 90842 elevation 37m. The walls are constructed with undressed boulders to a remaining height of 0.9m with an average width of 0.5m. There is a door opening on the N. facing wall but no evidence of any windows.

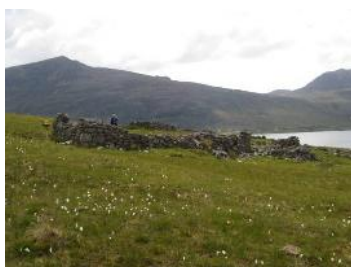
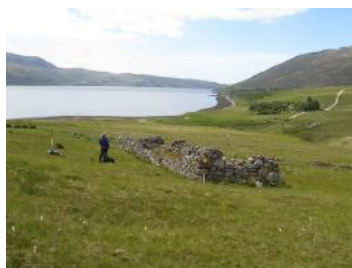
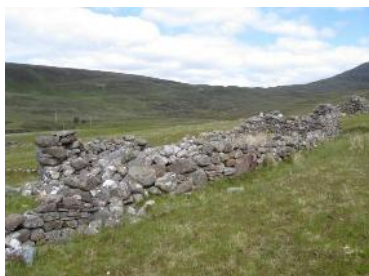
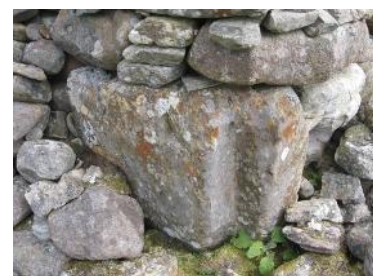
14. Ruin of a phased building with one section measuring 8.3 x 3.9m which is butted on to the larger building measuring 11.7 x 4.4m. NH 08107 90843 elevation 42m. The walls are constructed with some chosen but mainly undressed boulders to a maximum height of 1.5m with the walls in the main building averaging 0.9m width and 0.5m wide in the rougher smaller building. There is an outshot measuring 3.8 x 3.8m on the N. facing wall of the smaller section and from this a stone lined midden measuring 7 x 7m is clearly visible. There are two door openings on the N. facing wall, one for each section. At the door entrance in the smaller section is a partially dressed boulder. Along the S. external wall there is a ditch running the full length of the two buildings.

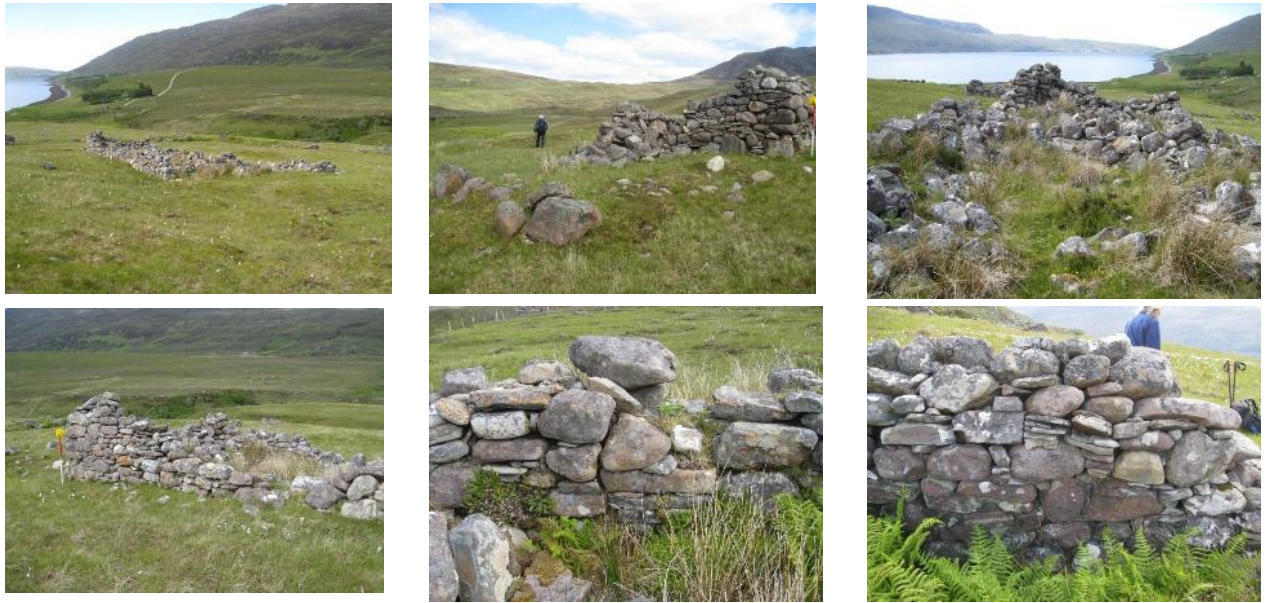
15. Ruin of a building measuring 15.5 x 4.3m. NH 08150 90850 elevation 45m. The building is constructed with a mixture of boulders and selected stone with some layering and snecking. The walls average 0.7m to a remaining height on one gable of 1.8m. The building is divided by a wall at 6.9m along its length which has a doorway in it, and there is a further doorway on the N. facing wall. No remaining evidence of any windows. There is an outshot measuring 4.8 x 3.10m butted on to the NE corner of the building with a doorway on to the hillside. No access into the building. A platform measuring 5 x 4m has been built out from the building on the W edge. 4m distant from the building on its N. side lies a 6m diameter midden.

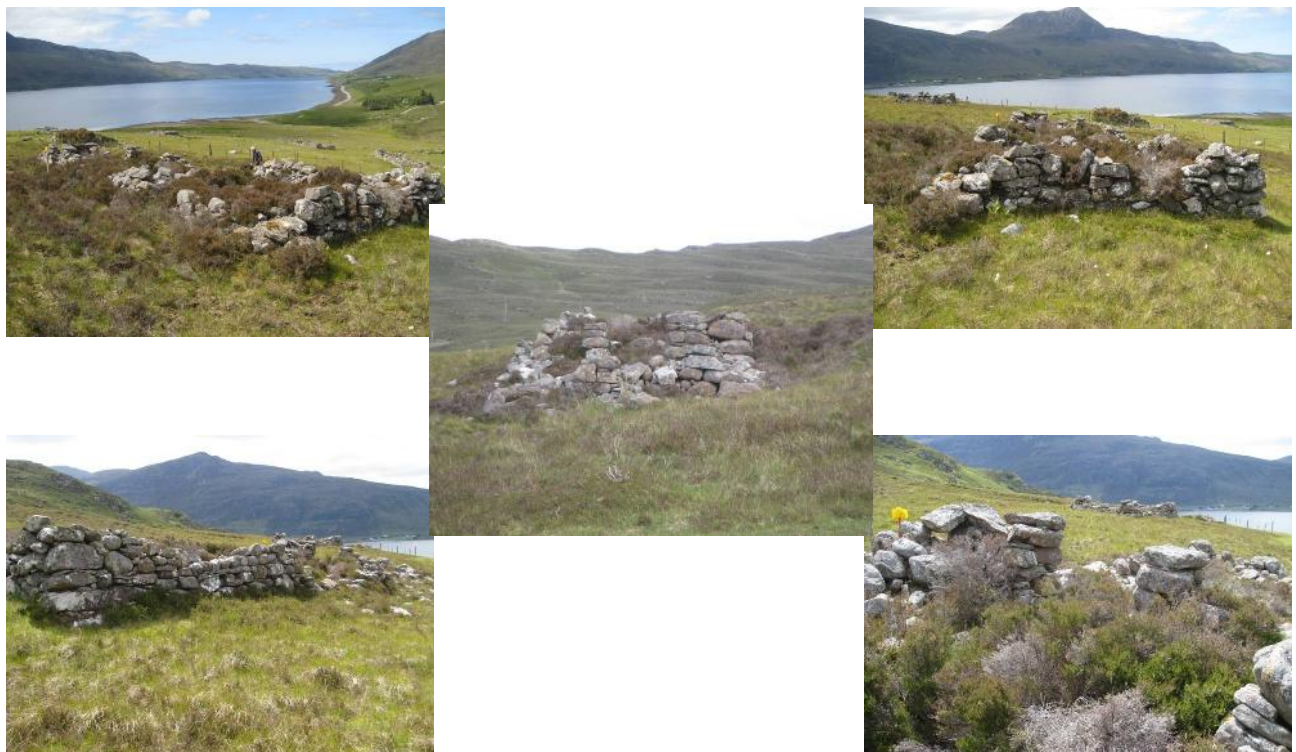
16. The ruin of a substantial building measuring 19.6 x 4.8m. NH 08202 90816 elevation 61m. The building is constructed with large boulders and some chosen stones, and has two dividing walls at 6.8 and 12m along its length. The walls remain to a maximum height of 1.2m with an average width of 0.7m. There are two doorways one on the N side of the building, and a wide doorway within the southernmost dividing wall. This has a column of boulders stacked on either side.

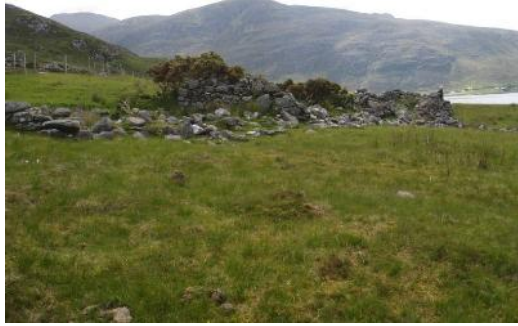
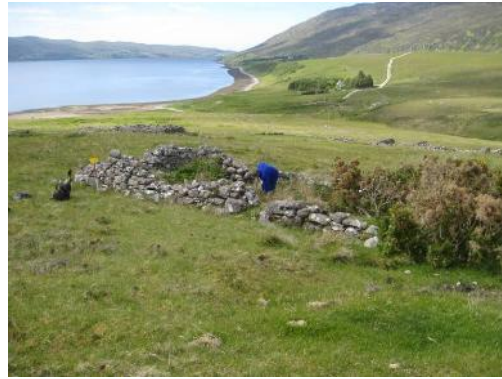
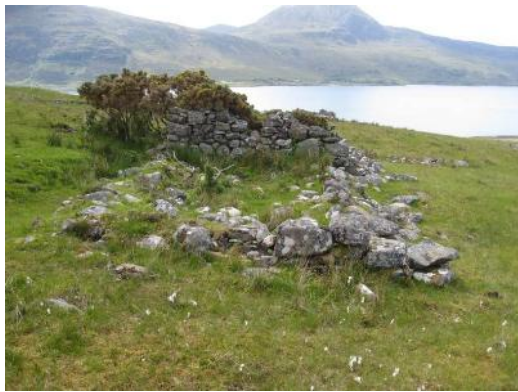
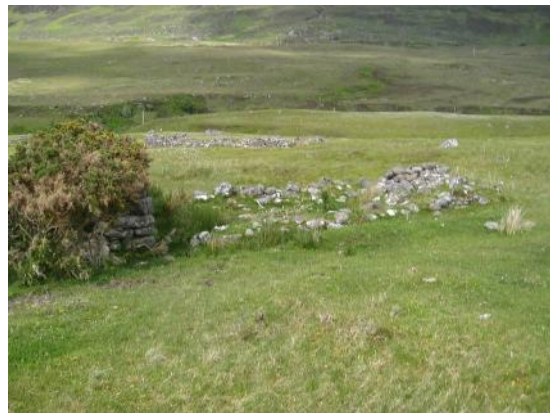
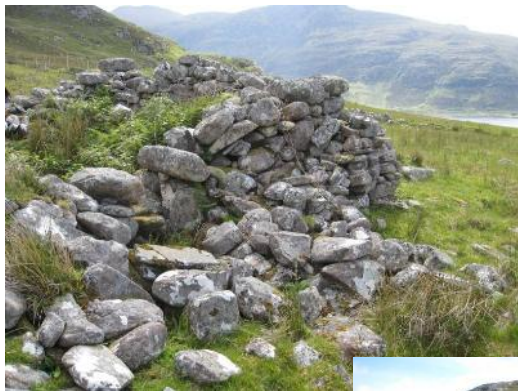
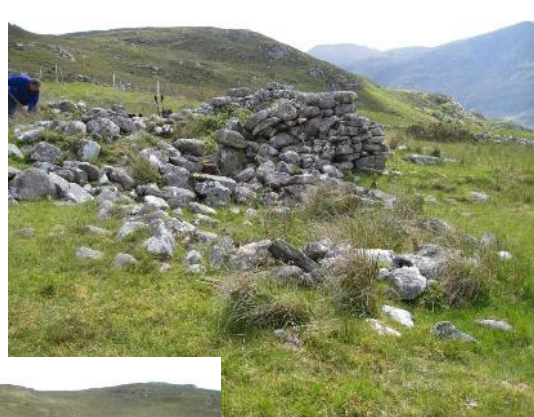
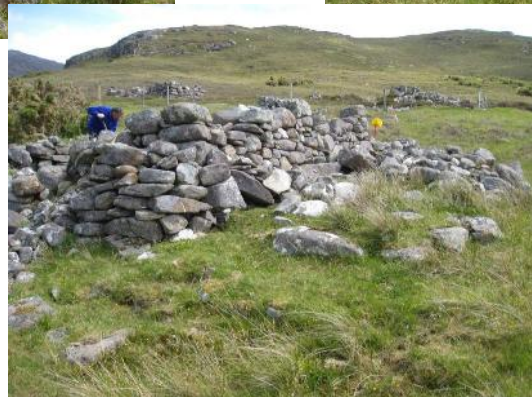
17. The ruin of a building with the footings of an adjoining building attached. NH 08155 90808 elevation 64m. This ruin is constructed with a mixture of boulders and chosen stones to a maximum remaining height of 1.4m with an average width of 0.7m. The building measures 13.7 x 5.10m with the attached footings measuring 8.4 x 4.5m. Within the building is a dividing wall at 4.0m with a doorway in it. There is another doorway in the N. facing outer wall at 2.2m which leads into the footings of an outshot measuring 4 x 3m, with this section of the building at a lower level. Beyond this there is a midden of 6m diameter ringed with stone with a buttress separating the building wall from the ring of stones. Running along the outer length of the building is a ditch on the S. side, and to the W. there is a platform built out from the slope measuring 2 x 4m.

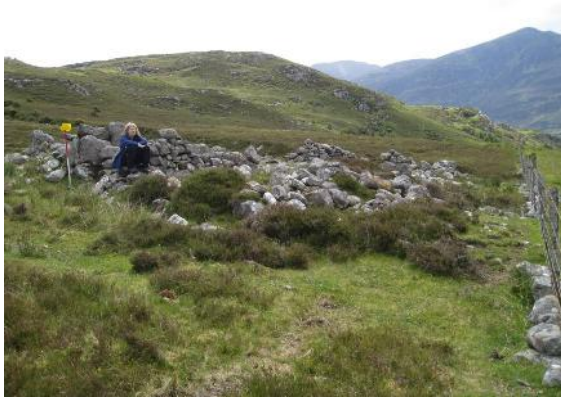
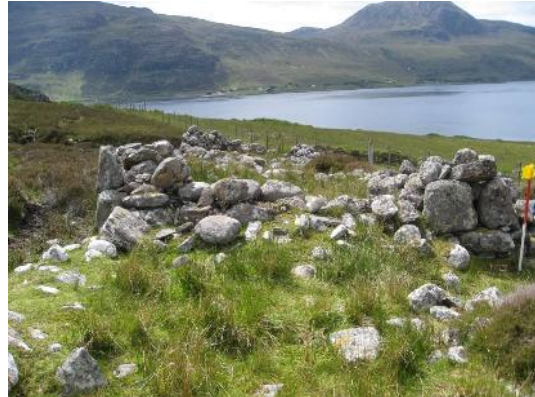
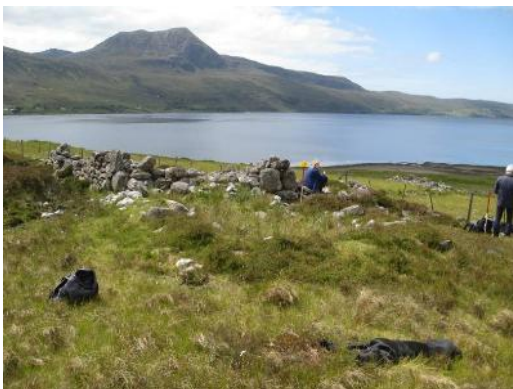
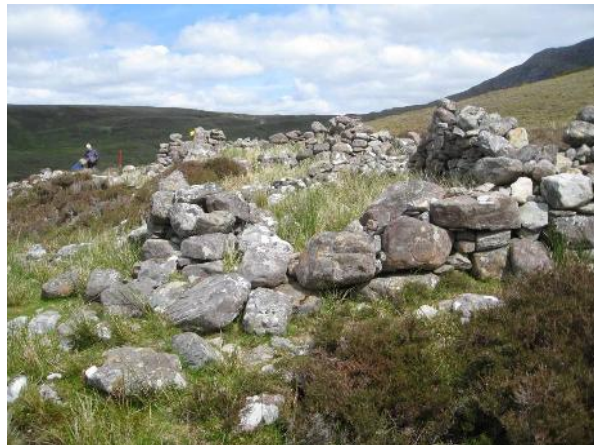
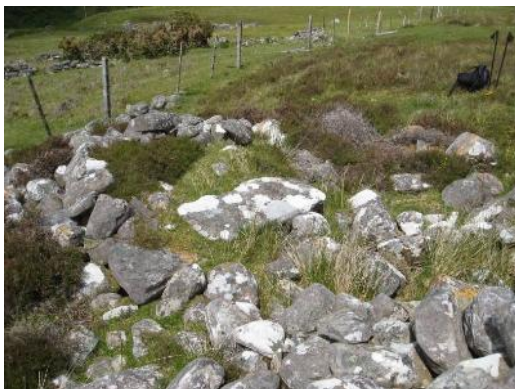
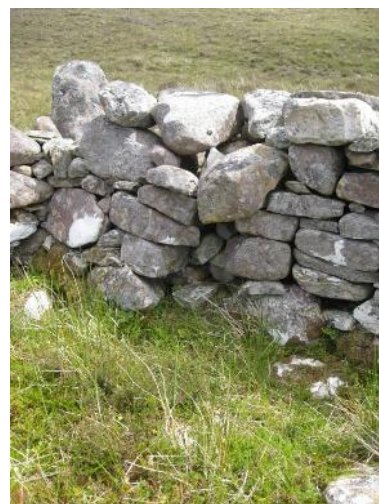
18. Ruin of building with footings of another building attached to it. NH 08172 90786 elevation 62m. The building measures 14.6 x 5.1m to a remaining height of 1.3m with walls of 0.7m wide. It is constructed with boulders and chosen stones with some layering and snecking. Within the building there are two dividing walls at 6m and 9.6m the latter having a doorway within it. There is another doorway on the outer N. facing wall. There are three platforms built out from this building. Two at opposite ends on the N. facing wall, both measuring 3 x 3m, and contained within one is a large lintel stone. We query if this might have been a kiln as the platform has built up stone walls. The third platform is on the S. gable end, running the width of the building to 1.5m. The footings of the attached building measure 6.3 x 4.4m and are constructed with boulders. To the rear of the buildings (upslope), along the full length runs a ditch.

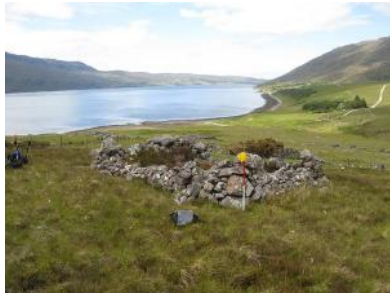
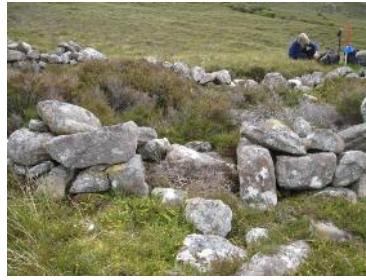
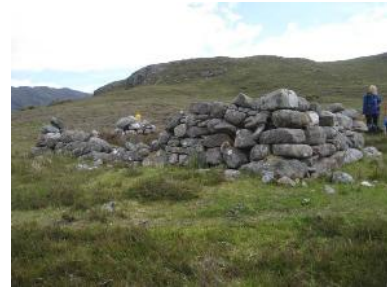
19. Ruin of a building measuring 7.4 x 3.6m. NH 08187 90801 elevation 57m. The walls are constructed with boulders to a remaining maximum height of 1.1m and width of 0.7m. There is a doorway on the N. facing wall but no remaining evidence of any windows. To the rear of the building a ditch runs along its full length.

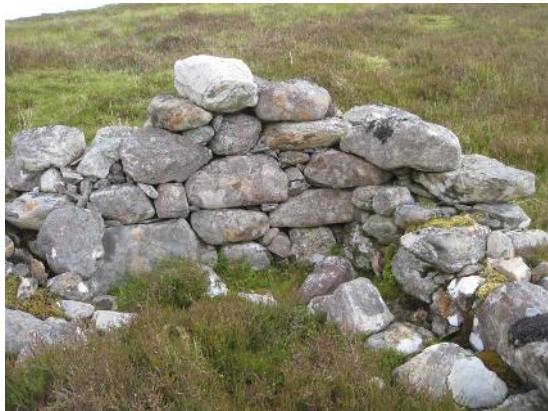
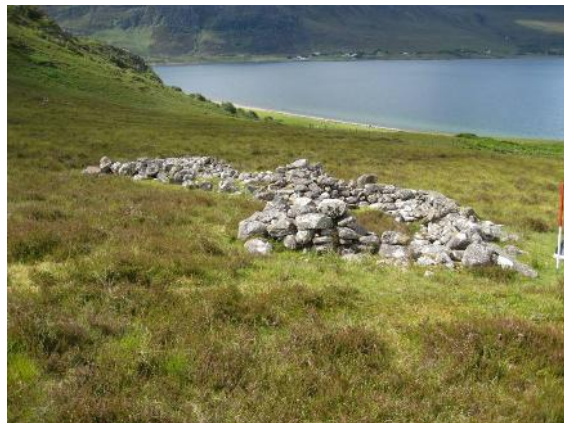
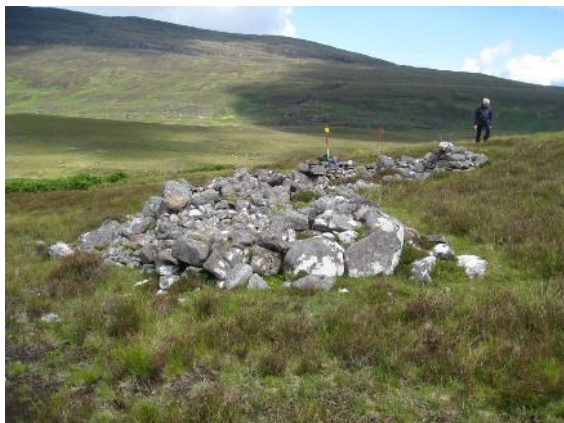
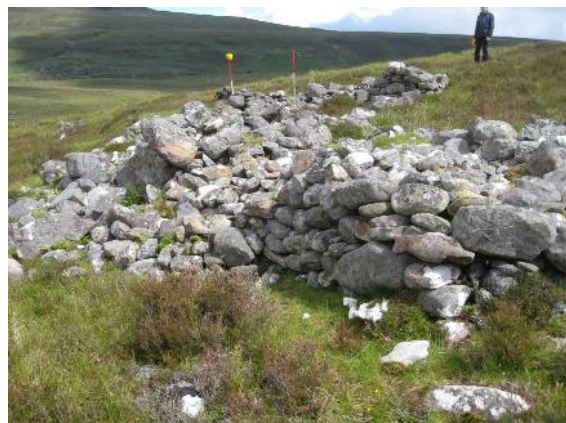
20. Footings of a Y shaped building consisting of three compartments. NH 08160 96673 elevation 64m. The walls are made with boulders and chosen stone with some layering remaining to a maximum height of 0.9m and width of 0.6m. No evidence of any doors or windows remaining. The main building measures 7.3 x 2.8m with a dividing wall, and attached to this at an angle is another building measuring 5.4 x 3.6m.

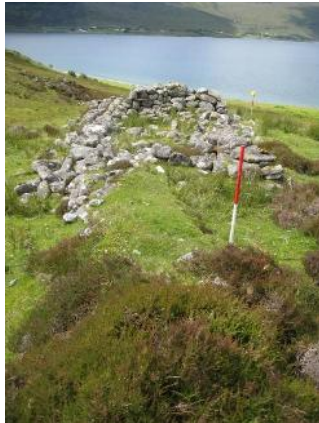
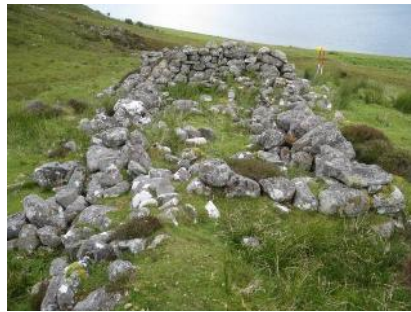
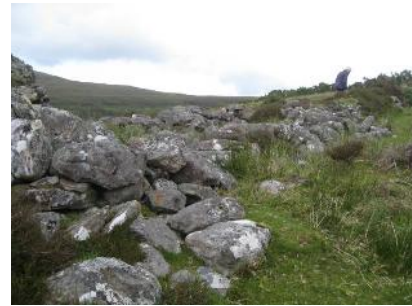
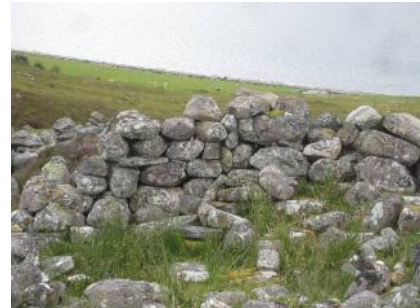
21. Ruin of a building measuring 7.5 x 3.10m. NH 08213 90665 elevation 82m. The walls are constructed with boulders to a maximum remaining height of 0.75m and width of 0.6m. There is no remaining evidence of any windows or doors, and the building is attached at each gable end to the S. side of the later township head dyke.

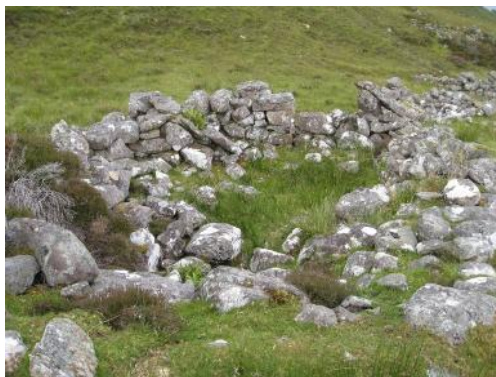
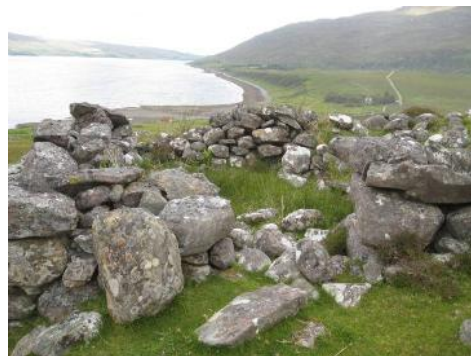
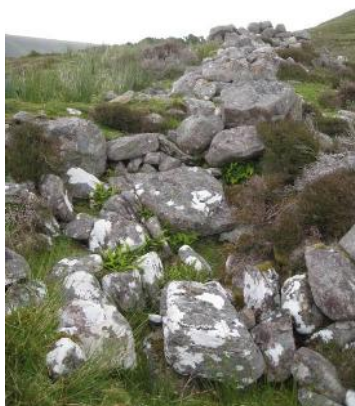
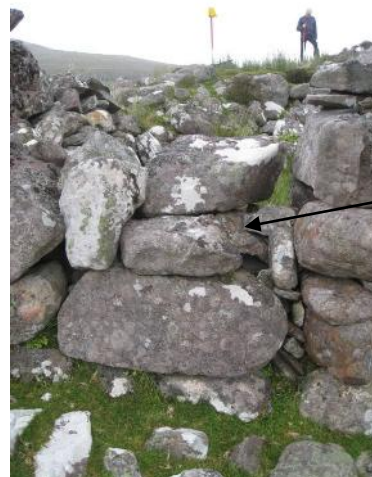
22. Ruin of a circular pen built into the later township head dyke. NH 08200 90656 elevation 72m. The walls are constructed with boulders to a maximum remaining height of 1m and a width of 0.6m. The diameter of the pen is 5.8m. The head dyke joins on at opposing sides of the pen. There are two openings within the walls both leading out on to the hillside outwith the township.

blocked doorway

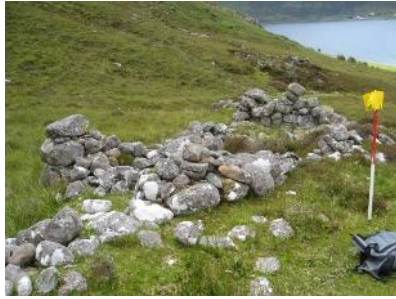
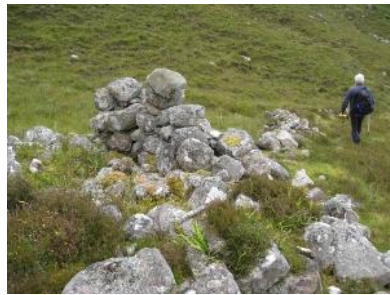
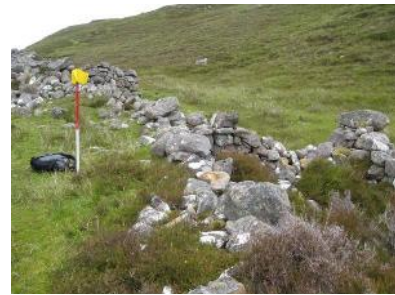
23. Ruin of a building attached to the later township head dyke at each gable end. NH 08193 90650 elevation 72m. This building is constructed with boulders to a maximum remaining height of 1m with walls 0.6m wide. It measures 6.3 x 3.3m. There is one doorway leading out on to the hillside outwith the township. On the inner side of the head dyke there are the remains of rig and furrow.

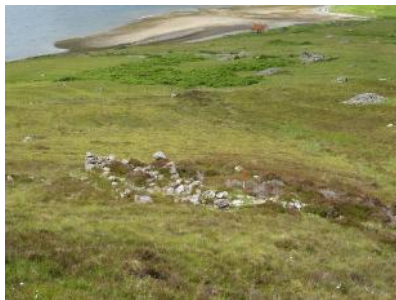
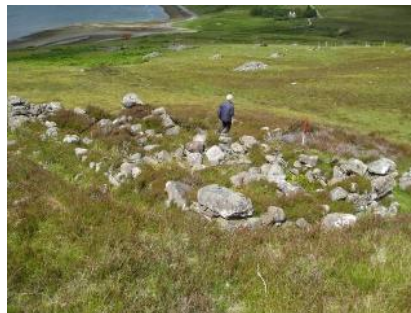
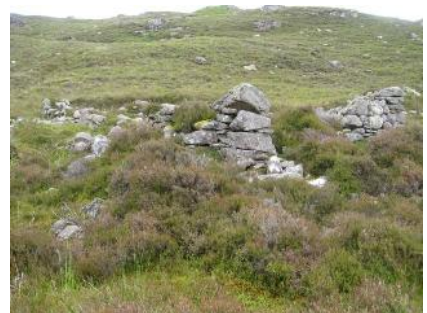
24. Ruin of a building attached to later township head dyke at each gable end. NH 08163 90607 elevation 63m. This building is constructed with boulders to a maximum remaining height of 0.9m with walls 0.6m wide. It measures 6 x 4m. There is a dividing wall within the building with one section being lower than the other. In the lower section there is a doorway leading out to a midden. To the rear of the building a ditch runs its full length.

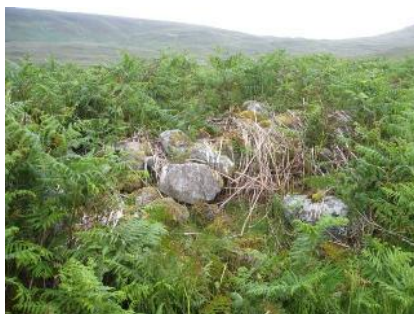
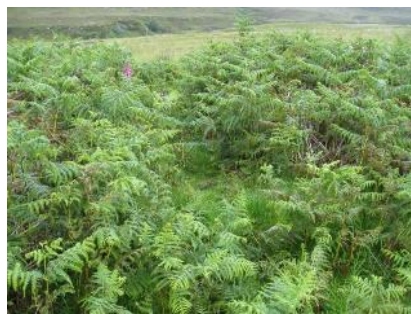
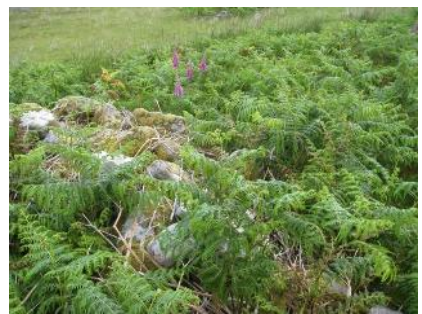
25. This ruin was so overgrown and tumbled that it was difficult to see if it was one or two buildings. NH 08030 90836 elevation 36m. The overall length of the walls was 4.6 x 16m along the same line. The walls remain to a height of 0.8m with a width of 0.6m and are constructed with substantial boulders. Within the building/s are two substantial walls across the full width at 5.5m and 9.5m with a width of 0.7m. It is between these walls that the query gap is.

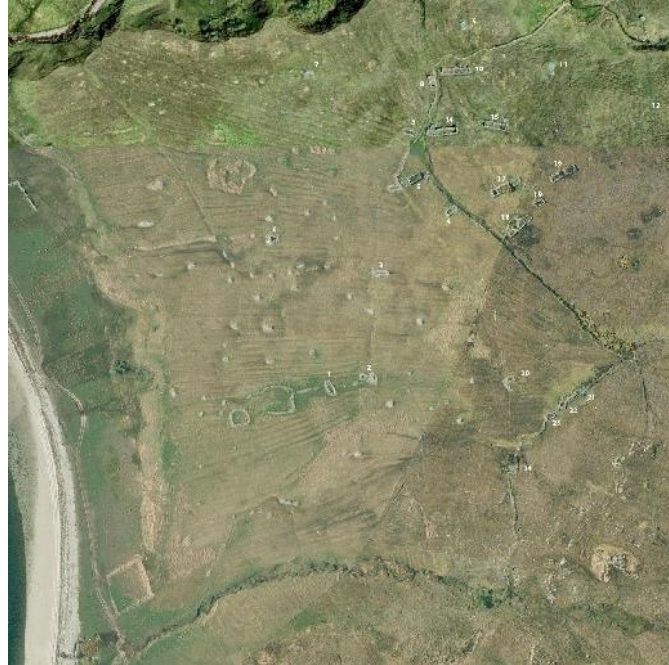
Aerial photo showing the cultivation rigs and stone clearance piles quite clearly.

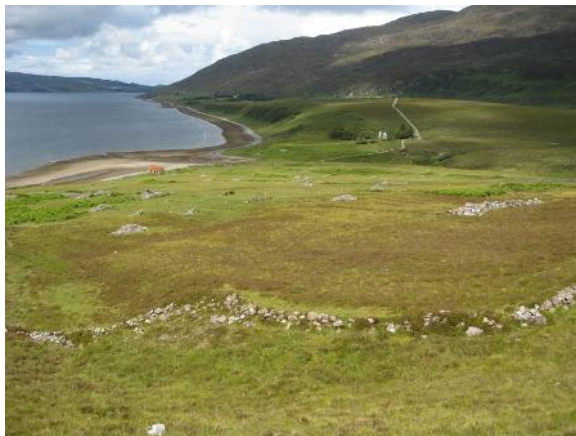
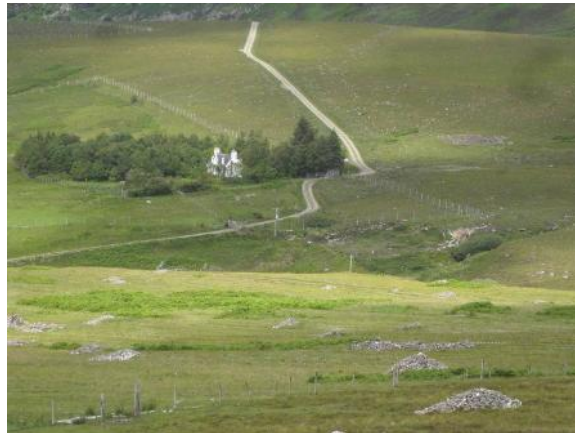
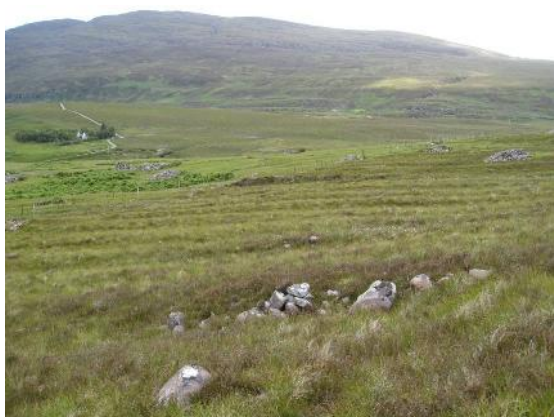
The ground lying between most of the buildings and the edge of the raised beach has been improved. Rigs can still be seen and there are numerous stone clearance piles, some very large and some piled in linear banks.

Photos of some of the rigs in the township. Different light highlights some of the features

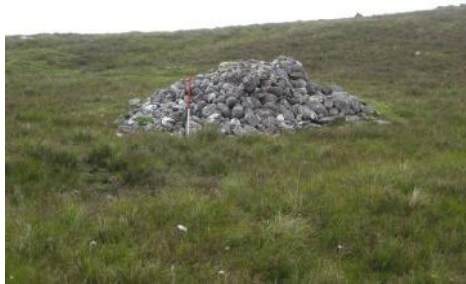
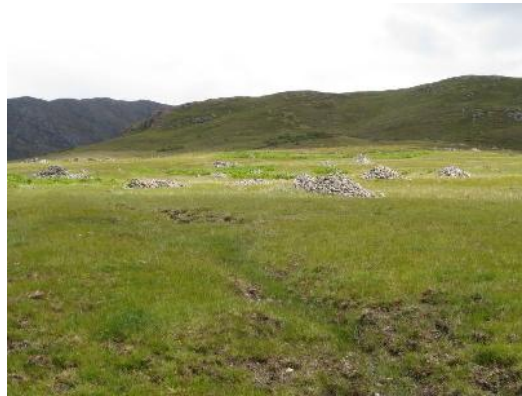
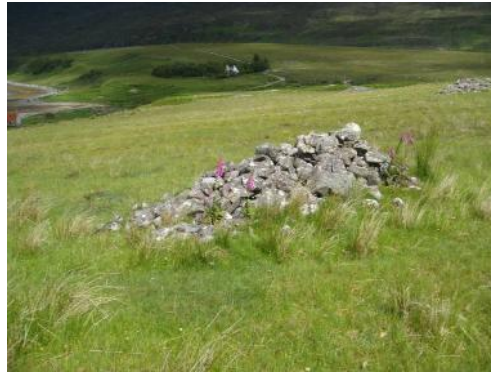
Some of the stone clearance piles

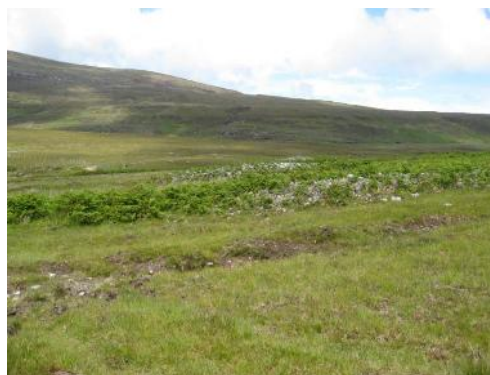
An example of a linear stone clearance bank also used as a terrace.

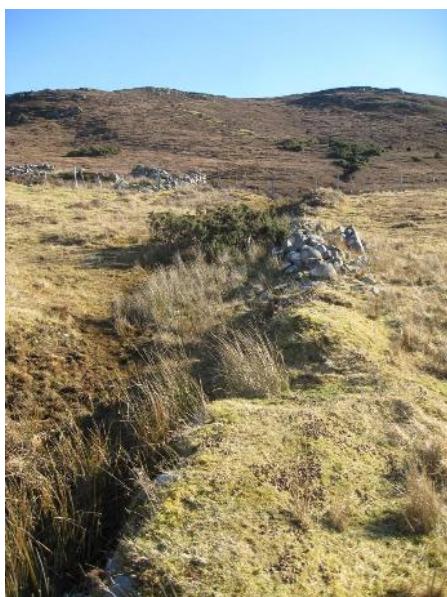
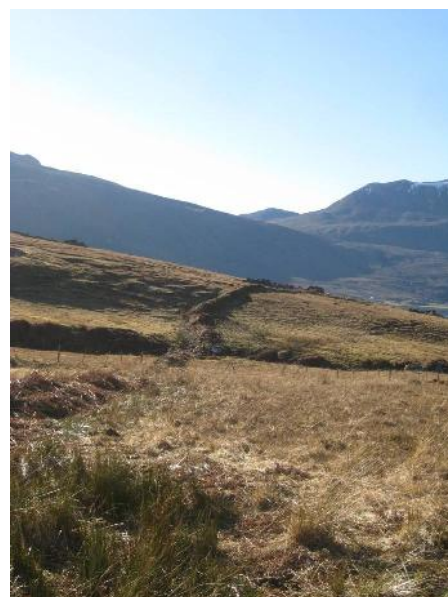
The head dyke around the village splits just S. of building 18 and also divides the township. This may indicate different periods in the township development, or may have been for stock control. It is constructed with both turf and stone.

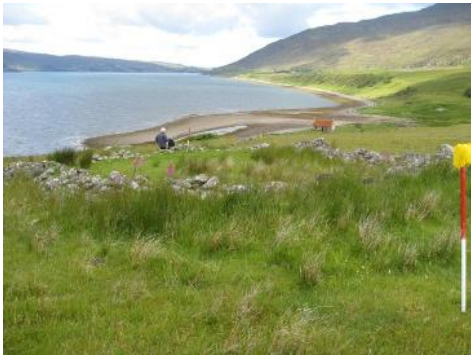
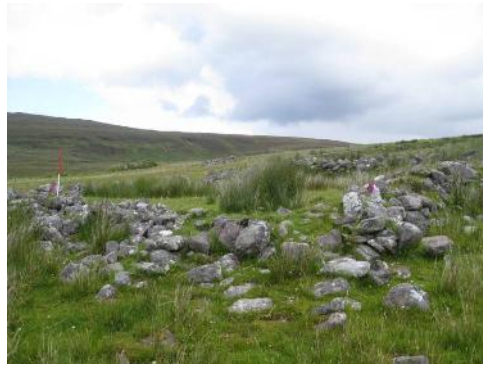
Enclosure A NH 07971 90644 measuring 10 x 8m and D shaped.

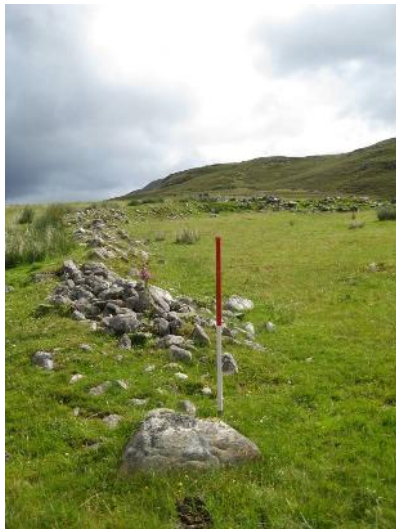
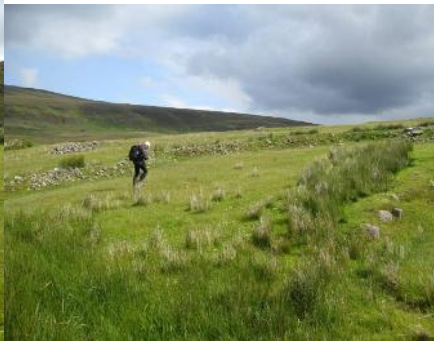
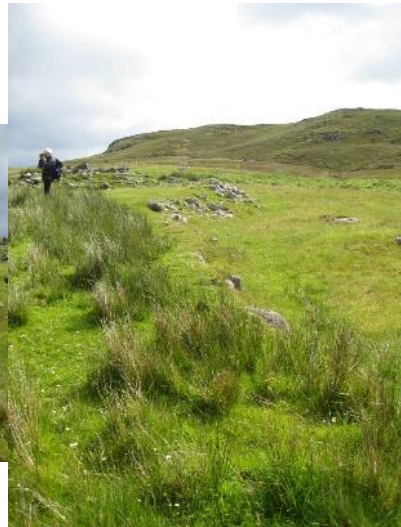
Enclosure B NH 07997 90639 measuring 25 x 16m

A stone dyke runs east from this enclosure to buildings 1 and 2.

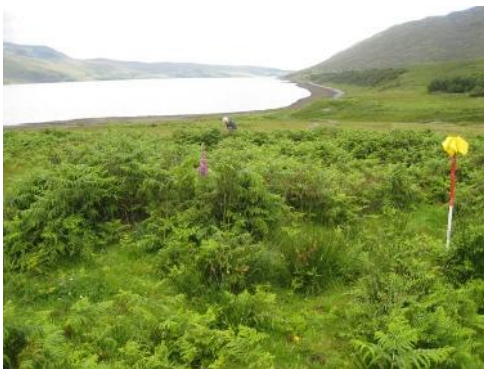
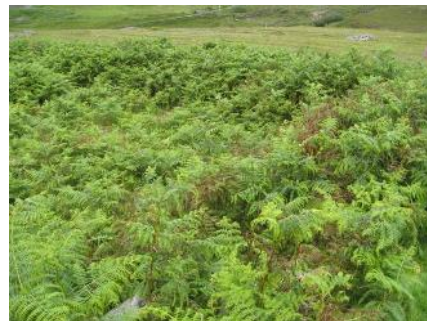
Enclosure C NH 07957 90842 measuring 8 x 6m possibly a walled garden?

Although the site was swamped in bracken the outlines of the wall can be seen in the photos.

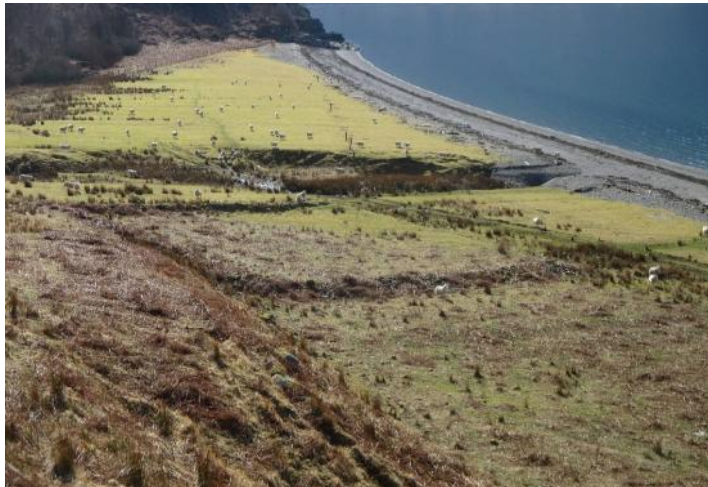
Enclosure D, NH 07884 90524 elevation 10m is The Square of Cromartie as previously described.

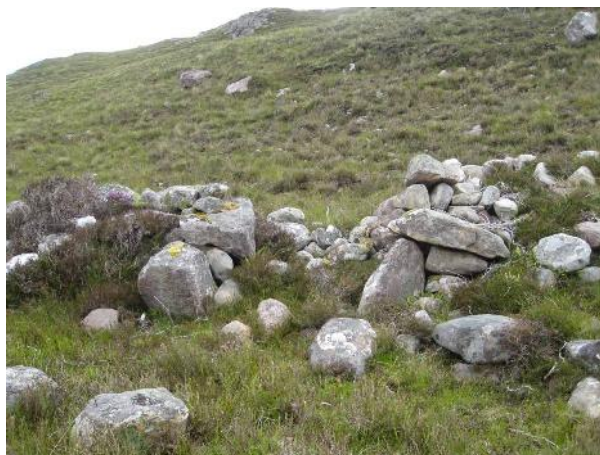
The gate marked on the plan seems to be an opening from the township on to the hill grazing allowing access for livestock.

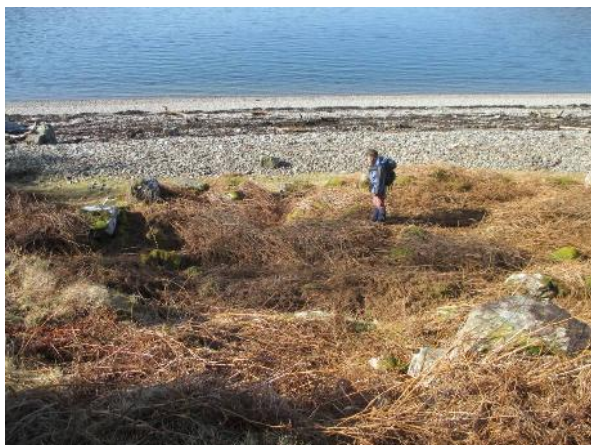
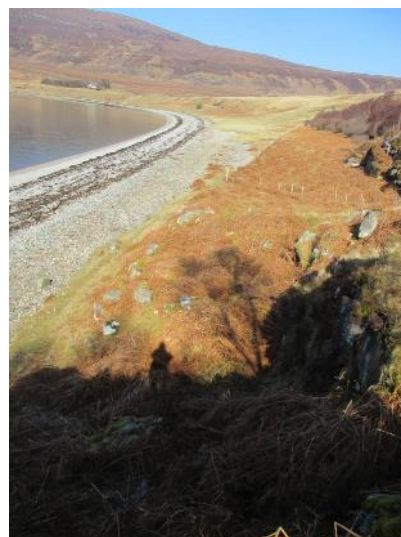
At the S. end of the shoreline the remains of a wall and building measuring 10 x 7m can be found in the vegetation. NH 07794 90145 elevation 4m. This was most likely associated with fishing, possibly herring which is known to have been plentiful at one time.

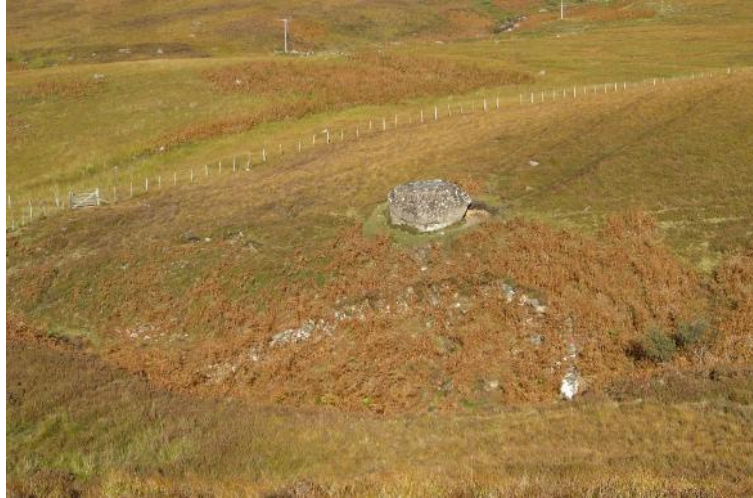
At NH 0827 9094 beside the burn and dissected by it lies an enclosure approx 14m diameter with a very large erratic boulder beside it. Purpose unknown. Imaginary 'preaching stone' perhaps?

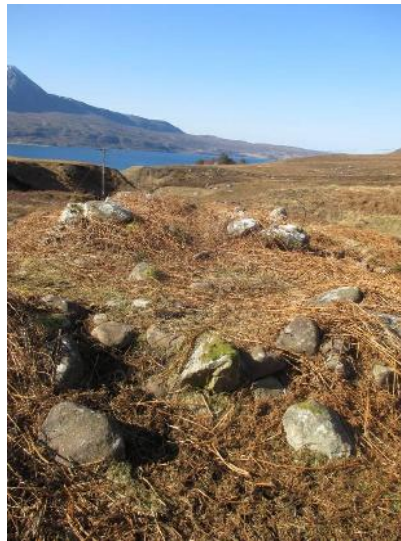
NH 08323 91090 elevation 39m, measuring 6 x 3m with a platform at its E. Gable measuring 3 x 3m and made of large boulders.

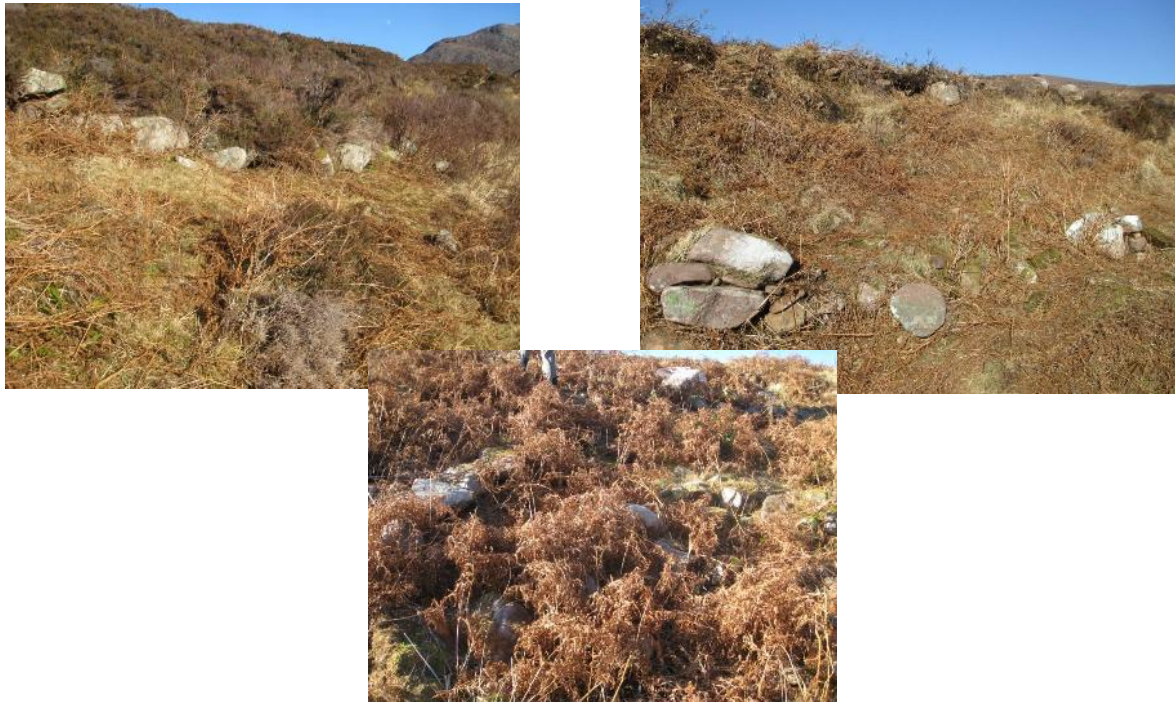
One of the walls and a possible shieling hut in the area

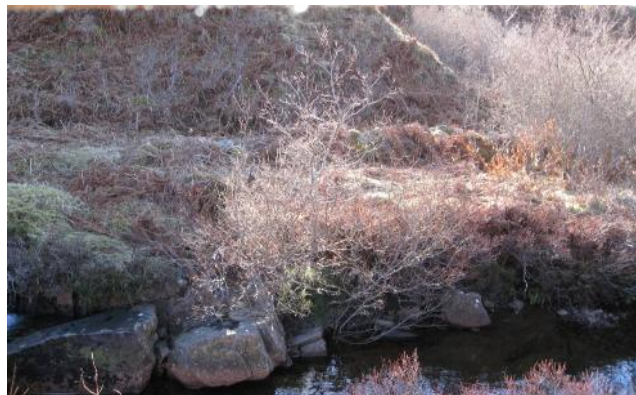
Situated on the N. side of Allt Mor Chill-Donnain just upstream from the lime kiln lies a wall at 08196 91078 elevation 26m. On the opposite bank a turf and stone dyke runs down to the burn.

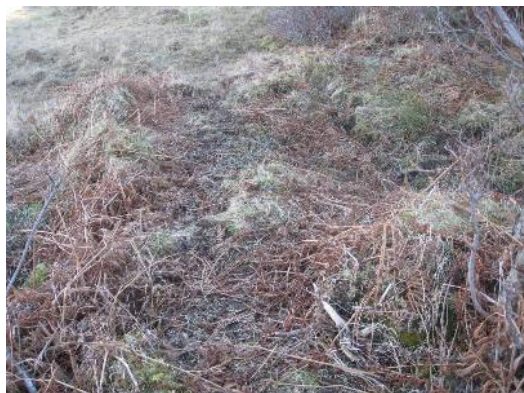
There are the footings of a small building at NH 07969 90943 elevation 24m

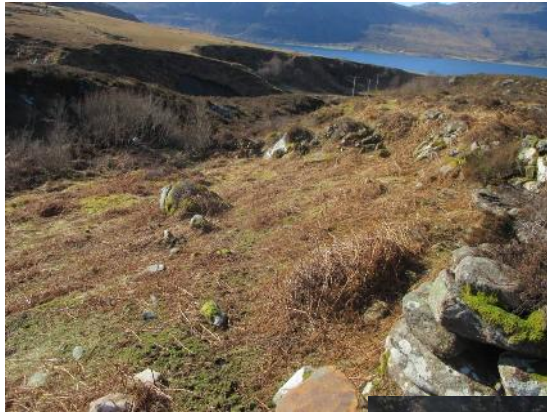
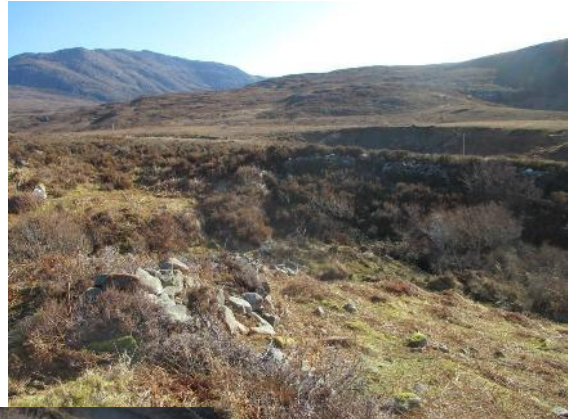
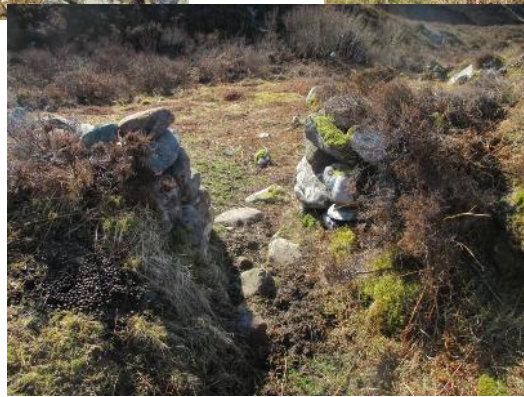
An enclosure known as An Phuind (the pound) is situated at NH 08139 91130 elevation 42m. It measures approximately 20m diameter. The walls are substantial and the enclosure straddles the burn of the same name. There is a gateway within the walls. Rules stated that if you impounded someone's sheep for straying you had to provide them with water.

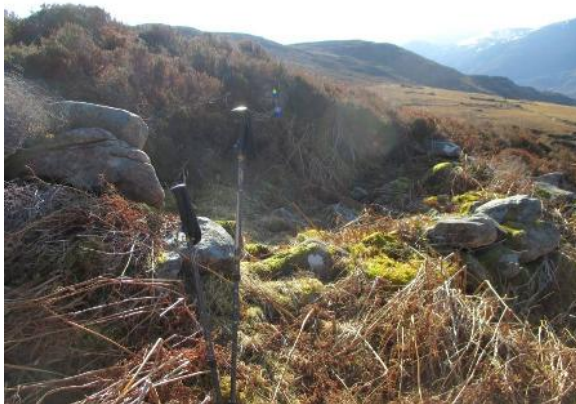
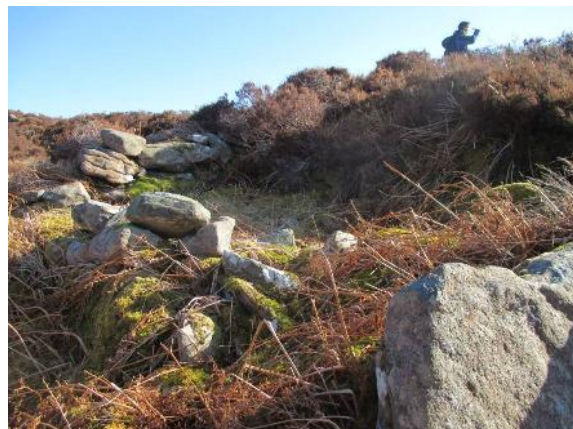
Built into the hillside 20m upstream from the enclosure is a building measuring 6 x 3m. NH 08157 91148 elevation 45m. There are some very large boulders within its walls, purpose unknown.

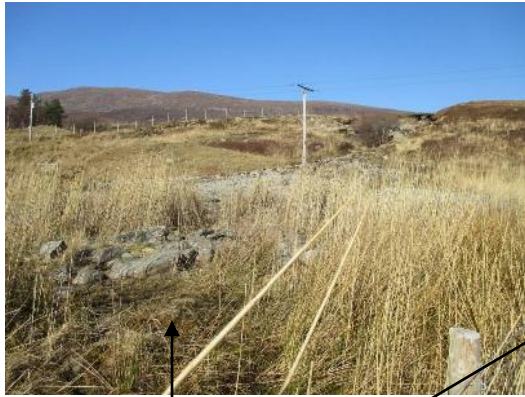
Photos of flood damage

On a visit to Kildonan in March 2015 we were shocked to find that during the spates of August 2014 substantial damage had been done to the chapel remains and the new fence. The chapel is now filled with sediment and rubble, the last bit of retaining wall along the burn has been washed away, and the E. Side of the fence bent and buried under the washout. Unfortunately this means that livestock can now access the burial ground, although fortunately because it is raised up it escaped any damage.

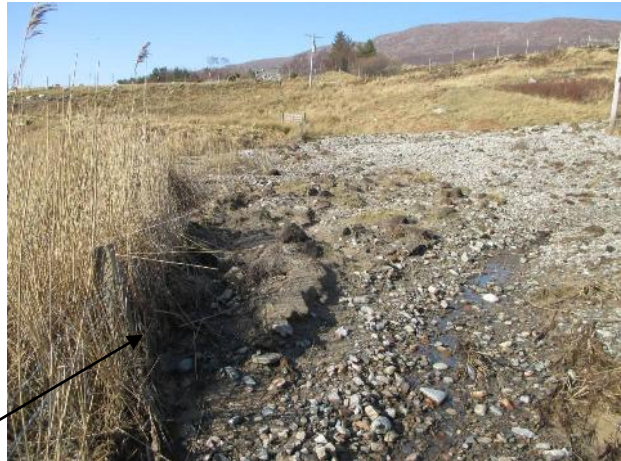
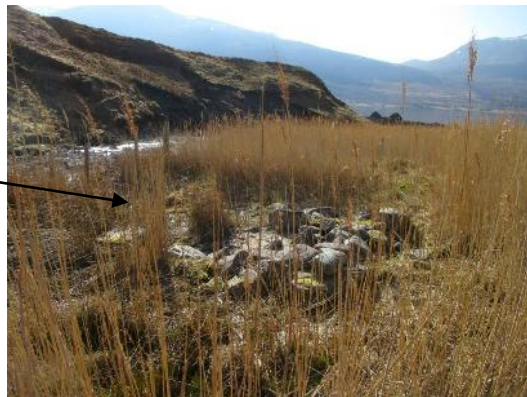
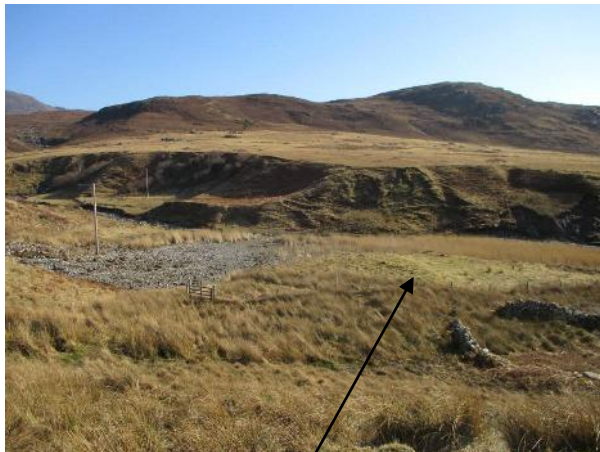
Chapel site

The outline of walls and a mound of stones are all that remains on the chapel site. It is in serious danger of being washed away as the bank of the burn erodes in spates.

Following our survey we were concerned at the damage being done by cattle to the burial ground so with permission and help from Dundonnell estate we have fenced off both the burial ground and the chapel. Access is by gate or stile.
