Lemlair House, near Dingwall

Archaeological Watching Brief

Data Structure Report

AOC 70146
24th November 2016

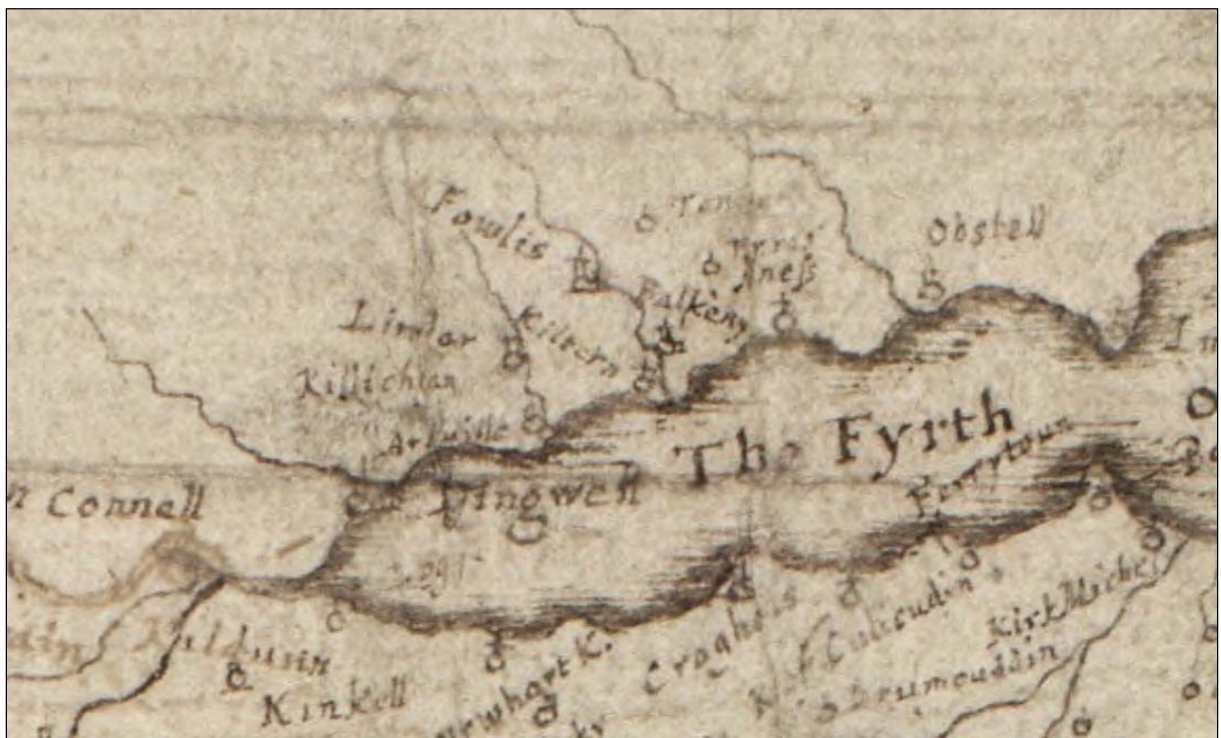
Figure 2 Extract from Robert Gordon's map, showing Limlar north of Dingwell

The first depiction of Lemlair is on Gordon's map (**Figure 2**), where the name *Limlar* is situated west of *Kiltern* and south of *Fowlis*. The map is not detailed enough to depict buildings.

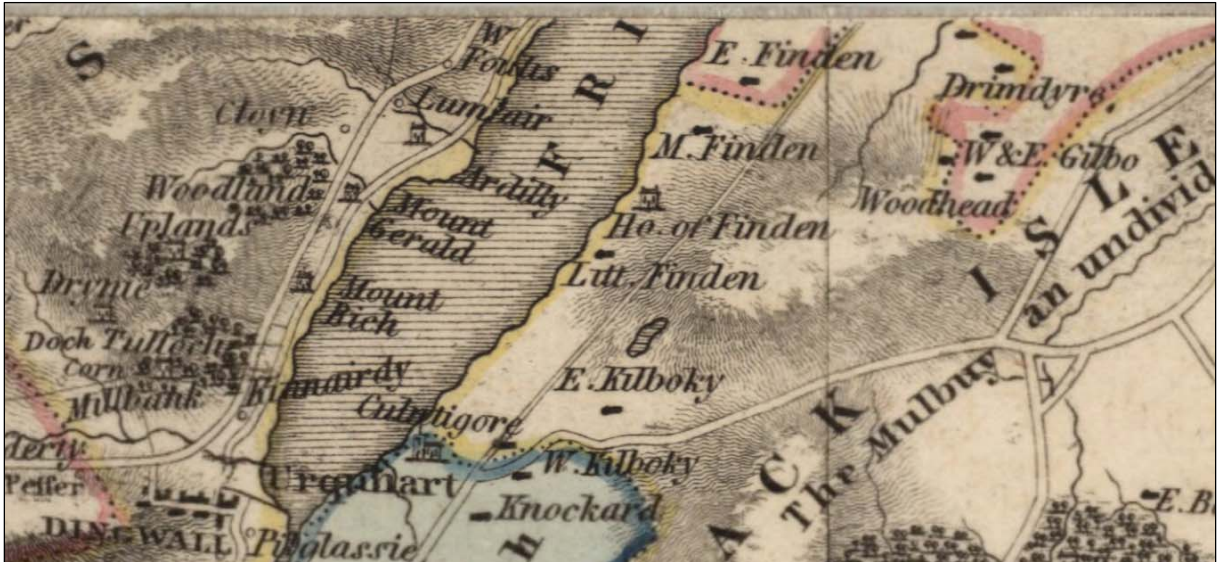
Figure 3 Extract from Thomson's 1832 map, depicting Lumlair

Lumlair is depicted on Thomson's map (**Figure 3**) with reasonable accuracy, lying between two roads, the south coastal road being the modern A9, and the north road undoubtedly the same modern B road.

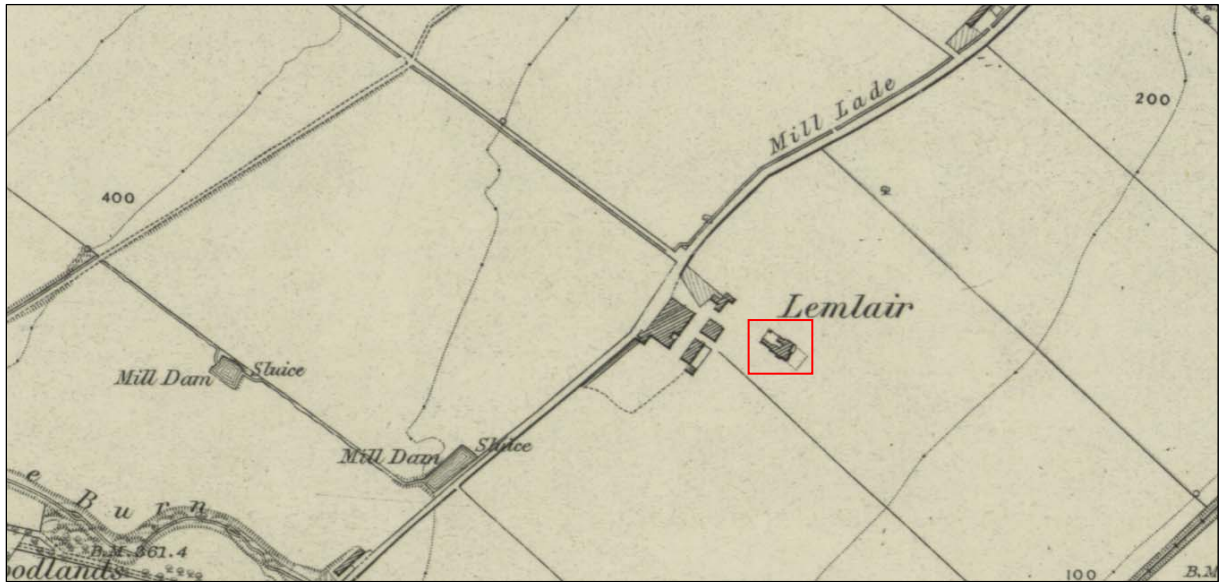
Figure 4 Extract from the 1880 1st Edition OS map, depicting Lemlair

The 1st Edition Ordnance Survey map shows a number of buildings associated with Lemlair. The house itself (**Figure 4**) is situated east of a cluster of at least five roofed buildings. A track leads around the steading buildings from the west. In the wider landscape there are several structural features associated with mill works – namely a mill lade to the north and two sluices and two mill dams to the west.

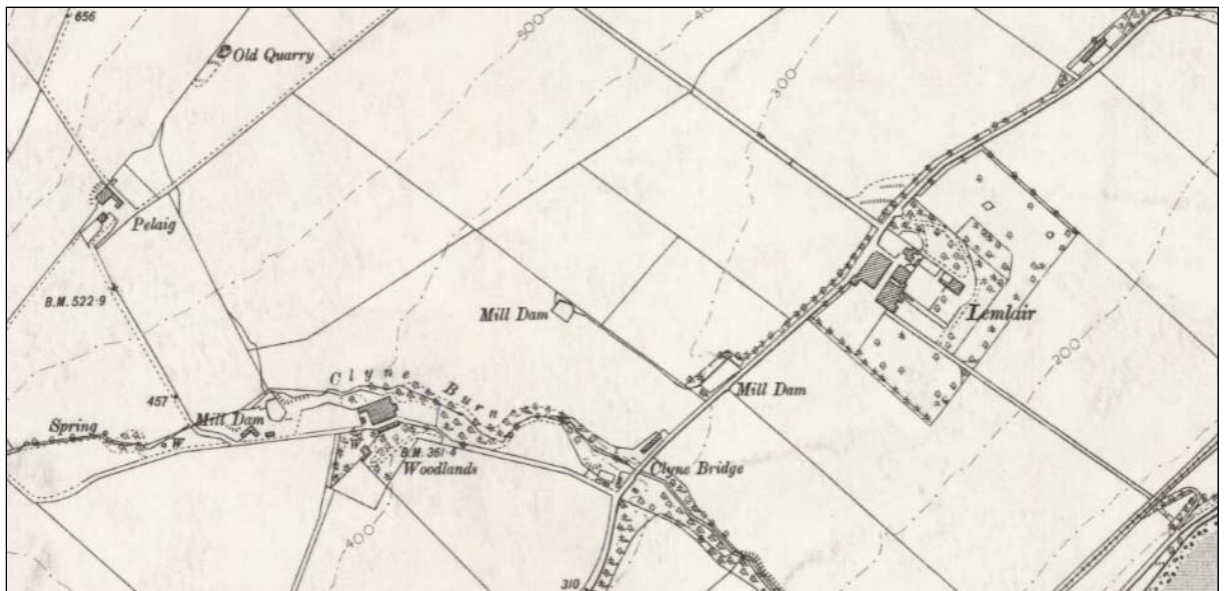
Figure 5 Extract from the 1907 2nd Edition OS map, depicting Lemlair

By the time of the 2nd Edition Map (**Figure 5**), a few significant changes have occurred to the Lemlair estate. The house itself has simplified in shape. The three central buildings, situated west of the main house, have conglomerated and expanded. Fences or walls have been erected around the entire grouping, with deciduous and coniferous woodland. The sluices and mill lade are no longer depicted but the mill dams are still evident.

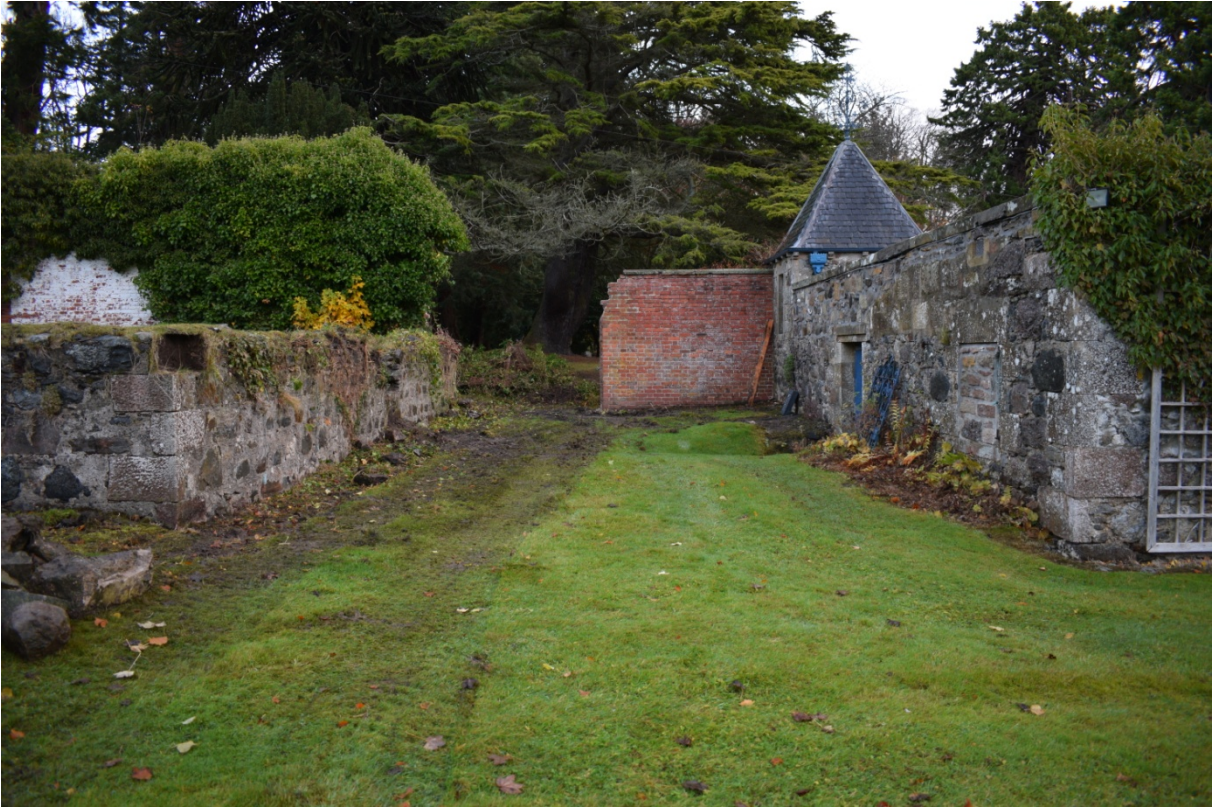
Plate 1 The development area before works started showing the revetment wall on the left and the courtyard wall on the right

- 6.1 The archaeological watching brief was carried out on 14th-17th November 2016. Conditions were mostly dry but cold and overall visibility was good. An area of approximately 15m by 15m was stripped of topsoil immediately west of an existing courtyard at the back of Lemlair House (**Plate 1**). Part of this area was artificially raised ground behind a revetment wall. The area between the revetment wall and the courtyard may have been already dug into during original construction works because the natural subsoil encountered behind the revetment wall was around 0.5m higher than that found in the area between.

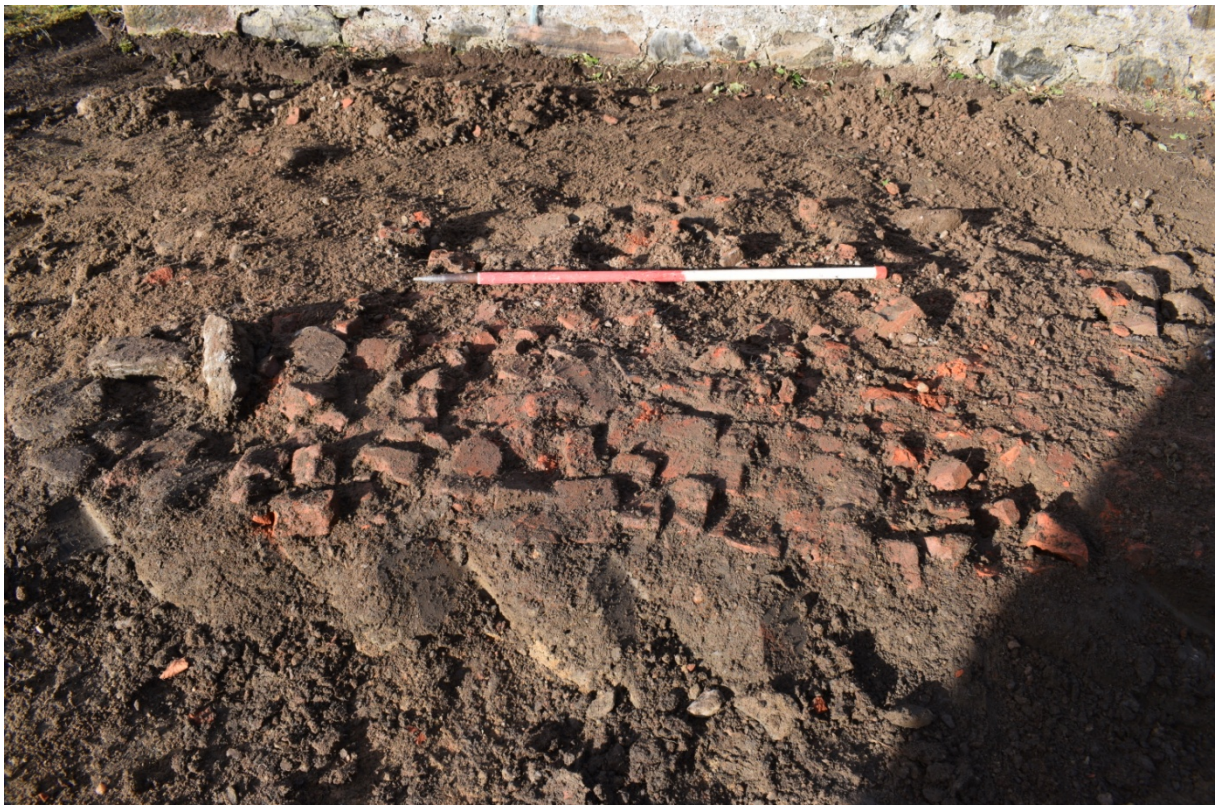
Plate 2 The possible remains of a cobble brick garden path (003)

- 6.2 No archaeological features were found behind the revetment wall but in the area between this and the courtyard there were two features, both probably relating to the gardens of Lemlair House (**Figure 7**). The first feature encountered was a surface of red brick and stone with a possible section of cobbled red bricks (003) (**Plates 2 and 3**). It was a linear spread aligned NE-SW towards the location of a previous archway in the garden wall. One section of this spread had a series of small angular red bricks set in rows as if it had once been a cobbled surface. This brick surface overlay of a series of sub-angular medium stones. The whole feature was truncated at the NE end by a modern electric cable trench and this may have also disturbed the west side of the feature. Due to its alignment leading to an archway in the garden wall this is thought to be the remains of a garden path.

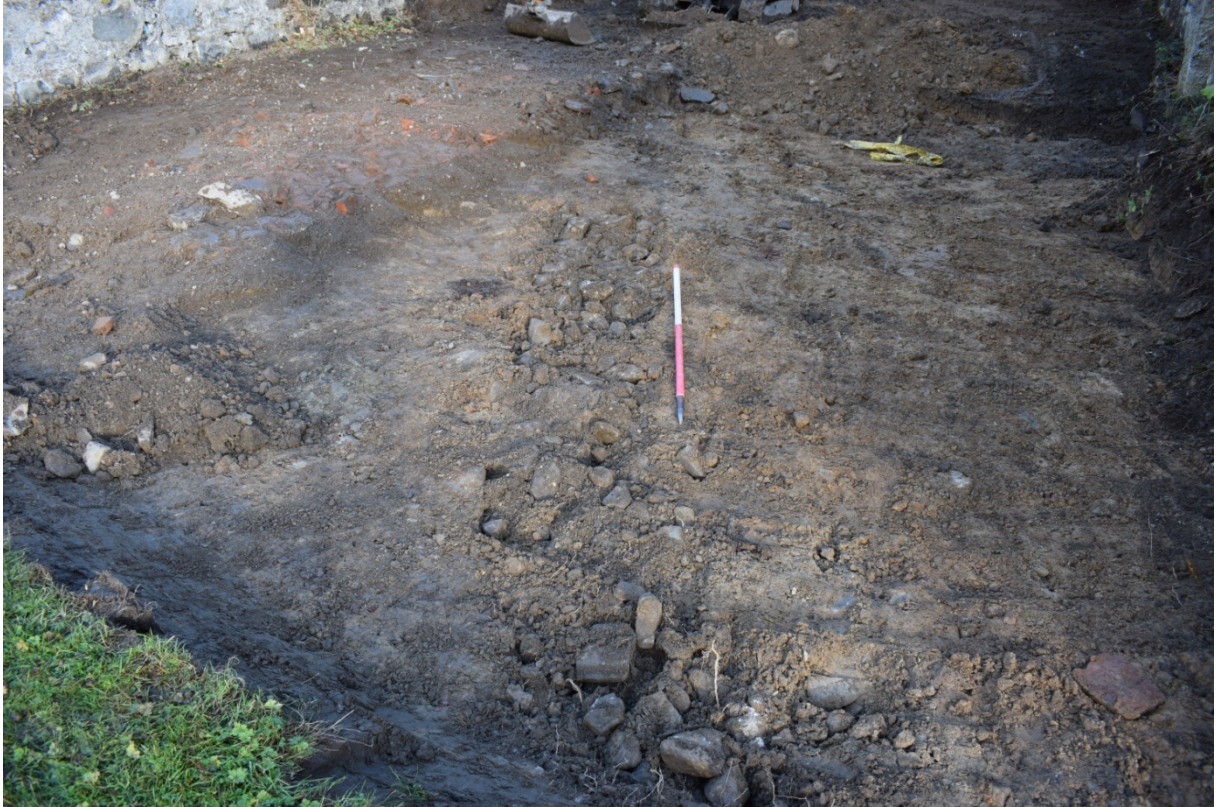
Plate 3 The drain (004) with the brick surface (003) in back left

- 6.3 Underneath the brick surface (003) was another linear feature (004) (**Plates 3 and 4**). This consisted of a ditch aligned N-S and 0.6m wide, that was filled with tightly packed large and medium sub-angular stones. It was interpreted as a drain constructed as part of the landscaping of the garden.

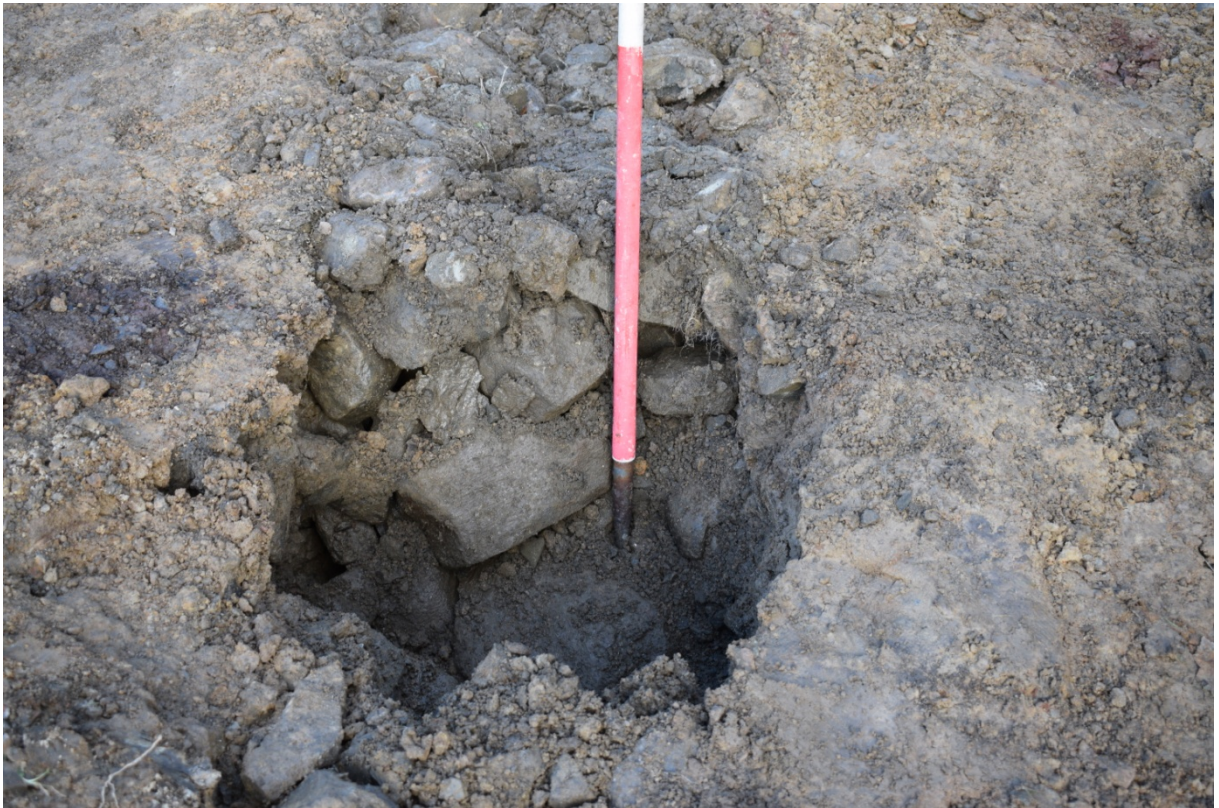
Plate 4 Slot dug through the rubble drain (004)

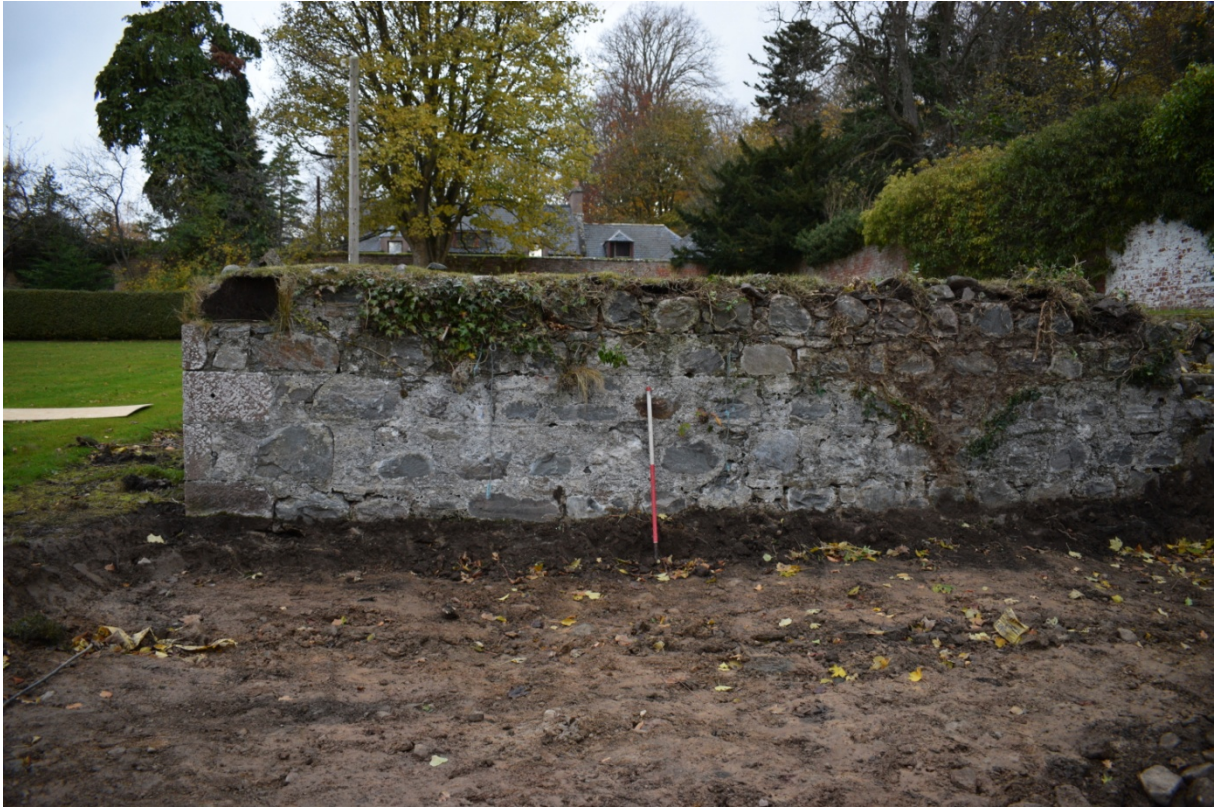
Plate 5 The south end of the revetment wall (006) before removal

- 6.4 Lastly the revetment wall (006) was recorded during its removal by machine (**Plates 5, 6 and 7; Figure 8**). The wall was stone and mortar built, aligned NE-SW to lie parallel to the opposite courtyard wall. It stood to 1.7m high and was 0.7m wide with two distinct faces, the NW-face being completely obscured by the raised garden soil. The wall was built with large sub-angular boulders, larger at the base, some of which have been squared or dressed including alternating dressed stones at the corner. The foundations of the wall comprised large flat boulders and the top of the wall was formed of sub-rounded stones on top of thin flat slabs. The wall core was a mixture of loose rubble and mortar. In places there were metal attachments and holes for gates or other fixings.

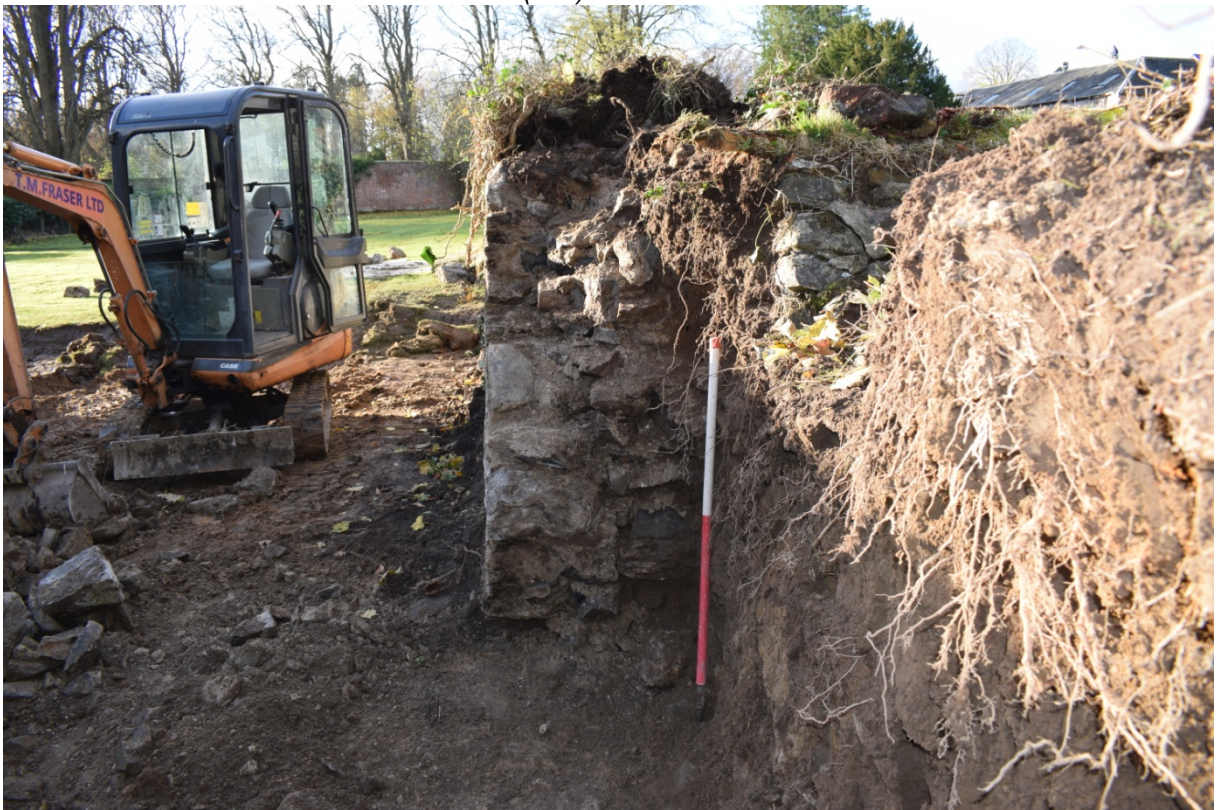
Plate 6 Machine dug section through the revetment wall (006)

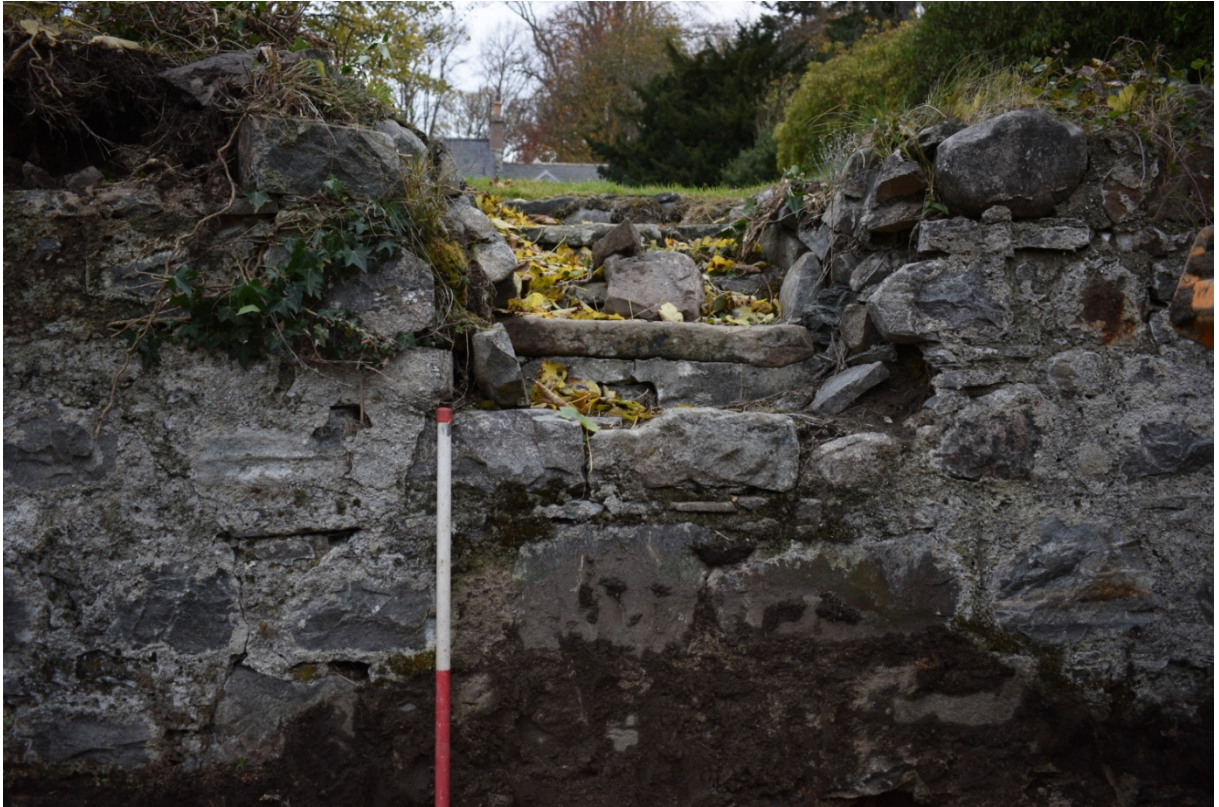
Plate 7 Steps in the revetment wall (006)

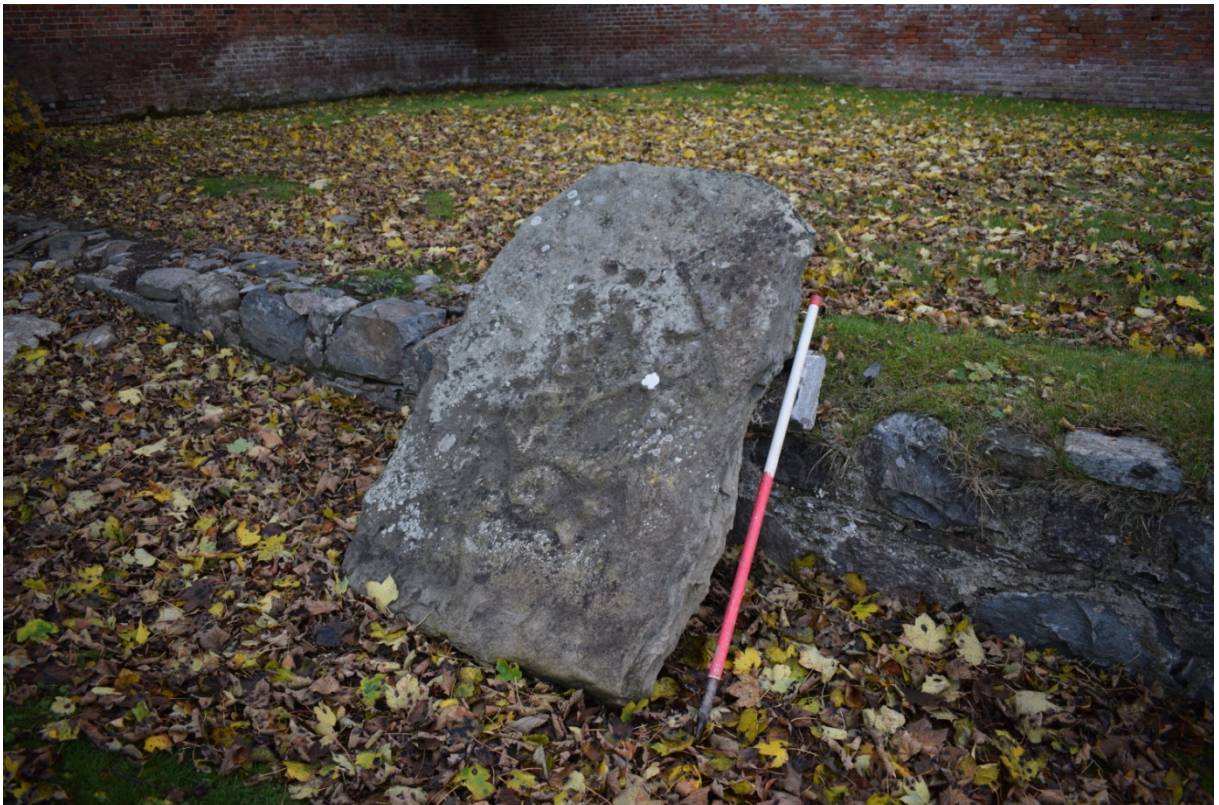
Plate 8 The cup and ring marked stone

- 6.6 During fieldwork the cup and ring marked stone (MHG8956) mentioned in the HHER as being within the grounds of Lemlair House was located (**Plate 8**). It was leaning against the revetment wall but in an area which should not be affected by the development. The stone closely matches the descriptions from previous visits mentioned on the HHER but it is possible that its location within the gardens has changed.
