Erection of Four Houses Land to South of St Maelrubhas Close, Poolewe Archaeological Survey Report

Erection of Four Houses, Land to South of St Maelrubhas Close, Poolewe Archaeological Survey Report

On Behalf of:	Fiona Tyers
Planning Reference:	16/04595/FUL
National Grid Reference (NGR):	NG 85617 80597 (centred)
AOC Project No:	70193
Prepared by:	L. Fraser
Illustrations by:	L. Stirling
Date of Fieldwork:	2 nd June 2017
Date of Report:	19 th July 2017
OASIS No.:	aocarcha1-290667

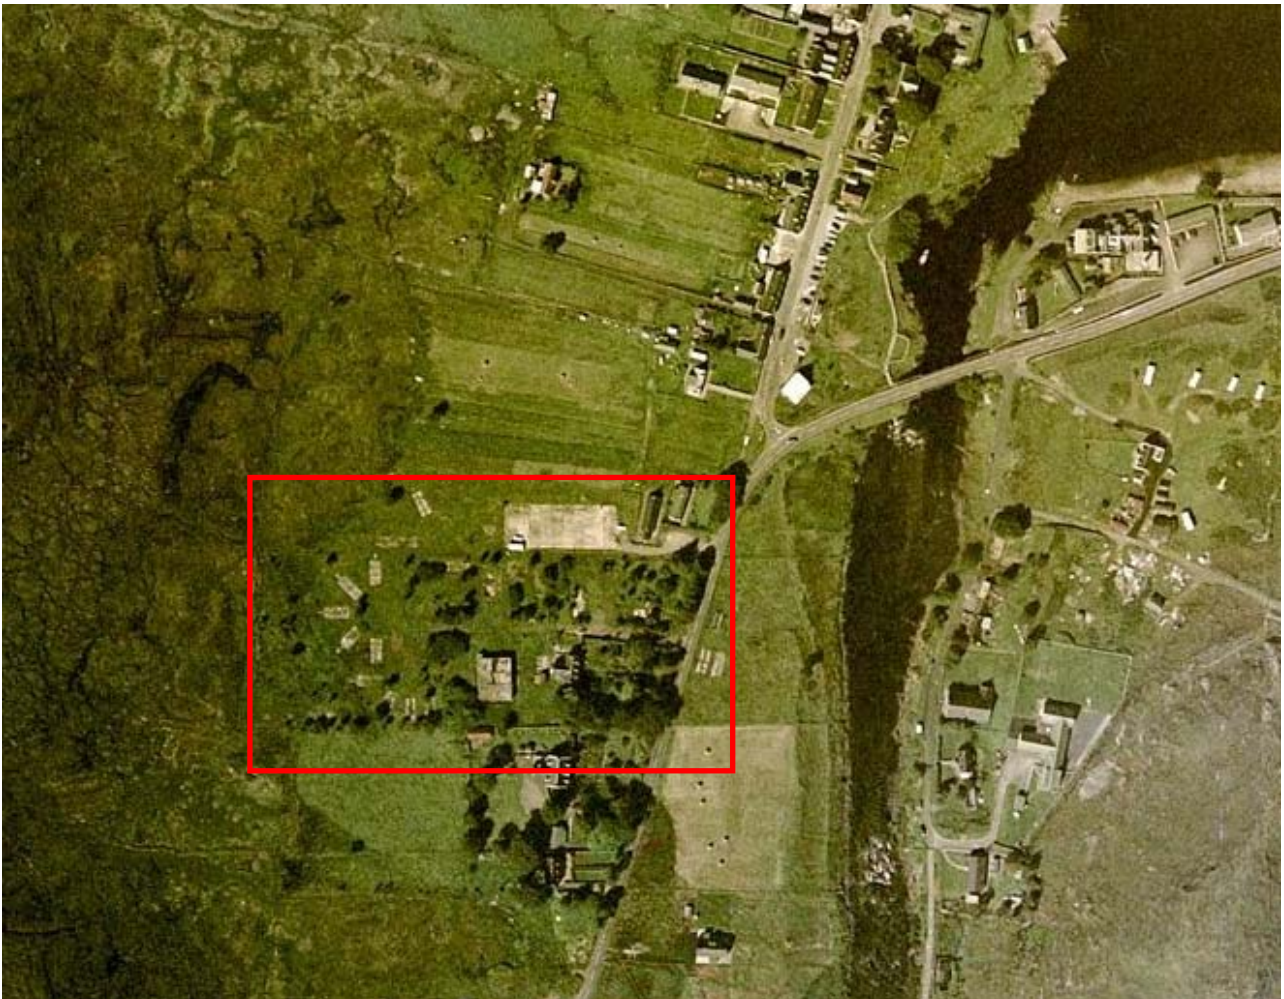
Plate 1: Aerial image from 22 August 1973 (National Centre for Aerial Photography), image no. NCAP-000-000-192-336

- 4.2.1 Satellite imagery was consulted on Google Maps 2017 (online) and, although the site is clearly overgrown with vegetation and mature trees, several footings of buildings are visible. The current landowner has already created a record of the site with aerial drone photography.
- 4.2.2 Historical aerial imagery was consulted online on 31 July 2017 at the National Centre for Aerial Photography (NCAP). A 1973 image (**Plate 1**) clearly shows the footprint of the arc of 5 platforms, the faint bases of the other platforms and the bunker to east.

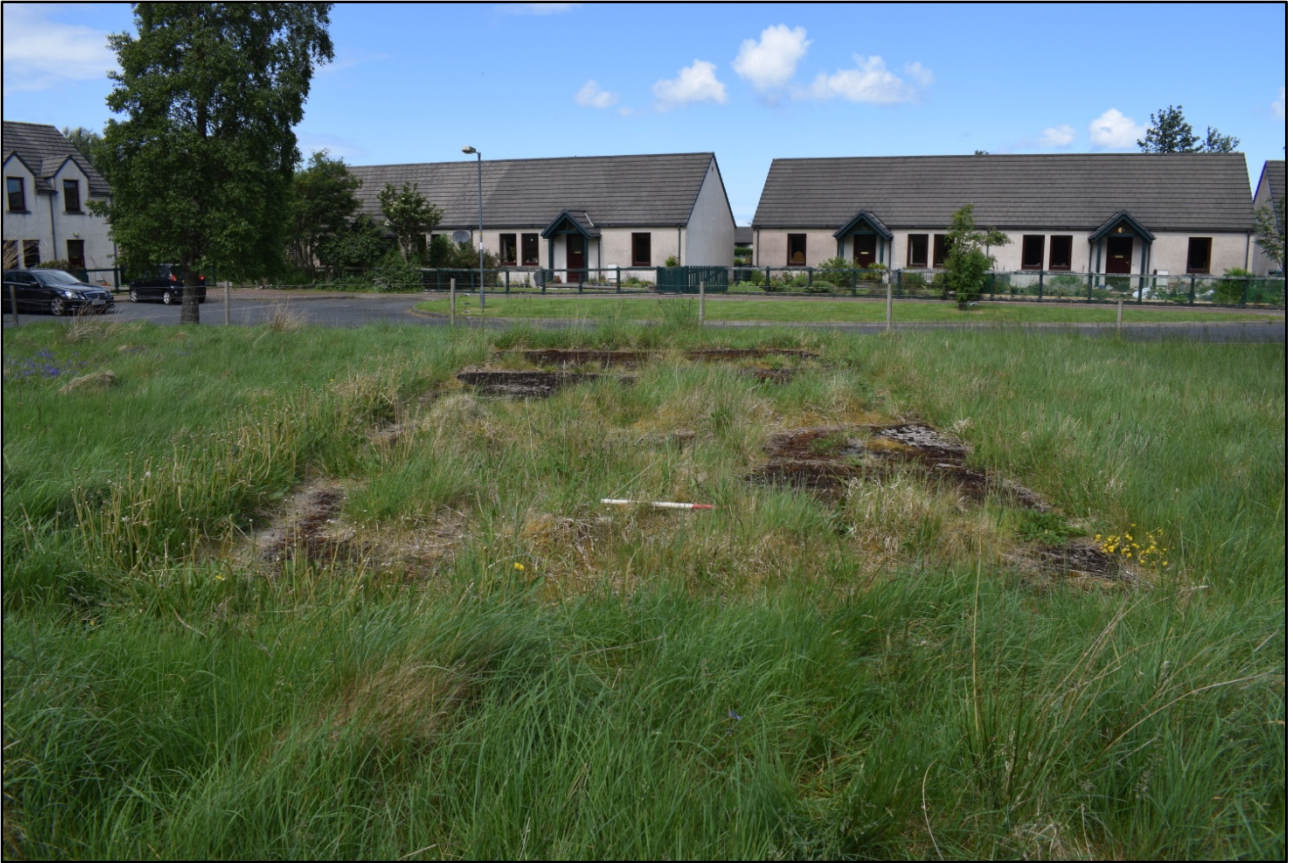
Plate 3: Site 1, facing NNW

Site Number	Site Type	Site Name	Description	Alignment	Condition	Period	Photo Number	Easting	Northing
1	Concrete footing	Highland Fieldcraft Centre	Partially overgrown concrete footing 12m x 5m with an extension 3.5m x 1m at the NNW end.	NNW-SSE	Degraded	WWII	1	185593	880625
2	Concrete footing	Highland Fieldcraft Centre	Concrete footing 12m x 5m with an extension 3.5m x 1m at the WNW end.	WNW-ESE	Degraded	WWII	2	185583	880609
3	Concrete footing	Highland Fieldcraft Centre	Overgrown concrete footing 12m x 5m with an extension 3.5m x 1m at the NNW end.	WSW-ENE	Degraded	WWII	3	185584	880592
4a	Ditch	Highland Fieldcraft Centre	A ditch measuring 0.75m wide and 0.50m deep with square, straight sides.	-	Degraded	WWII	4-5	185586	880622
4b	Pit	Highland Fieldcraft Centre	A pit 10m x 7m and up to 1m deep lined with terram.	NW-SE	Degraded	WWII	6	185571	880585
5	Concrete footing	Highland Fieldcraft Centre	Concrete footing 6m x 5m with an extension c. 4m x 1m at the SSW end. The last 2.5m of the extension are raised. NNE end obscured by trees.	NNE-SSW	Degraded	WWII	7	185599	880581

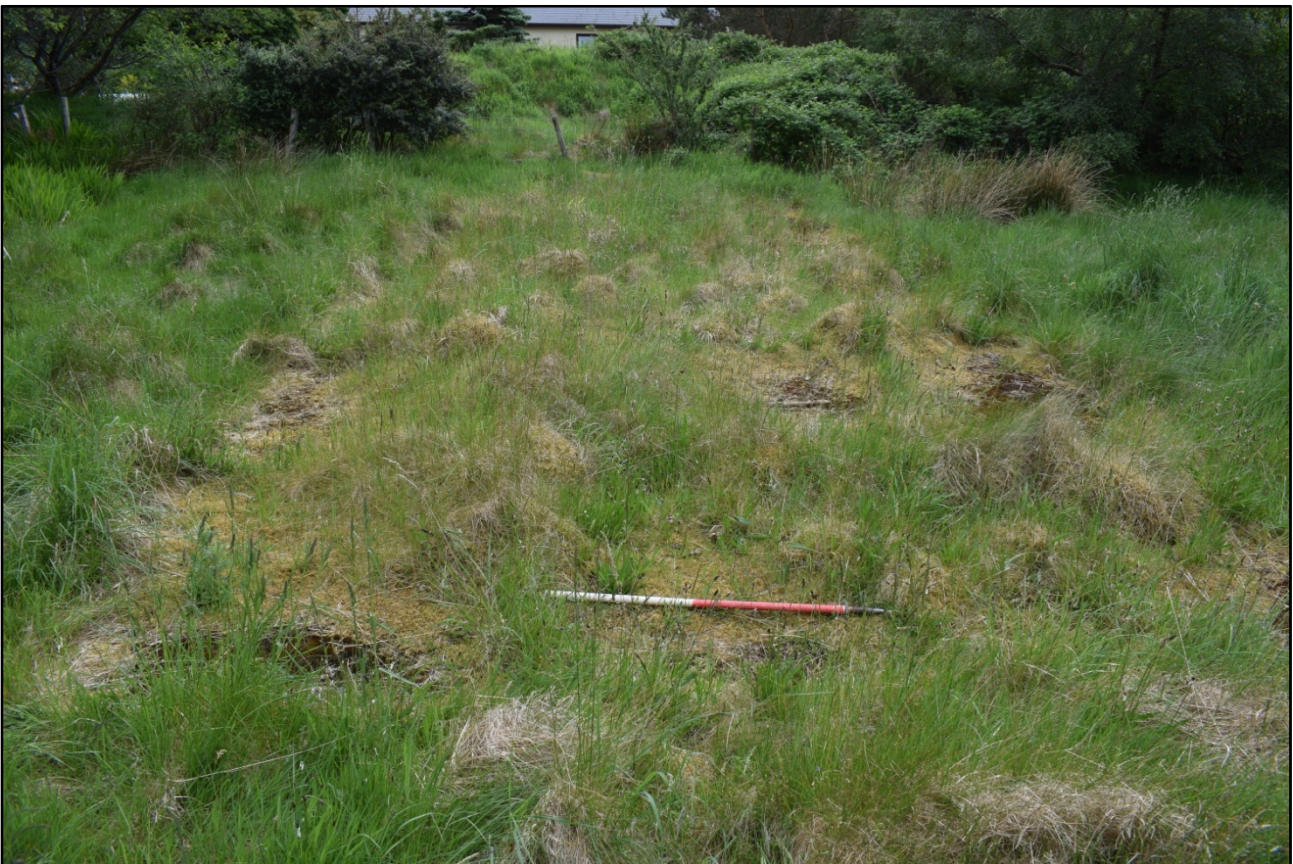
Plate 4: Site 8, facing SE

6	Concrete footing	Highland Fieldcraft Centre	Overgrown concrete footing 12m x 5m. SE end has an extension c. 4m x 1m under trees at the SE end.	NW-SE	Degraded	WWII	8	185616	880584
7	Concrete footing	Highland Fieldcraft Centre	Overgrown concrete footing 12m x 5m.	NW-SE	Degraded	WWII	11	185641	880569
8	Concrete footing	Highland Fieldcraft Centre	Overgrown concrete footing 12m x 5m.	NW-SE	Degraded	WWII	12	185648	880573
9	Ditch	Highland Fieldcraft Centre	A ditch c. 18m long running NNE-SSW from the corner of a bunker 1m wide and 0.5m deep with the remains of a pipe in the base. It returns to the W at the SSW end where it terminates in an overgrown, low corrugated iron covered structure (c1.5m x 4m).	-	Degraded	WWII	13-14	185643	880591

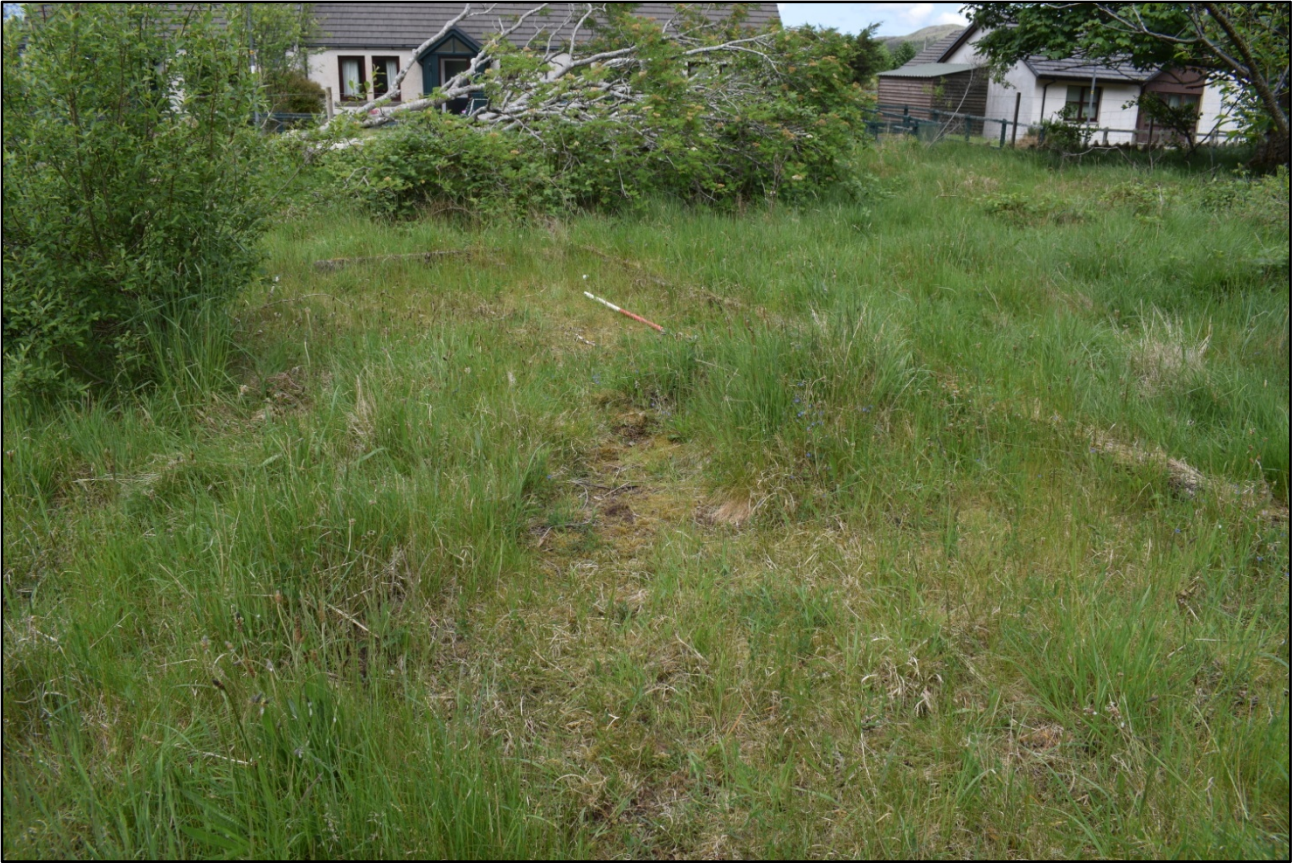
Plate 5: Site 12, facing N

Site Number	Site Type	Site Name	Description	Alignment	Condition	Period	Photo Number	Easting	Northing
10a	Concrete footing	Highland Fieldcraft Centre	Grassy mound surrounding a raised concrete square measuring 1.5m x 1.5m. Concrete block is 0.10m thick. May not be in its original position.	-	Degraded	WWII	15	185610	880607
10b	Concrete and rubble mound	Highland Fieldcraft Centre	Concrete and rubble mound about 3m in diameter.	-	Degraded	WWII		185612	880612
11	Concrete footing	Highland Fieldcraft Centre	Concrete base measuring 21m x 1.6m. Irregular shapes attached at both ends, but hard to discern as the site is very overgrown. Row of trees planted along the SE side.	NE-SW	Degraded	WWII	16	185635	880620
12	Concrete footing	Highland Fieldcraft Centre	Concrete base with a raised kerb around the edges measuring c. 12m x 5m. Overgrown with small trees growing in the centre. Fallen tree over W corner.	NW-SE	Degraded	WWII	17-20	185643	880646

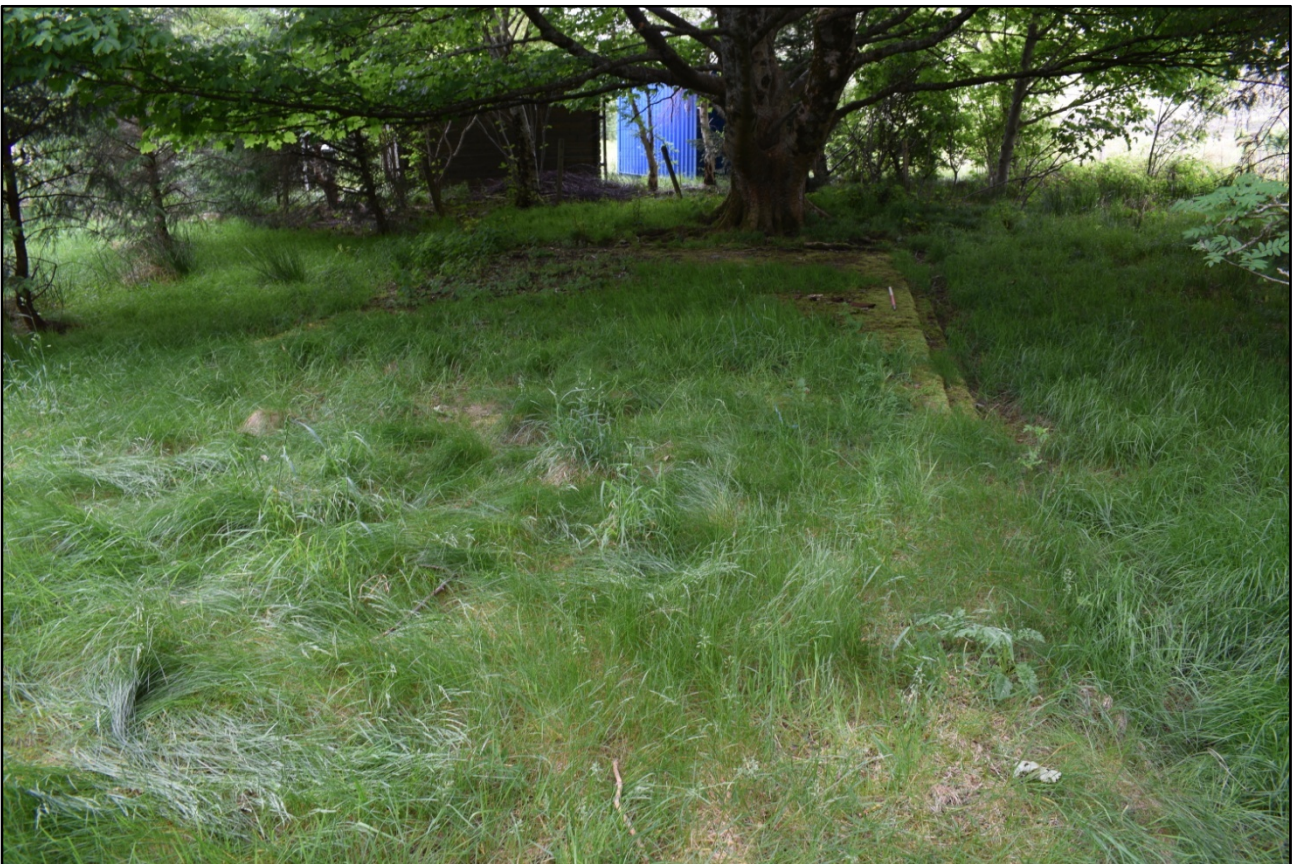
Plate 6: Site 13, facing S

13	Concrete footing	Highland Fieldcraft Centre	Concrete base with a stepped edge measuring 12m x 5m. Tree growing at the S end. Almost completely overgrown.	N-S	Degraded	WWII	9-10	185627	880577
14	Concrete footing	Highland Fieldcraft Centre	Extremely overgrown concrete base 8m x 6m. Trees growing at edges and moss- and bramble-covered.	E-W	Degraded	WWII	29	185614	880563
15	Concrete footing	Highland Fieldcraft Centre	Heavily overgrown concrete base measuring 5m x 4m.	NW-SE	Degraded	WWII	30	185610	880559
16	Bunker	Highland Fieldcraft Centre	In the southeast corner of the site, surrounded by thick vegetation and trees was a brick built bunker with a flat roof measuring 18m NNW-SSE by 14m and approximately 4m high. It has 2 protruding porch-like entrances at northwest and southwest corners and a 3 rd entrance built into the north wall and was partly below ground level. A sloping, hand-dug track led out from this entrance.	NW-SE	Degraded	WWII	22-26	185648	880573

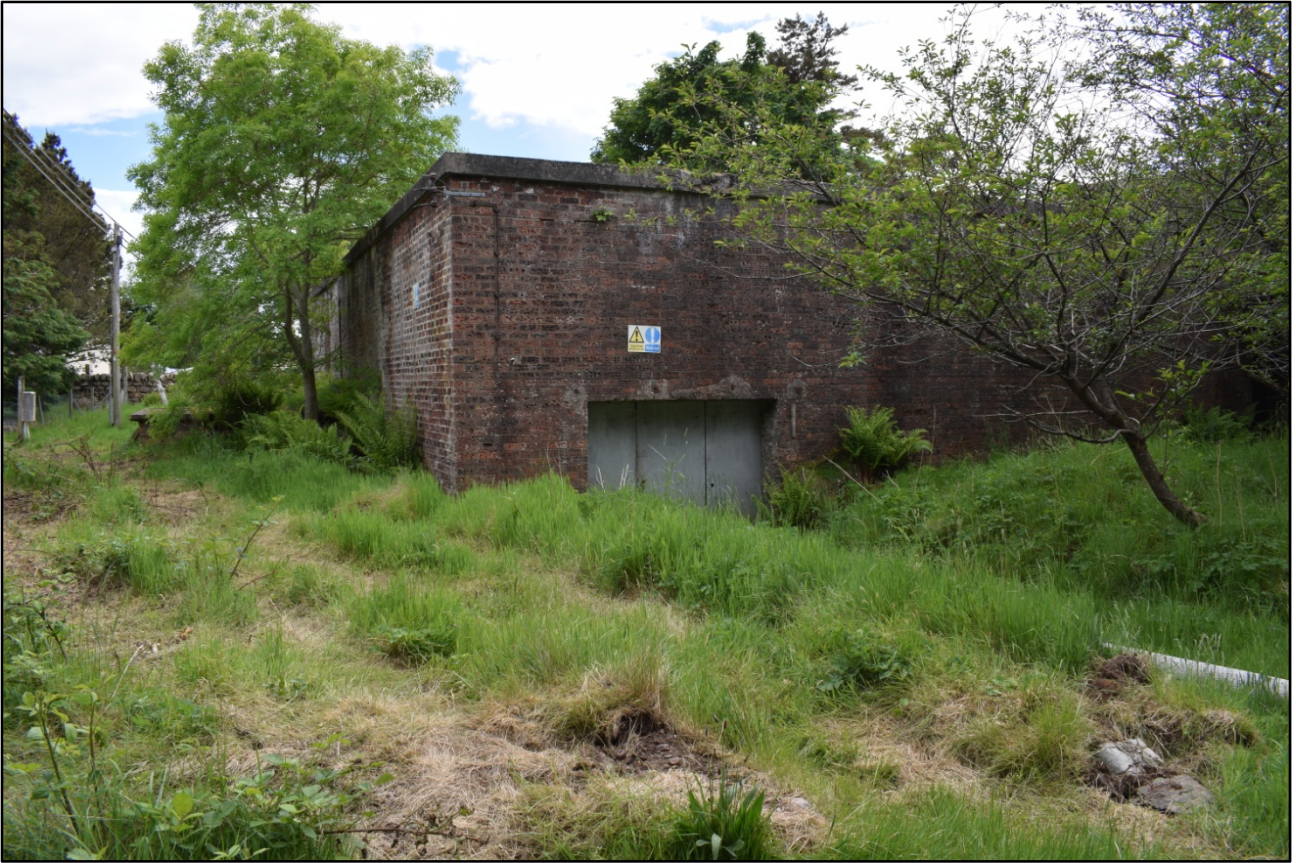
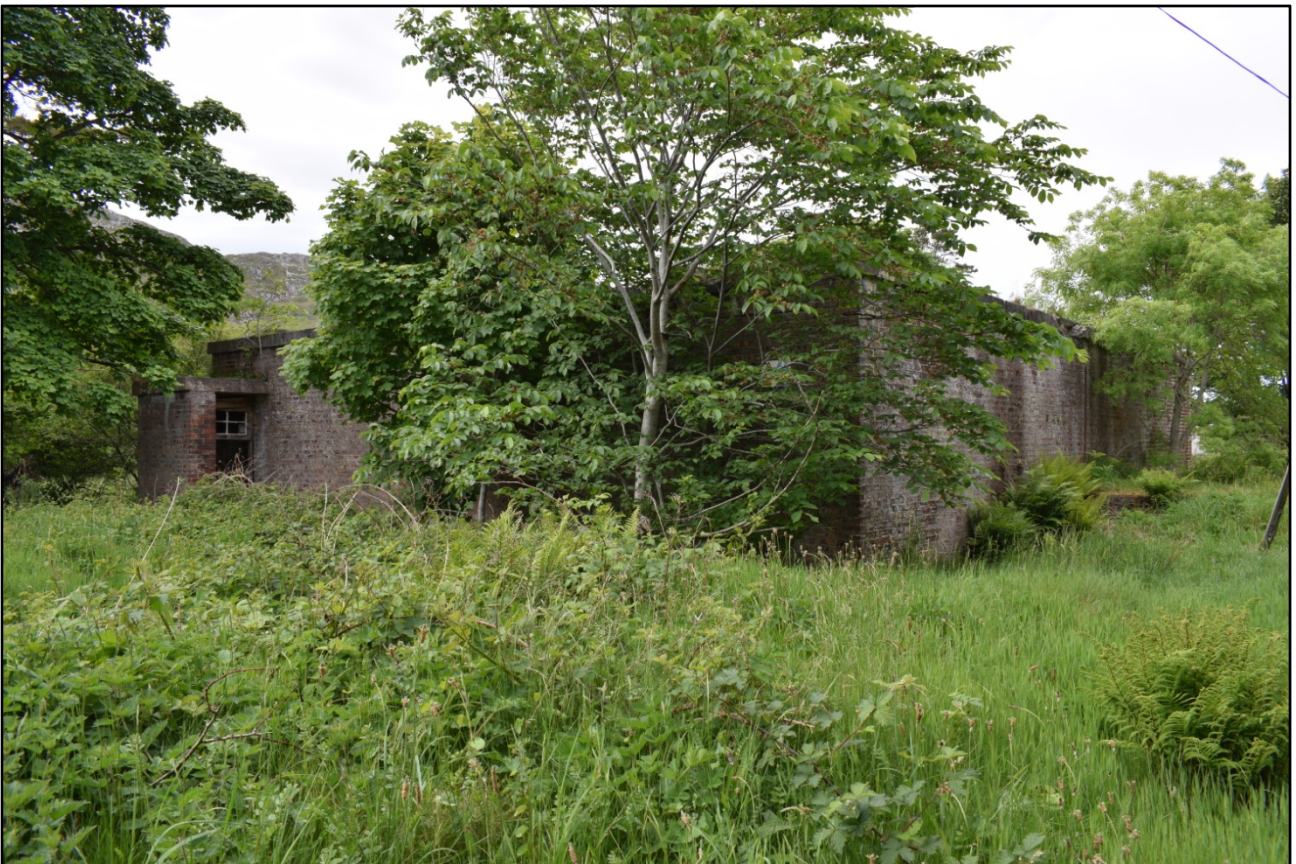
- 6.2.2 In the southeast corner of the site, surrounded by thick vegetation and trees was a brick-built bunker, Site 16, with a flat roof measuring 18m NNW-SSE by 14m and approximately 4m high. The building had two protruding porch-like entrances at its northwest and southwest corners. A third entrance (big enough for a vehicle) was built into the north wall and was partly below ground level. A sloping, dug track led out from this entrance (**Plates 7-8**).

Plate 7: View over the brick bunker, Site 16, facing S

Plate 8: View over the brick bunker, Site 16, facing WNW
