Galmisdale Wreck Eigg, Small Isles, Highlands

Undesignated Site Assessment

Ref: 109130.03
March 2016

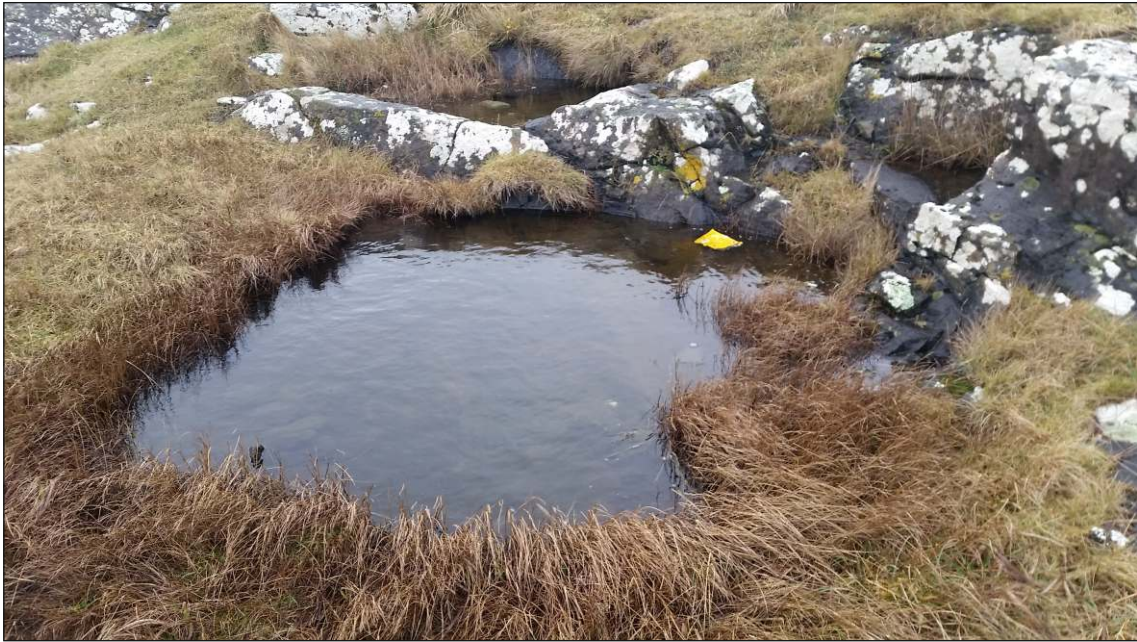
Plate 3: The freshwater rock pool where timbers T13, T14 and T15 were stored, near the old pier

- 4.1.7 Further storms over the autumn and winter of 2015 resulted in more timbers washing ashore where they were recovered by locals and stored in a rock pool near the pier. (**Plate 3**). WA Coastal & Marine was then commissioned by Historic Environment Scotland to recover these timbers and conduct a monitoring visit to the site.

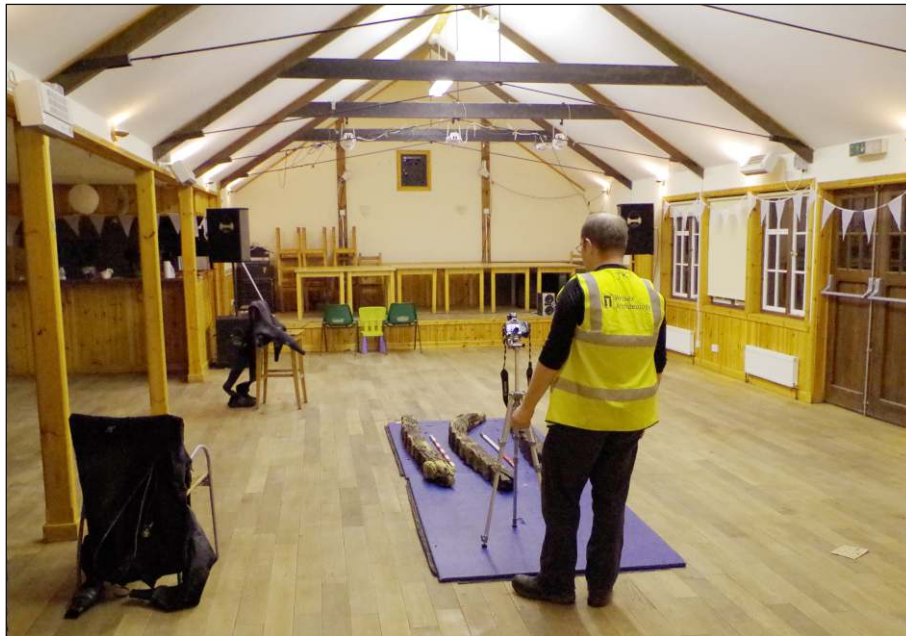
Plate 4: The photogrammetric survey of the Galmisdale timbers in the Eigg community Hall

5.3.1 All recovered timbers were reunited on Eigg and were photographed at the Eigg community hall in order to generate detailed scaled orthomosaics. All images were taken using a Canon 550D with tripod and remote trigger to avoid image blur. Timbers were recorded in batches of three or four with recording of both sides (**Plate 4**). The resulting photographic datasets were processed into 3D models using Agisoft Photoscan and

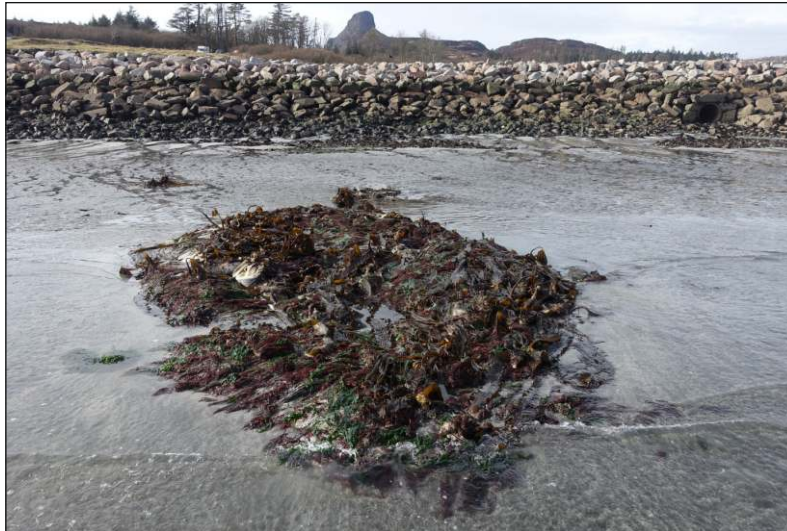
Plate 7: Exposed bow and stern visible at spring low tide in March 2016 facing west (Copyright Greg Carr 2015)

- 5.4.2 Through discussions with Camille Dressler it was decided that local residents would visit the site at the next low spring tide when the site was expected to be fully exposed and attempt a photographic survey which would allow for some assessment of the current condition of the wreck. Photographs of the wreck taken by local resident Greg Carr on the 10th of March 2016 were subsequently provided to the WA Coastal & Marine team and show that most of the wreck is still intact with some further evidence of exposed timber at the stem and stern and of edges of at least one in-situ strake between them (**Plates 7-9**). Currently the bow and stern seem to be partially covered by sandbags. Some parts of the bow and stern however are exposed posing a risk to the conservation of the vessel in the future. Amidships the wreck remains largely covered with sand as it was at the time of the 2002 survey.

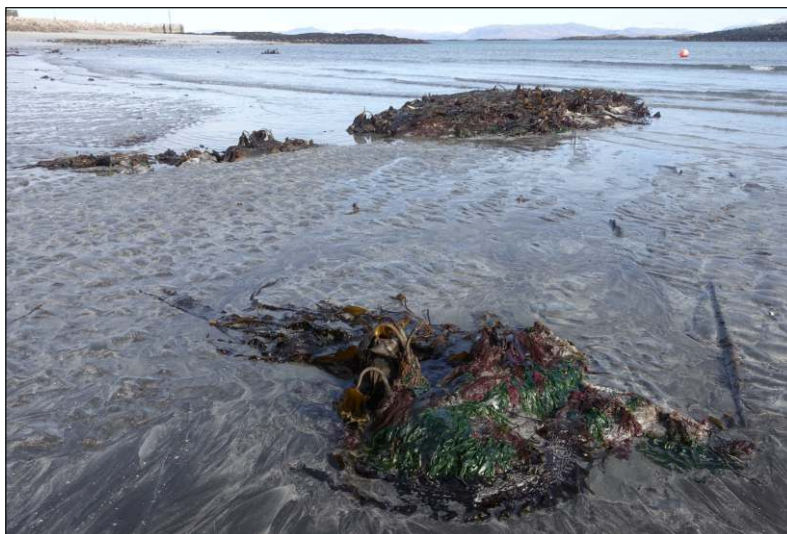
Plate 8: Exposed bow and stern visible at spring low tide in March 2016 facing north (Copyright Greg Carr 2015)

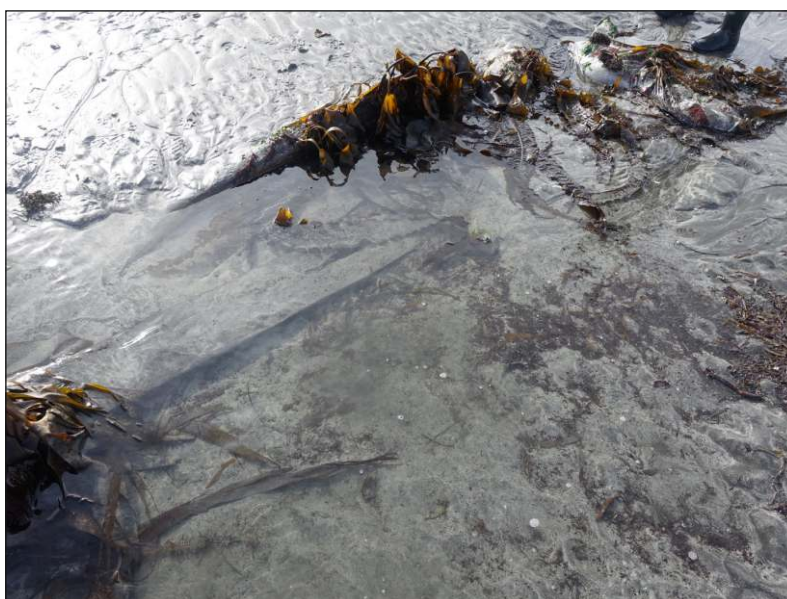
Plate 9: Exposed timber visible at low spring tide in March 2016 (copyright Greg Carr 2015)

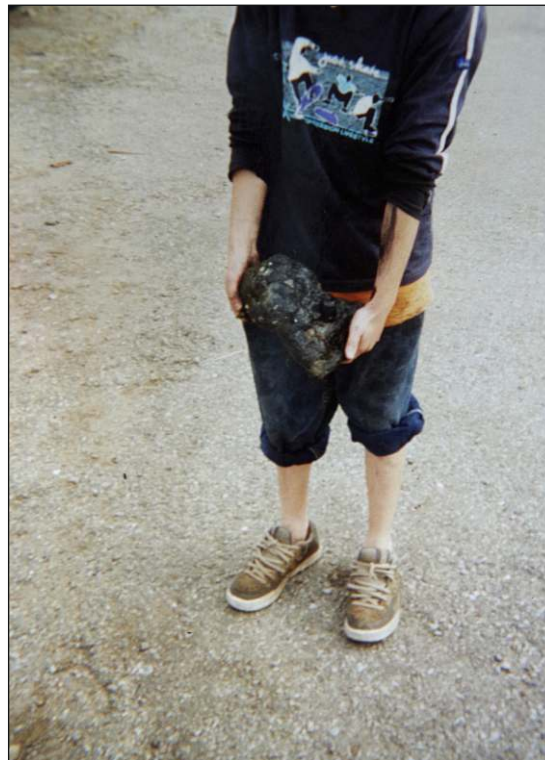
Subsequent analysis of this concretion by the RCAHMS and the National Museum of Scotland suggested that it might be an iron axe (Birch 2002, 3). Correspondence with David Caldwell, formerly of the National Museum, established that the iron axe was found to be highly corroded and unsuitable for further analysis. Its current location is unknown (pers. comm. Caldwell 05/02/2016).

Plate 11: Concretion of what is thought to have been an iron axe found on the Galmisdale wreck, photographed around 2001 (copyright Camille Dressler 2015)

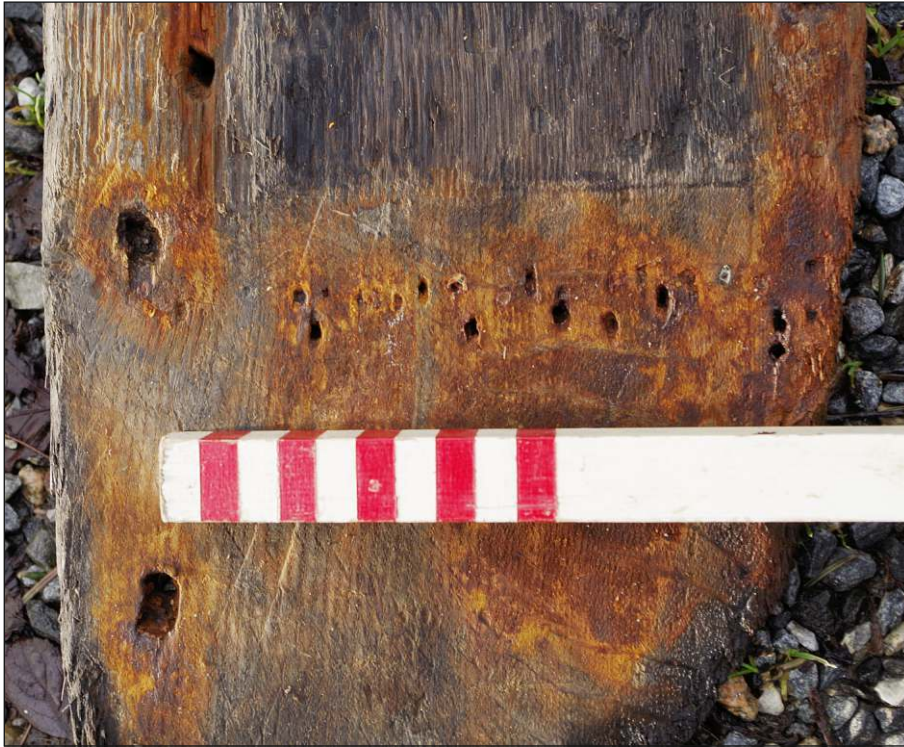
- 5.6.10 There are two types of fastening evident on the timbers. Single metal fastenings of around 6 mm square are holding strakes together and are spaced around 50 to 30 mm apart. An indent observed in some of the strakes by a square or rhombic rove of between 20 and 40 squared mm is an indicator of the fastenings being metal bolts or nails clenched over roves or washers. These fastenings are related to the clinker build of the ship which allowed the planks to overlap each other creating a flexible hull capable of withstanding tougher sea conditions than frame first constructed vessels (McGrail 2004; pp.149–153). The iron fastenings connecting the strakes to the frames on the other hand are slightly larger, around 8 and 10 mm squared and are mostly paired to give the strakes more stability. The twinned fastenings are spaced between 200 and 400 mm from each other indicate that the frames were placed closer together at different points of the vessel.

Plate 12: An example of small fastenings visible on the scarph joints (T-16)

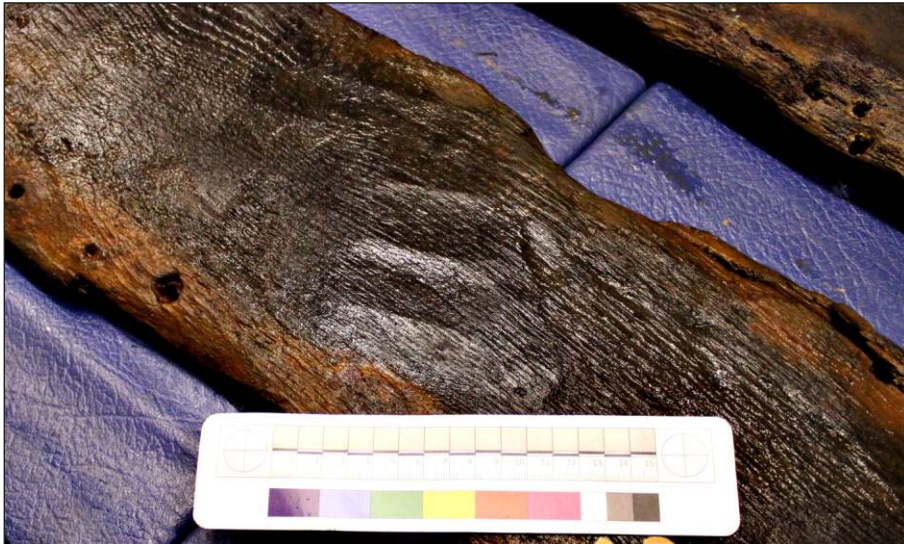
Plate 13: Traces of adze marks on T-18

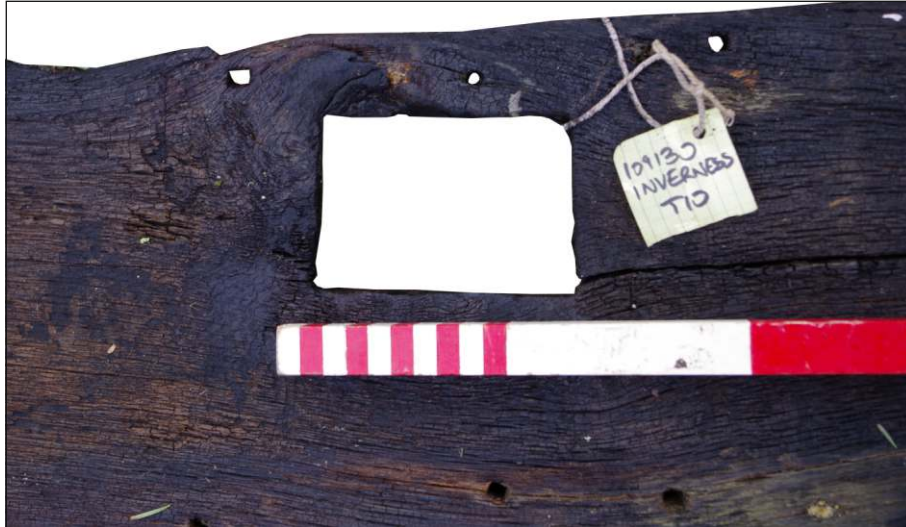
- 5.6.8 A square hole of 70 by 110 mm is found on one of the planks which might be related to the bilge pump (**Plate 14**).
- 5.6.9 It was noted that some of the strakes exhibited a distinct curvature in one direction and in some cases a slight longitudinal twist. One strake (T-7) had a distinct twisted and is therefore considered likely to be from near the bilge at the raked stern or stem of the vessel.

Plate 14: Square hole found on one of the strakes (T-10) which may be associated with a bilge pump

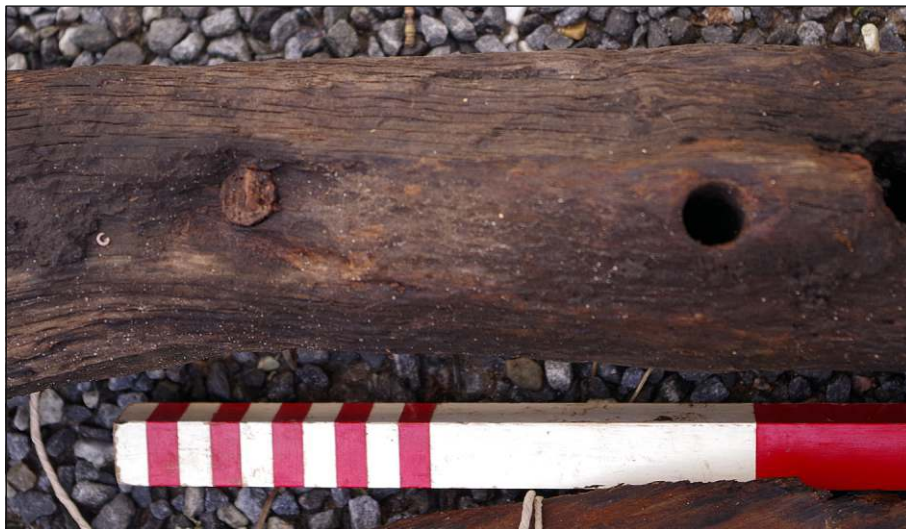
- 5.6.11 Treenails have been found on T-3 (3 in total) and T-10 (2 in total), both with a diameter of around 20 mm (**Plate 15**). On T-3 the treenails were most likely used to fasten what could be a floor timber to the keelson. Although previous analysis of timbers from this site has mentioned treenails at the end of the frames, these were not observed during recording. This may be due to the degradation of the timbers.

Plate 15: Treenails visible on a possible floor timber (T-3)

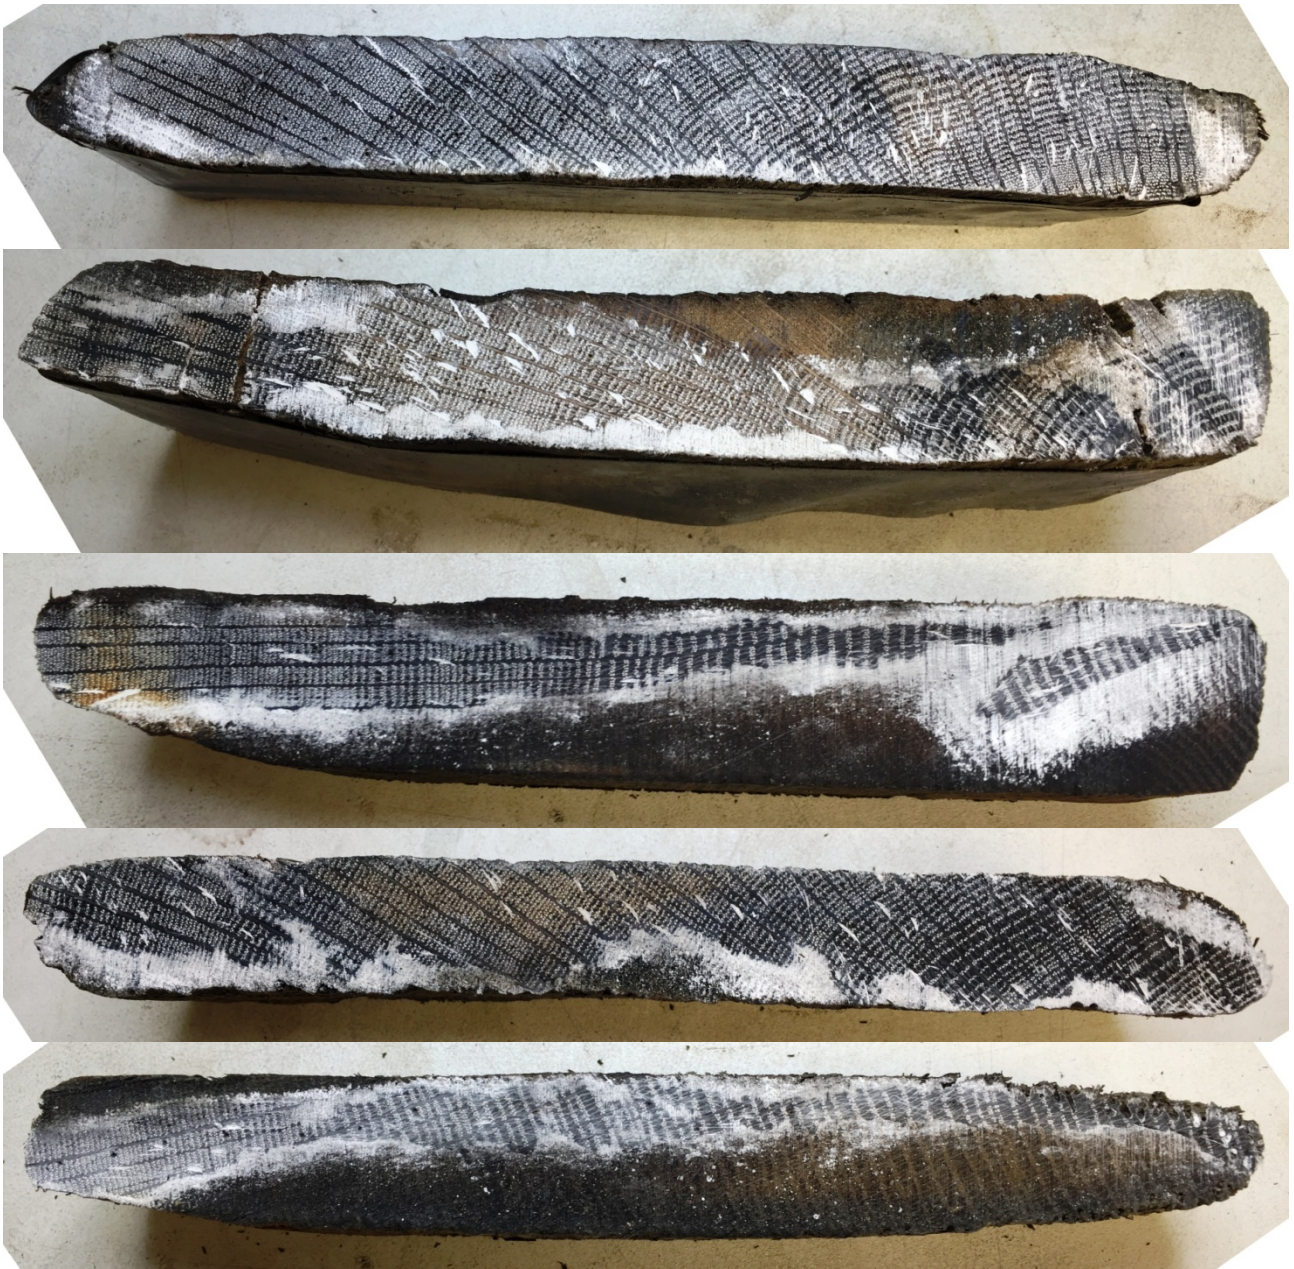
Illus 1: prepared samples, T11, T12, T16, T17 & T18, from top to bottom.

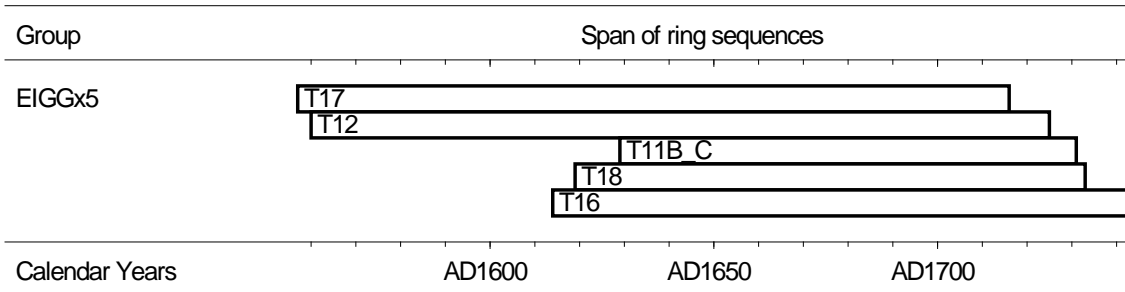
The dendrochronological analysis of timbers from the Galmisdale Bay boat wreck has produced a 188 year chronology which has been dated to AD 1557 – 1744. Allowing for missing tree-rings this provides a *terminus post quem* date of AD 1754 and it was probably felled sometime in the last decades of the 18th century. The timber used to make the strakes had been imported from America, probably from Massachusetts.

Illus 2: bar diagram showing chronological relationships within EIGGx5
