Land at Sir Walter Scott Drive,
Slakbuie, Inverness

Archaeological Evaluation
Report No. 3069

Archaeological Evaluation

Report No. 3609

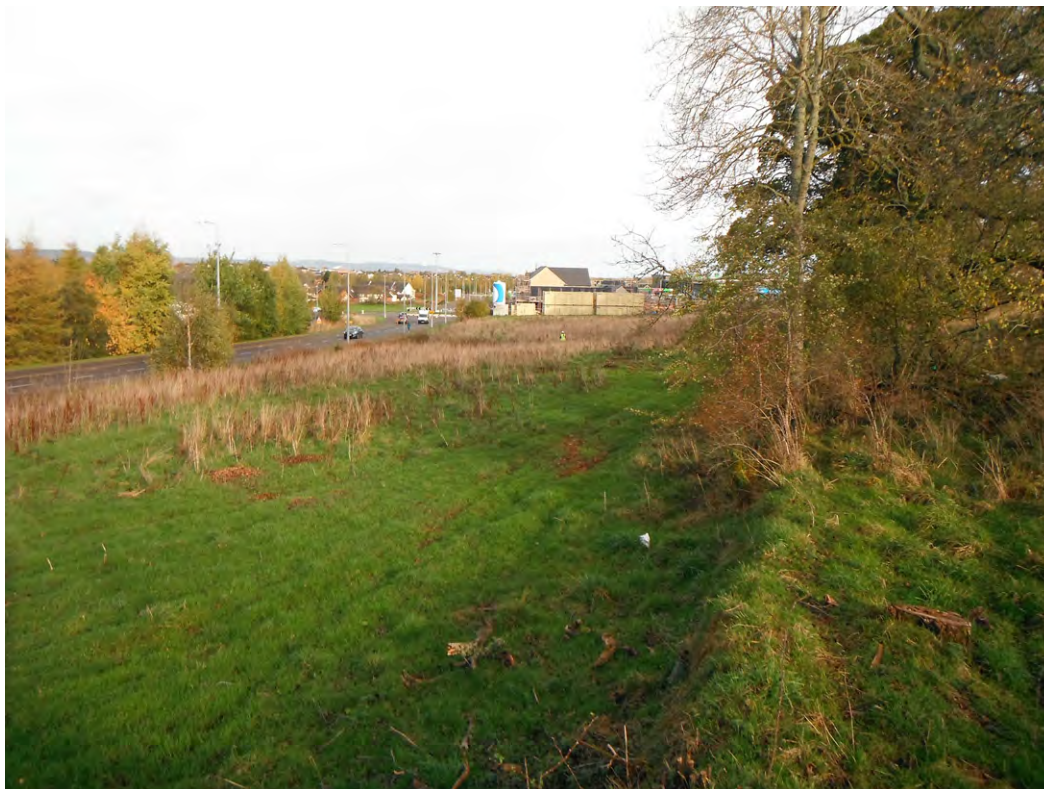
The site (Fig. 2) was generally North-West facing. Sir Walter Scott Drive formed the North-Western site boundary and a line of mature trees formed the elevated South-Eastern site boundary. The land to the North was currently being developed.

Fig. 2 General view of the site from the south-west

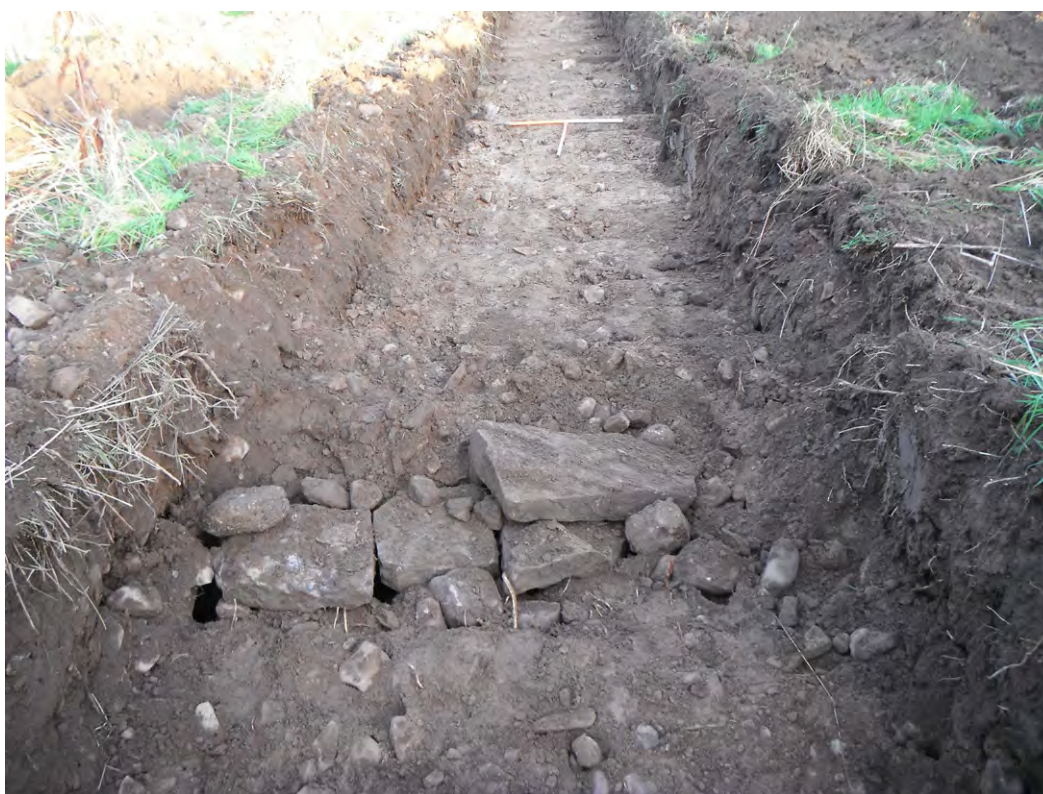
Three features were recorded in this trench. At the western end, a culvert drain (**201**) made from sandstone slabs (**202**) was aligned SSE-NNW (Fig. 3). The channel was roughly 0.3m wide and the same deep.

Fig. 3 Trench 2, culvert 201

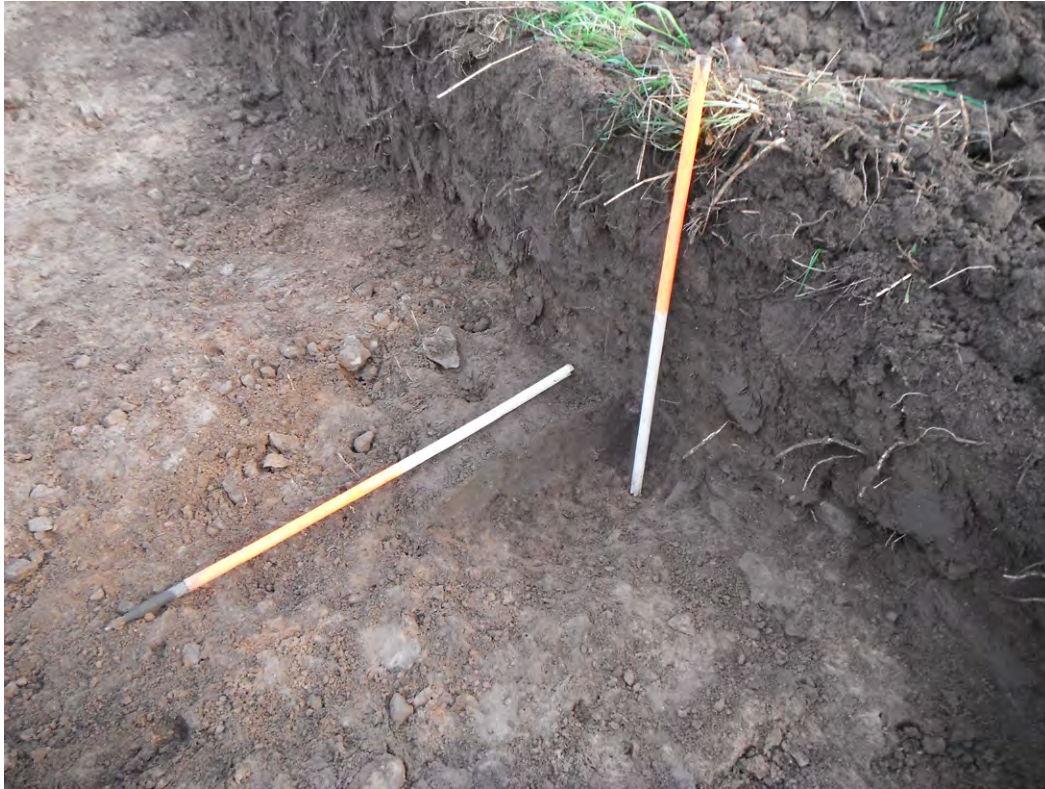
Further east, feature **203** ran out of the trench so its full shape in plan was not identified. It measured over 0.7m in length, 0.6m in width and a section showed it had a depth of 0.2m (Fig. 4). It was filled with a sterile brownish grey silty sand (**204**),

little different from the overlying subsoil (**002**). No finds were recovered.

Fig. 4 Trench 2, feature 203

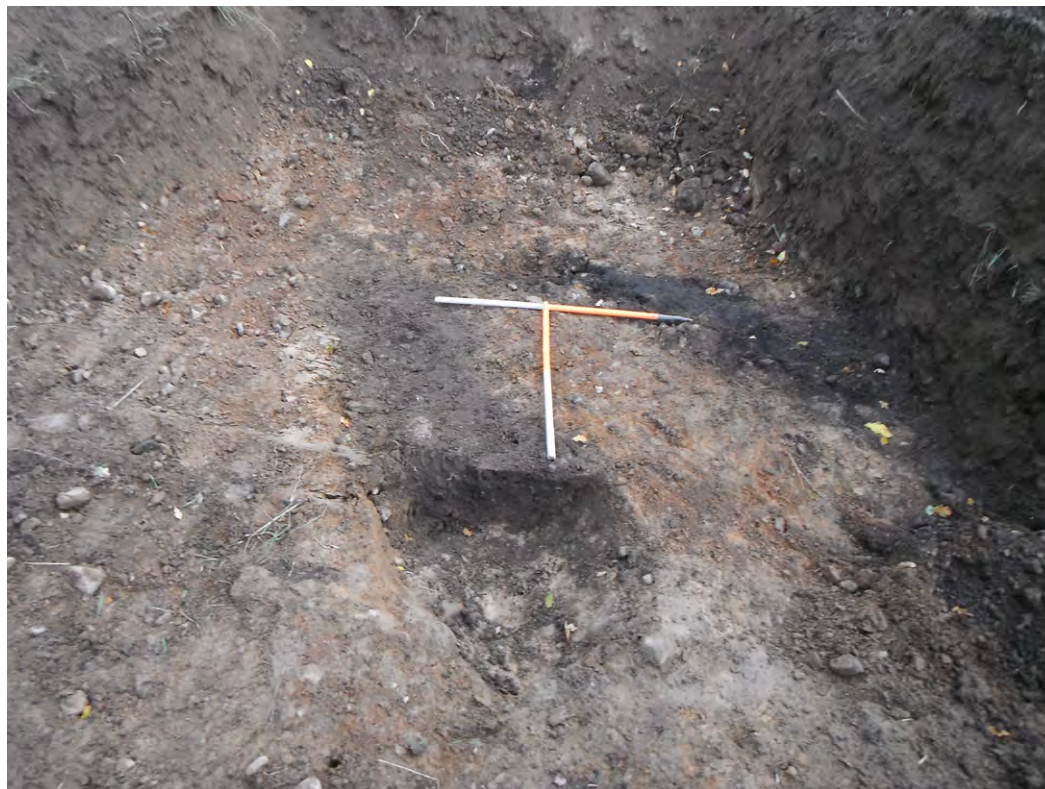
Near the eastern end of the trench, a second feature (**205**) was partially exposed and the trench was later extended by 14m² (Fig. 5) to further reveal it. Feature **205** was revealed to be an elongated pit, with a length of around 3m, a width of 0.8m and a depth of 0.25m. It was filled with a sterile dark grey silty sand (**206**). No finds were recovered. Next to Pit **205**, a second elongated pit (**207**) (Fig. 11) was partially revealed. This feature had a length of over 2m, width of 0.6m and a depth of 0.15m. It was filled with grey-black silt and frequent cobbles (**208**). No visible charcoal was present and no finds were recovered.

Fig. 5 Trench 2 extension, features 205, 207 from the north

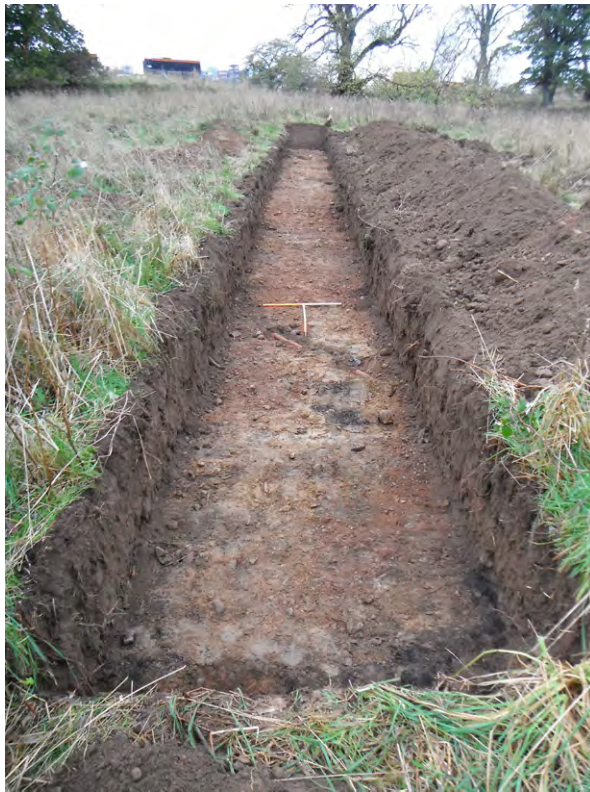
Trench 3 (Figs. 1, 6-7) was aligned roughly N-S and measured 30m by 1.8m. It ran obliquely across the slope in the centre of the site. Topsoil (**001**) with a depth of 0.25m overlay subsoil (**002**) with a depth of between 0.4m and 0.5m. At the north end of the trench, a discontinuous lens of grey-black peaty silt was present at the base of the subsoil (**301-2**) (Fig. 7) and this filled shallow undulations in the natural below (Fig. 6 foreground). The natural subsoil was a well drained sandy gravel at the north end and a silty sand and gravel at the south end.

Fig. 6 Trench 3, general view from the north

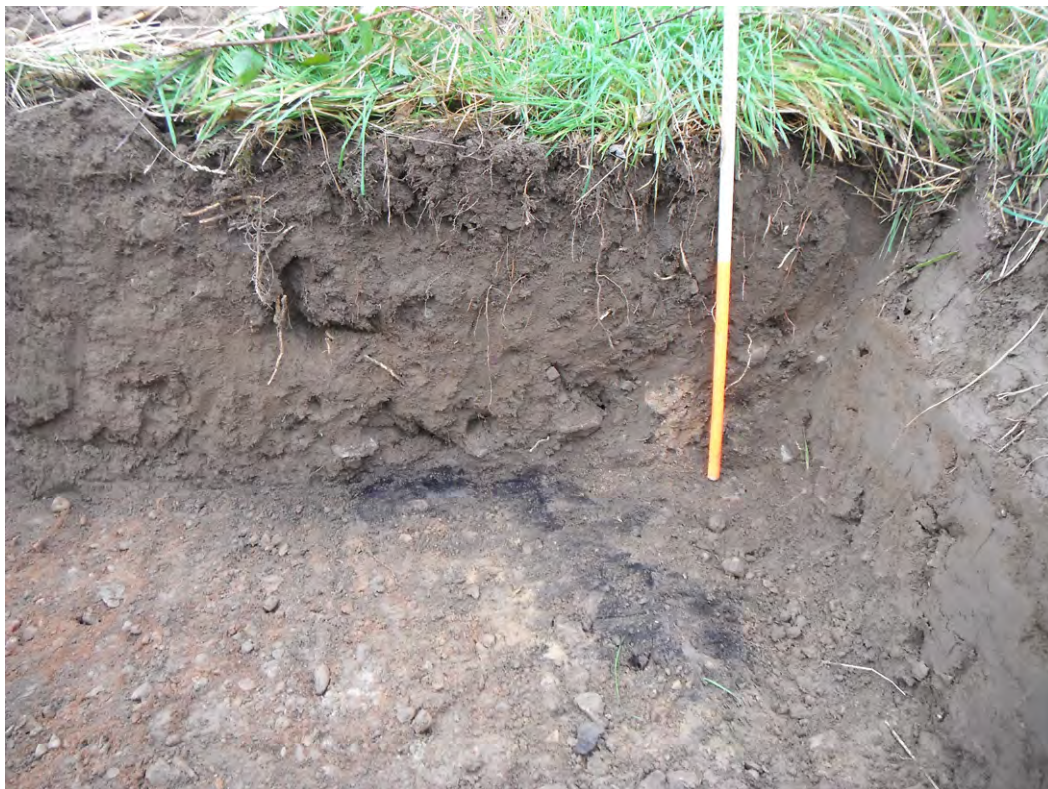
Fig. 7 Trench 3, section at the north end showing the grey-black peaty silt 301 at the base of the profile

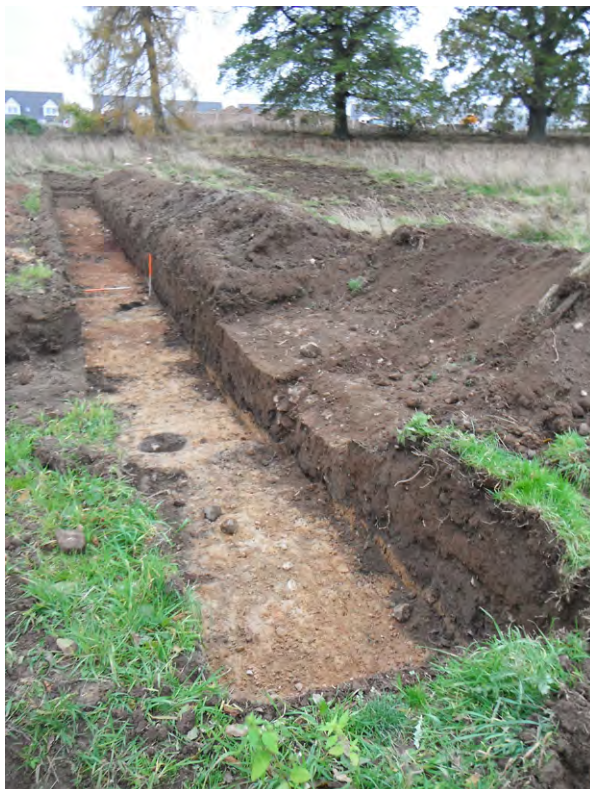
Trench 5 (Figs. 1, 8-10) was aligned roughly WNW-ESE and measured 30m by 1.8m. It ran at 90° to the contours up the slope in the northern edge of the site. Topsoil (**001**) with a depth of 0.3m overlay subsoil (**002**) with a depth of between 0.7m and 1.1m (Fig. 8). In much of the central part of the trench, a discontinuous lens of grey-black peaty silt was present at the base of the subsoil (**004**) and this filled several irregular shallow hollows in the natural below (Fig. 9). At the western end of the trench, the

A circular pit (**501**) was recorded in the centre of the trench (Fig. 8). This feature was 0.55m wide 0.15m deep (Fig. 10). It was filled (**502**) with sterile light grey-brown silt and a few pebbles. No finds were recovered.

Fig. 8 Trench 5, general view from west-north-west with pit 501 in the centre of the trench

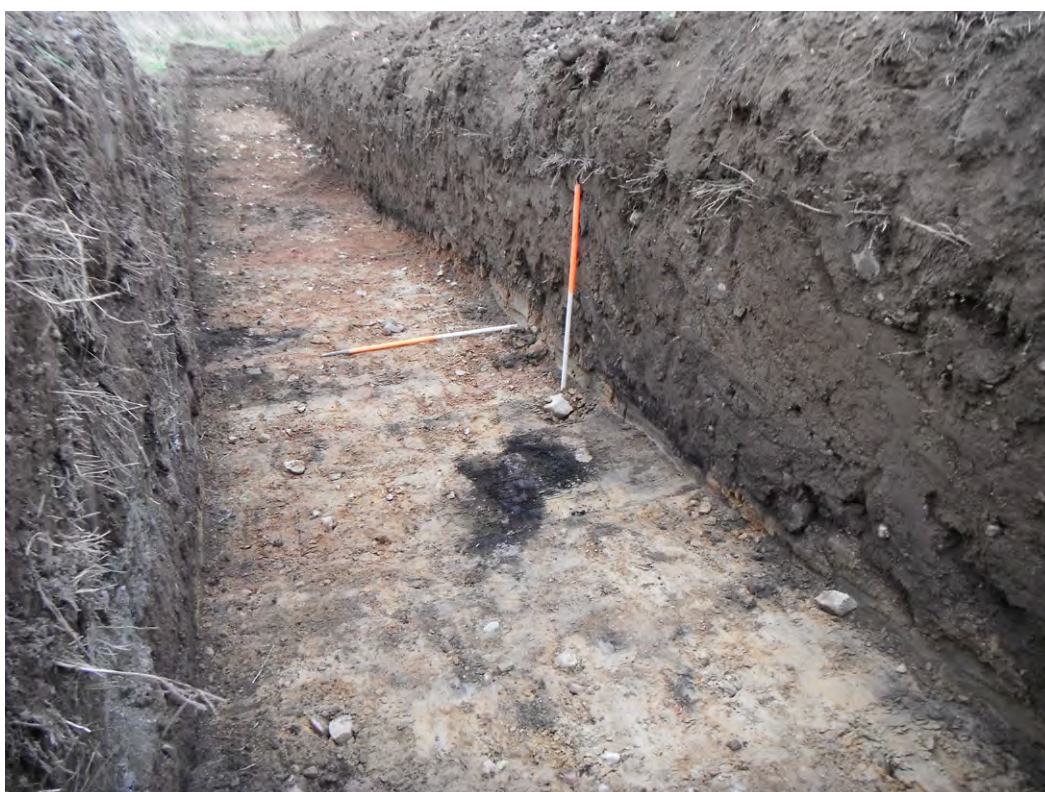
Fig. 9 Trench 5, section at the centre of the trench showing the grey-black peaty silt 004 at the base of the profile

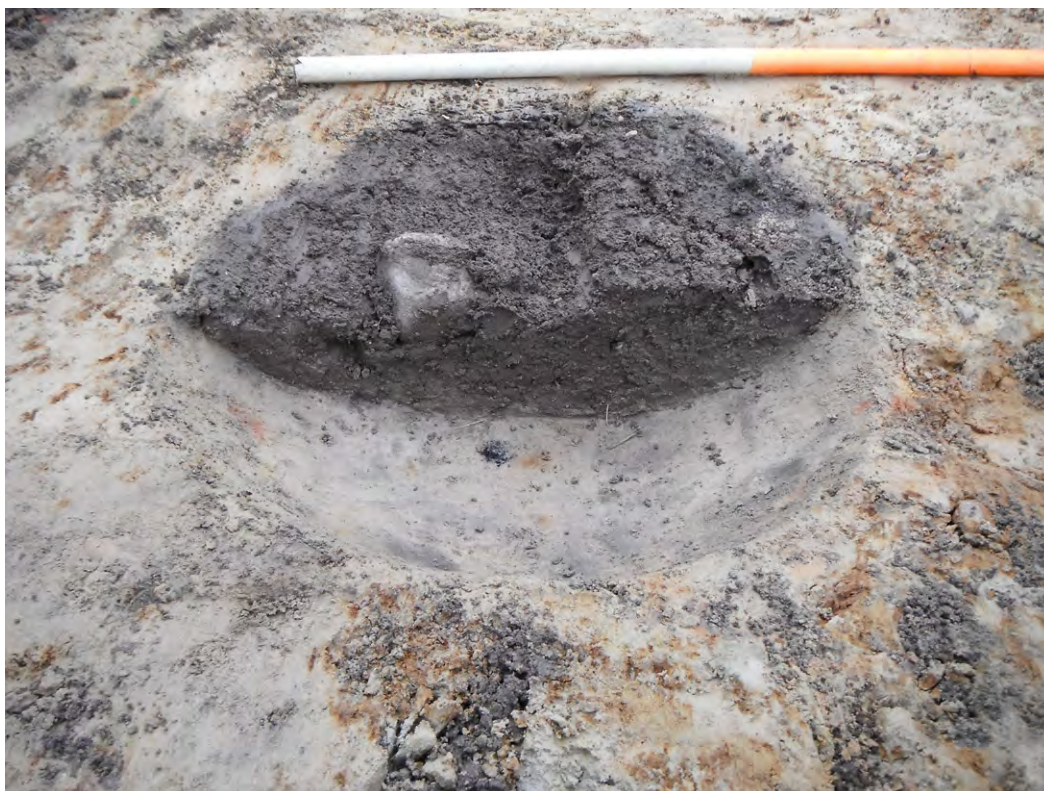
Fig. 10 Trench 5, pit 501 section

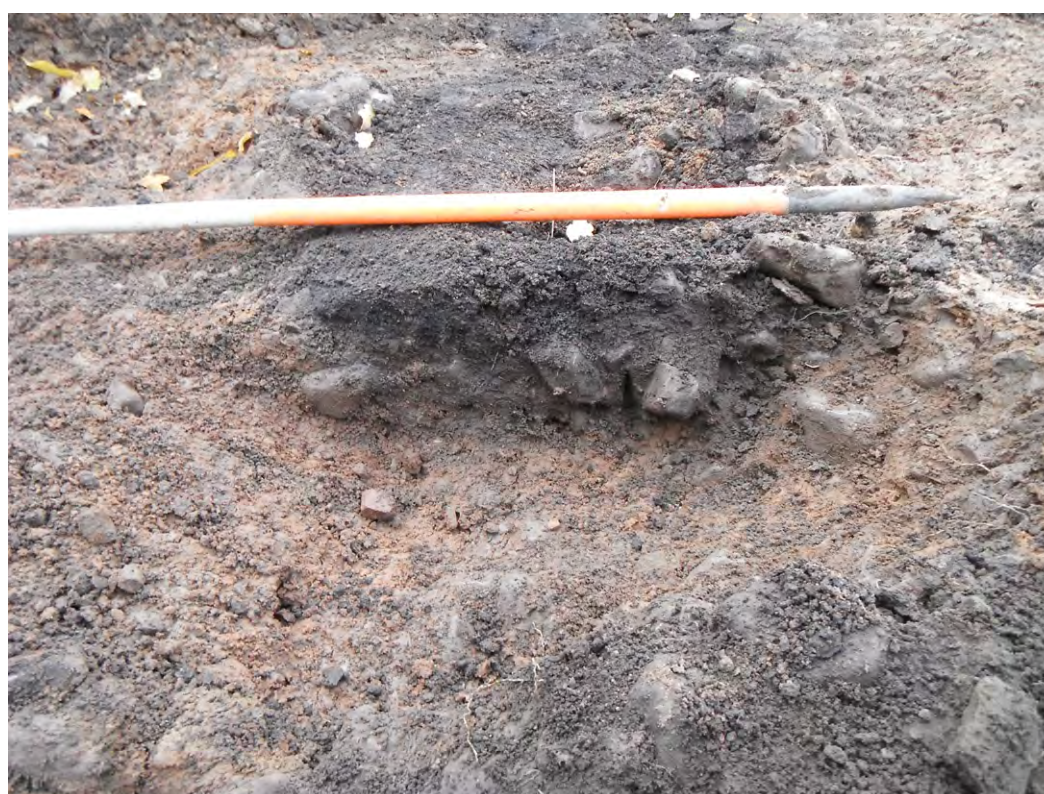
Fig. 11 Trench 2, feature 207 section
