UHI Accommodation
Land at Former Abattoir, Dornoch

Archaeological Evaluation
Interim Report

Report No.	HAS160908
Site Code	DOR16
Client	O'Brien Construction
Planning Ref	16/00887/FUL
OS Grid Ref	279771 889536
Date/ revision	26/9/2016
Author	Pete Higgins

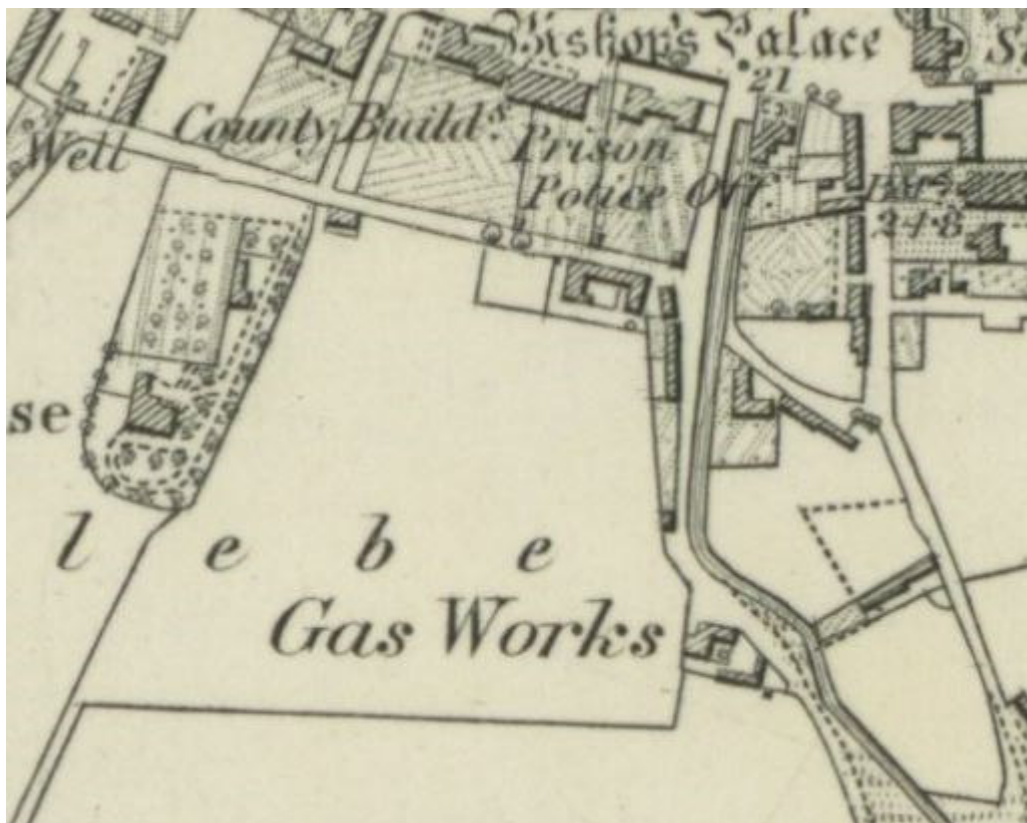
Figure 3 First edition 25" OS map, surveyed 1872, Sutherland Sheet CXIII

The first edition OS 25" map (Sutherland Sheet CXIII) shows several structures and enclosures along the eastern and northern boundaries of the site.
