A drystone structure identified by  
Keith Coghill at Strone  
overlooking Urquhart Castle,  
Loch Ness, Inverness-shire

Archaeological Survey, February 2018  
Report No. [HES-PIC323-2018-02](#)

**A drystone structure identified by Keith Coghill  
at Strone overlooking Urquhart Castle,  
Loch Ness, Inverness-shire**

**Archaeological Survey, February 2018**

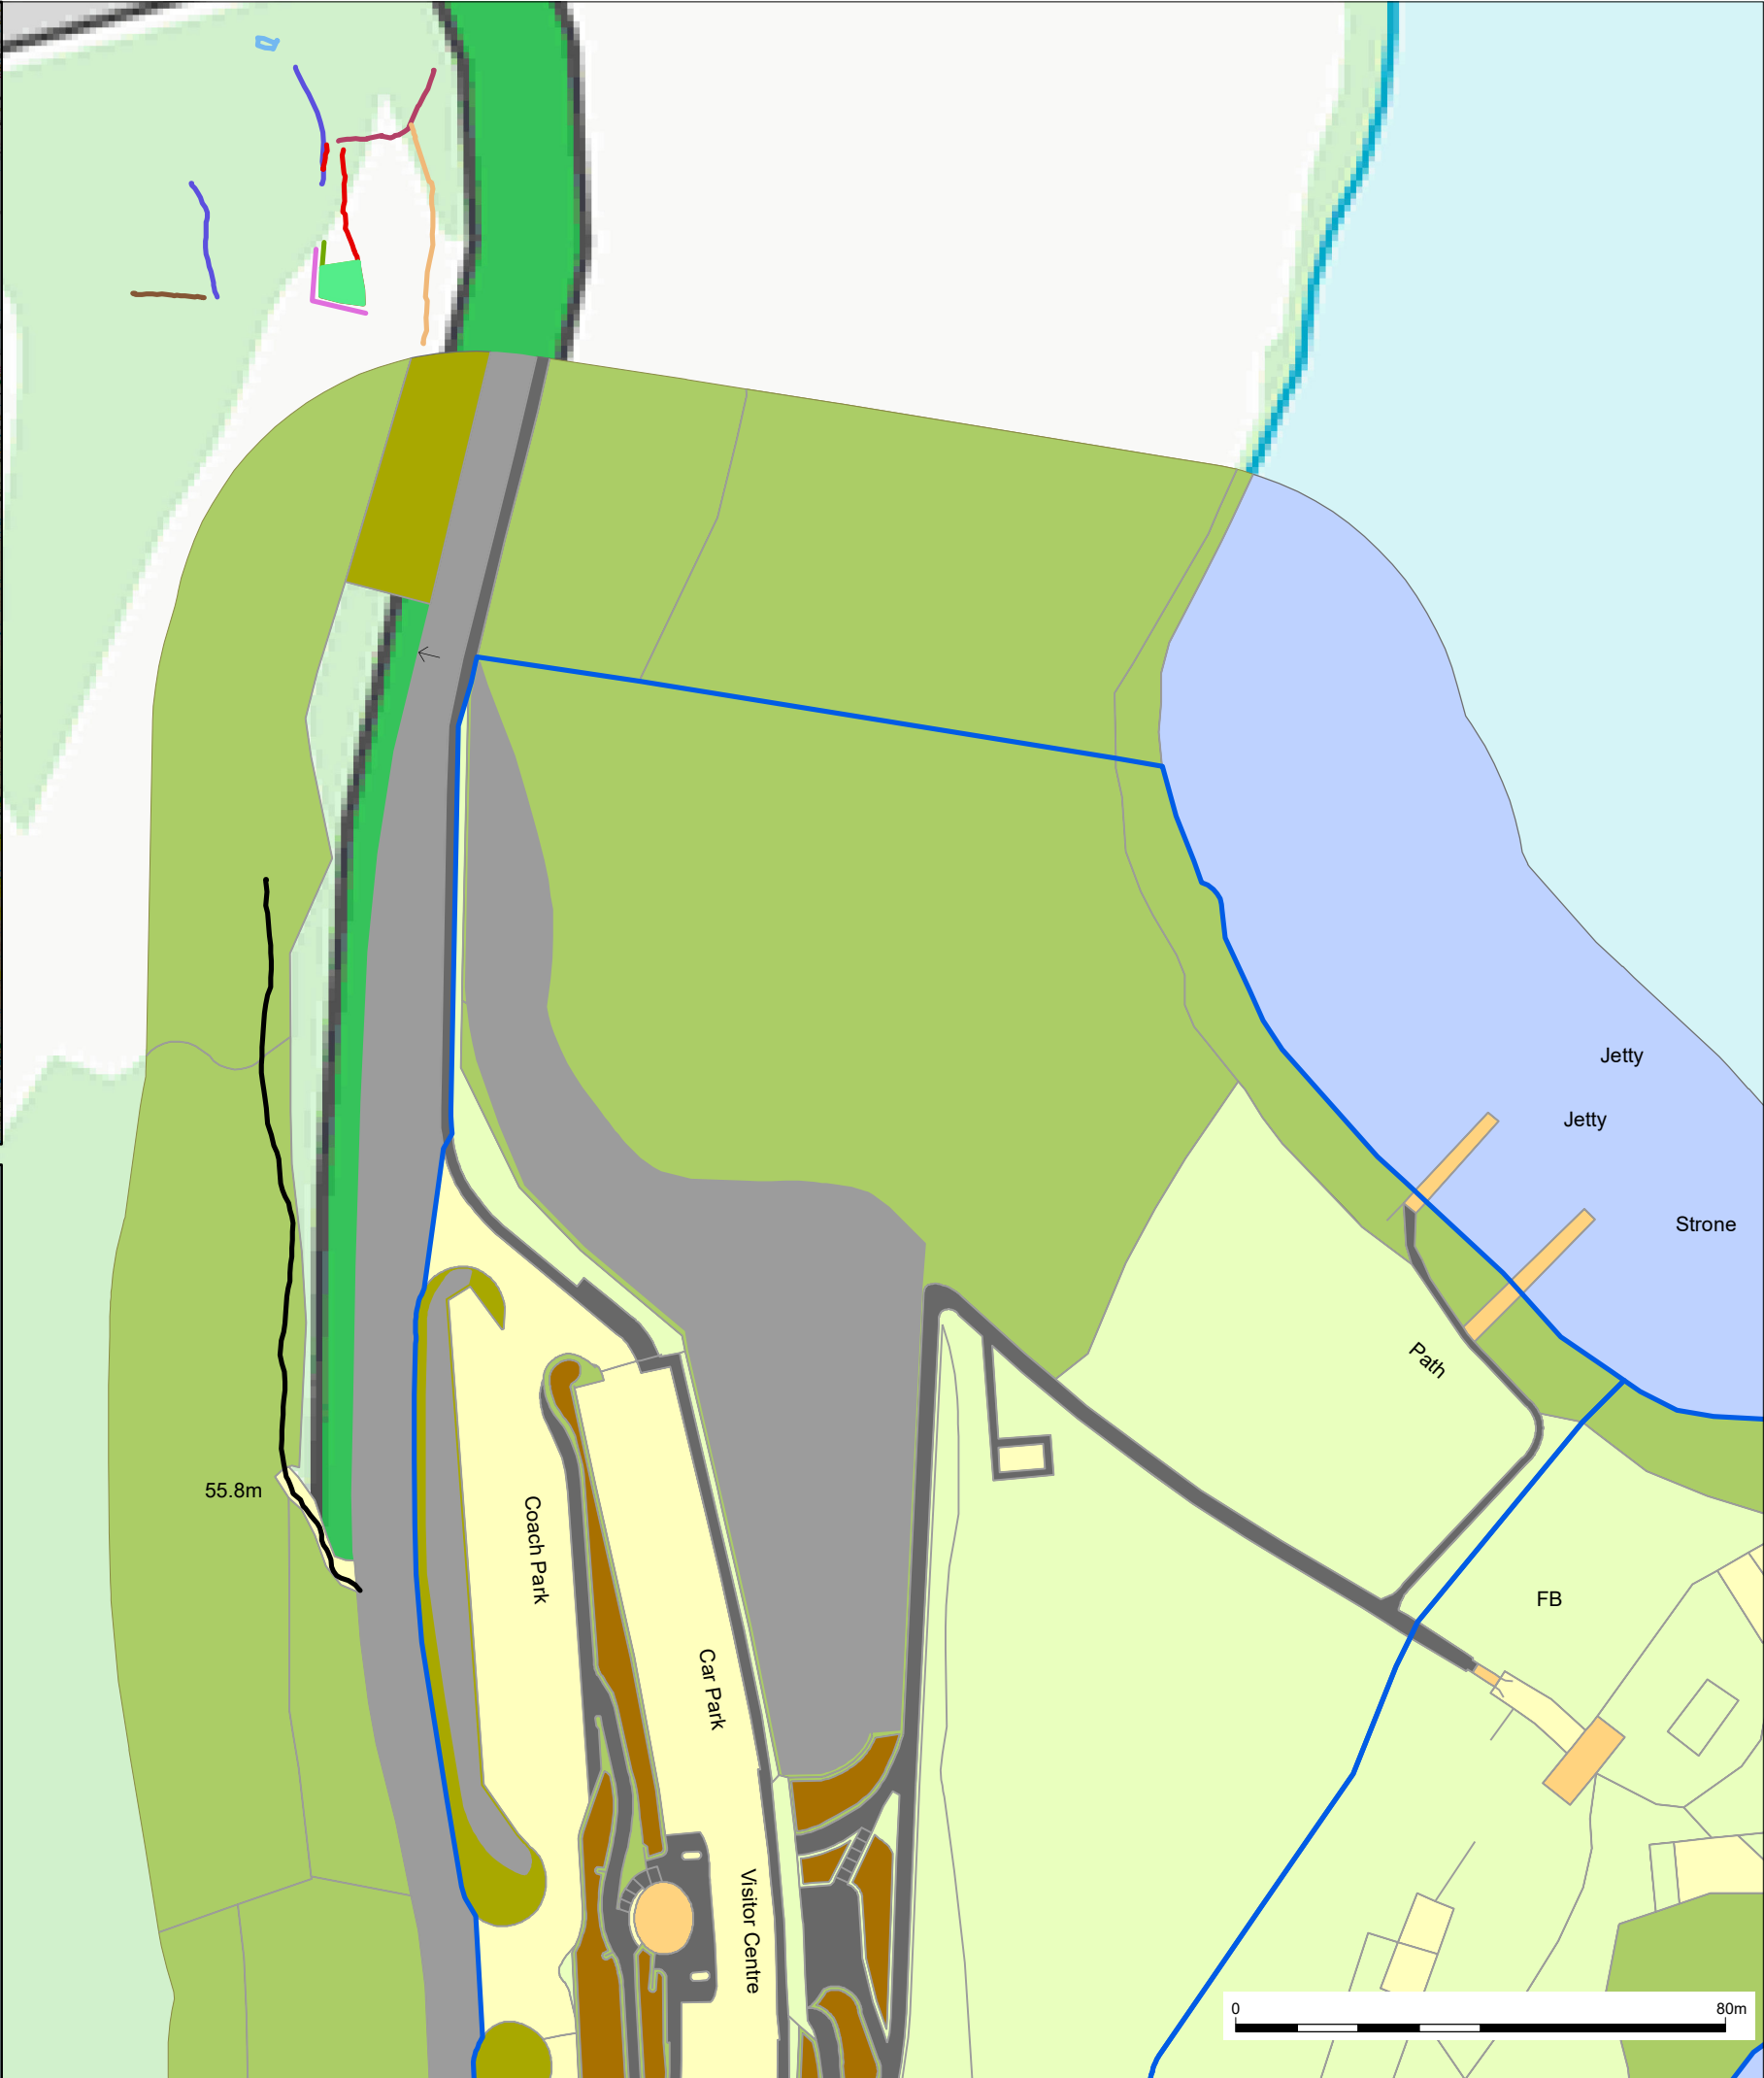
<b>Drawn by:</b> MP	<b>Checked:</b> MJ	<b>Date:</b> 19/06/2018
<b>Report No:</b> N/A		<b>Fig. No:</b> 1

The site (Fig. 1) is located on a moderate to steep East or South-East facing slope. Several mature trees and bushes now intrude but the elevated site offers a commanding view of Urquhart Castle and Loch Ness (Fig. 2). The remains are moss covered and partly hidden beneath trees, brambles and broom bushes but they consist of several phases of drystone walls around what appears to be an irregular level platform on the slope (Fig. 3). This measures roughly 6m North-South by 7.5m East-West. The internal surface is grassy and contains no features.

**Title:**  
The site location overlooking Urquhart Castle

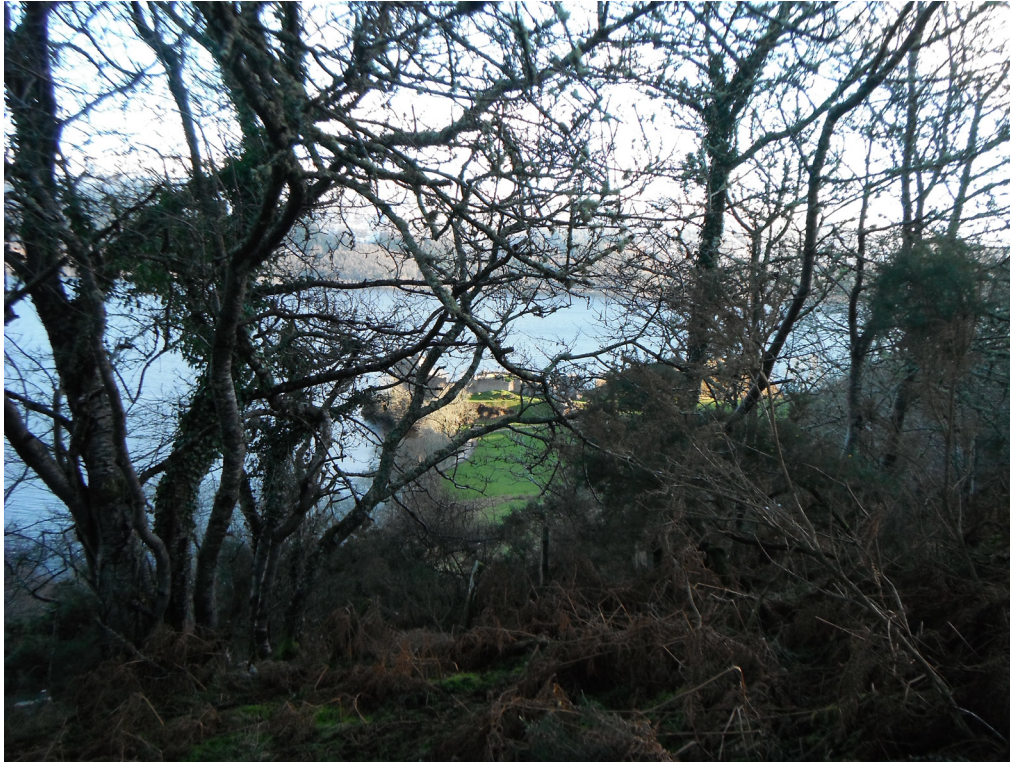
Fig. 2 - The view from the site South-East to Urquhart Castle

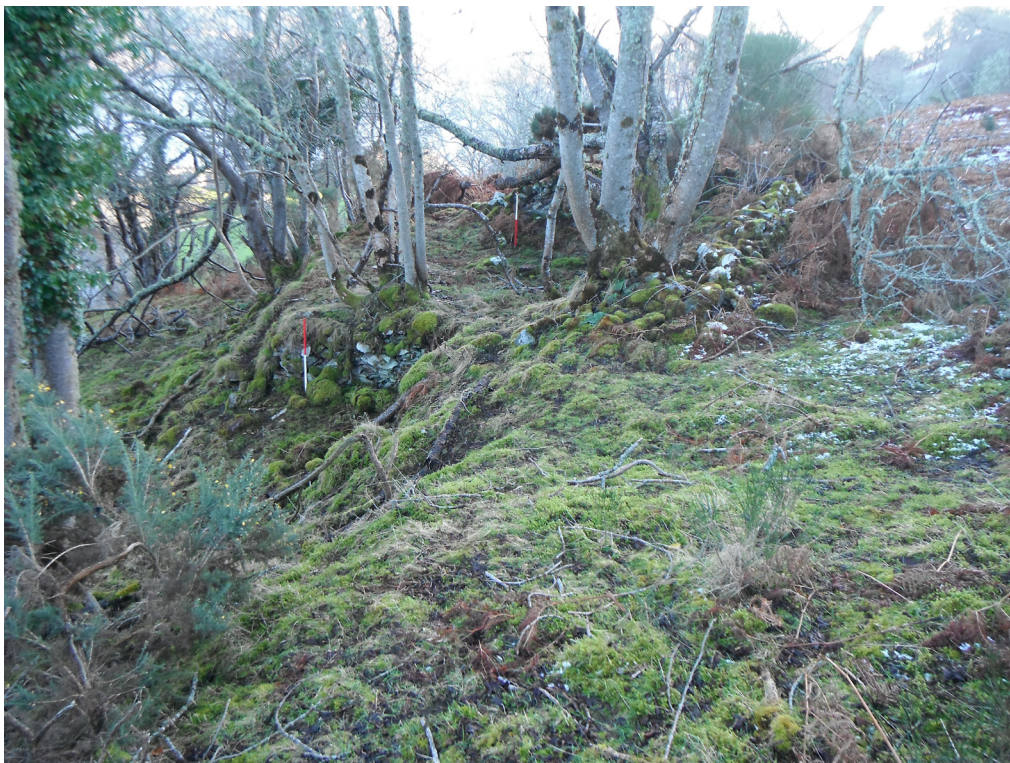
Fig. 3 - General view of the site from the North-West

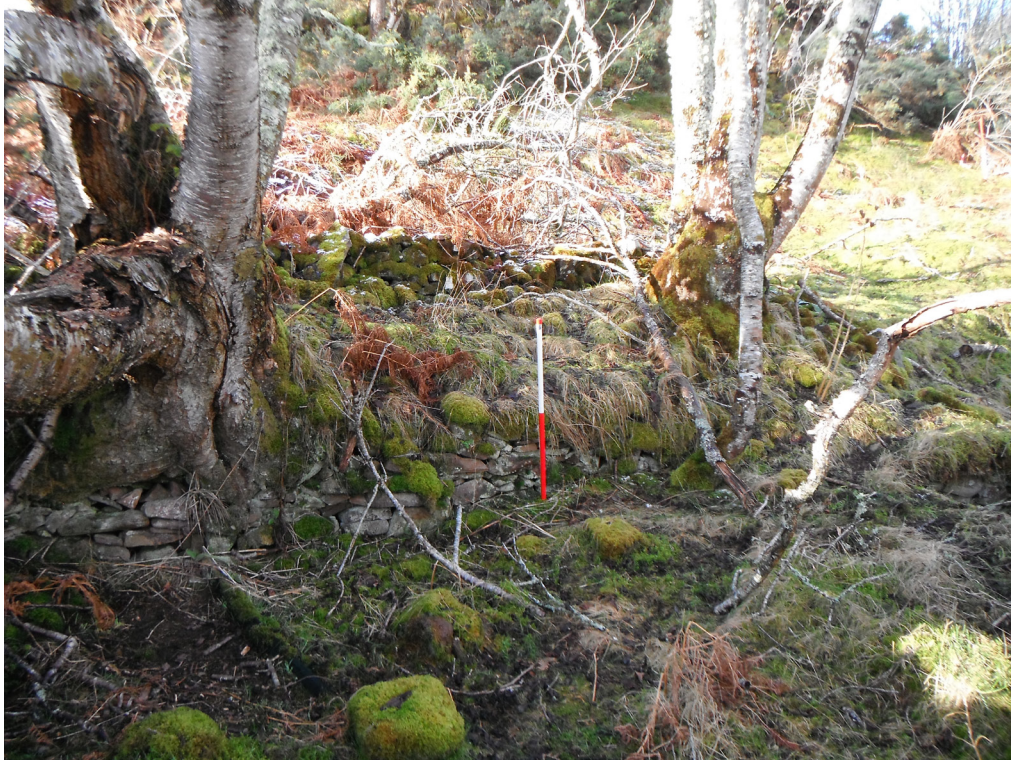
On the Eastern side, what may be bedrock is exposed below the platform but quantities of tumbled stones below suggest this was either faced with stones, or a wall was once present on the edge of the platform above. On the southern side, a low revetting wall with a height of 0.2m is present at the edge of the platform along with an area of quarried bedrock. Less than 0.5m to the south is a ruinous drystone field wall. On the western side, a continuation of the revetting wall is present with a continuation of the same field wall at a distance of 2m beyond (Fig. 4). On the Northern side, the platform is revetted or retained by a drystone wall with a height of 1m. This wall abuts a second retaining wall running to the North. The walls of the platform are of quarried red sandstone. Those of the field wall are of more rounded schist and red sandstone.

Fig. 4 - The revetting wall on the Western side of the enclosure  
with the field wall beyond from the South-East
