# Burn of Whilk Wind Farm Borrow Pit 1:

## Archaeological Works

### Draft Data Structure Report

*Planning Ref: 12/01242/FUL - Condition 9: Archaeology*

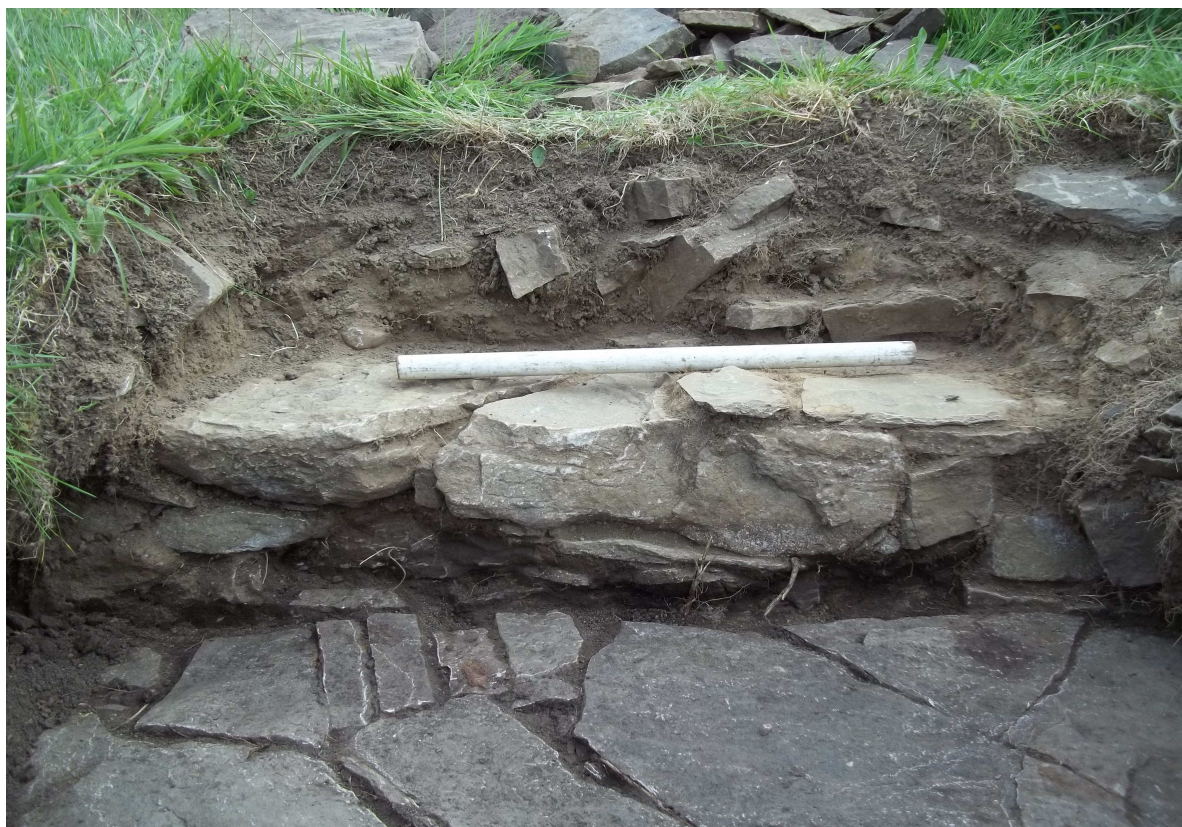
Plate 1: Wall [3810] and associated flag flooring [3809] from south

Trench B was aligned north-east to south-west, across the width of the building, and adjoined Trench A at its south-eastern end. The trench was 9.0 m in length and revealed two further substantial wall segments. Wall [3810], located at the north-eastern edge of the trench, was constructed of a combination of turf and stone and represents the external wall of the building. Wall [3806] represents the same wall identified in Trench A. Wall [3806] was adjoined to the south-west by a wall segment [3812], which represented the edge of a curvilinear structure, abutting the main building. The wall was 1.80 m in width and had an associated rubble core [3813].

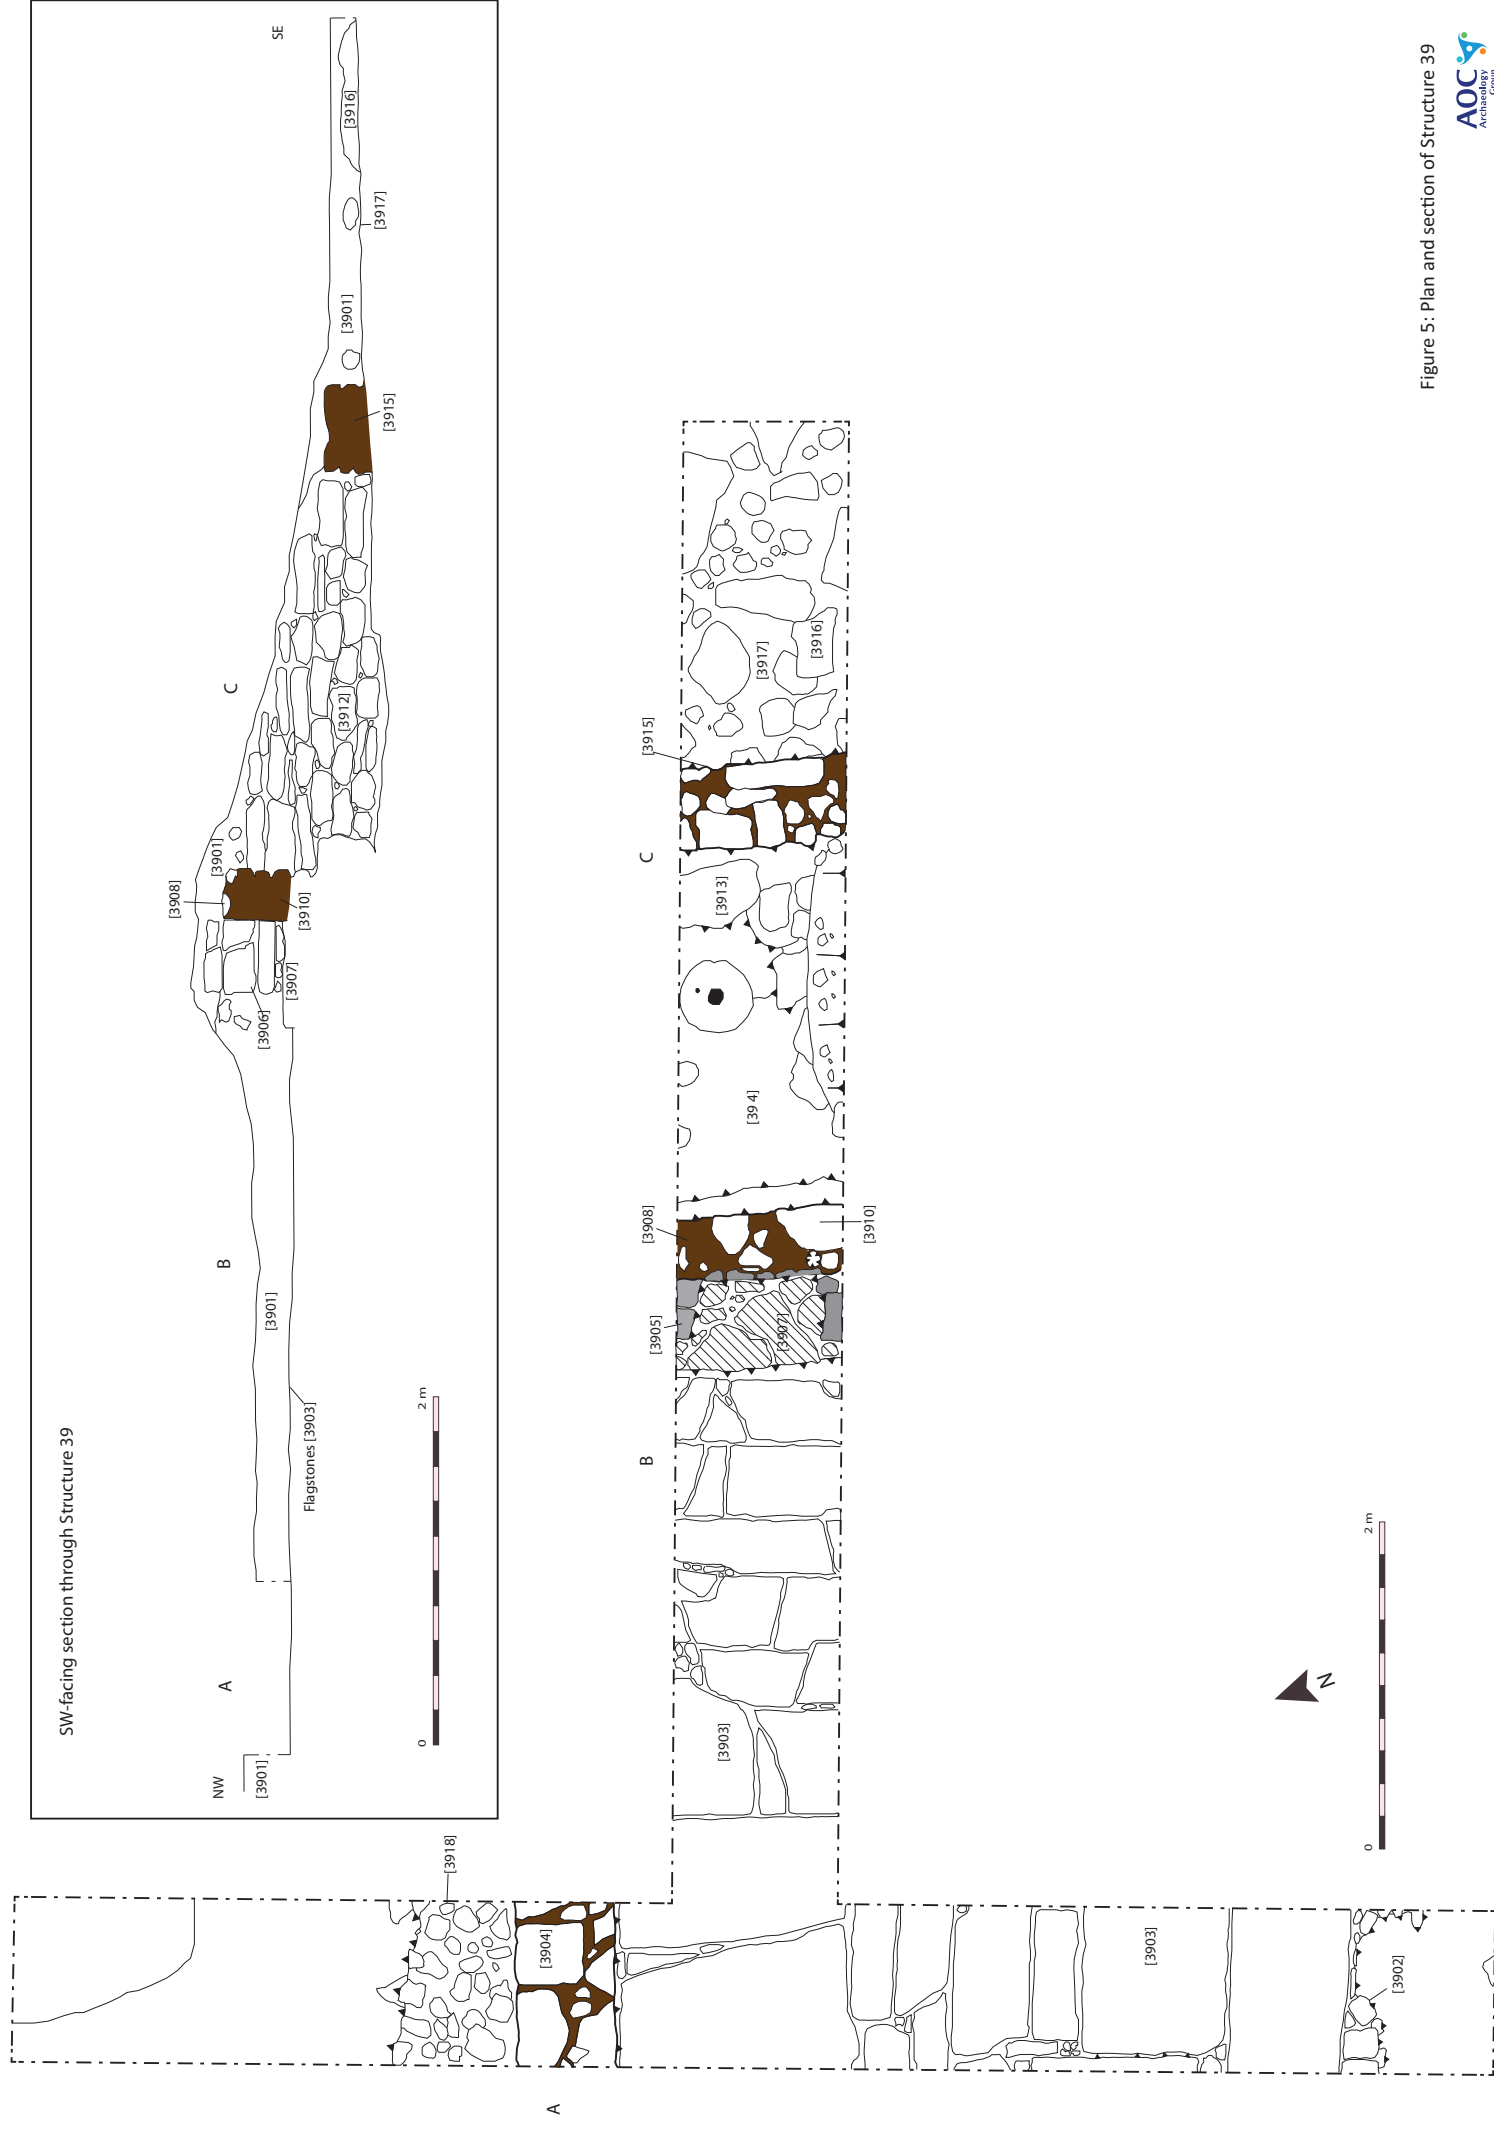
Figure 5: Plan and section of Structure 39

### 4.3 Building Platform [Structure 39] (Figure 5)

4.3.1.1 Two conjoined trenches (A & B) each measuring nine metres in length were excavated across the Building Platform, Structure 39. As with Building Platform, Structure 38, these revealed several stone and turf walls and floors. These represent the remains of two separate rooms within a probable croft of mid 19<sup>th</sup> century date. The smaller of the rooms revealed an *in-situ* rotary quern together with the remains of its associated super-structure.

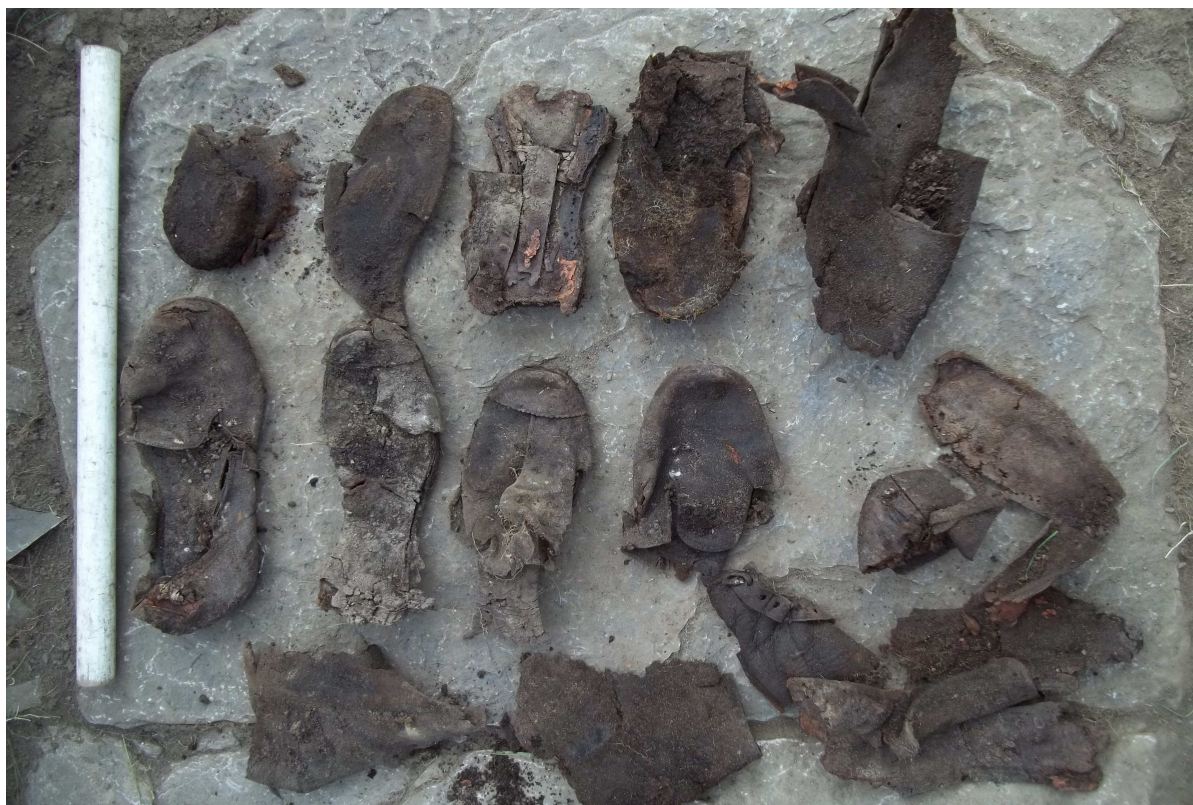
Plate 2: Cache of leather shoes found within the demolition layer above floor [3808]

top-soil and clay [3803]. A cache of leather shoes were recovered from the demolition material overlying this flooring.

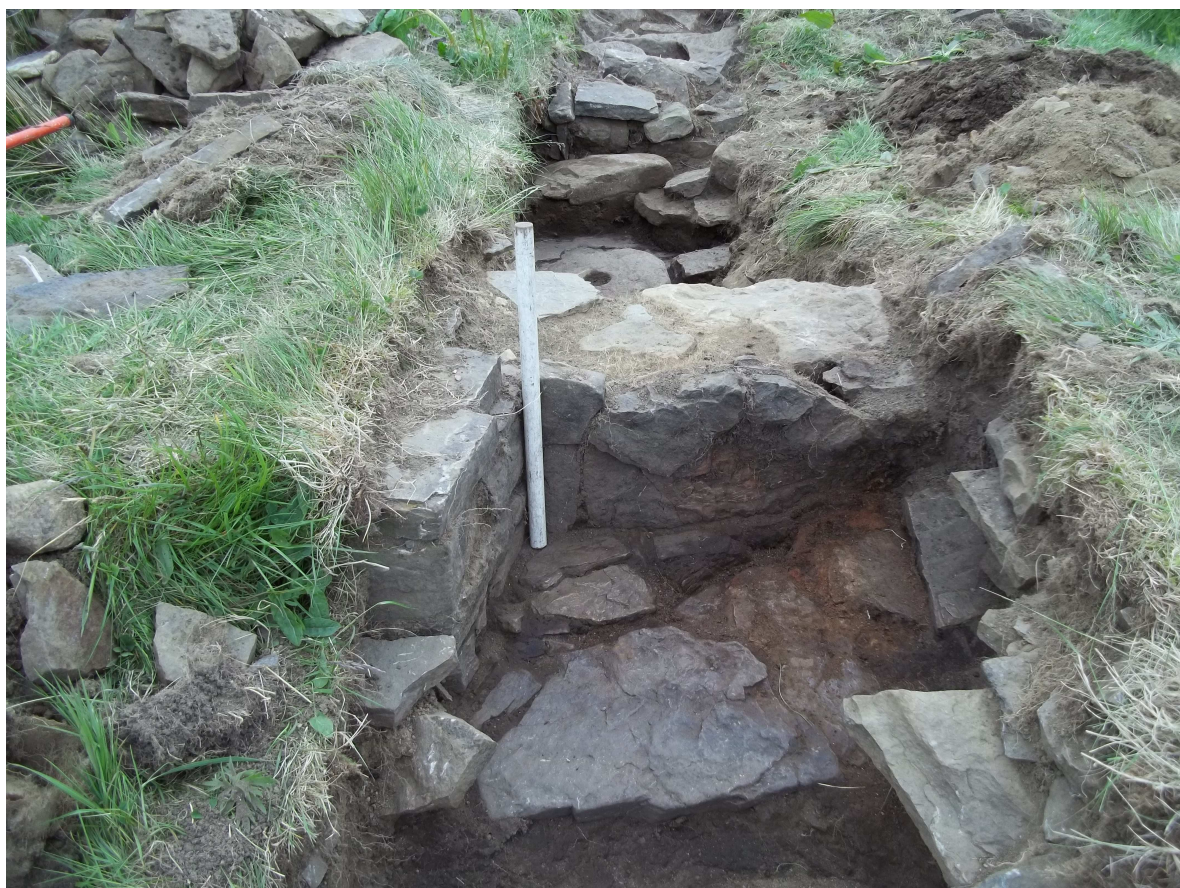
Plate 3: The fire-place [3905] taken from the west, Site 39

A substantial and well made un-bonded flag-stone fire-place [3905] was revealed within the middle of Trench B (Plate 3). The structure was composed of side [3906], base [3907] and rear [3908] slabs and measured 0.40 m in depth by 0.30 m in height. The rear of the fire-place was composed of several upright stone slabs set into the western face of wall [3910]. The base of the fire-place contained a mix of ash and grey sandy clay [3909] 0.05 m in depth.

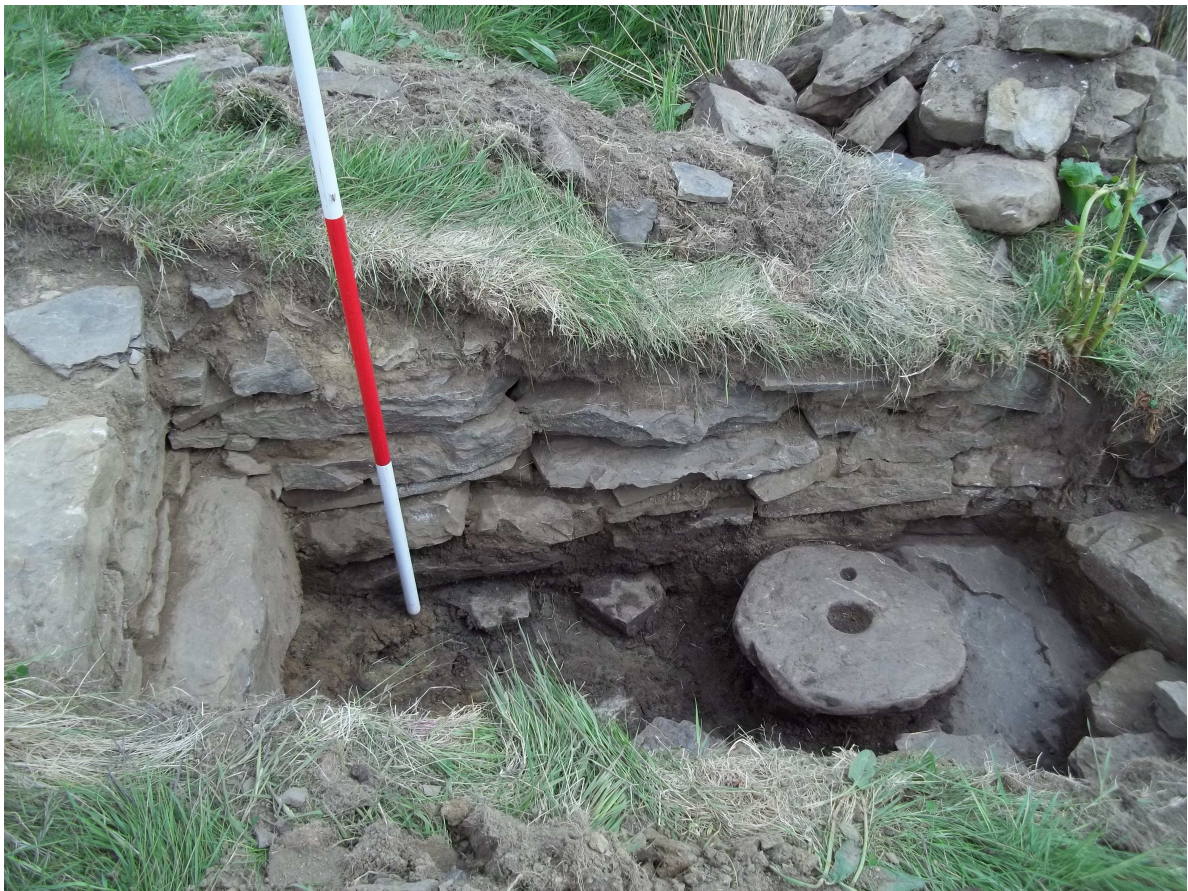
Plate 4: The 'Grinding Room' showing *in-situ* rotary quern

wall was two metres in length and 0.80 m in height. A third adjoining wall [3915] was recorded crossing the trench north to south. This was 0.60 m in width and 0.35 m in height. The three walls appear to form a small ancillary room. Excavation revealed a large in-situ rotary quern and supporting structure [3913]. The quern was fixed onto a large supporting slab with a corroded iron pin. An area of hard-standing [3917] was located to the east of the structure.
