**Erection of House and Associated Groundworks**  
**Land 80M NE Of Applecross Village Hall, Camusterrach**  
**Applecross Parish**  
**17/02567/FUL**

**Archaeological Evaluation**

**17/02567/FUL - Erection of house at Land 80M NE Of Applecross Village Hall,  
Camusterrach, Applecross Parish**

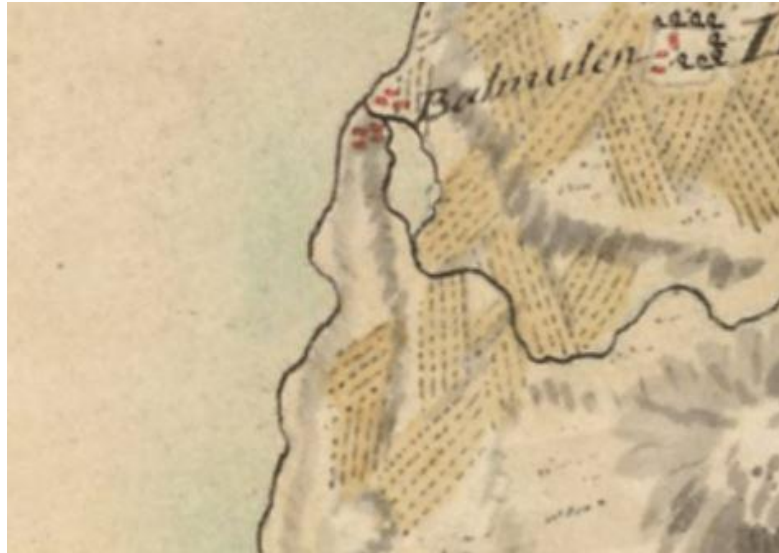
**Roy's Military Survey 1750s**

This area corresponds to land under cultivation as shown on Roy's Military Survey of the 1750s south of Loch a' Mhuilinn (Milton on Roy's map is given its original Gaelic name of Balavulen (Bail a Mhuilinn))

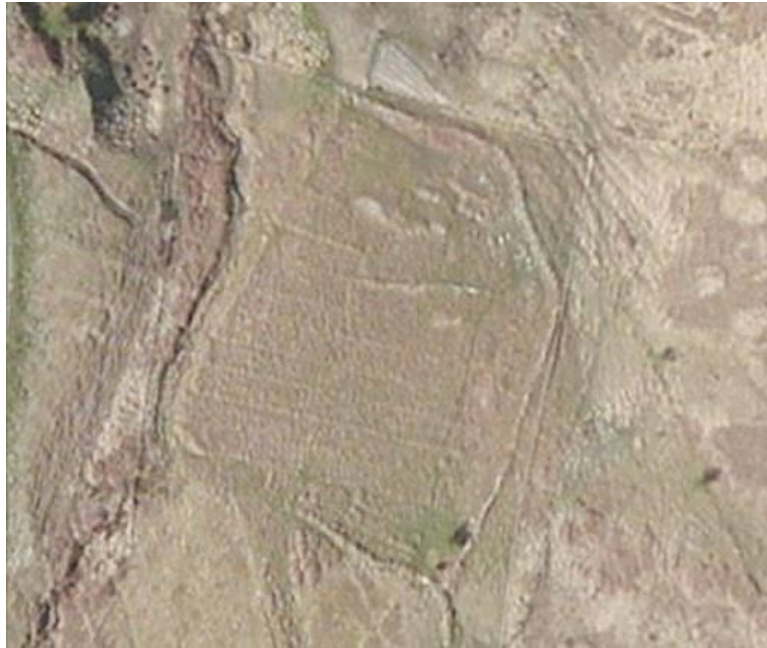
**Detail of Bing satellite image of north enclosure with possible farmstead in north east corner**

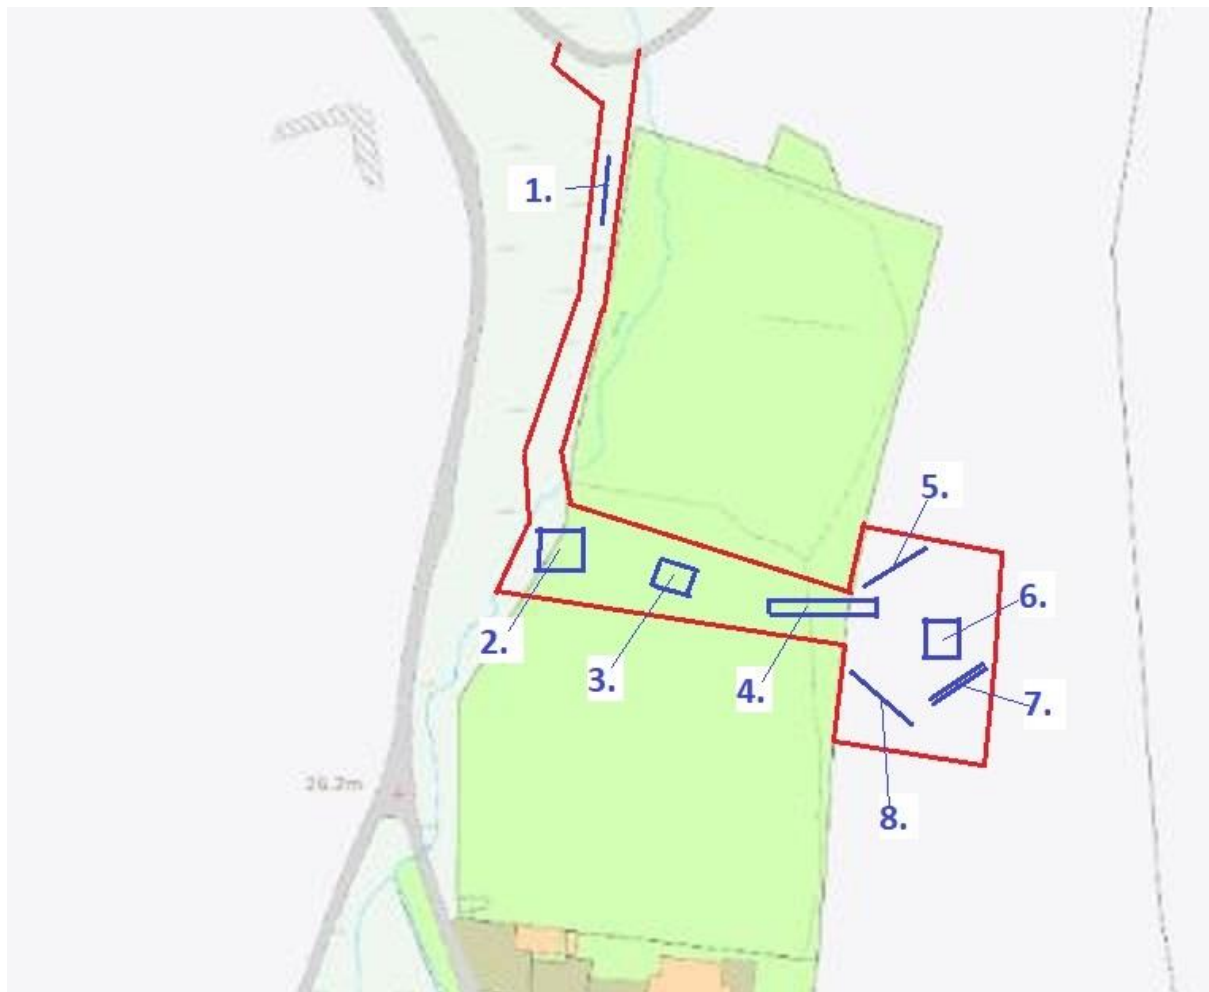
The initial proposal for trial trench locations is shown below. This design was based on information from the desk-based evaluation

**Plan of area of development and indicative trench locations**

1. 10m x 1m aligned N-S along the section of access road west of the small watercourse.
2. 5mx5m aligned E-W. This box trench will expose the west boundary dyke of the enclosure and an area of the interior of the enclosure

3. 4mx4m. This box trench will expose an area of the interior of the south compartment of the enclosure, including one of the drains visible on satellite images, aligned NW-SE.

4. 25m x 2m. This long trench will cross and expose sections of the east boundary dyke of the enclosure and the possible earlier boundary to the east, with the area of possible early rig cultivation between the two dykes.

5. 15m x 1m aligned NE-SW. This trench is located on ground presumed to be outwith the area of former cultivation
6. 5m x 5m. This box trench is located on ground presumed to be outwith the area of former cultivation but is closest to the defined area of prehistoric settlement

7. 10m x 2m aligned NE-SW. This trench is located on ground presumed to be outwith the area of former cultivation but is close to the defined area of prehistoric settlement

8. 15m x 1m aligned NW-SE. This long trench covers the south part of the proposed house development site.

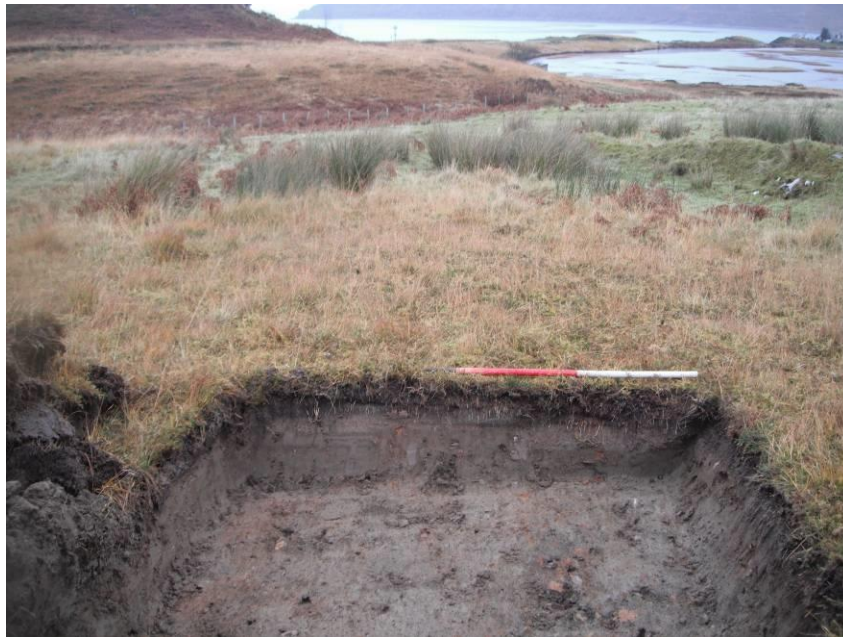
**Trench 2:** at west side of the enclosure just to the east of the steep drop down to the stream, measuring 2m NE-SW by 3m NE-SW

**Results:** Vegetation of mossy grass on a shallow rooty soil 001, 100mm in depth over a sandy, stone-free subsoil. A few charcoal flecks on the subsoil surface indicate a possible grass fire or vegetation clearance but is too ephemeral to be of significance.

**Interpretation:** evidence for stone clearance but not for ploughing

**Trench 2, view from SE**

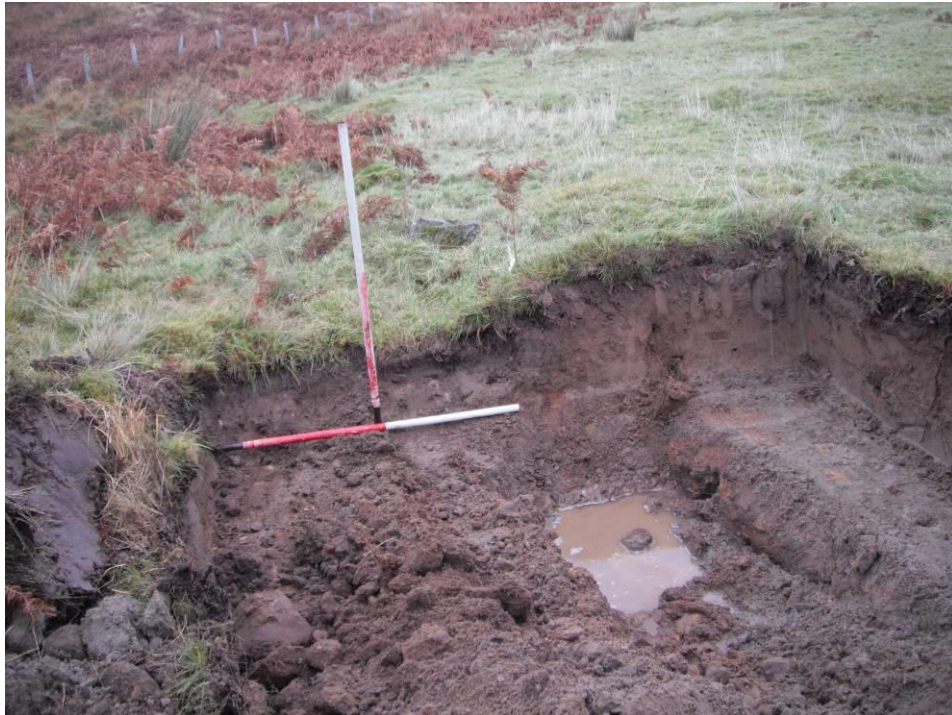
**Results:** vegetation cover of mossy grass on a very shallow bracken root – filled soil 001 over an intermediate soil. 002 notably stone free and reddish sandy, similar to the underlying subsoil 003, and gradually merging from 002 to 003.

**Interpretation:** There was no evidence for any ditch or other visible boundary other than the slight drop in levels between the two strips, leaving the linear mark visible on satellite images.

**Trench 3, profile of section crossing linear feature, showing drop in level but no cut or ditch**

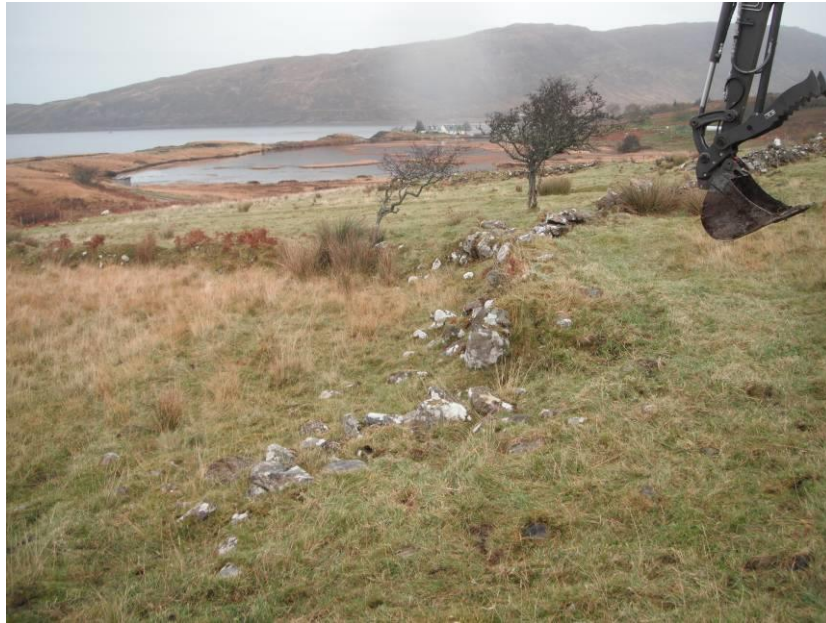
**Trench 4:** Crossing the rubble dyke marking the original east boundary of the enclosure and taking in rough ground to the east and improved ground to the west, measuring 2m N-S by 10m E-W

**Results:** vegetation east of the fence very rough tussock grass, bracken and bog myrtle, west of the fence grazed grass. Soil 001 was grey and sandy containing some bracken roots, with little change in soil from one end of the trench to the other. There was a noticeable drop in levels from the east to the west side of the rubble dyke, possibly indicating a build-up of slumped soils uphill and a reduction by cultivation to the west.

**Trench 4, Boundary Dyke before excavation**

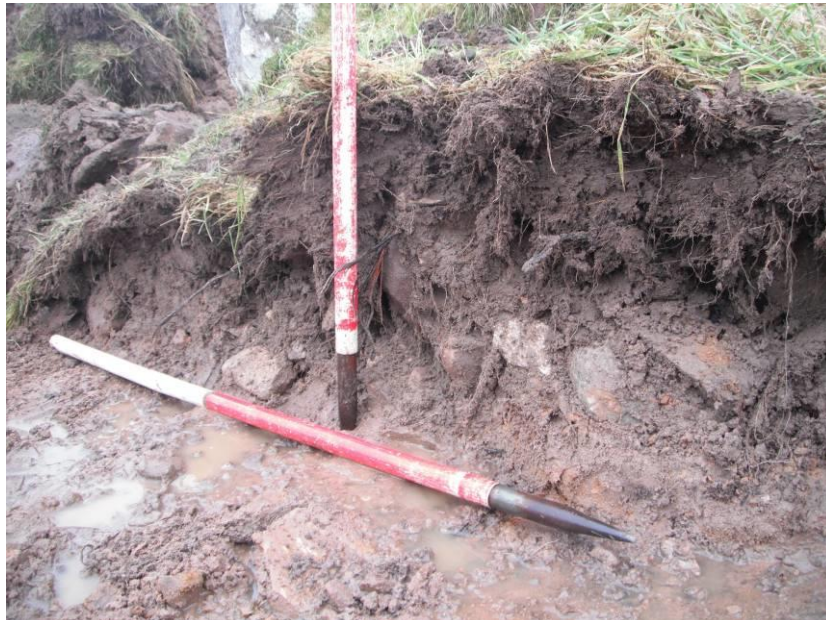
The trench was placed to avoid damage to the rubble boundary dyke but to expose a section in the south-facing section of the trench. This demonstrated that there was no sophisticated construction to the dyke, which consisted of medium-sized stones forming a rough low base to an earth bank

**Trench 4, section across boundary dyke, view from south.**

**Interpretation:** Field boundary of probable Early Modern date, possibly cutting a formerly larger area of minor ground improvement in the form of stone clearance, improved vegetation maintained by modern grazing.

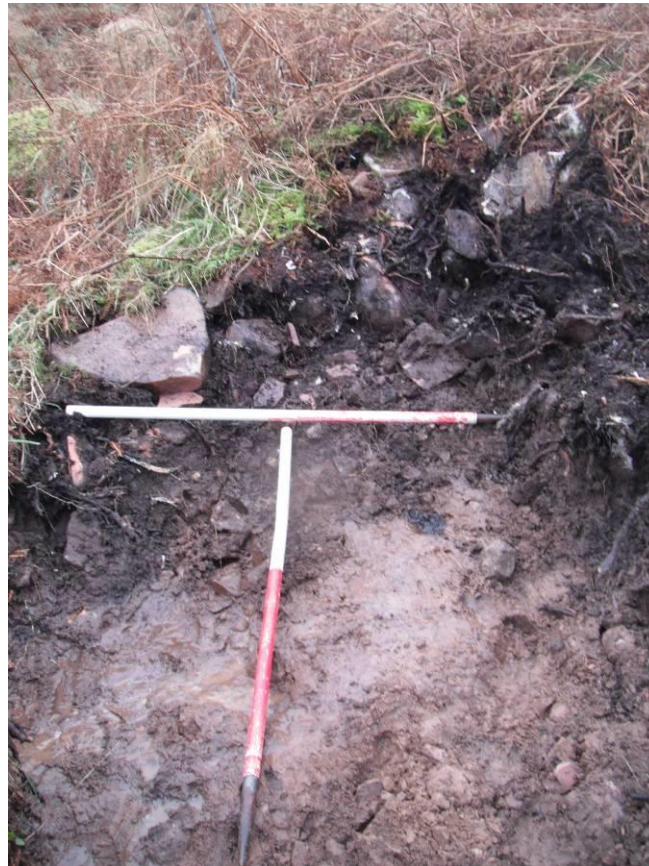
**Results:** At the NE end of this trench the soil 001 was black, filled with bracken roots and stony, the central section crossed a waterlogged sump, to the SW of which the soil 002 was grey, gritty and stony. Both soil types merged gradually into the subsoil, indicating an absence of improvement by ploughing. At the NE end of the trench was a stone pile interpreted as field clearance. This consisted of large stones in a matrix of the black soil. One small fragment of green glass was recovered from the matrix of this feature.

**Interpretation:** The presence of the field clearance pile indicates some improvement of the ground, but the residual stoniness and the waterlogged sump suggest that cultivation is unlikely and that the stone clearing was to improve grazing.

**Trench 5, stone field clearance pile**

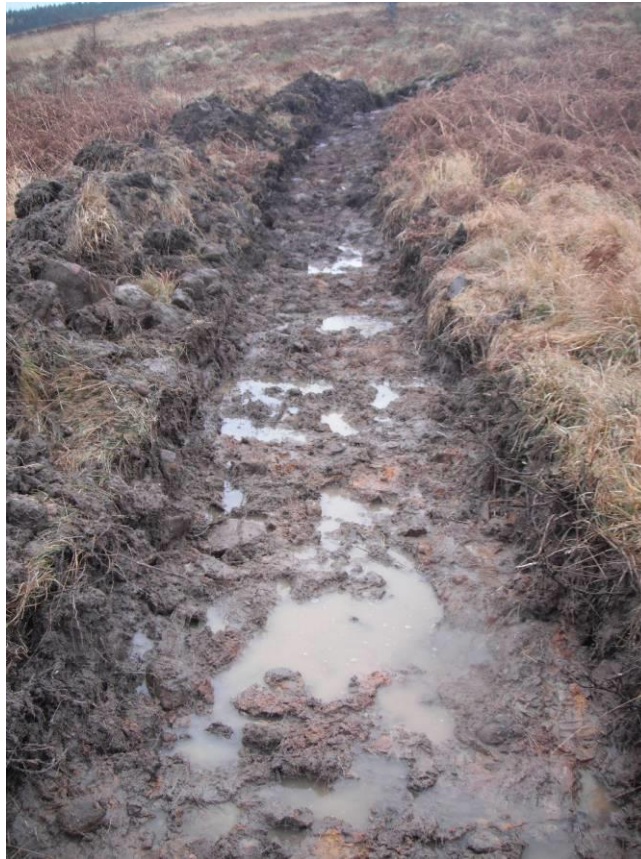
**Trench 5, waterlogged SW section**

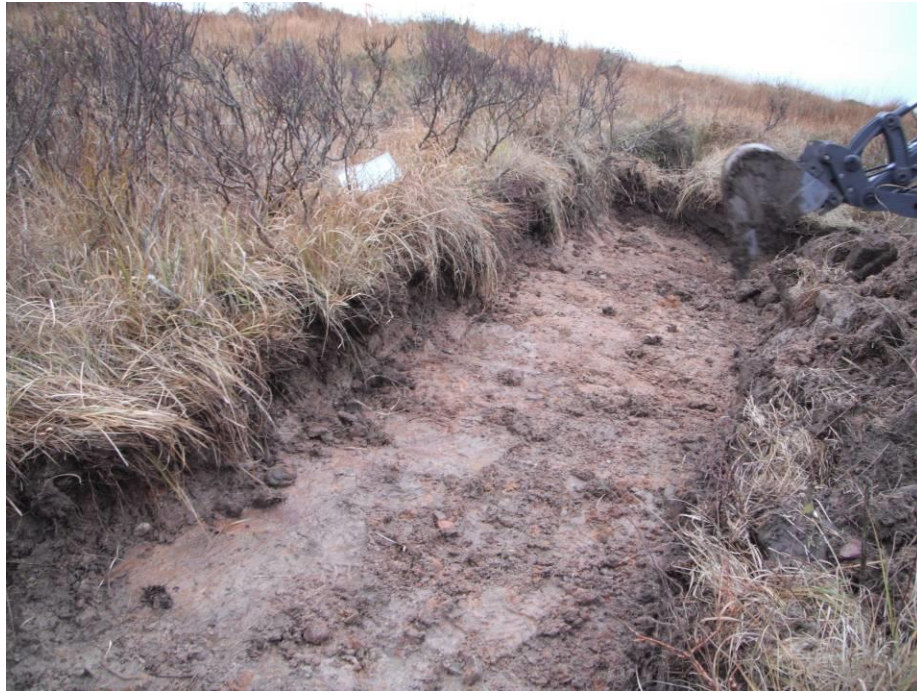
**Site description:** Steep stony slope with a dense vegetation of bog myrtle and tussock grass.

**Contexts:** Peaty, rooty pale brown earth 001 containing embedded large stones, varying in size from 500x300mm to 100x100mm. This peaty soil, to a depth of 300mm overlies a subsoil 002 of streaky grey-orange clay also with embedded boulders.

**Interpretation:** there is no evidence in this trench for any clearance of the natural distribution of stones, and it is unlikely that any cultivation or habitation has taken place on this steep slope.

**Trench 6, under excavation at top of slope, view from North**
