Report of the Survey of the Arbol Links Township, Easter Ross, carried out by members of NOSAS in January 2017

Introduction

Description of Arboll Links Township – GR centred on NH 8835 8283

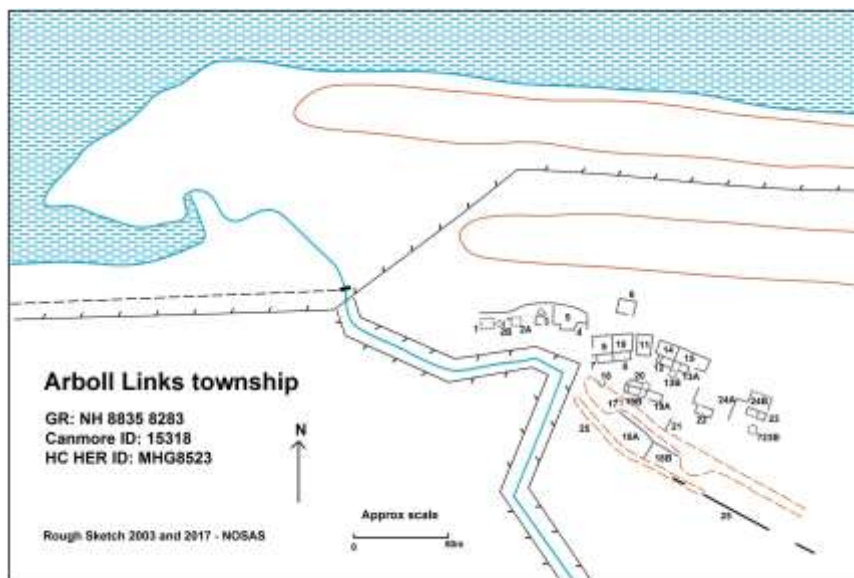
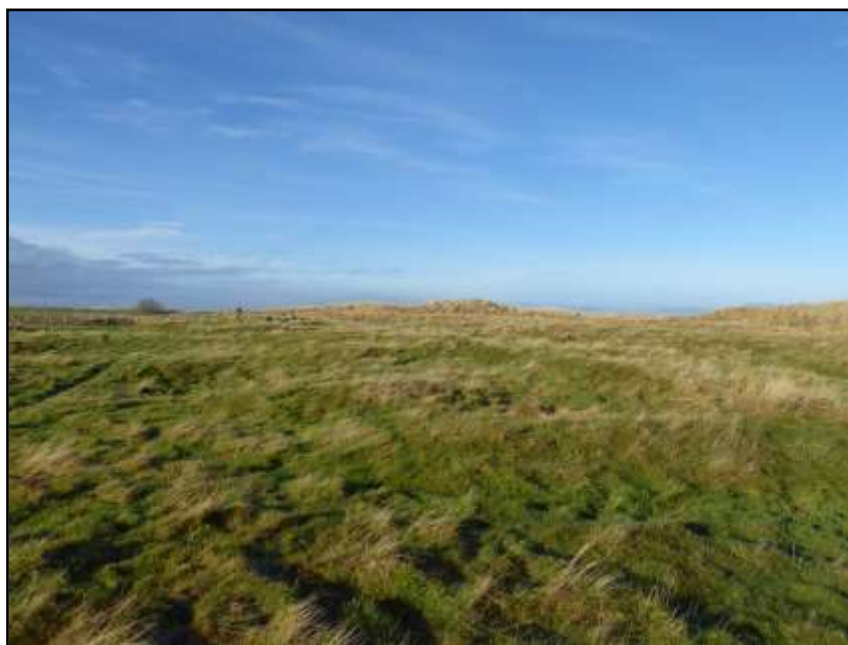
General view of the township from the SE

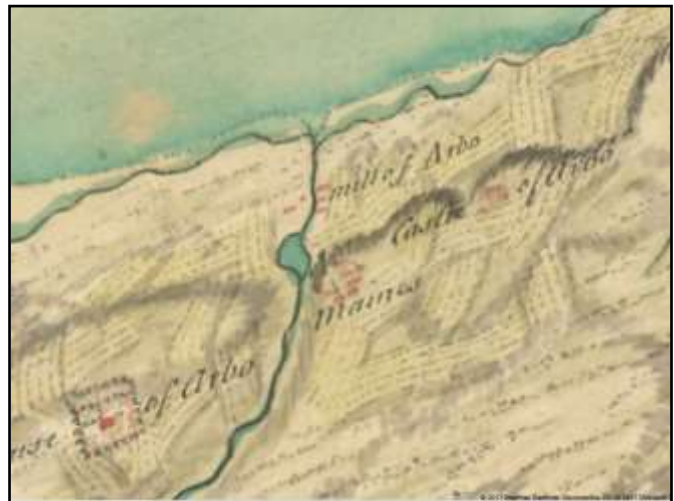
The township does not appear on the maps of 1876 (*1st edition OS survey*) and 1904 (*2nd edition OS survey, above*) but it is marked on an estate plan of Geanies dated 1833, where it has at least 7 roofed buildings. Interestingly the Roy map of c1750 (*right*) has the township of "mill of Arbo" nearby with a pond to the south; a very different landscape to that of today.

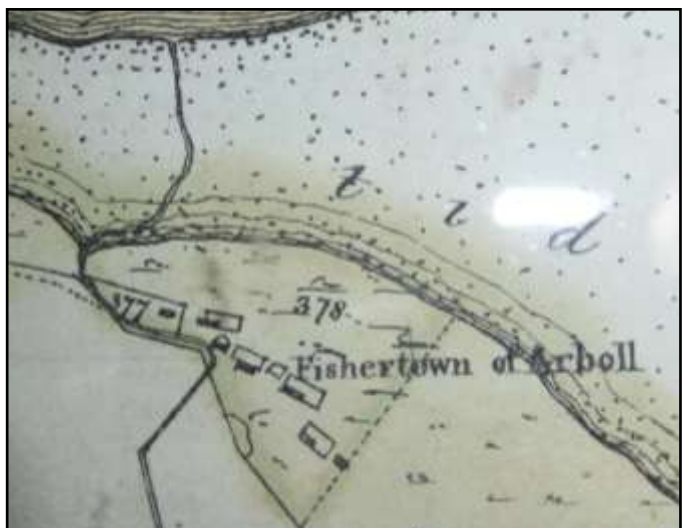
Extract from a plan of Geanies Estate dated 1833

The township appears to have been a result of a population cleared from the hinterland, settled on marginal ground outside the estate boundary and expected to make a living from pastoral and fishing activities; the estate plan produced in 1833 (*almost certainly surveyed a few years before that*) has the township annotated as "Fishertown of Arboll". The enclosures were possibly for kale or other crops and their number suggests that the cattle were free to roam about the township. It is quite likely that the community was heavily affected by the cholera epidemic of 1832 and it may well have been abandoned about this time

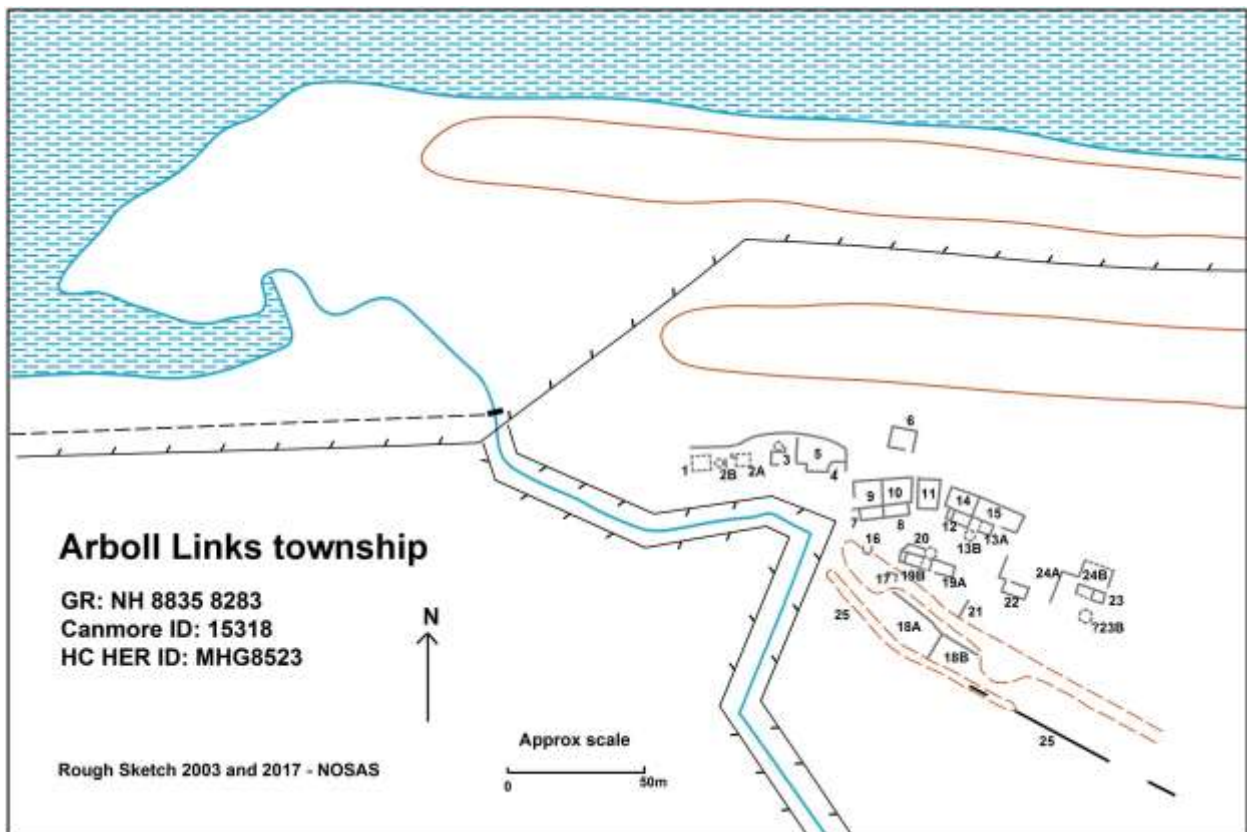
The township comprises the remains of 9 (possibly 11) buildings, up to 12 enclosures, several midden pits and a possible kiln. The features appear to be grouped into 4, possibly 5, distinct units possibly suggesting farmsteads for families. Each unit has a building or two conjoined buildings, an enclosure or two, and most have a midden pit or two

The footings of a discontinuous dry stone wall (feature no 25), probably an estate wall, bounds the south side of the settlement; remnants of this structure can be traced for at least 1km eastwards. A trackway (*not described*) traverses the north part of the township.
