New Housing, Leachkin Road, Inverness

Archaeological Evaluation

Data Structure Report

AOC Project Number: 70416

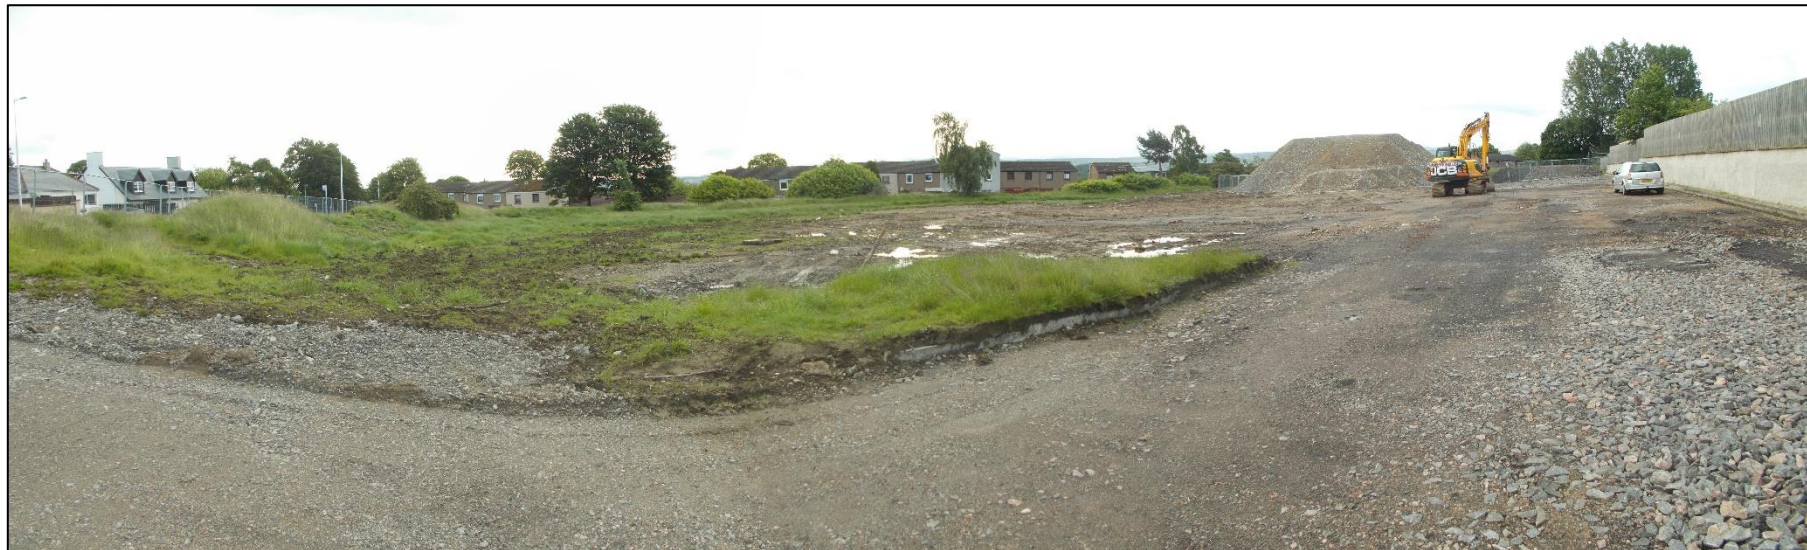
Plate 1: The development site pre-works

- 2.1 The proposed development site is situated on the south side of Leachkin Road in Inverness, centred on NGR NH 64419 44962 (**Figure 1; Plates 1-2**). The archaeological evaluation investigated the part of the development area that was outwith the footprint of the building which had previously been present on the site and was recently demolished.

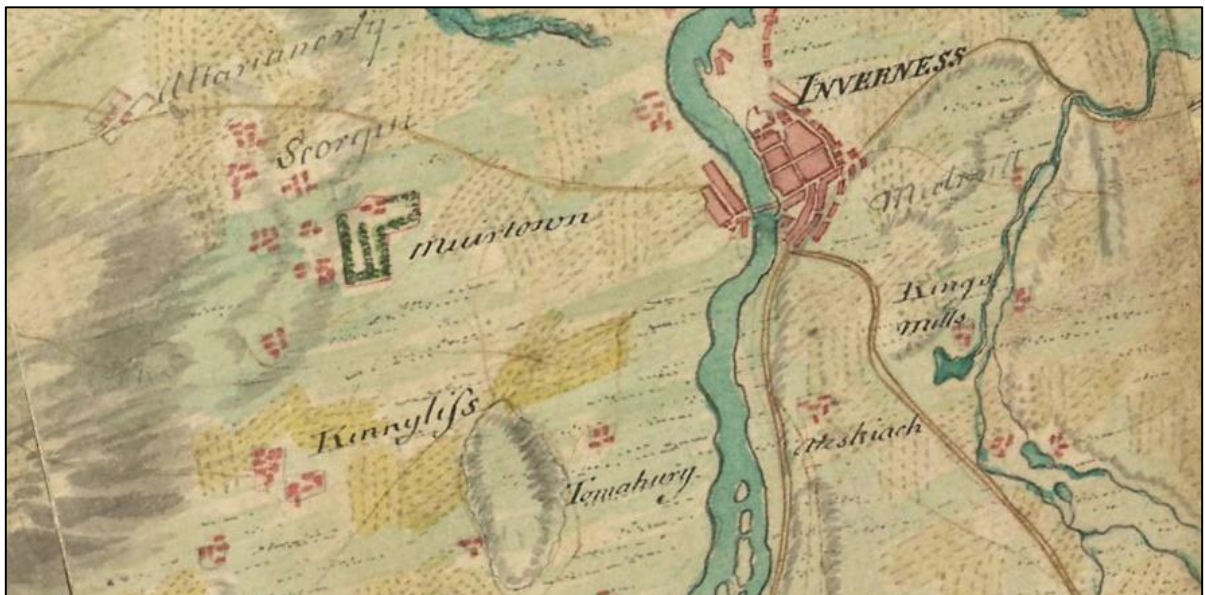
Figure 2: Excerpt from Roy's map (1752)

Several small settlements are shown in the current area of Leachkin Road, including *Kinnyliss*, *Muirtown* and *Scorgue* (**Figure 2**) The surrounding landscape is shown as cultivated land.

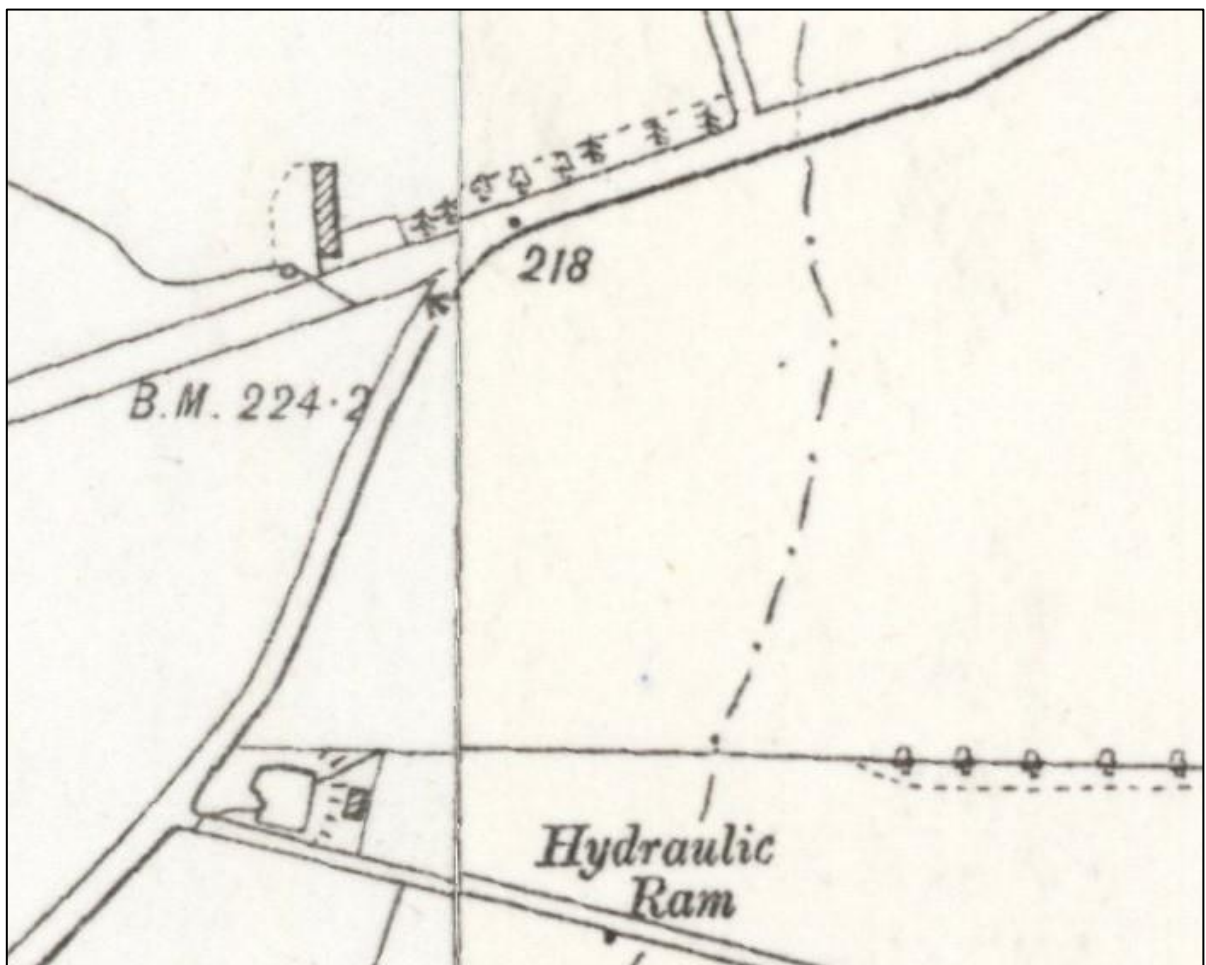
Figure 4: Excerpt from the OS Six inch-mile 2nd Edition map

There are only minor changes evident on this map compared to the 1st edition (**Figure 4**).

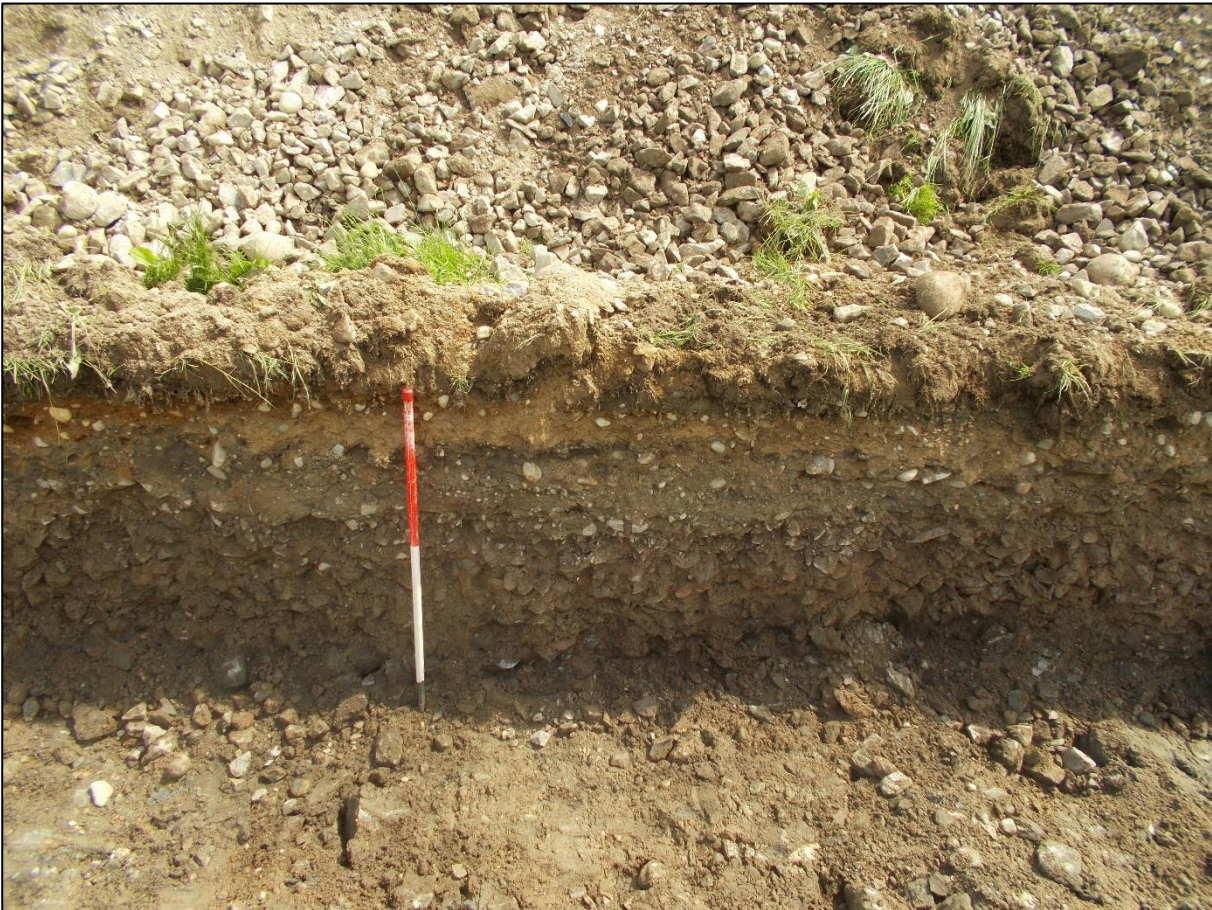
- 5.1 The evaluation was carried out on 17th-18th June 2019. A total of ten trenches were excavated across the site (**Figure 5; Plate 3; Appendix 1**). Topsoil across the site was mixed, mid-brown, sandy silt, which had been redeposited on top of type 1, compact hard-standing (**Plate 4**). There was a lot of modern debris and construction waste in this soil and in some places it was well over 1m deep. Subsoil across the site was generally mid orange-brown silty sand with occasional stones (**Plate 5-6**). Several large topsoil bunds were present on site and these were moved and excavated below, confirming similar stratigraphy to the rest of the site.

Plate 4: Site stratigraphy as seen in Trench 2

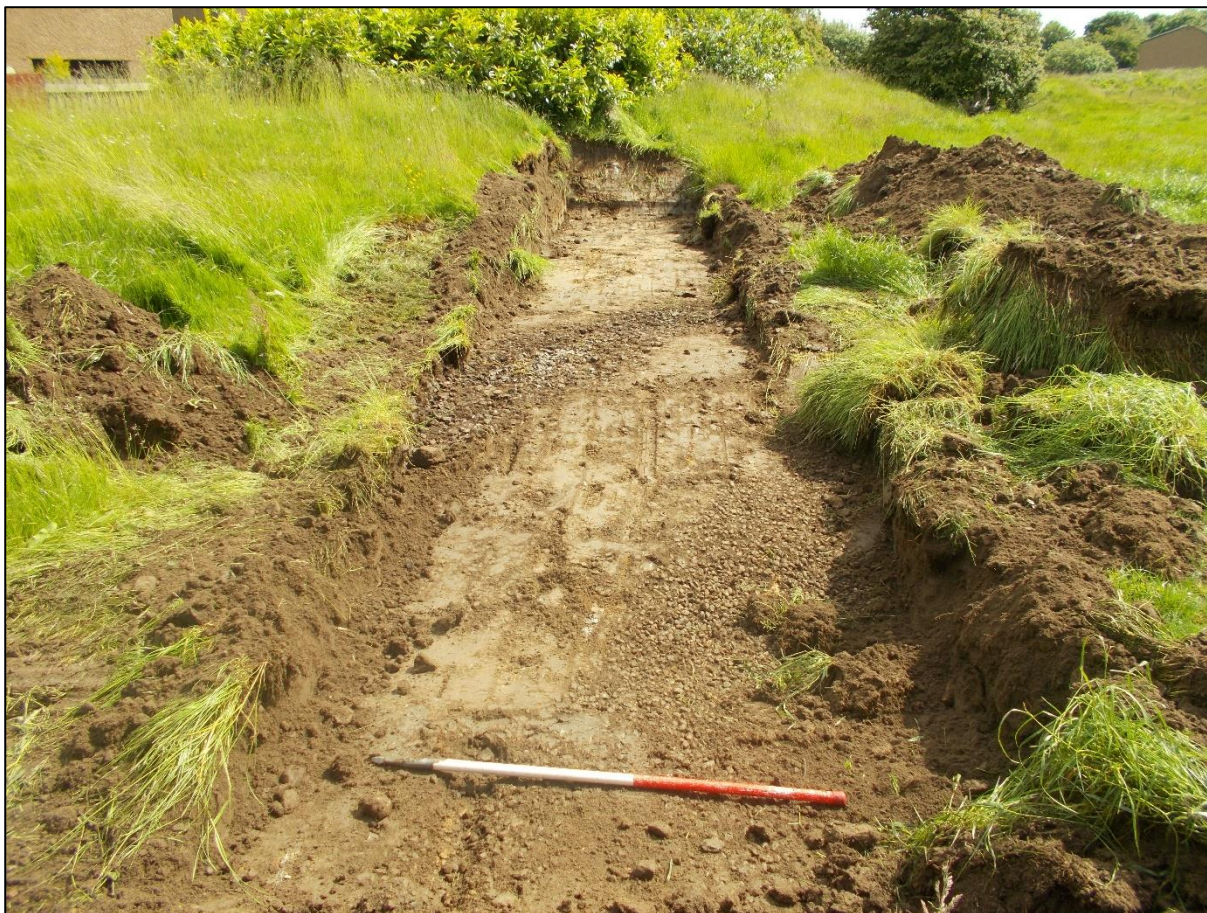
- 5.2 There were no archaeological features observed in any of the trenches. Most of the trenches showed signs of modern disturbance in the form of ceramic or gravel and plastic field drains (**Plate 7**). In some trenches there were also old water pipes, manholes and hazard tape warning of buried services. Where warning tape was encountered the trenches were not excavated any deeper at that point.

Plate 7: View of Trench 10 showing gravel field drain
