# Dundreggan Re-wilding Centre, Glenmoriston, Inverness

## Archaeological Evaluation Data Structure Report

October 2020

AOC Project Number: 70483

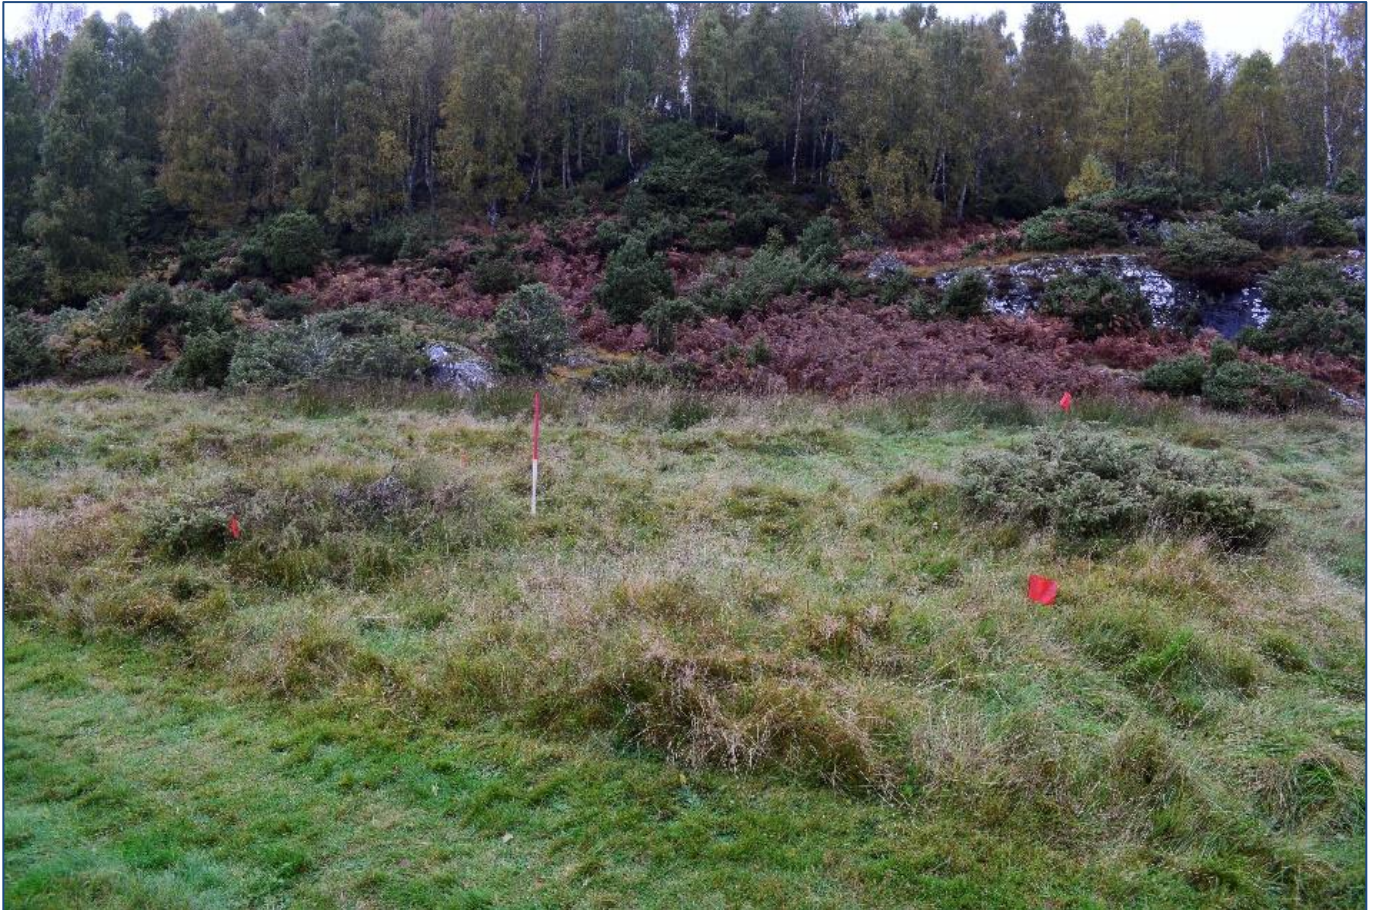
*Plate 1: Pre-excavation view northwest over structure, red flags marking the visible corners of the bank*

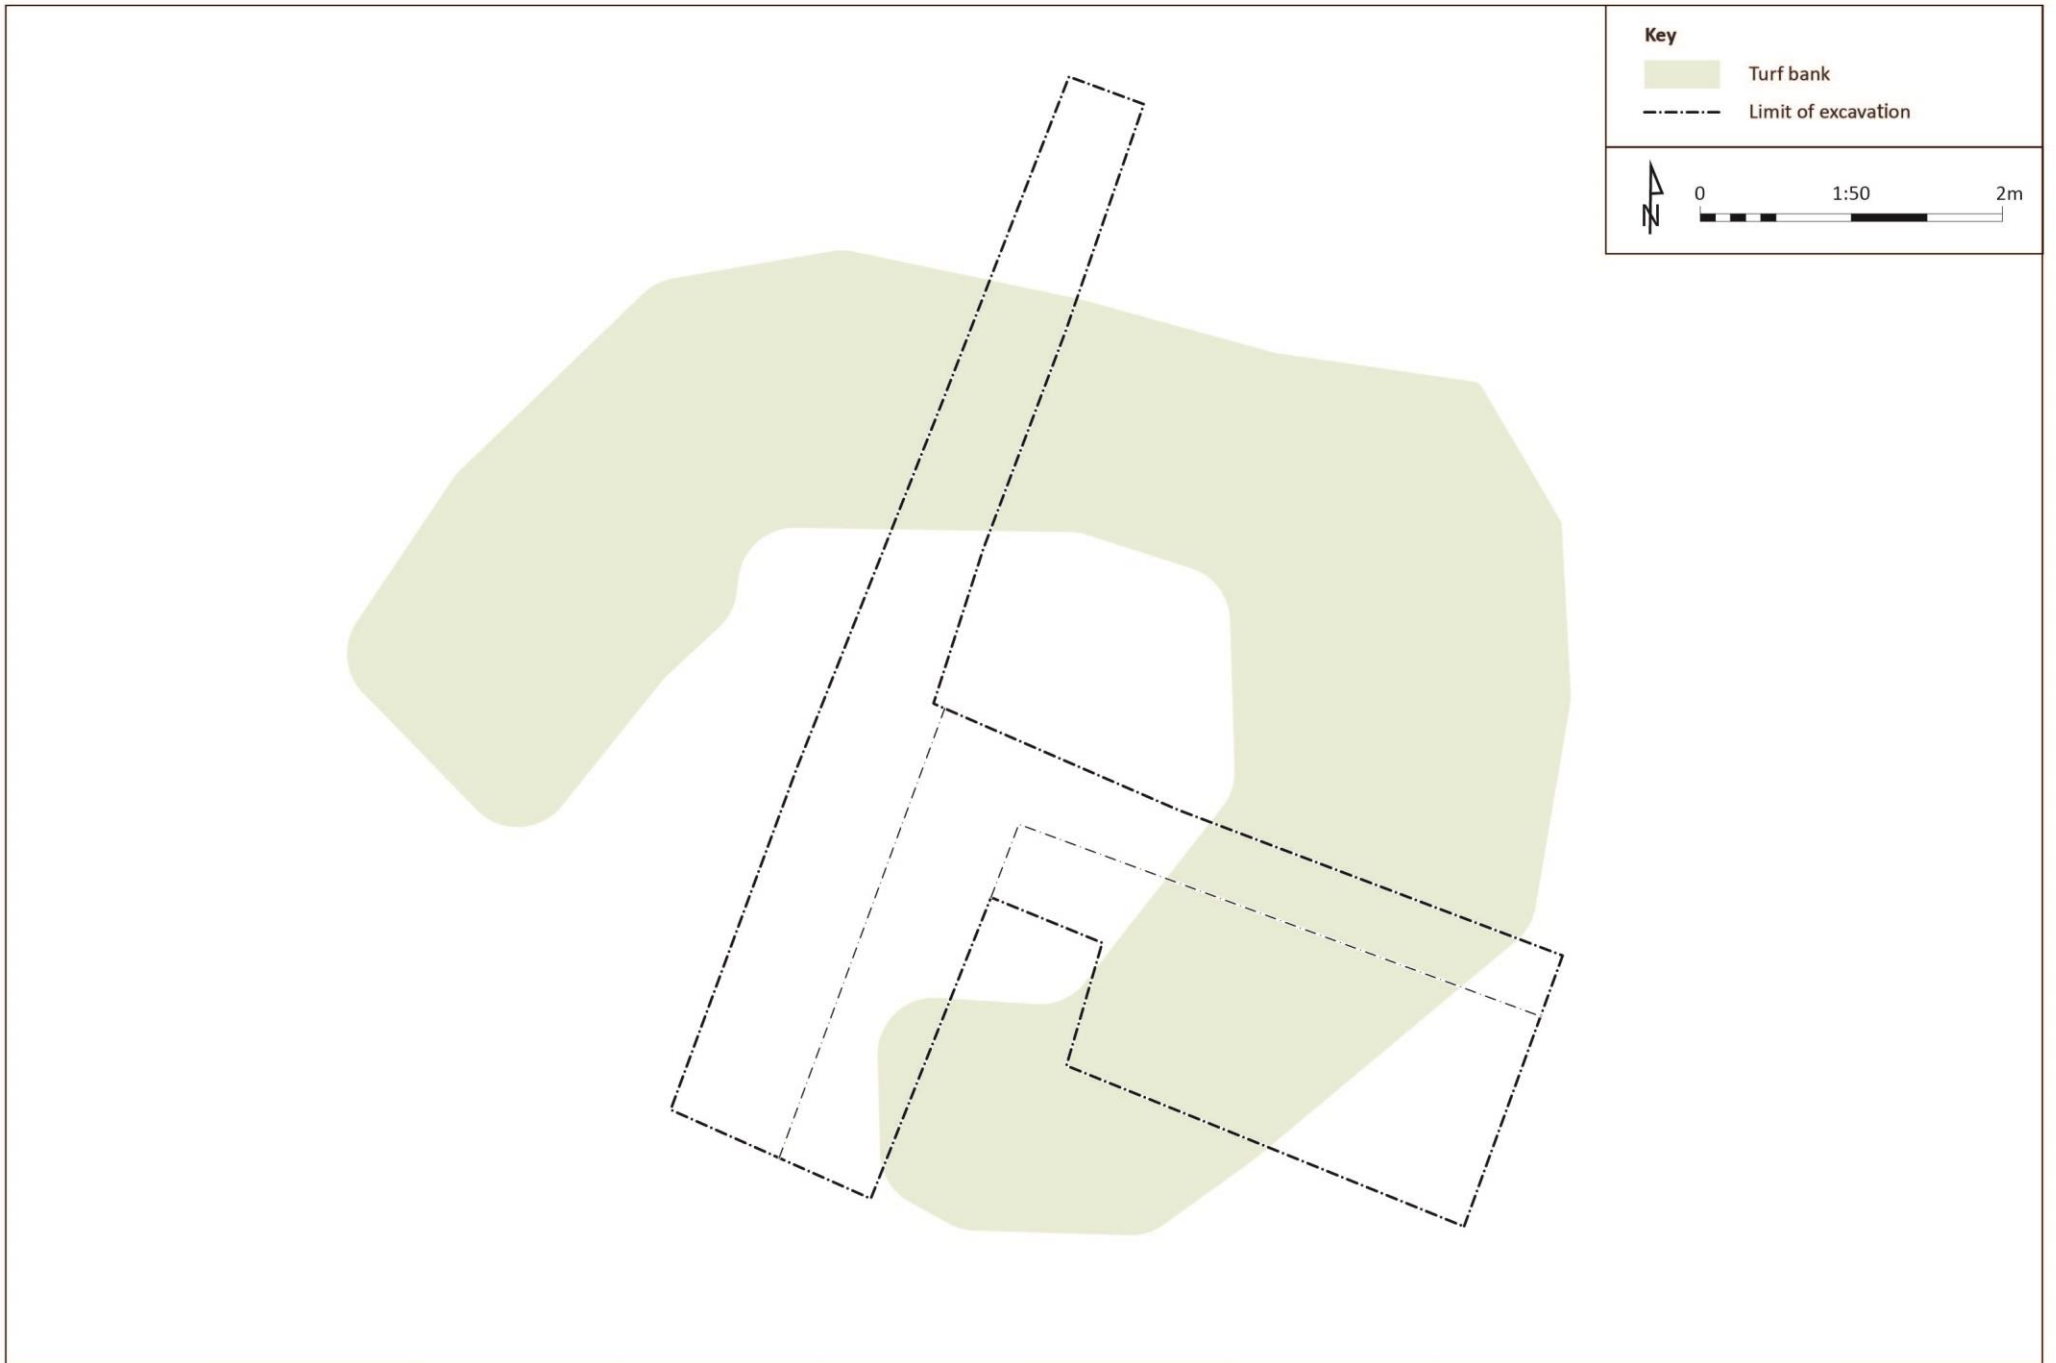
Figure 2: Location of trench over existing bank

5.2 A measured survey was carried out prior to excavation works to create a detailed recording of the site in its entirety. This was conducted using a Trimble R8s (DGPS equipped) capable of centimetre accuracy, used to record the extent of the surviving banks (**Figure 2**).

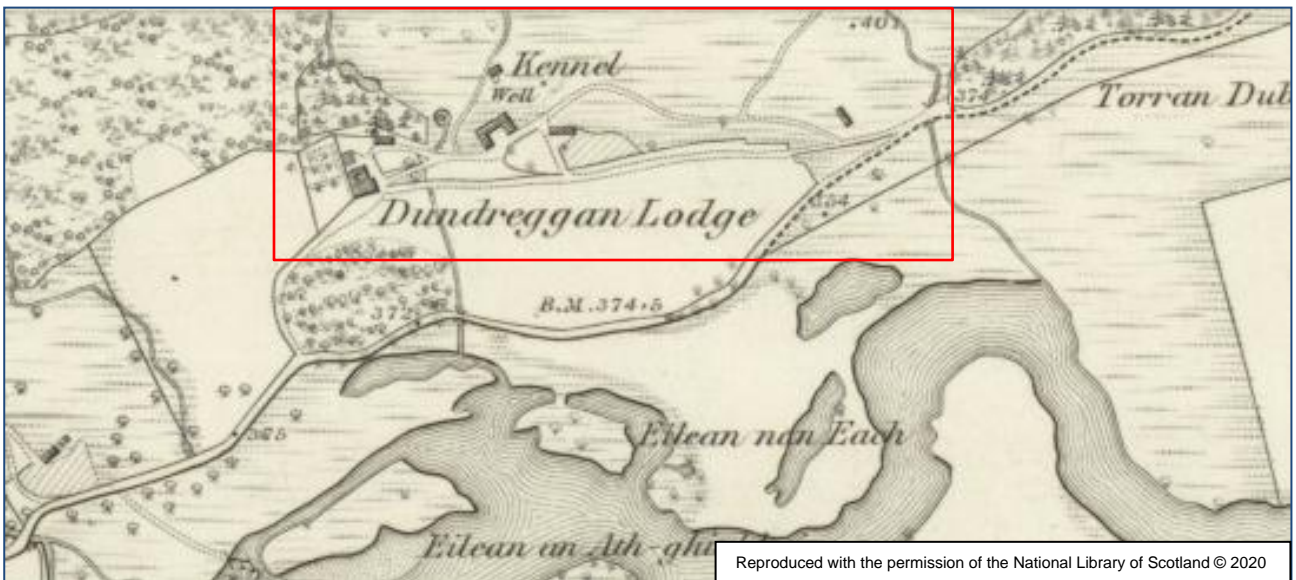
Figure 6: Extract from the OS 1st edition 6-inch-to-the-mile map 1874, showing building located in prospective compensatory planting zone of development

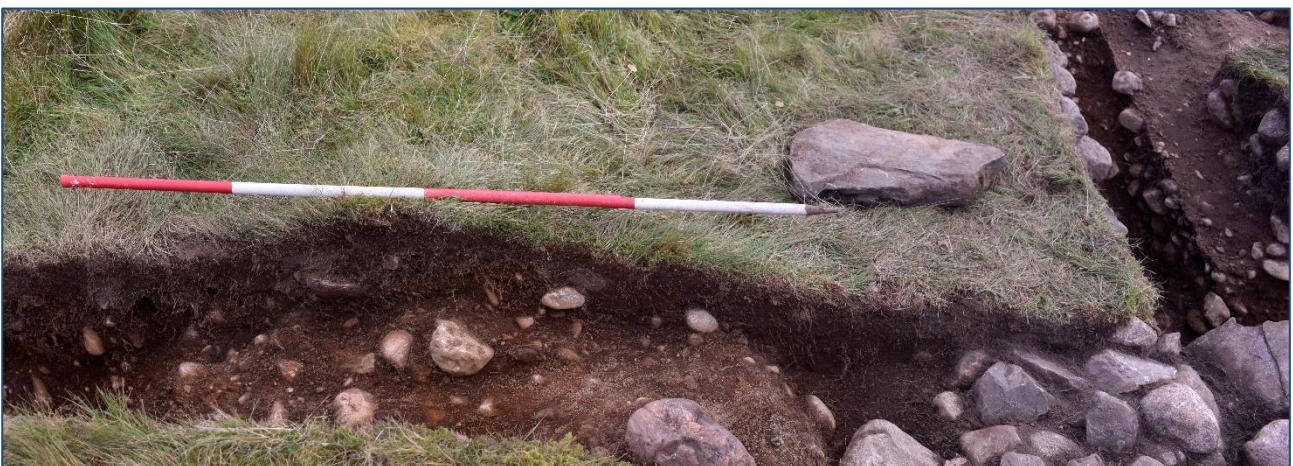
- 6.5 The eastern part of bank [004] was situated below a layer of mottled orangey brown gravel, (009), interpreted as disturbed and redeposited natural upcast over the bank during quarrying within the interior of the drumlin. The revetted stone [003] had been placed over (009) towards the top of the bank on the eastern side of the trench. A fine brown sandy silt, (002) was concentrated over the redeposited subsoil (010), and beneath the topsoil (001). This deposit also overlay the revetment of stone [003] set against the exterior east face of the bank, and extended into the interior, partially beneath a deposit of large rounded and subrounded stone within an orangey-brown sandy silt matrix (007) before dissipating. It is suspected that this deposit (002) may form the extremely degraded remains of a turf constructed wall that has eroded over the stone platform and wall [003] and the inner face of the bank [004].

*Plate 2: West-northwest facing section of north trench extension showing profile of continuation of bank 004 (centre) and abutting clearance material 005 (right)*

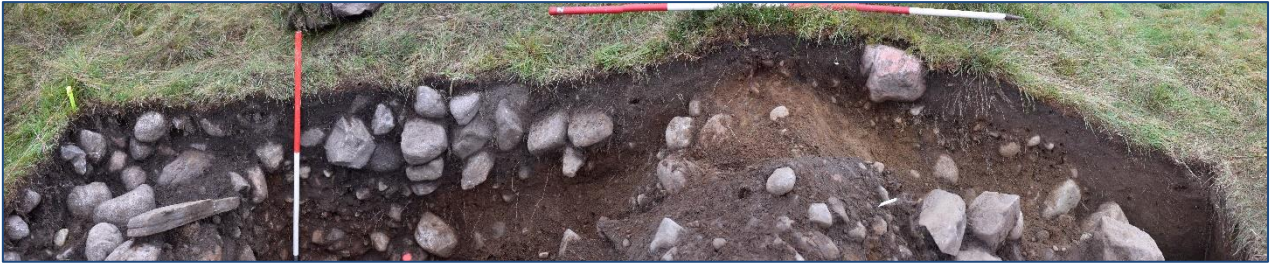
*Plate 3: South-southwest facing section of trench showing profile of bank 004 (centre right), and internal deposits (left)*

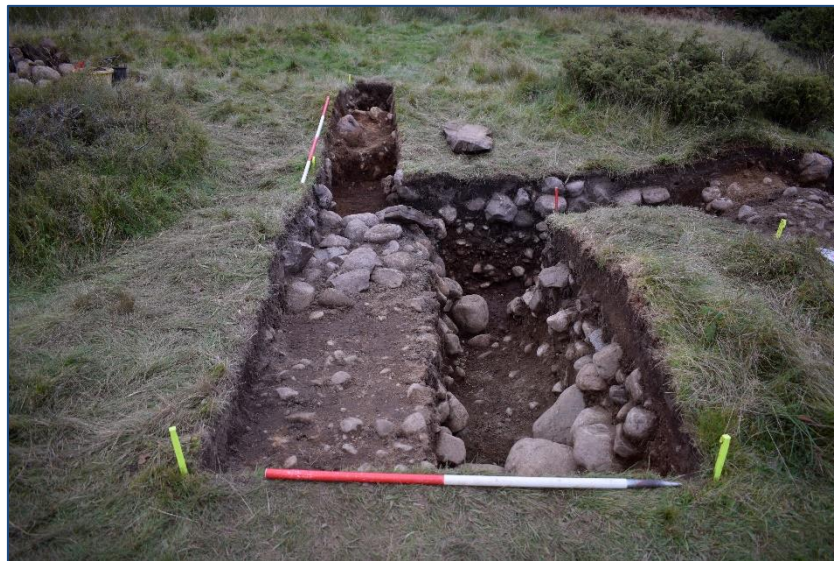
*Plate 4: Post-excavation view over trench, facing north-northeast and showing bank 004 beside rear ranging rod and on the right side of frame. 005 is on the foreground left side, and the sondage on the right has been excavated*

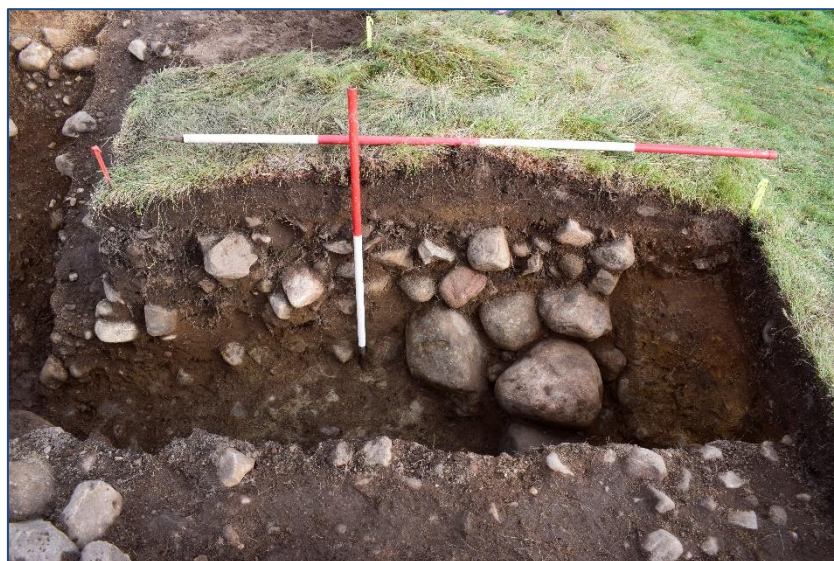
- 6.6 The quarried interior of the drumlin [016] was somewhat stepped into the interior, and reached a flattish base approximately 1m below the turf. The stony layer (007) overlay the disturbed natural, (009) and true natural (010) within the interior of the possible structure. Feature [006], a large V-shaped pit somewhat circular in plan and measuring approximately 2m in diameter, was cut into (007), and filled with a mixture of subrounded and subangular stone. This material also contained a number of items of C19/20 material culture (Small Find No. 1) including: red earthenware suspected to be from dairy bowls; transfer printed ceramics; green and brown bottle glass; roofing slate fragments; miscellaneous iron/metal objects; and frequent fragments of coal. This layer was notably compacted at the top and may have been utilised as a very rough floor surface at some point. The setting of some of the large flat angular stones (at precarious angles protruding from the rest of the stone) would suggest it was not a floor upon which one would leave livestock or one that would be frequently moved about on by people. It is also notable that the natural subsoil on the north side of the surviving bank was charcoal flecked, possibly representing evidence of vegetation clearance.

*Plate 5: West-northwest facing section of trench showing deposit of stone 007, including large boulders to the right abutting potential remnants of bank 004 on right, and the visible cut of pit 006 visible on left side of ranging rod, diving down to the trench corner on left side*

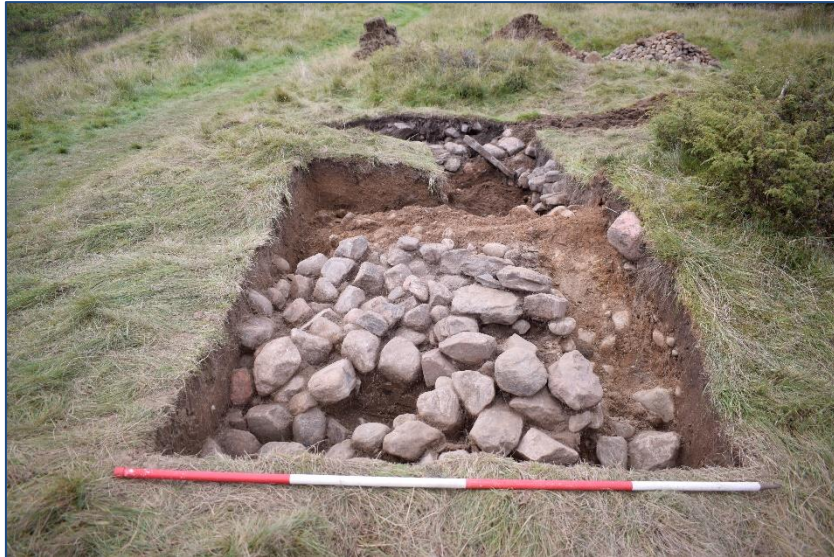
*Plate 6: Post-excitation view west-northwest of trench, showing revetted stone 003 on east exterior of bank 004 (visible behind stone) with possible post hole 014 visible on lower left*

| Context No. | Context Type | Description | Over | Under | Fill of | Filled By | Cuts | Cut By | Same As | Interpretation |
|---|---|--|---|---|---|---|---|---|---|--|
| 014 | Cut | Amorphous cut defined by stone setting within revetted wall 003, measures 0.7m northeast-southwest with a flat base. Stone settings are upright. Situated immediately adjacent to eastern coursing of stone that seems to form edge of platform, potentially for turf wall foundation. | 004 | 002 | - | 015 | - | - | - | Likely post hole situated on external side of potential turf platform. Well-placed for such a feature, supports the weight of a timber room on a crook that extends away from the turf wall. |

- 8.2 It is recommended that further investigation of the structure during the watching brief is carried out, in particular to clarify the following key questions: to what extent does the revetted wall extend around the eastern side of the bank; to determine the character of the turf bank on the west side; to investigate the immediate surrounding area of the structure for additional features. Additionally it has highlighted the fact that many of the seemingly natural features in the immediate landscape may be degraded structures, and should be carefully monitored during ground-breaking works in order to accurately identify and investigate any of archaeological potential.

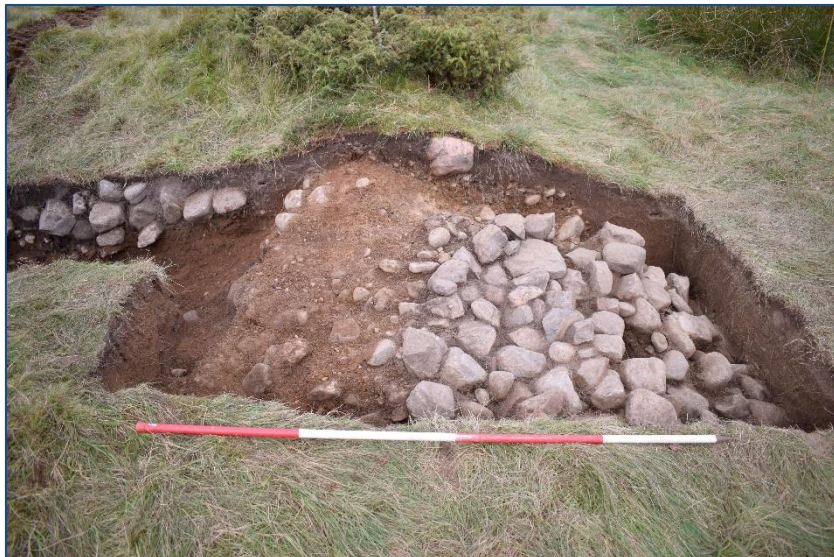
*Plate 7: Post-excitation of trench showing platform of revetted stone 003 (right) set against the manufactured bank 004 (left)*

- 7.1 The trench revealed a well-defined bank of natural glacial material, created by intentionally hollowing out of the centre of a drumlin – perhaps as a small gravel quarry. A revetment of stone was then constructed on the eastern portion of the bank, with a possible flat platform to support a turf-built wall, the remnants of which were observed to have formed a layer of material over the bank [004] and wall [003]. The possible post hole [014] may indicate the structure had a roof, the posts for which were situated outwith the turf wall. After an indetermined amount of time – though long enough that the potential turf had degraded and encroached well into the interior of the hollow, the internal area was infilled and levelled with stones in a silty matrix. The last phase of use of the site is evident in the form of a large V-shaped pit, containing clearance material and frequent ceramic sherds and other miscellaneous material culture potentially representative of the 19<sup>th</sup>/20<sup>th</sup> century.

| Context No. | Context Type | Description | Over | Under | Fill of | Filled By | Cuts | Cut By | Same As | Interpretation |
|---|---|---|---|---|---|---|---|---|---|---|
| 003 | Structure | High concentration of small to medium sized stone, up to 0.3m long, on the east side of the structure. Concentrated as a flat platform with two parallel courses of stone forming the edges of the platform, stones comprising this are somewhat more angular than the rest. The stones on the east side (downhill slope side) are more rounded and loosely terraced/revetted against the eastern face of the slope of the bank 004, likely as a revetment. Stone setting 014 set within this on east side of the platform, likely a post hole. | 004, 010 | 002 | - | - | - | - | - | Revetted stone wall built in terraces against the external face of the modified bank 004, stone forming a flat platform towards the top of the bank that potentially acted as a foundation for a turf-built wall. Post setting 014 set in logical place (external of wall) to distribute weight of a potential roof off the wall. |

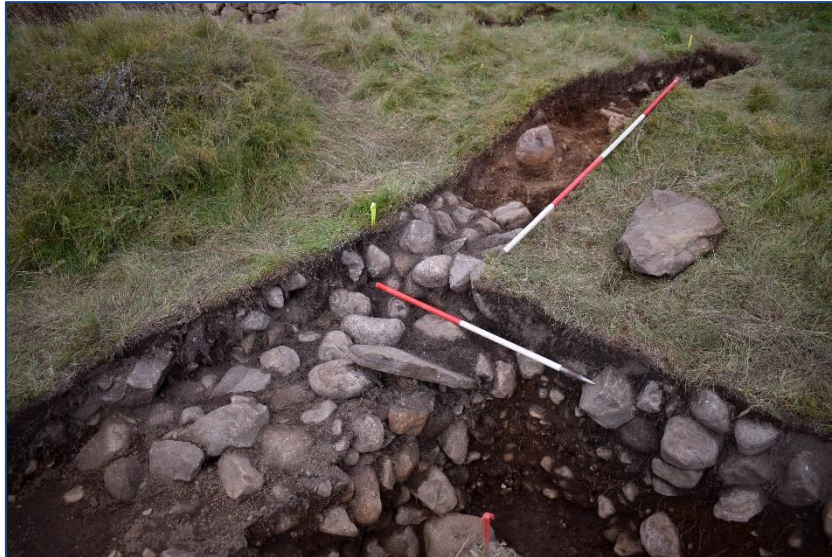
*Plate 8: Oblique view northwest over north-northeast trench leg, showing stone 005 within pit 006 in foreground, abutting bank 004 in background*

| Context No. | Context Type | Description | Over | Under | Fill of | Filled By | Cuts | Cut By | Same As | Interpretation |
|---|---|--|---|---|---|---|---|---|---|--|
| 005 | Deposit | Collection of medium to large sized stone (up to 0.5m long), comprising subrounded and subangular stone some of which may be crudely dressed. Situated within a dark brown/black sandy silt matrix containing fragments of coal, slate, ceramics, glass and iron. Compacted towards top of deposit, potentially trample surface - stones observed to be 'tipped' and protruding to such an extent it would not make a practical floor surface for livestock etc, | 006 | 001 | 006 | - | - | - | - | Fill of pit 006. |
