Lairg to Loch Buidhe Reinforcement

EIA Report: Volume 2:
Main Report
January 2019

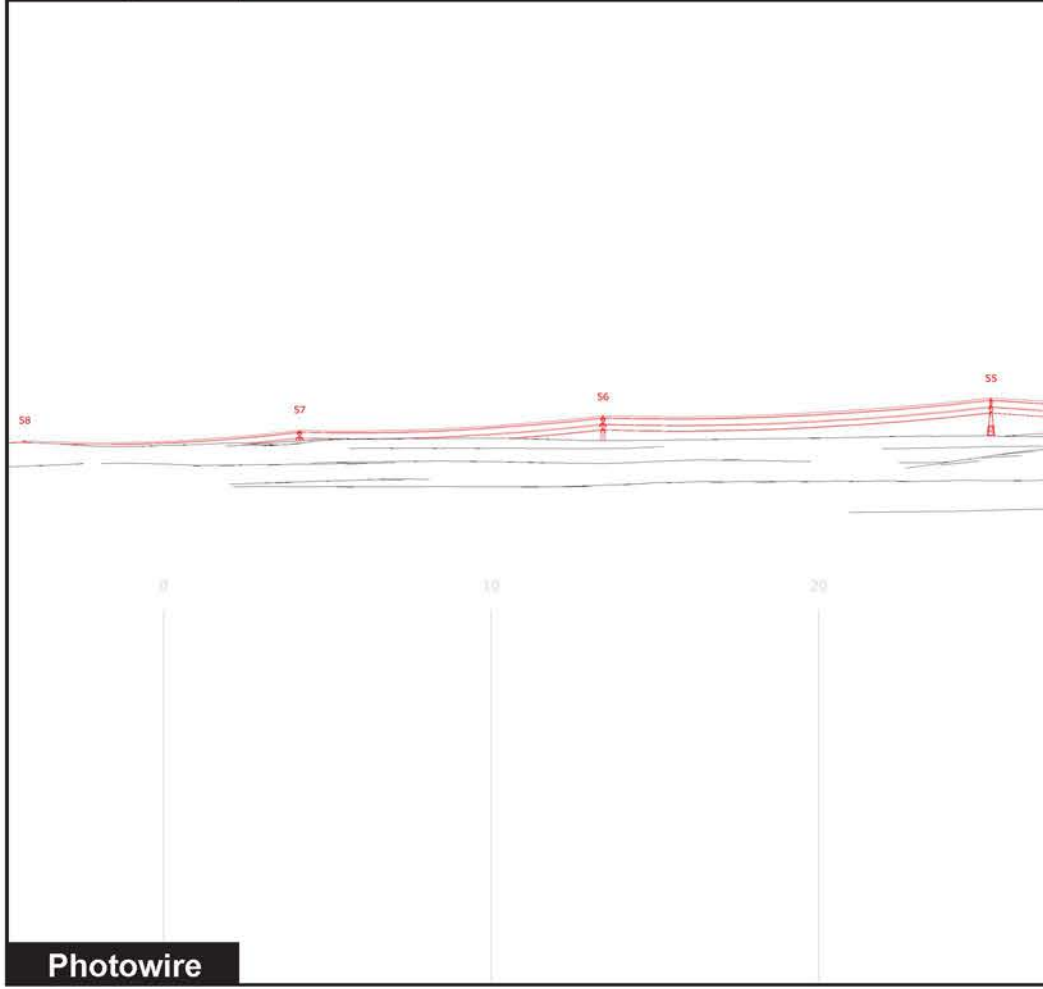
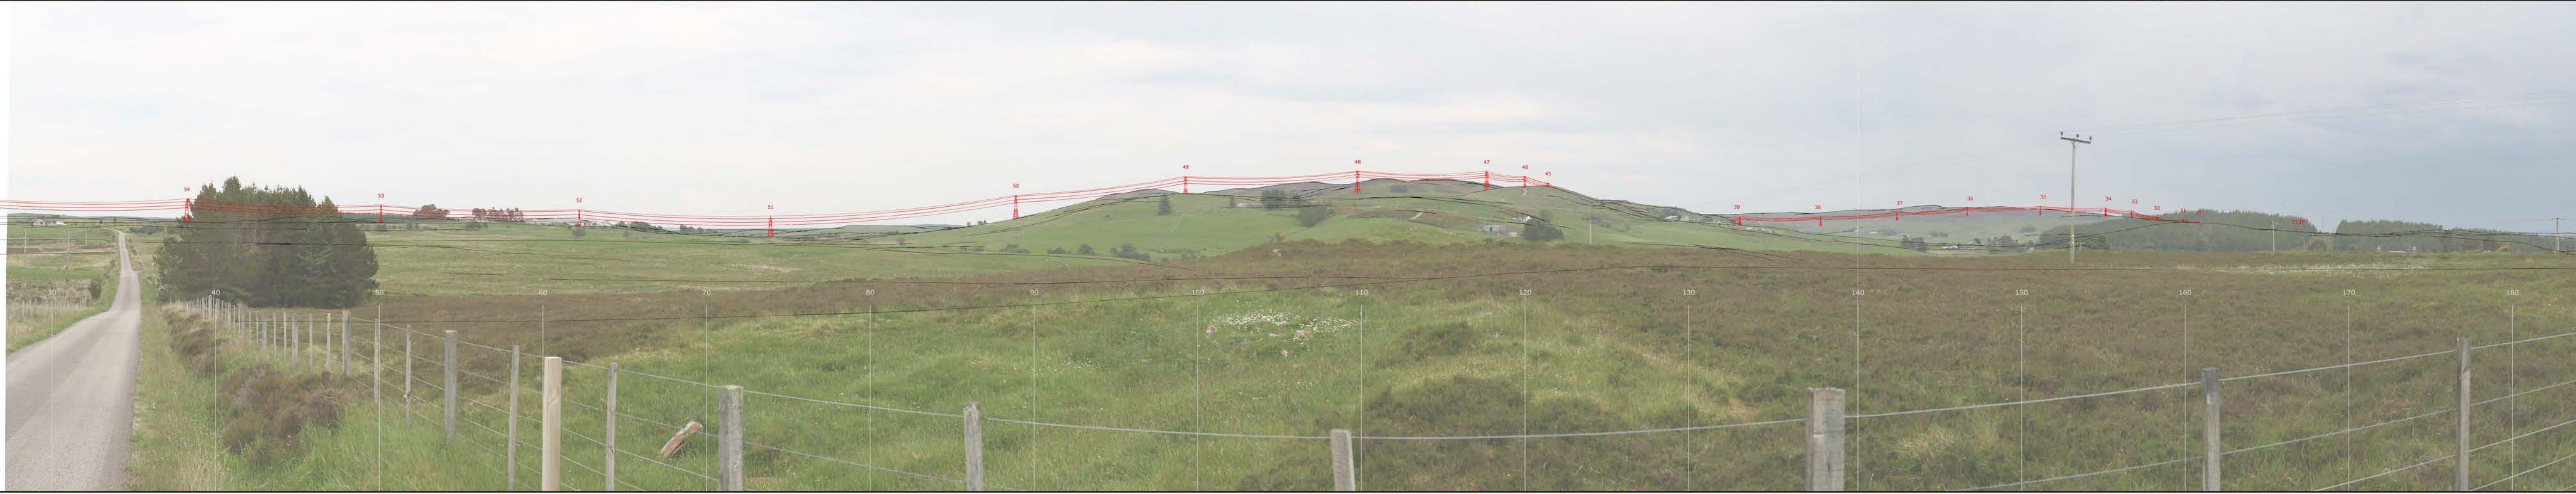
CULTURAL HERITAGE (Fig 7.5)
 Viewpoint 2 Lairg Muir North Chambered Cairn (SM1817)

Photowire

OS Grid reference: 258972 E 907306 N
 Eye level: 137.9 AOD
 Bearing to nearest tower: 140°
 Distance to nearest tower: 1106.211m

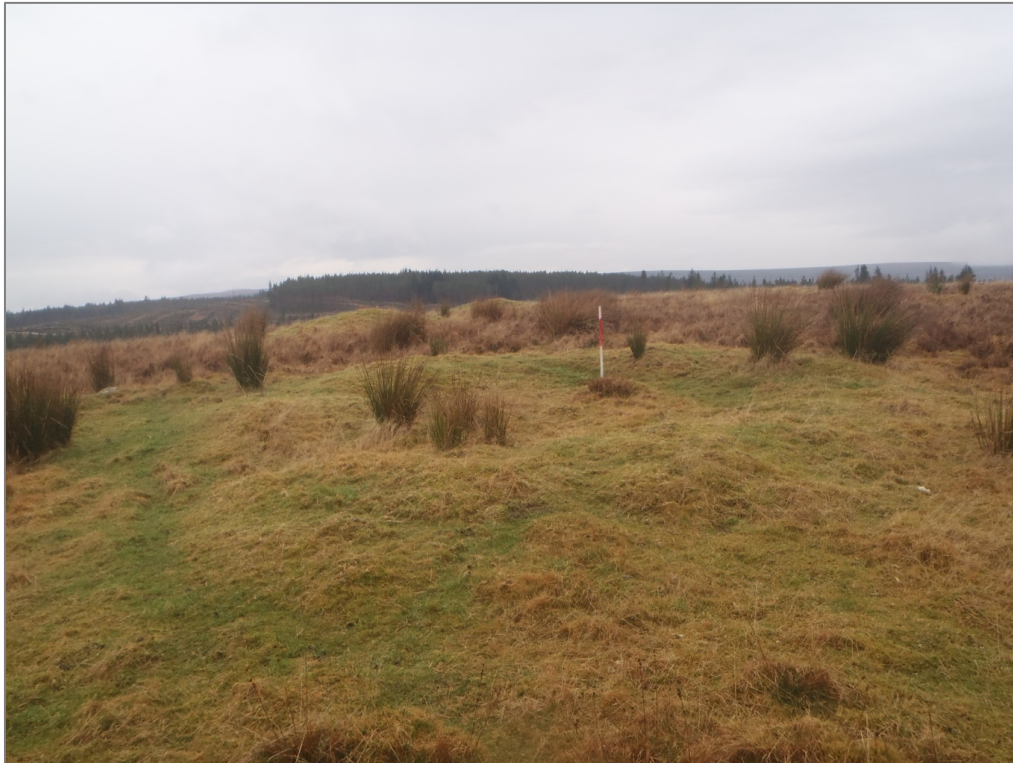
Plate 7.1: Hut-Circle (1b), taken from the North East (CFA Archaeology Ltd)

This section of the Inner Study Area has within it, where it passes Lairg, the remains of six hut-circles (1a, 1b, 5, 10a, 33 and 52). These are generally well-preserved remains, ranging in size from 5 m to 10 m in diameter and defined by stone and turf banks (Plate 7.1); all of those recorded were identified in areas of relatively flat ground on the periphery of Lairg. Hut-circles are commonly attributed to the period of the Bronze Age and Iron Age and several excavated examples, recorded at Auchinduich (just south-west of Lairg) in the 1990s, have been dated to the Bronze Age; one provided Iron Age dates showing that settlement here continued throughout this later period (McCullagh & Tipping 1998⁴). The hut-circles are components of an extensive later prehistoric landscape that surrounds Lairg and they are considered to be of regional heritage importance and medium sensitivity.

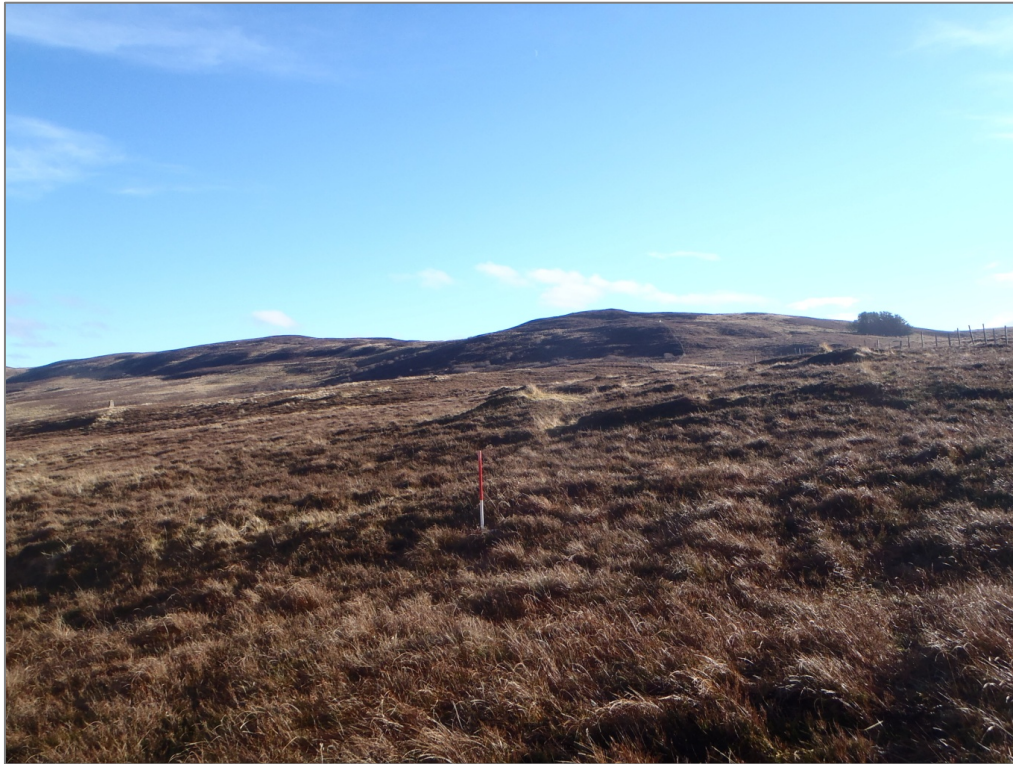
Plate 7.2: General shot of Cairnfield (6), taken from the West (CFA Archaeology Ltd)

Extensive cairnfields (1c, 3-4, 6, 13-14, 16, 18-21, 25, 34 and 46) (Plate 7.2) were found scattered along and throughout the Inner Study Area; in areas of rough pasture and heather moorland at Saval, Baddhu, Tomich and Rhina Breck for example. 'Cairnfield' is a generic name for groups of small heaps of stones, roughly rounded or oval in plan, often less than 5 m in diameter and numbering from several to many hundreds in any one location. They are not characteristic of any one particular period since stone clearance has been practised in Britain from the Neolithic to the present day. However, in this instance, their close association, either surrounding or in close proximity to the remains of hut-circles, would suggest that the majority are likely to be of prehistoric date and contemporary with the prehistoric settlement remains. As with the hut-circles, the cairnfields are components of an extensive prehistoric landscape that survives surrounding Lairg and they are considered to be of regional heritage importance and medium sensitivity.

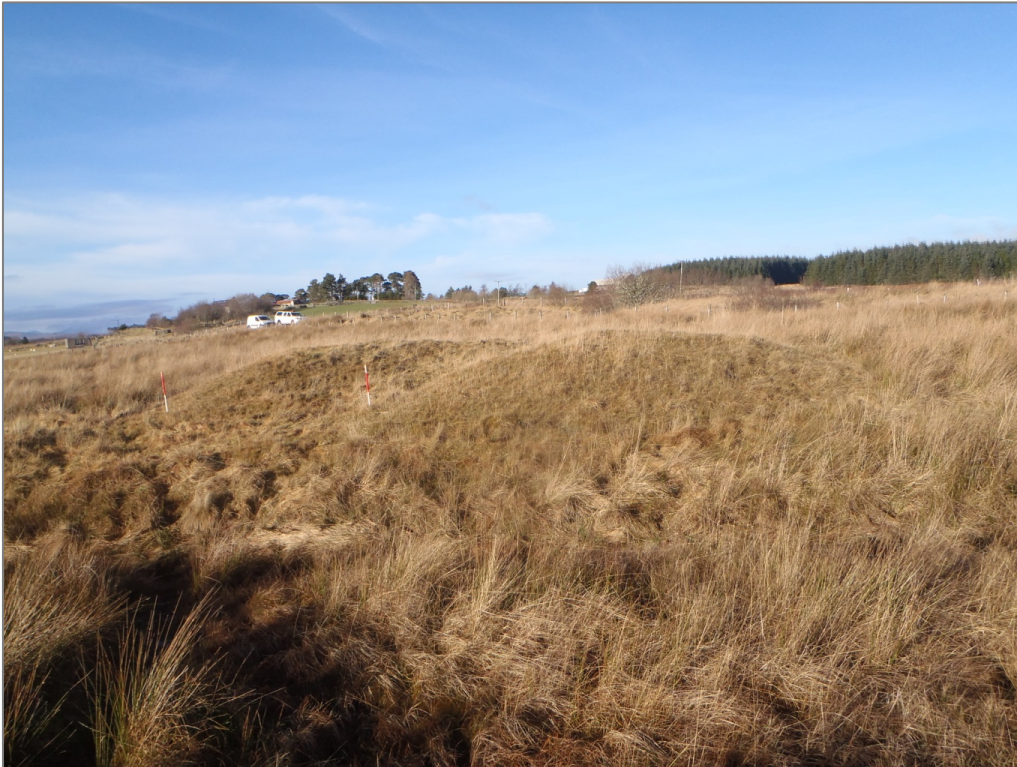
Plate 7.3: Burnt Mound (8), taken from the South East (CFA Archaeology Ltd)

As a well-preserved example, the burnt mound (8) is considered to be of regional heritage importance and medium sensitivity.

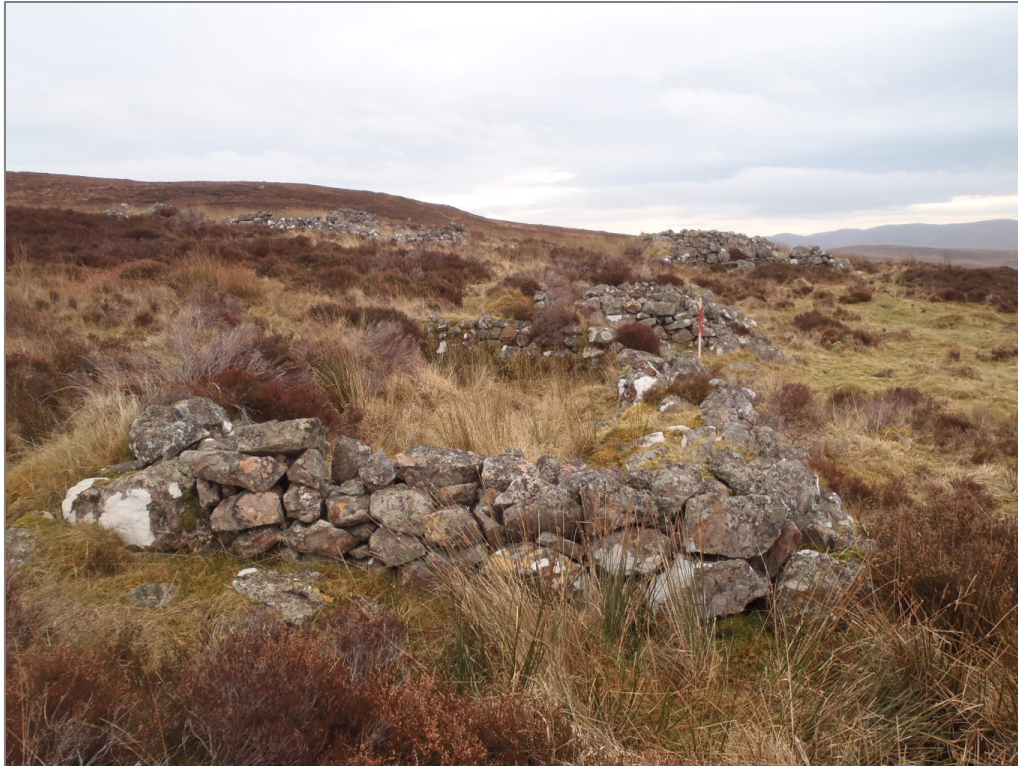
Plate 7.4: General shot of the remains of Township (77), taken from the North West (CFA Archaeology Ltd)

The first (77) is depicted on Burnett and Scott's map of 1855⁷ annotated 'Peilfraoich' and is shown on the Ordnance Survey 1st Edition map (1879) as comprising four roofed buildings, an unroofed building, a circular enclosure and four fields. The name 'Peilfraoich' translates as 'boggy heather'. By the time of the 2nd Edition map (1908) all of the buildings are shown as unroofed, indicating that it had been abandoned by that date. The ruins of the township survive today in an area of heather moorland just north of a trackway leading to Loch Laro and on a south facing slope. The township ruins are well preserved and complex (Plate 7.4), comprising of at least nine buildings, five enclosures and a number of large clearance heaps. The remains of an extremely well-preserved corn drying barn and kiln (Plate 7.5) survive on the southern edge of the township, revetted into the hill slope (at 261934, 898964). The buildings, all of drystone wall construction, vary in size; the largest being 21 m long by 5 m wide with walls 0.5 m-1 m high. The township remains are spread over an area measuring approximately 400 m by 400 m and extend to either side of the trackway leading to Loch Laro. The main elements of the township are enclosed by a number of sinuous turf and stone banks, forming a series of enclosures and which together generally define the extent of the township; although occasional features, probably associated with the township (for example a sheepfold (75), several clearance cairns/heaps including assets (76) and (78), bank (71) and a bridge (72): see details below), lie outside of the enclosed areas.

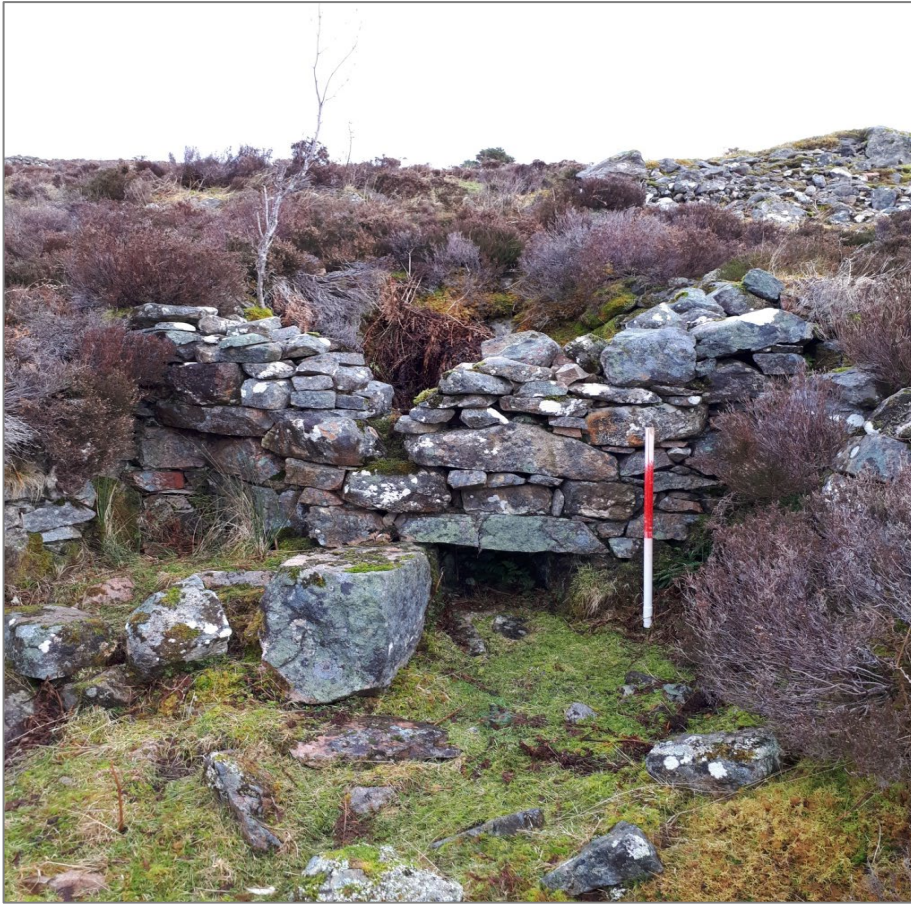
Plate 7.5: Corn-drying Kiln surviving within Township 77, taken from South West (CFA Archaeology Ltd)

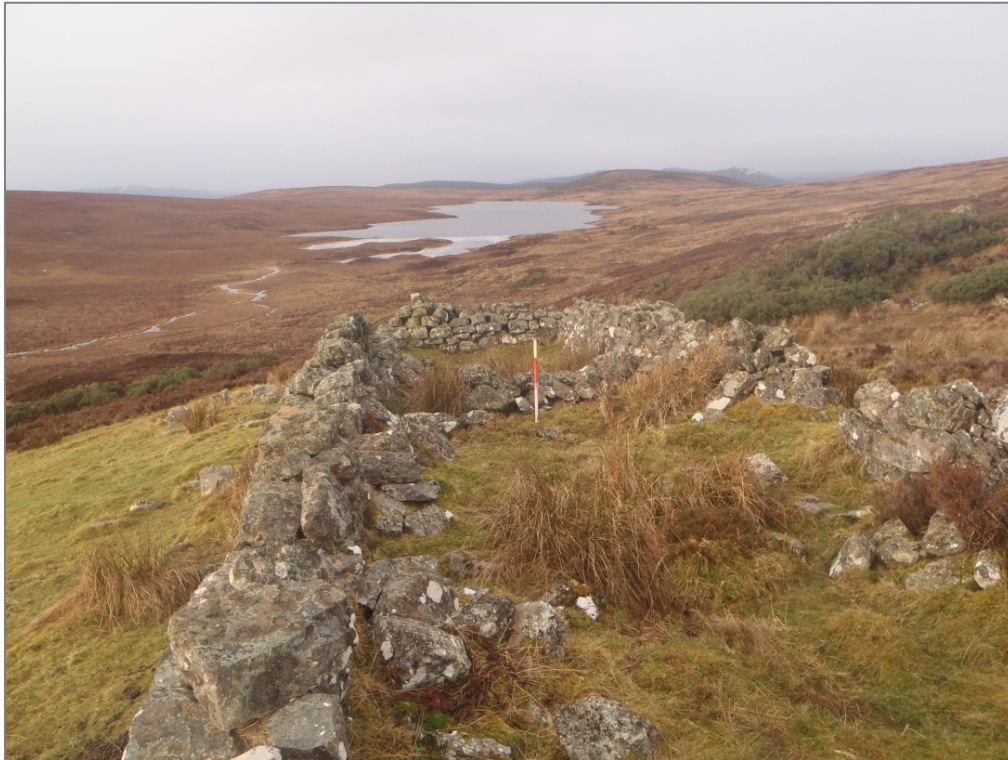
Plate 7.6: General shot of Buildings within Township (80), taken from the South East (CFA Archaeology Ltd)

The second township (80), around 330 m to the east of 'Peifraocih' (77) is depicted on the 1st Edition map (1879) comprising four roofed buildings, one unroofed building, two enclosures and a ring-dyke. As with 'Peifraocih' (77), the buildings forming this township are all shown as unroofed on the later 2nd Edition map (1908) indicating that it was also abandoned by that date. The ruins of this township are also well preserved and complex (Plate 7.6), at least four buildings, a series of large clearance cairns and at least four enclosures and several field banks were recorded during the field survey, spread out over an area measuring approximately 350 m by 320 m and extending either side of the trackway to Loch Laro. Several particularly large clearance cairns (stone heaps), which are rectangular in plan, were recorded within the main township enclosure and these may well overlie remains of additional buildings (Plate 7.7). The extent of the township is defined by a stone and turf bank, which encloses the main elements of the township; although two buildings are present outside the enclosure bank, just to the north-west of the township.

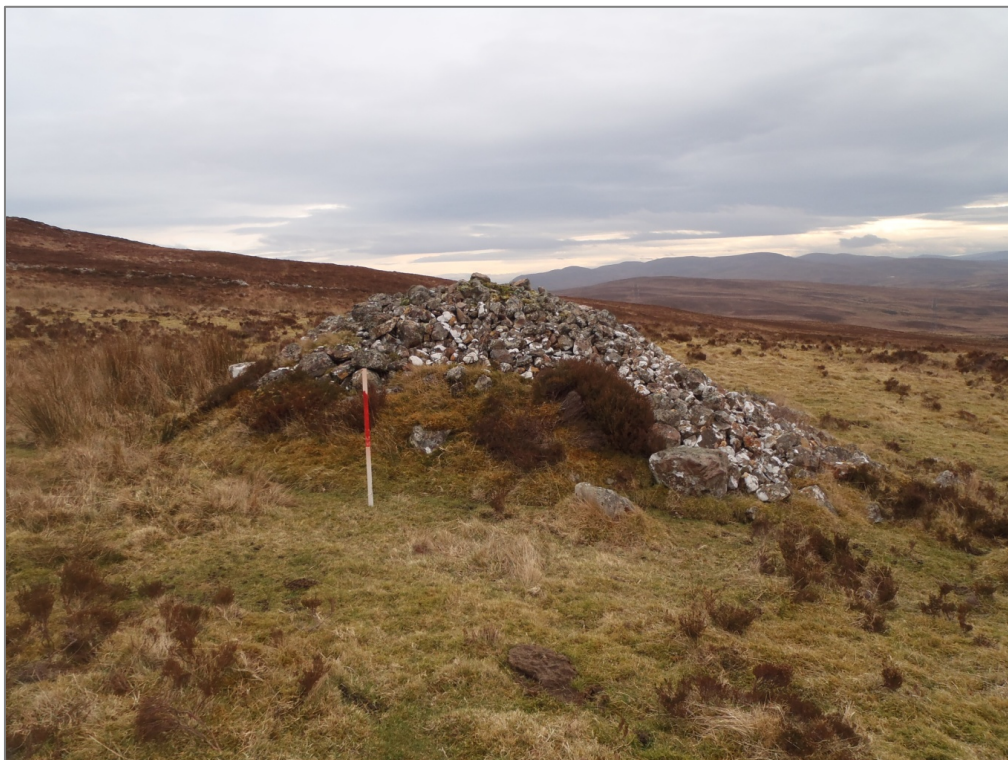
Plate 7.7: An example of a Large Clearance Cairn (stone heap) within Township (80) which may overlie former Building remains, taken from West (CFA Archaeology Ltd)
