Balachladich and Achnacarnin Mains Rehab Project Assynt, Sutherland

Archaeological Desk Based Assessment and Walkover Survey

National Grid Reference	NC 03009 30276 and NC 04206 32092 (centred)
Site Code	Balachladich 20
Author	Steven Birch
WCAS Report #	2020-125/BALACH/20
Client	Scottish Water
Date	25-03-2021

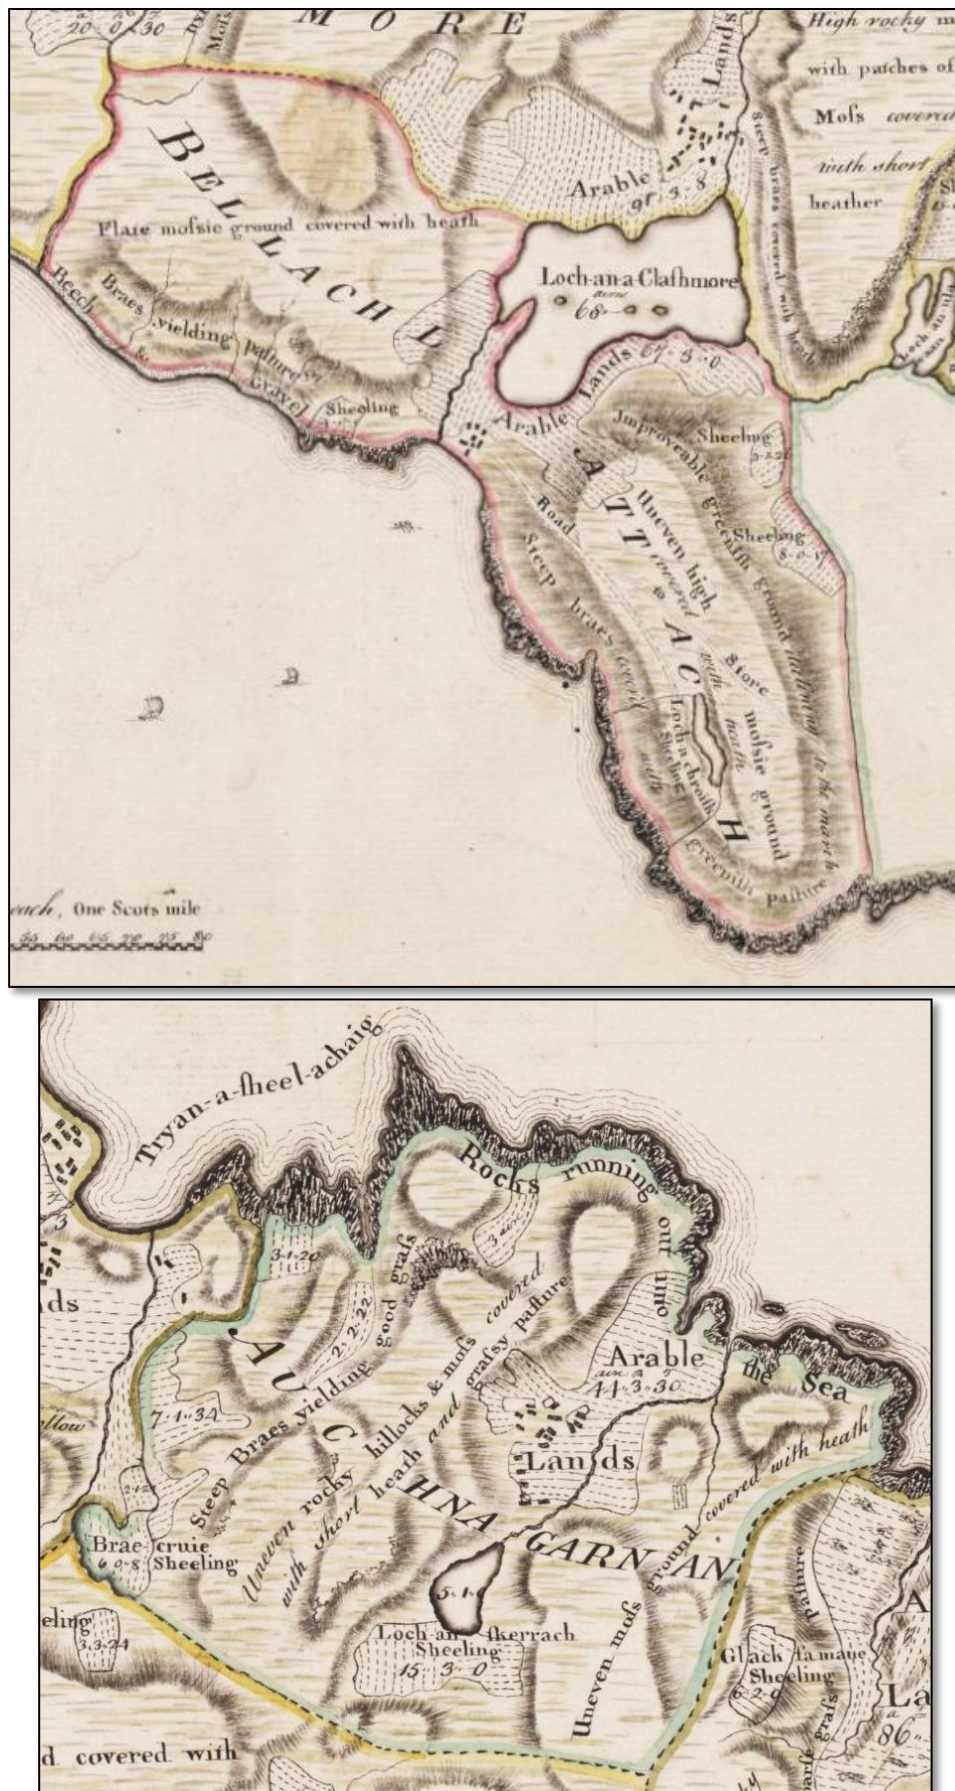
Figure 4: Excerpts from John Home's Estate Map showing Balachladich and Achnacarnin (© NLS)

The earliest map showing any detail of the historical landscapes at Balachladich and Achnacarnin is John Home's Survey of Assynt in 1774, which was produced at a critical time in the development of these settlements. The map shows a cluster of buildings representing the settlement of Balachladich located at the back of the beach at Balachladich Bay, and to the southwest of *Loch-an-a-Clashmore* (Loch na Claise). There appears to be at least 8 buildings, with improved ground and arable fields located to the northwest, north and northeast. The main focus of the settlement appears in a different location to that seen today on the ground, with the shift most likely taking place during the large-scale improvements in the 1870's when the model farm was constructed by the Sutherland Estate. The shieling grounds for the township are located to the west and southeast of the main area of settlement, in coastal locations.

John Home's Survey of Assynt, 1774 (No.2 – A plan of the farms of Clashnessie, Aghnagarnan [Achnacarnin], Culken [Culkein], Clashmore and Bellachlattach [Balachladich]). NLS Dep. 313/3585 (Figures 3 and 4)

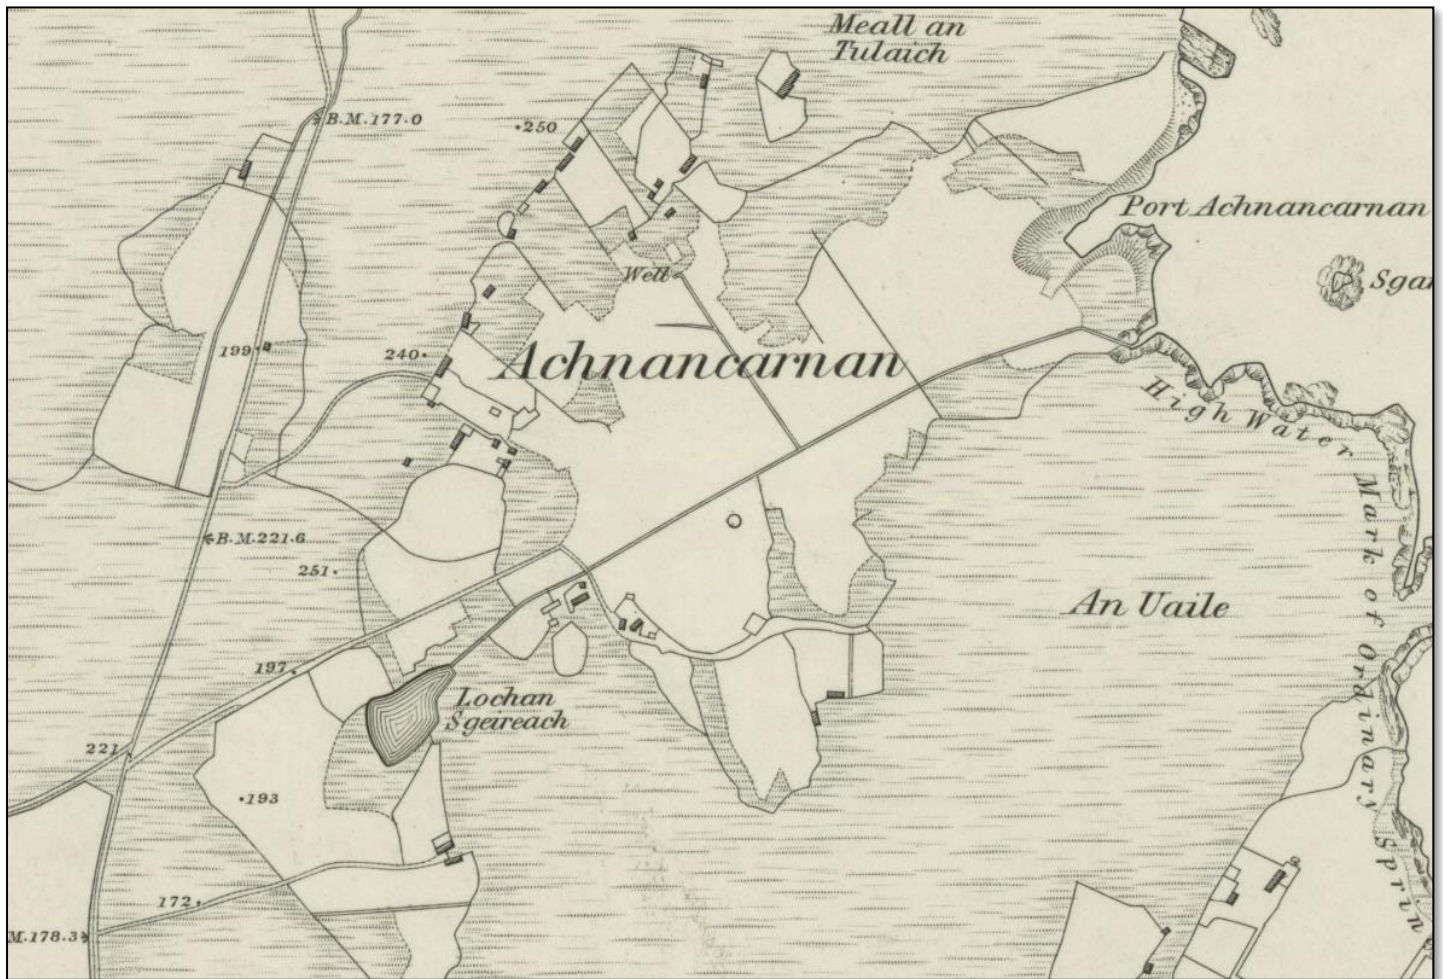
Figure 6: Excerpt from 1st Edition OS map sheet LVIII showing Achnacarnin (© NLS)

The same map sheet showing the Achnacarnin Township displays the main focus of the settlement fringing the northwest side of the improved ground and fields, along with additional settlement and fields on the southwest side of Lochan Sgeireach – which comprised the main shieling grounds on Home's estate map of 1780. The area taken by the main route of the water main to the WNW shows enclosed fields and the large drainage channel, along with two buildings. It will be noted that at both townships, most of the buildings have been constructed outside the main improved

fields, and on the edge of rough pasture, although some structures have kaleyards adjacent to them containing improved ground.

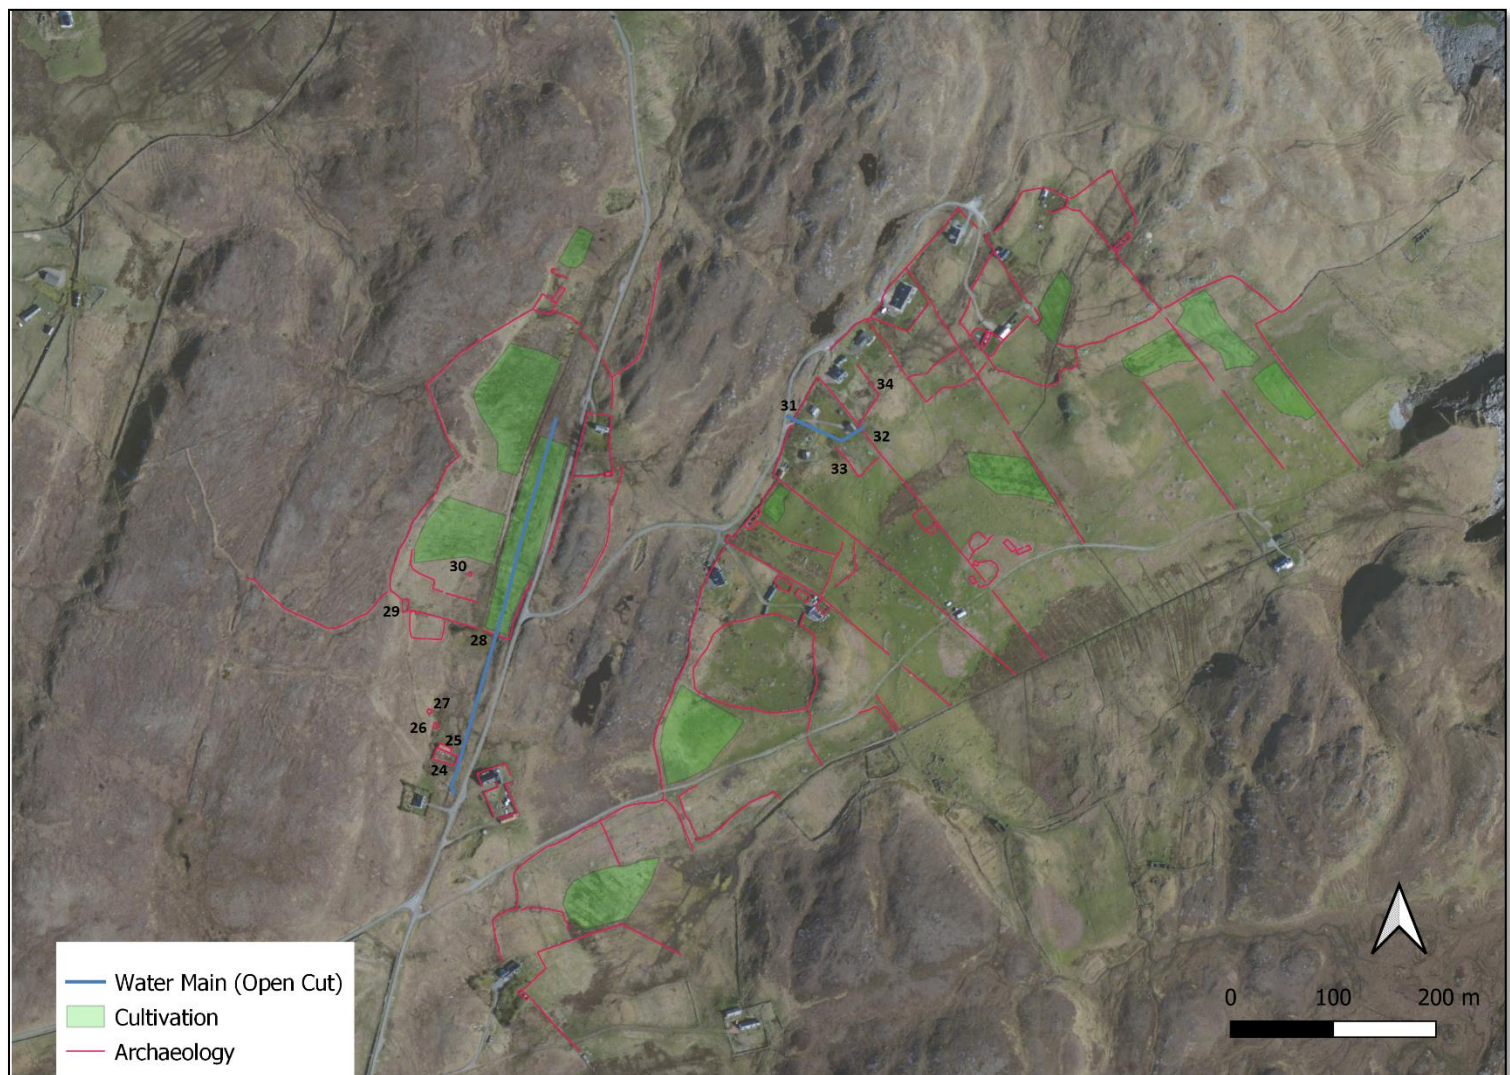
Figure 11: Aerial image showing overlain archaeological sites and open cut pipeline route - Achnacarnin (light blue line) – Includes ESRI World Imagery © 2021

- 8.3 The proposed water main pipeline route proposed at Achnacarnin will not impact on any archaeological features, with the exception of a stone enclosure dyke. Therefore, no further archaeological input is recommended on this section of the route.

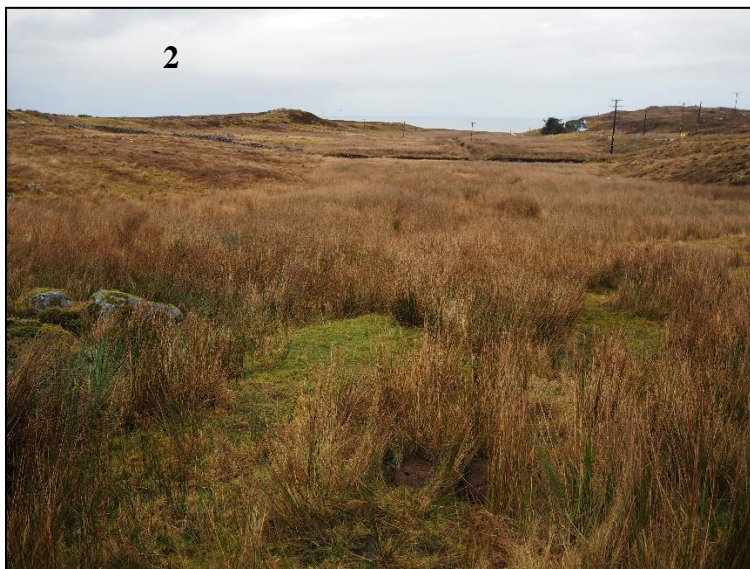
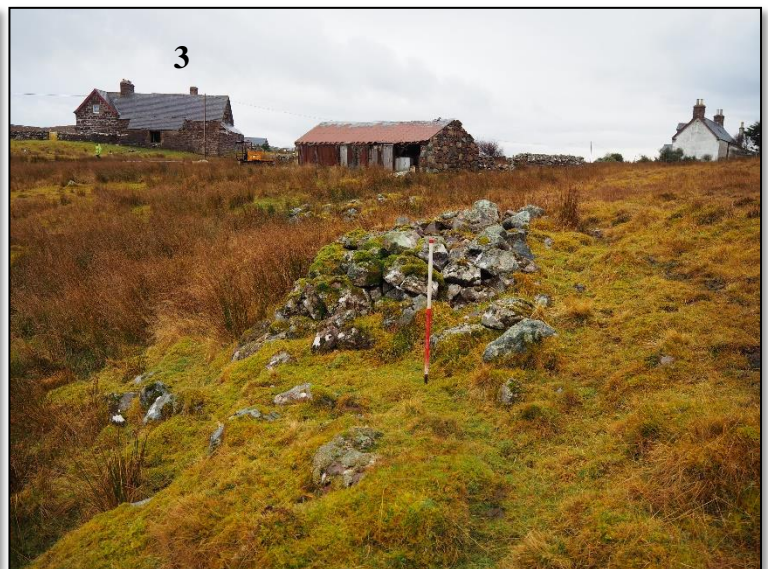
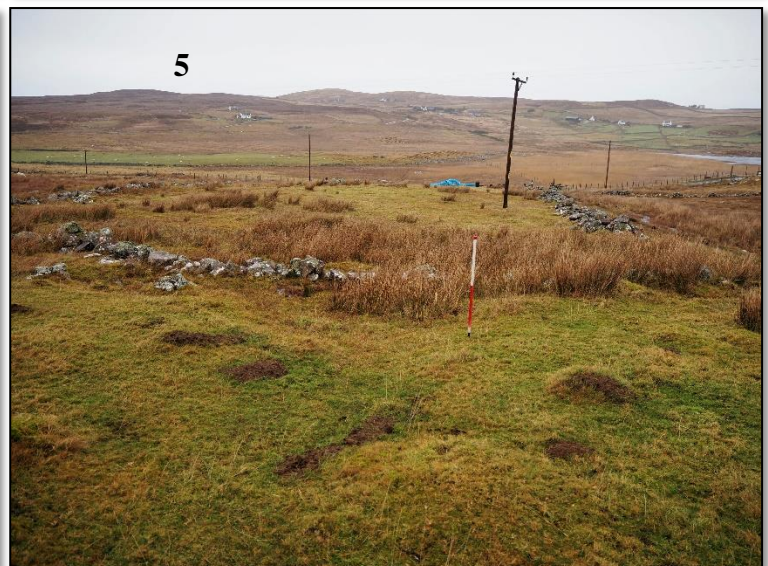
Plate 2: View N from Site 25 over main Achnacarnin pipeline route; Plate 3: Clearance cairns (Sites 26 and 27) with byre Site 25 beyond, Achnacarnin; Plate 4: Looking ESE along the Township road at Balachladich showing proximity of field/enclosure walls to pipeline route; Plate 5: Route of water main at Balachladich where it runs S from Township road through enclosures

24	Enclosure	Achnacarnin	Roughly rectangular-shaped stone-built enclosure with walls 0.7m wide and >1.5m high-although some sections reduced down to 0.5m high	NW-SE	Degraded	Post Medieval	67	204181	931967
25	Byre	Achnacarnin	Byre attached to and forming part of NE wall of enclosure Site 24, had stone-built gables and SW wall and corrugated iron NE wall and roof; the iron held on a wooden framework. Wooden doors in NE wall. Building has square corners with mortared walls 0.6m wide and surviving up to fill gable and wall-plate height. Measures 12.8m long by 5.0m wide	NW-SE	Ruinous	Post Medieval	67	204180	931976
26	Clearance Cairn	Achnacarnin	Stone clearance cairn measures 5.7m long by 4.8m wide and 1.2m high	N-S	Degraded	Post Medieval	65	204171	931998
27	Clearance Cairn	Achnacarnin	Stone clearance cairn measures 4.0m diameter and 0.9m high	-	Degraded	Post Medieval	65	204165	932012

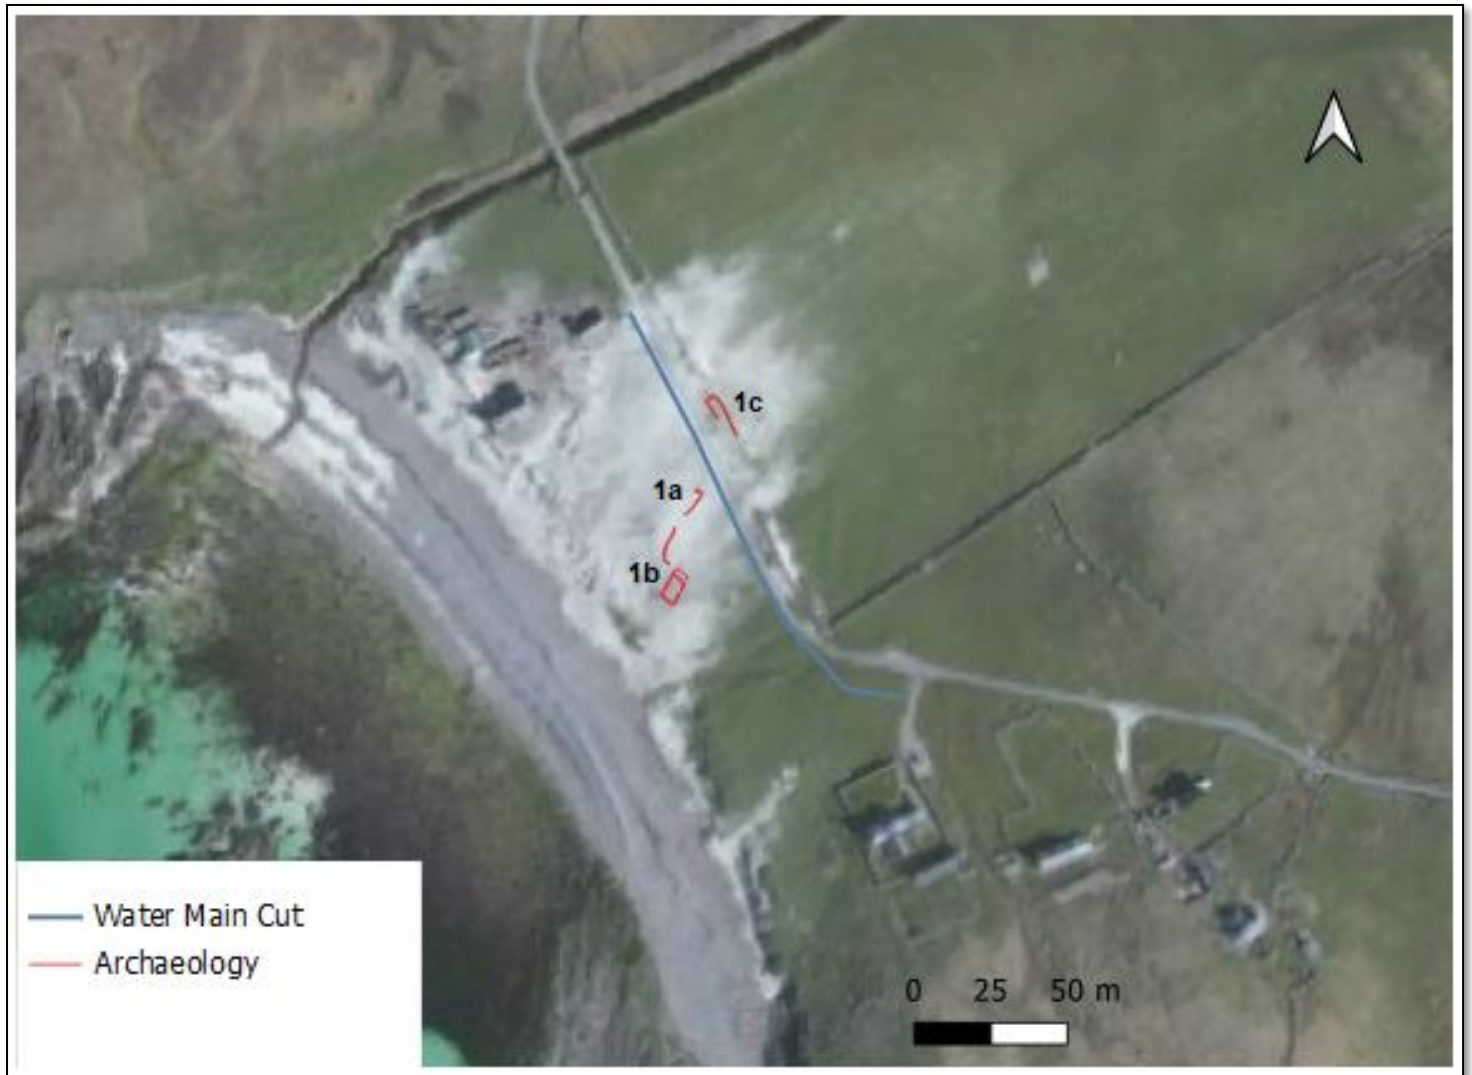
Figure 12: Aerial image showing recorded eroding structures at Balachladich Bay

Site No.	Site Type	Site Name	Description	Alignment	Condition	Period	Ht OD (m)	Easting	Northing
1	Structures /Midden	Balachladich Bay	Area of eroding dune system at back of Balachladich Bay. Eroding stone features and areas of shell midden. The midden includes shellfish (limpets and periwinkles), fish bone, animal bone, Industrial period ceramics, and degraded iron objects	-	Eroding	Post Medieval	11	202678	930496
1a	Building/ Walls	Balachladich Bay	The eroding NE gable and SE side wall of a building, of unknown dimensions, but approx. 5.5m long and 2.8m wide internally , with walls spread up to approx. 0.8m wide and standing to 0.3m high	NE-SW	Very Degraded	Post Medieval	11		
1b	Building/ Walls	Balachladich Bay	The very degraded and eroding remains of a building, located at the front edge of the dune system at Balachladich Bay. Measures approx. 8.2m long by 3.0m wide internally, with walls spread to 0.8>1.2m wide and standing to a maximum height of 0.4m. No visible entrance, but a part of the ENE gable survives and measures 0.6m wide. Structure is surrounded by eroding midden deposits including shellfish, animal and fish bone. A fragment of wall, most likely comprising a part of an enclosure of field dyke, runs from close to the N corner of the building in a NE direction. The wall is heavily disturbed and is spread to between 0.7 and 0.9m wide and stands >0.5m high	ENE-WSW	Very Degraded	Post Medieval	11

1c	Building/ Walls	Balachladich Bay	Two heavily eroded and disturbed sections of wall are located on the NE side of the single track road. Running NNW-SSE, the SW wall measures approx. 6.5m long and is spread between 0.7 and 1.1m wide and stands to 0.5m high. The NE wall fragment is at least 8.8m long and is spread from 0.6>0.8m wide and stands up to 0.4m high. The walls curve together at the NNW end	NNW-SSE	Very Degraded	Post Medieval	12

- 8.2 Where the proposed new open cut for the water main runs along the back of Balachladich Bay, it is recommended that the route follows as closely as possible the verge of the road. Eroding and degraded walls have been recorded in this area, along with associated midden deposits (Figure 9, Site 1; Figure 12; Plates 6-11), and it is possible that windblown sand may be masking other features and deposits. A follow-up visit was made to the site by West Coast Archaeological Services after the water main had been cut through this area. No archaeological structures had been disturbed, but midden deposits were noted in the backfill of the trench including marine shell (limpet and periwinkle), fish and animal bone, Industrial period ceramics and glass, and some corroded iron fragments. Examination of the exposed midden deposits across the eroded dune system at the back of Balachladich Bay revealed no prehistoric, or earlier material during the site visit and it is probable that the eroding structures recorded here are post medieval in date.

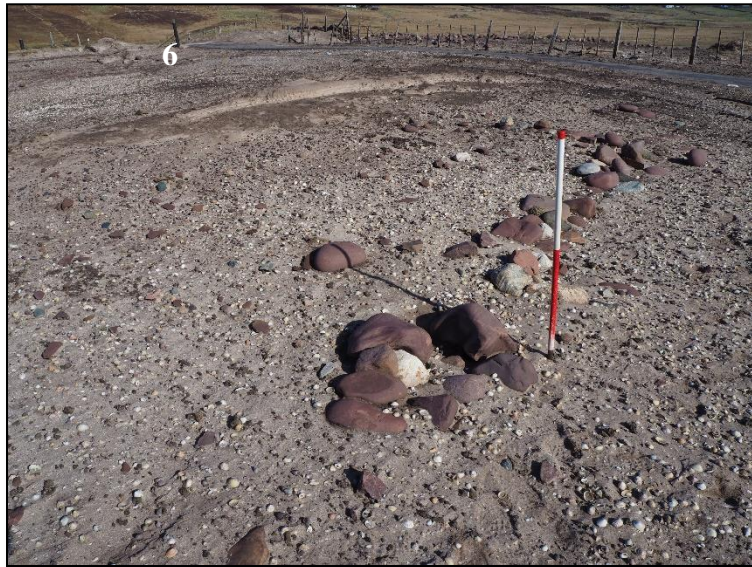
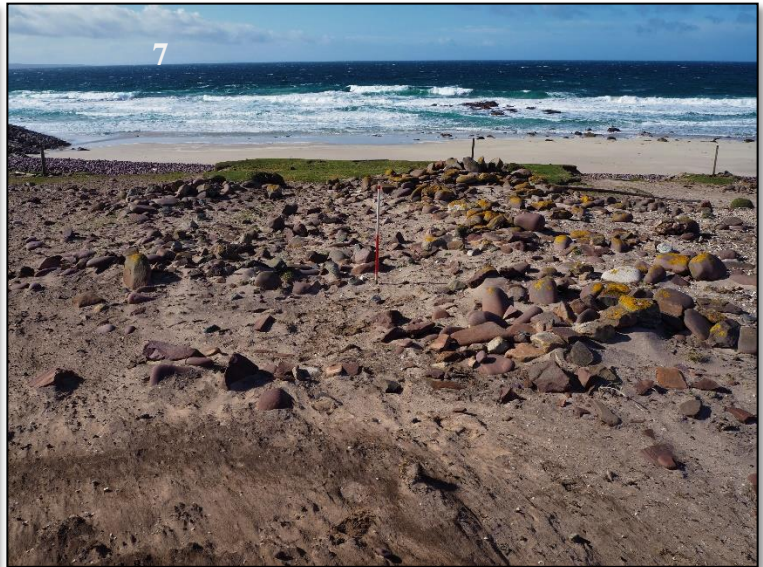
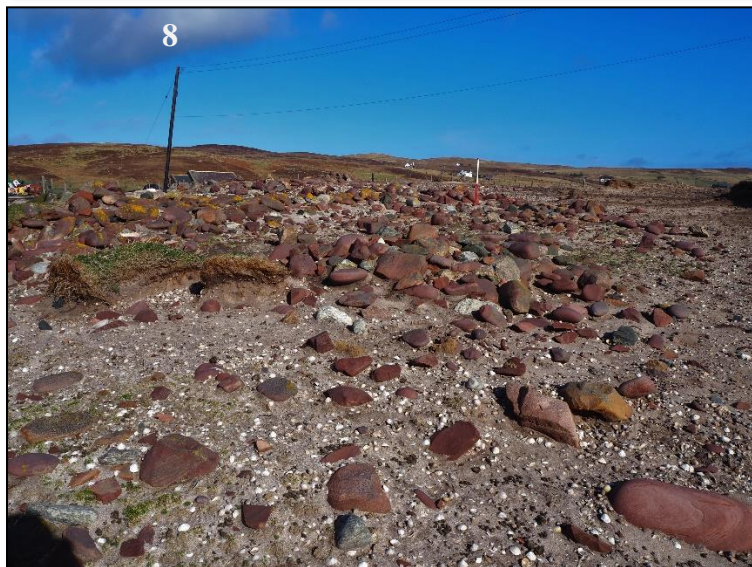
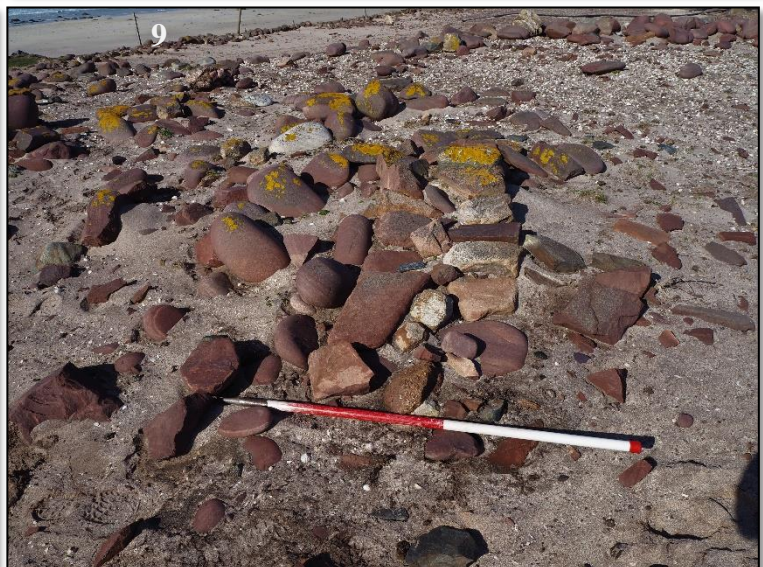
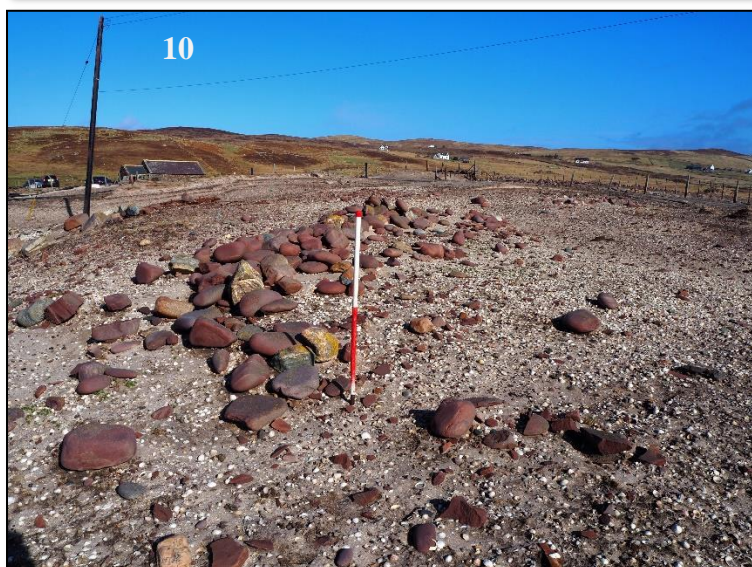
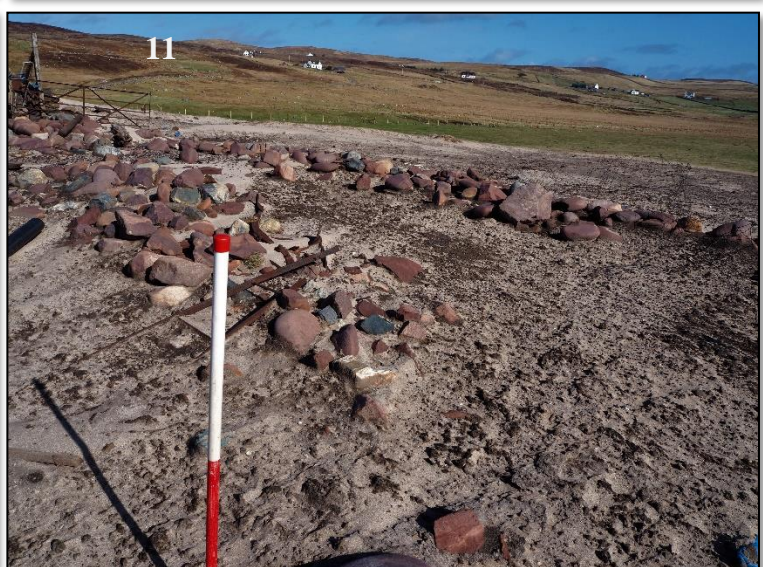
Plate 6: Eroding structure Site 1a, Balachladich Bay; Plate 7: Structure 1b, Balachladich Bay; Plate 8: View towards structure 1b, Balachladich Bay; Plate 9: Surviving section of ENE gable wall, structure 1b; Plate 10: Enclosure of field wall running from N corner of structure 1b; Plate 11: Parallel walls at Site 1c

14	1b	NW	In-situ section of ENE gable wall of structure 1c, Balachladich Bay, with possible enclosure/field wall extending running off to the right (top right in image)	24.03.21	SB

Photo No.	Site No.	Direction facing	Description	Date	Taken by
15	1c	N	View over two eroding wall structures on the NE side of the road at Balachladich Bay, which may form the two side walls of a building. Alternatively, the walls may be a part of earlier field walls	24.03.21	SB
16	1	NW	View to Site 1 at Balachladich Bay, with backfilled cut for water main running parallel and close to the edge of the road	24.03.21	SB
17	1	NW	View to Site 1 at Balachladich Bay, with backfilled cut for water main running parallel and close to the edge of the road	24.03.21	SB
18	1	NW	View to Site 1, Balachladich Bay, showing the structures eroding from the slight mound at the back of the active beach	24.03.21	SB
19	1	W	General view over the beach at Balachladich and the eroding from edge of the dune system	24.03.21	SB

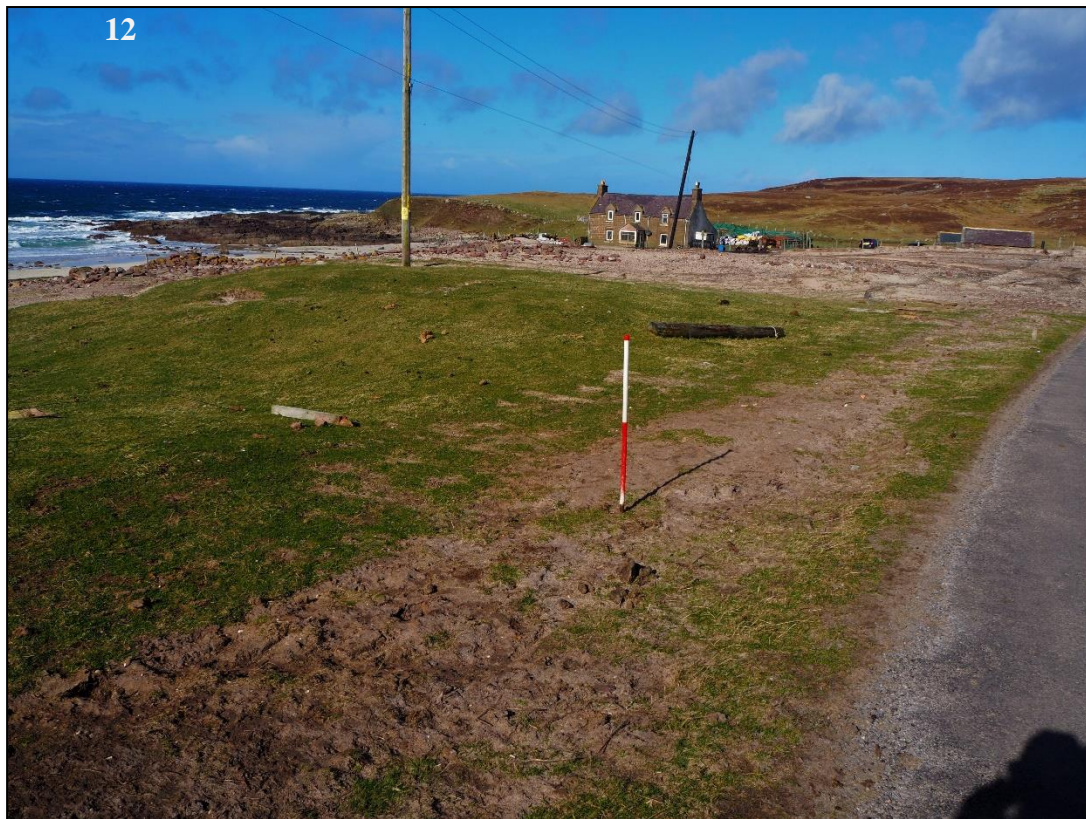
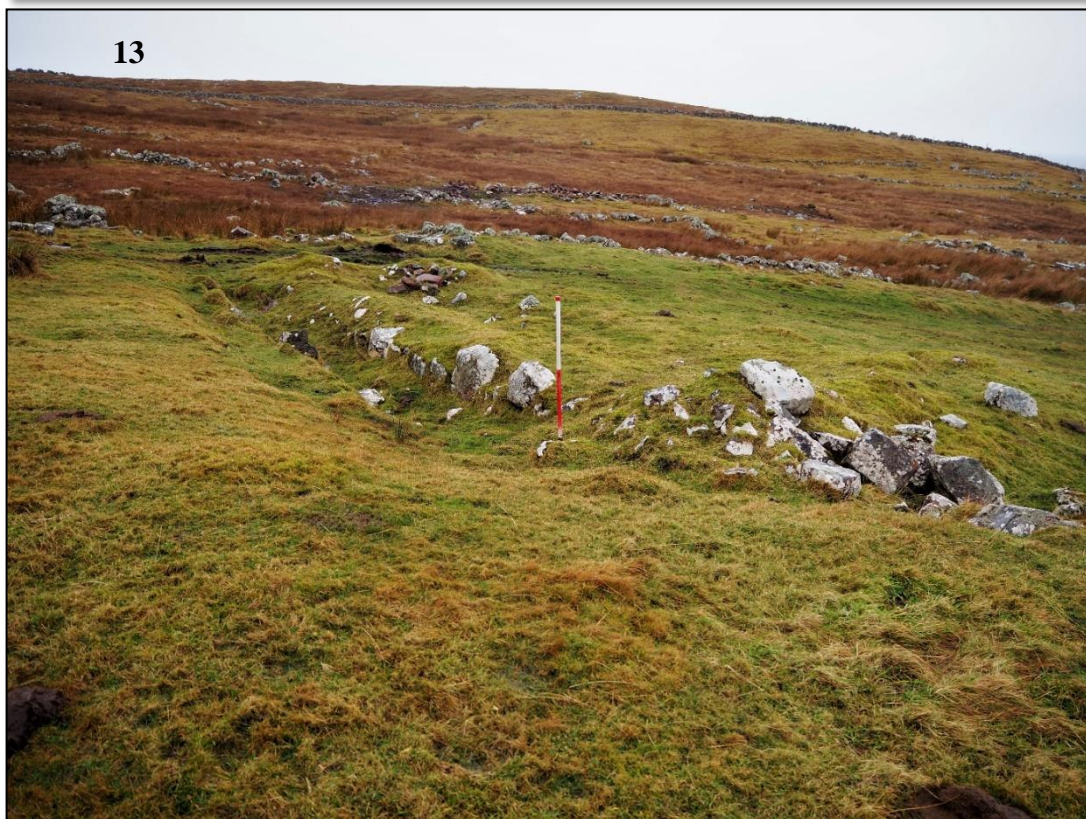
7	5, 6, 9, 11	NNW	View over very degraded and reduced remains of building Site 11, and drainage gully, with field enclosure walls and sands of Balachladich Bay beyond	21.12.20	SB
8	1a	NE	View over structure 1a, a possible house, eroding from the sand dunes at Balachladich Bay	24.03.21	SB
9	1a	NE	Closer view of structure 1a showing curving NE gable and SE side wall. Shell midden including fish bone and animal bone	24.03.21	SB
10	1b	NNE	View over degraded field or enclosure wall eroding from sand dunes at Balachladich Bay, with structure 1a to right	24.03.21	SB
11	1b	WSW	Very degraded building eroding from sand dunes with Balachladich Bay behind. ENE gable wall in foreground	24.03.21	SB
12	1b	N	View to slight mound with eroding structure 1c, with spread stone and shell midden around structure	24.03.21	SB
13	1b	N	Same view of structure as Image 12, but from slightly higher elevation-showing disturbed stone from structure	24.03.21	SB

Plate 12: General view towards Site 1, Balachladich Bay, with backfilled water main trench running down the side of road; Plate 13: View over very degraded and reduced remains of building Site 11, and drainage gully, with field enclosure walls beyond, Balachladich Township
