## Grantfield Croft, Tain Archaeological Trial Trenching

### Data Structure Report and Recommendations

# Grantfield Croft, Tain Archaeological Trial Trenching Data Structure Report and Recommendations

<b>HAS Report No.</b>	GCT22-005
<b>Site Code</b>	GCT22
<b>Client</b>	David Murison
<b>Planning Reference</b>	22/00887/FUL
<b>OS Grid Reference</b>	NH 76500 77900
<b>Date</b>	20/12/2022
<b>Author(s)</b>	Karen Kennedy
<b>Approved by</b>	Lachlan McKeggie

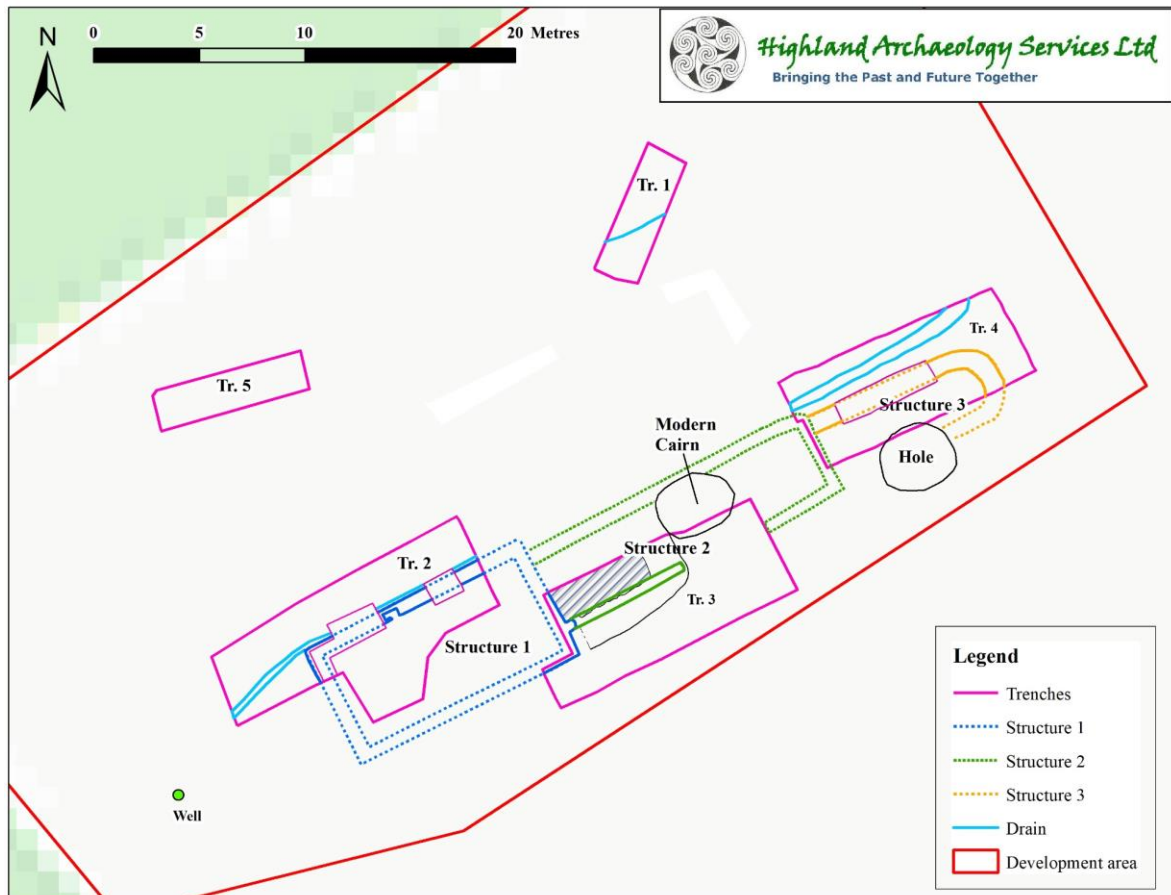
Figure 6: Overall Trench Layout and Structures

Five trenches were excavated in total (see Figure 6 below), three of which targeted the known structures within the site. Trench 5 and Trench 1 were excavated to establish whether any associated buried features may be present, or if there was any indication of use in these garden or cultivation areas. Trenches 2, 3 and 4 targeted the structures previously identified on the site. Overall the subsoil was an orange/yellow sandy soil with many black patches with frequent stone inclusions. The topsoil was a dark brown silty loam with moderately frequent small stones and was between 0.3m and 0.65m in depth. Descriptions for all contexts recorded within each trench can be seen in the context register within the appendices. With the exception of a drain in trench 1 (see Figure 6 below) and the trenches that targeted the structures in trenches 2, 3 and 4, no other archaeological features were noted.

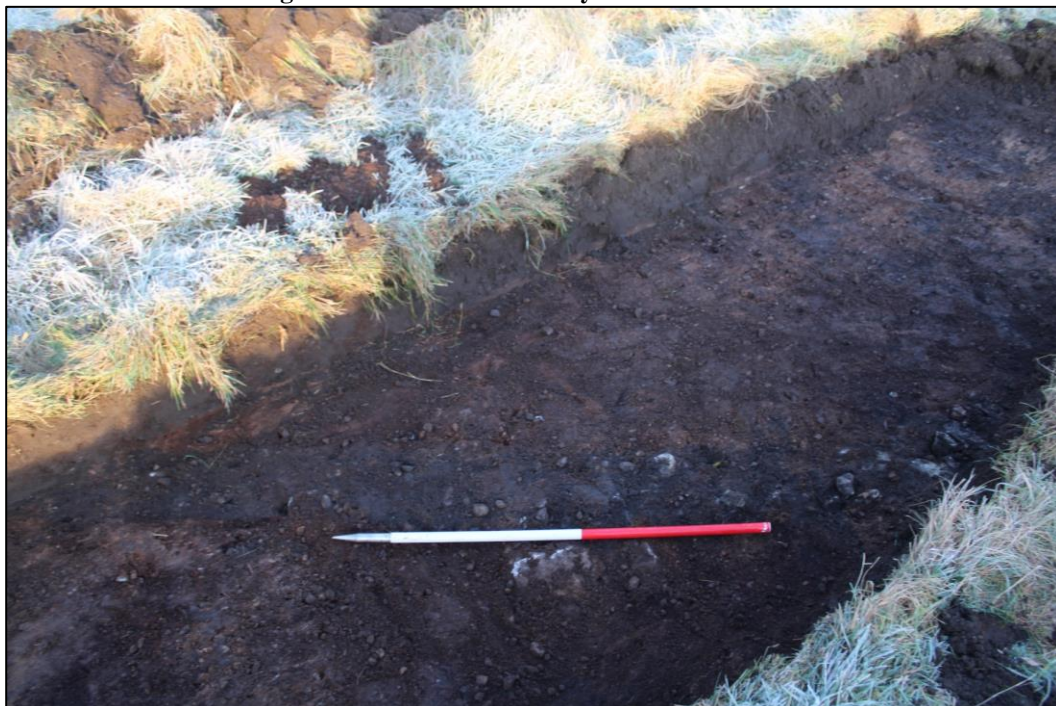
Figure 7: Photo 4941, Trench 1 facing N, 1m scale

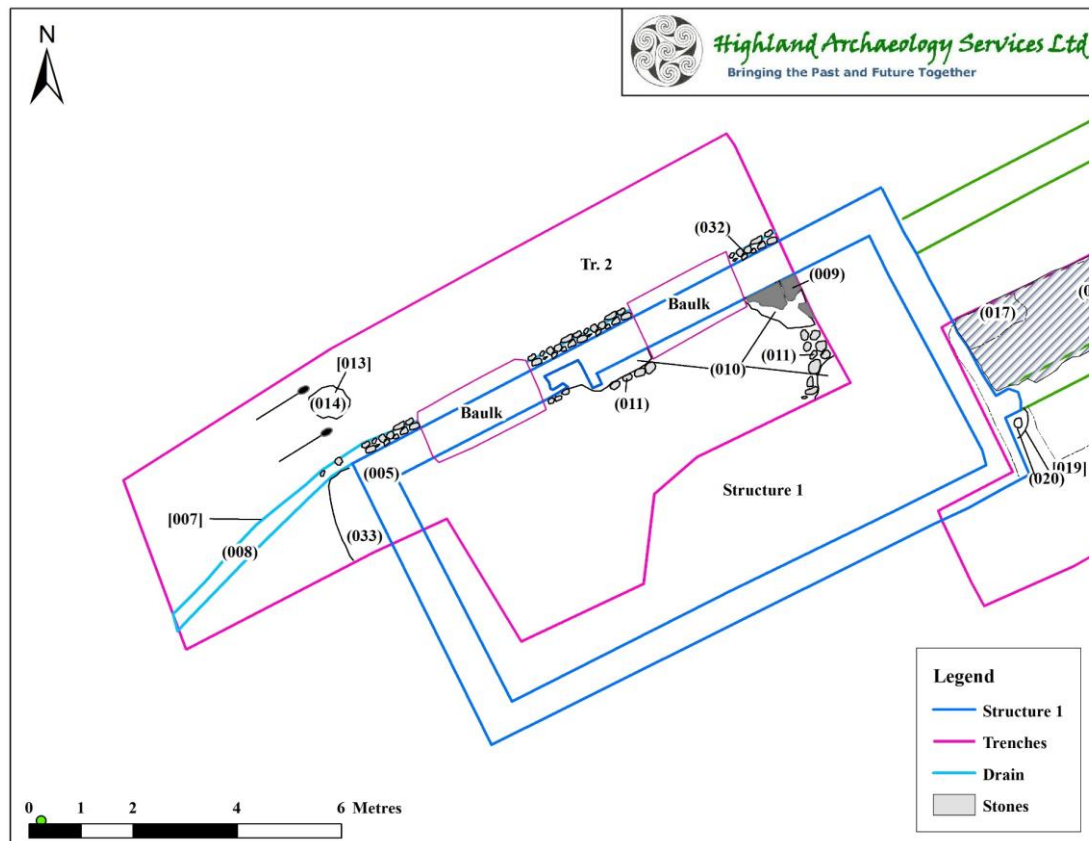
Figure 8: Structure 1

Trench 2 was opened over the north and west of Structure 1 (see Figure 8 above). This was a stone built structure comprising a mix of square stones laid in courses, large rounded boulders, which were mostly at the foundation level or at the corner of the structure and some smaller stones which acted as an infill (005) (see Figure 9 below). The stones were tightly packed but did not appear to be mortared or clay-bonded. There were some small areas of pointing on the outside of this structure which was a pale yellow colour with small gravel inclusions (see Figure 10 below). The wall survived around a metre high and was 0.6m wide. The even height of survival suggests that the building was deliberately demolished and left at this height.

Running along the north edge of the structure's wall ran a drain [007] (see Figure 8 above) which continued south west towards the well within the garden of the structure. The ditch was filled with a dark brown soil with frequent large stones (008) through the garden area, and was densely packed with stones that were heaped against the wall where it ran along the side of the structure (032) (see Figure 9 and 10 below). It contained some voids and water was accruing within the ditch.

A little to the north of the corner of the structure was a posthole [013] this contained a grey-brown clay soil and still contained the post (014) (see Figure 8 above). This was the cut and posthole for a fence marked on the historic mapping (see Figure 4 and 5). To the west of this the subsoil sloped down to create an area with deeper topsoil, which had been within an enclosed area to the side of the building. On the ground against the west gable of the building a dark brown, dense soil had accumulated prior to the demolition of the building (033).

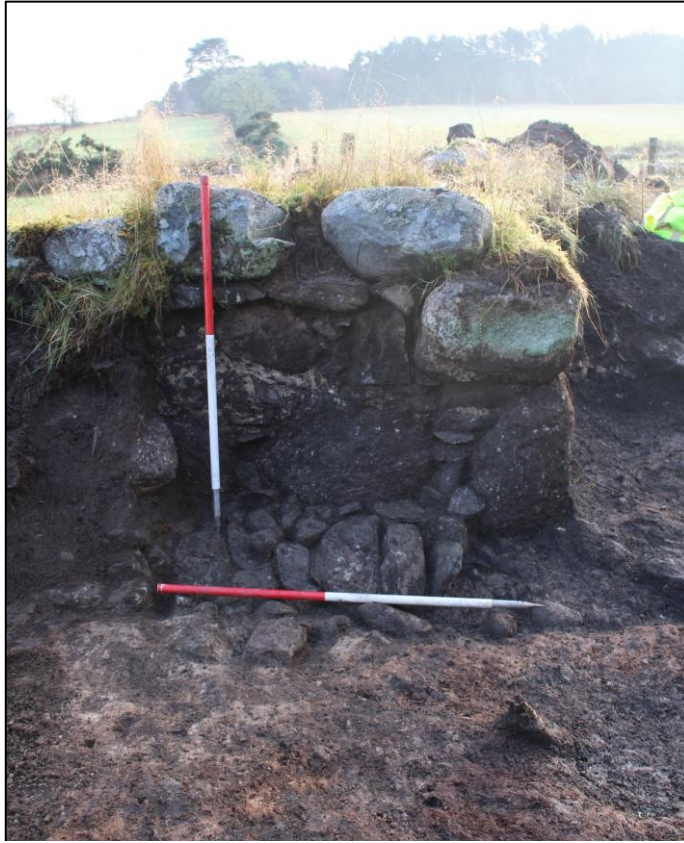
**Figure 9: North facing elevation of western external corner of structure 1**

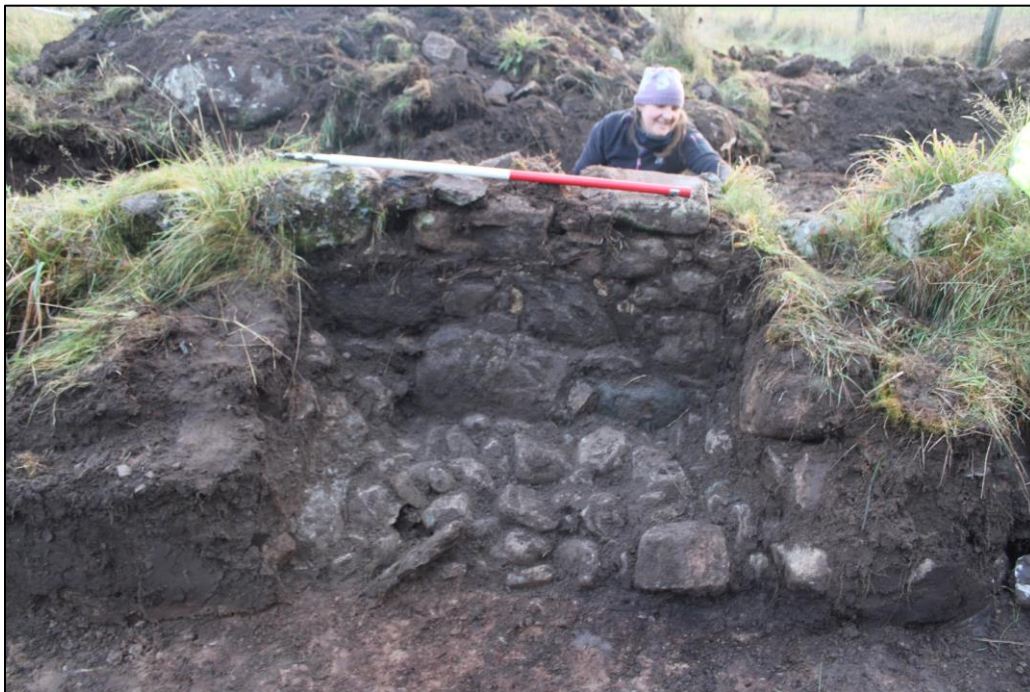
**Figure 10: North facing elevation of central part of external wall, structure 1**

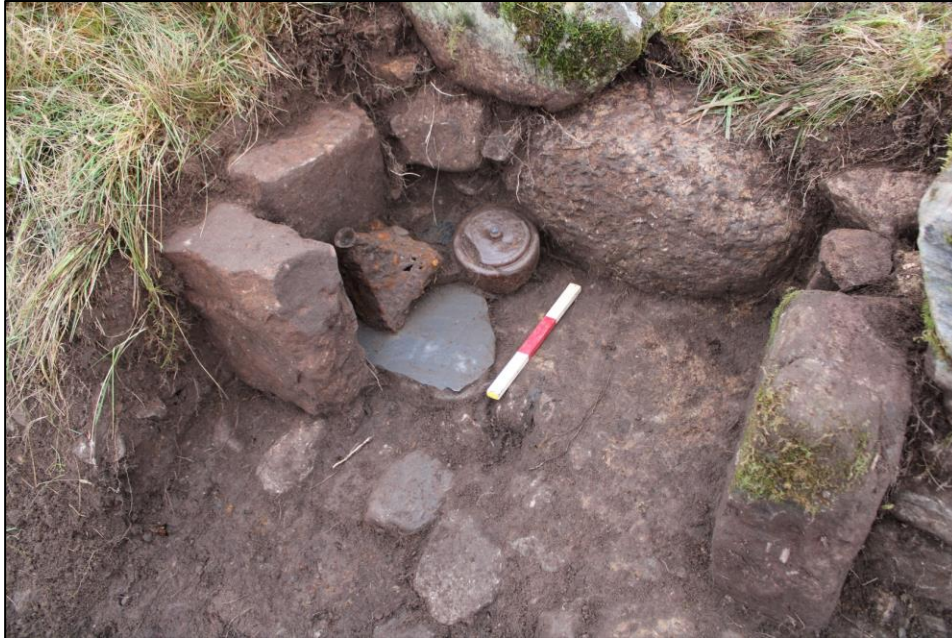
On the inside of the structure, in the centre of the northern most wall a pantry was built within the wall this contained the remains of a 20<sup>th</sup> century lamp with pyramid-form metal base and an amber-coloured glass shade with honeycomb pattern (see Figure 11 below). Fragments of a glass bottle and a copper-alloy switch casing were found inside the glass lampshade. The floor of the pantry comprised a yellowy-grey clay (010) with a slate on top, indicating that slates may have been used as the floor of the cupboard.

**Figure 11: Photo 5039, facing north showing pantry with lampshade and base with 30cm scale**

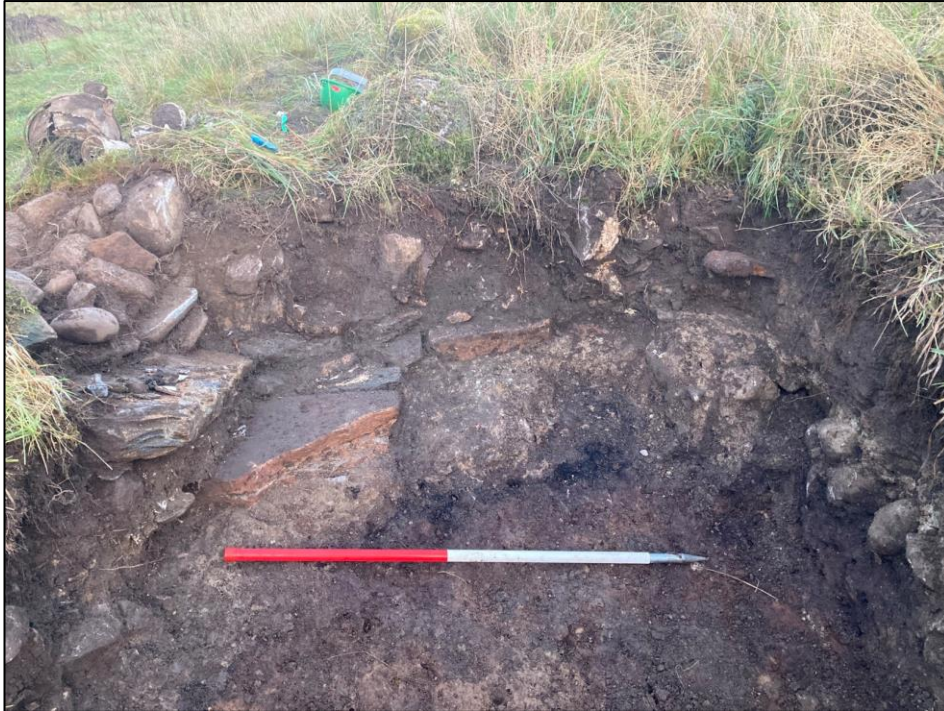
The floor across the rest of the structure had largely been destroyed, probably during demolition. However, towards the east end of the trench a small number of flagstones (009) were uncovered (see Figure 12 below), some of which were quite square and sat nicely against each other with little in the way of gaps. This sat on top of the clay layer (010) which was a pale yellow-grey clay and was reasonably compact and not very deep. Beneath (010) a layer of rounded stones (011) was revealed, with stones 10-20cm in diameter. The stones appeared to have been placed directly onto an old topsoil layer of black brown soil (034). (034) say directly on to the natural (002). The floor within the building was notably higher than the outside ground level, which was likely due to the need to keep water out of the building.

**Figure 12: Inside structure 1 with remains of floor, facing east, 1m scale**

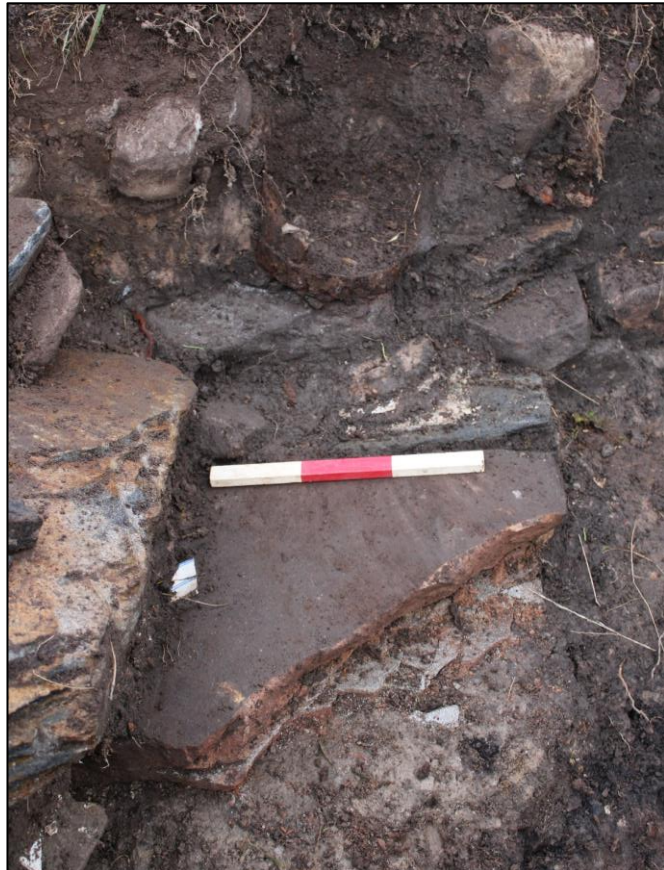
A brown and yellow clay soil layer (012) was uncovered overlying the flagstones in Structure 1. This was interpreted as the initial abandonment layer overlying the floor layer. This contained artefacts such as pottery and a metal bucket (see Figure 13).

**Figure 13: pottery and metal above flagstones in (012)**

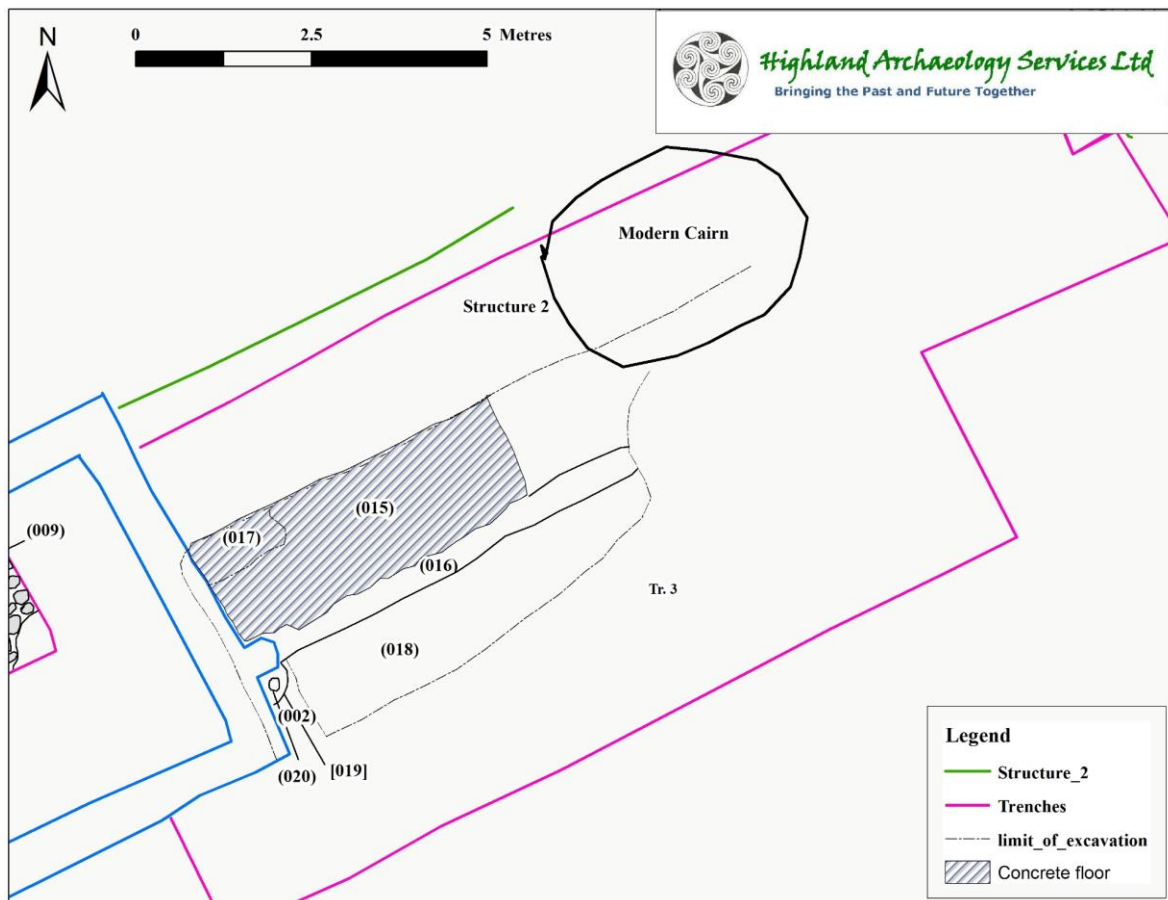
Figure 14: Trench 3, Structure 2

Trench 3 was opened over the south west side of structure 2 and the corner of structure 1 (see Figure 14 above). Structure 2 was a stone-built structure which like structure 1 was comprised of large rounded stones and some smaller stones. In the south west of the structure a layer of orangey yellow concrete (015) (see Figure 15 below) with frequent pebble inclusions was uncovered. This was very degraded and uneven and appears to have sunken or collapsed with the underlying floor. The eastern edge of the concrete layer was very straight. A thin layer of mottled clay survived in parts (021) on top of the concrete (015). This was mostly grey but with dark purplish staining as well as yellows and pinks. It also contained many small fragments of coal and a piece of textile (find no. 2) was found within this layer. Beneath the concrete was a layer of stones (016) with a facing on the south side forming the edge of the structure described as a structure 2. (016) had smaller tightly packed stones on the inside underlaying the concrete (015).

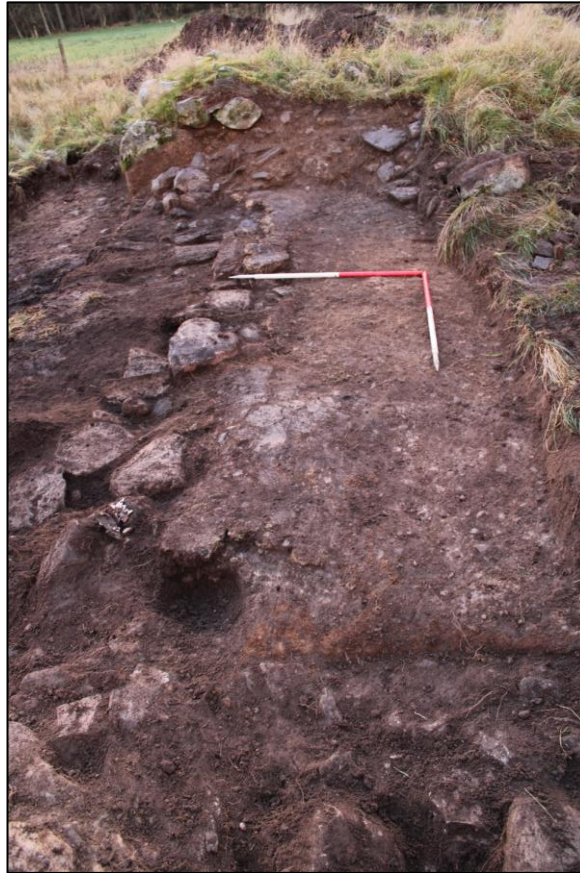
**Figure 15: Photo 5021, Concrete layer (015) facing W, 1m scales**

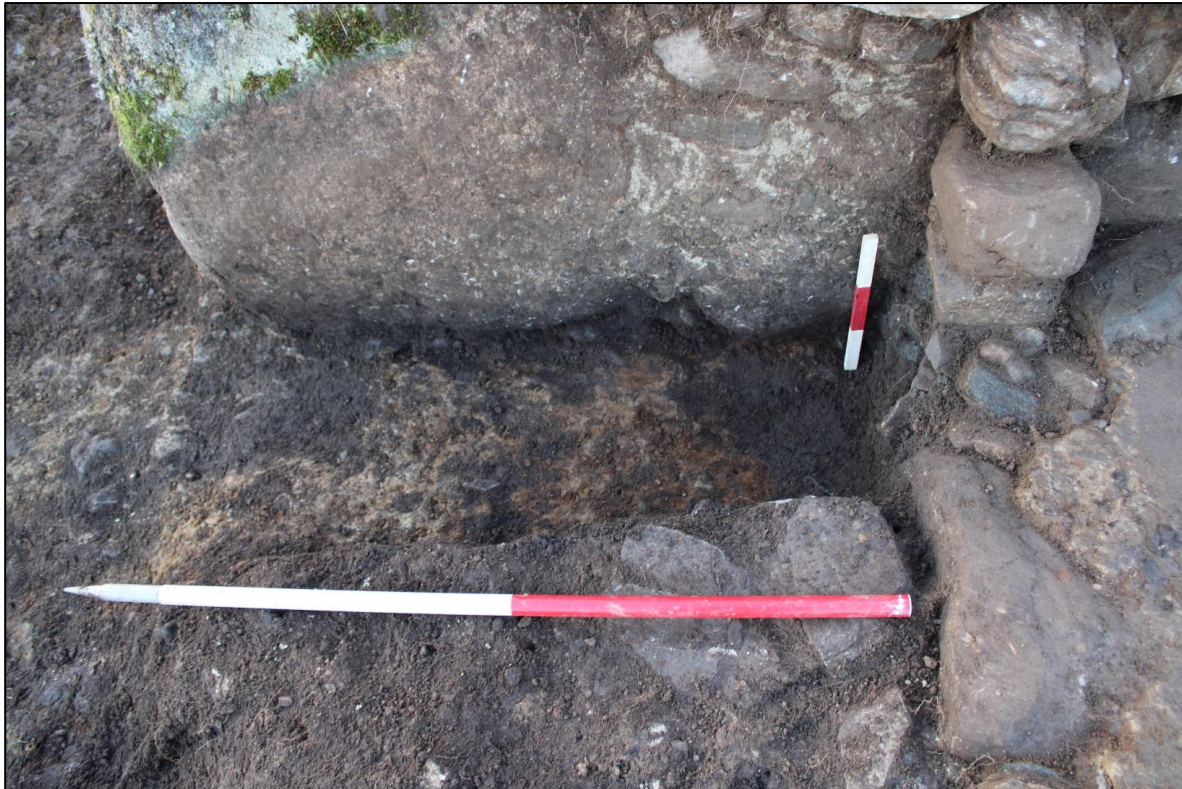
A slot was excavated to establish the relationship between structures 1 and 2 (see Figure 16, Figure 17 and Figure 18 below). This established that adjacent to the concrete was a layer of orangey brown gravelly soil (017), this was fairly compact and contained medium sized angular stones and appears to be collapse from structure 1. (017) also contained some metal items including lamp fragments. A layer of brown homogenous soil containing large stones (018), was similar to the topsoil but lay beneath the collapse layer (017). Within the slot was a posthole [019], this was situated between the edge of structure 1 and 2 and circular in plan. The fill (020) was mainly dark brown but had a charred circle signifying the location of circular post, which had probably been charred to preserve it. The posthole was approximately 15cm in diameter and was around 4cm from each structure.

The wall (016) just to the north west of post [019] forming the faced of structure 2 was found to be built into wall (005) of structure 1 showing they were contemporary (see Figure 16).

Figure 16: Photo 5026, facing West showing slot outside structure 1 within structure 2, 1m and 30cm scales

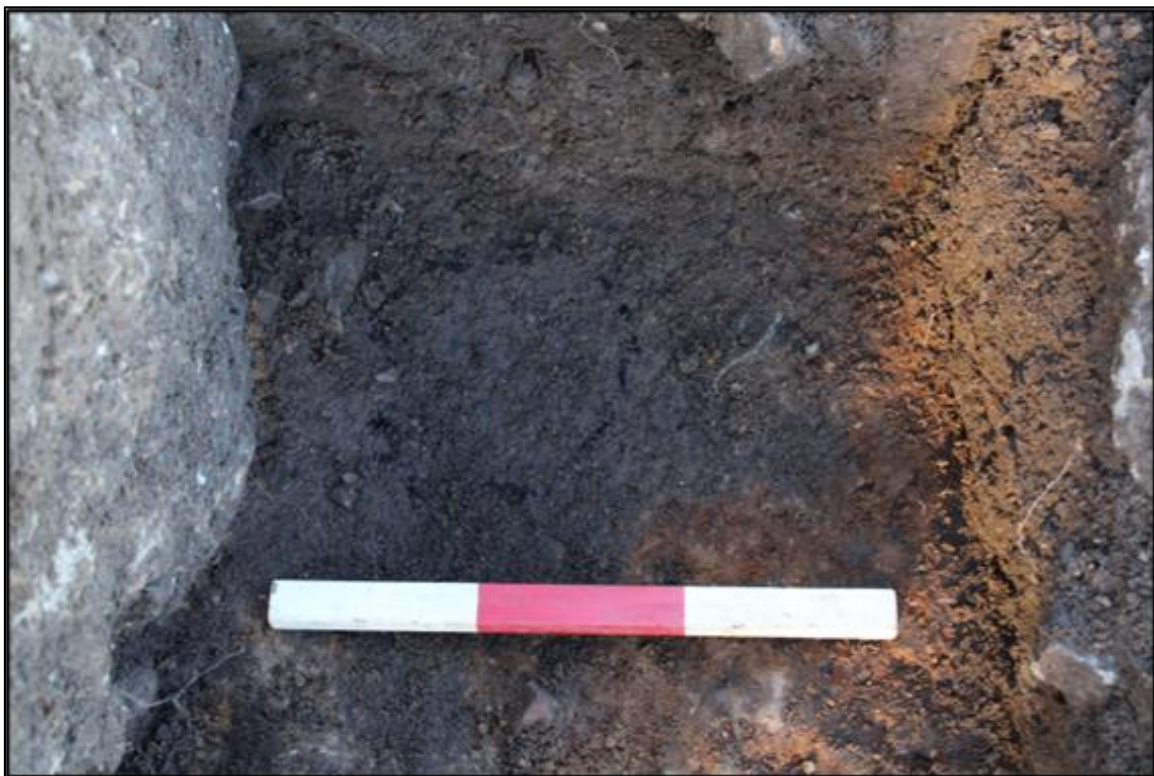
Figure 17: Photo 5032, showing posthole [019], 30cm scale

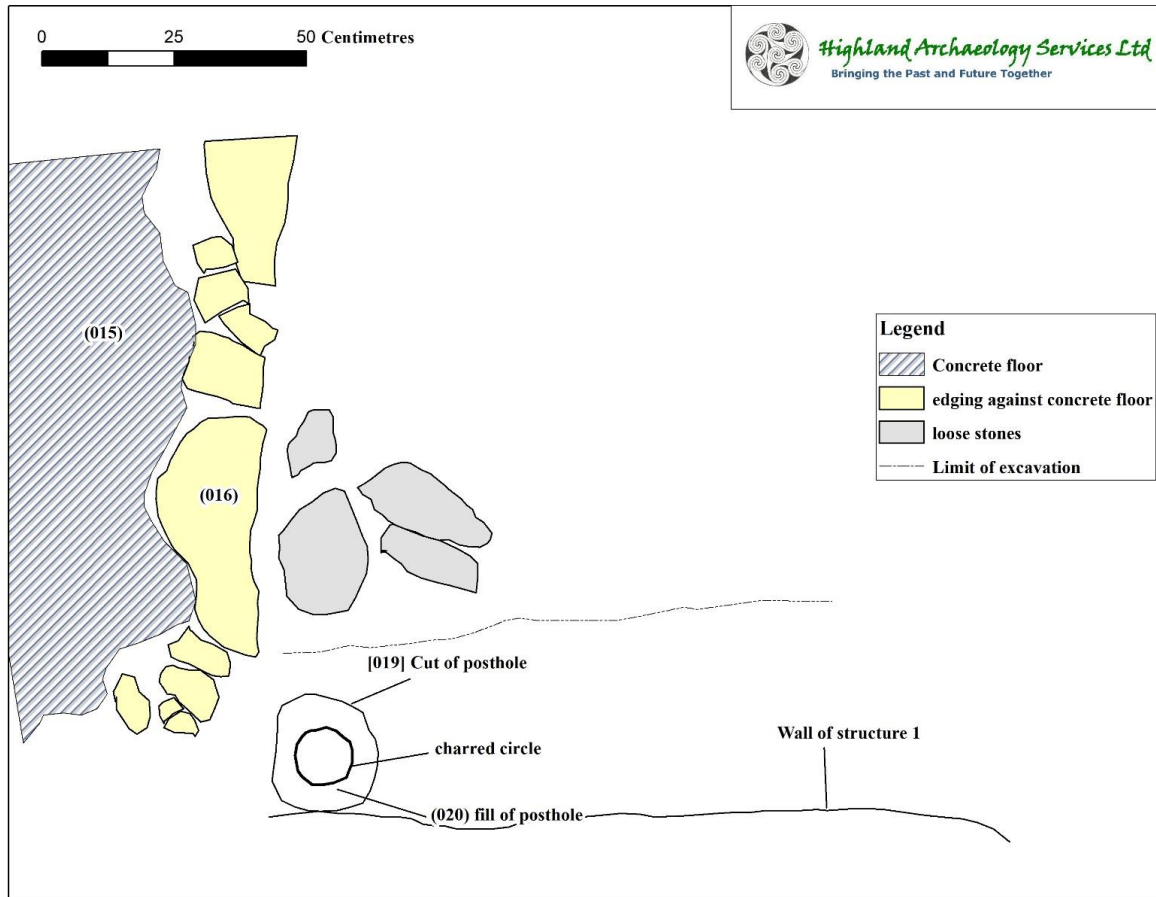
Figure 18: Plan of slot within structure 2, showing posthole

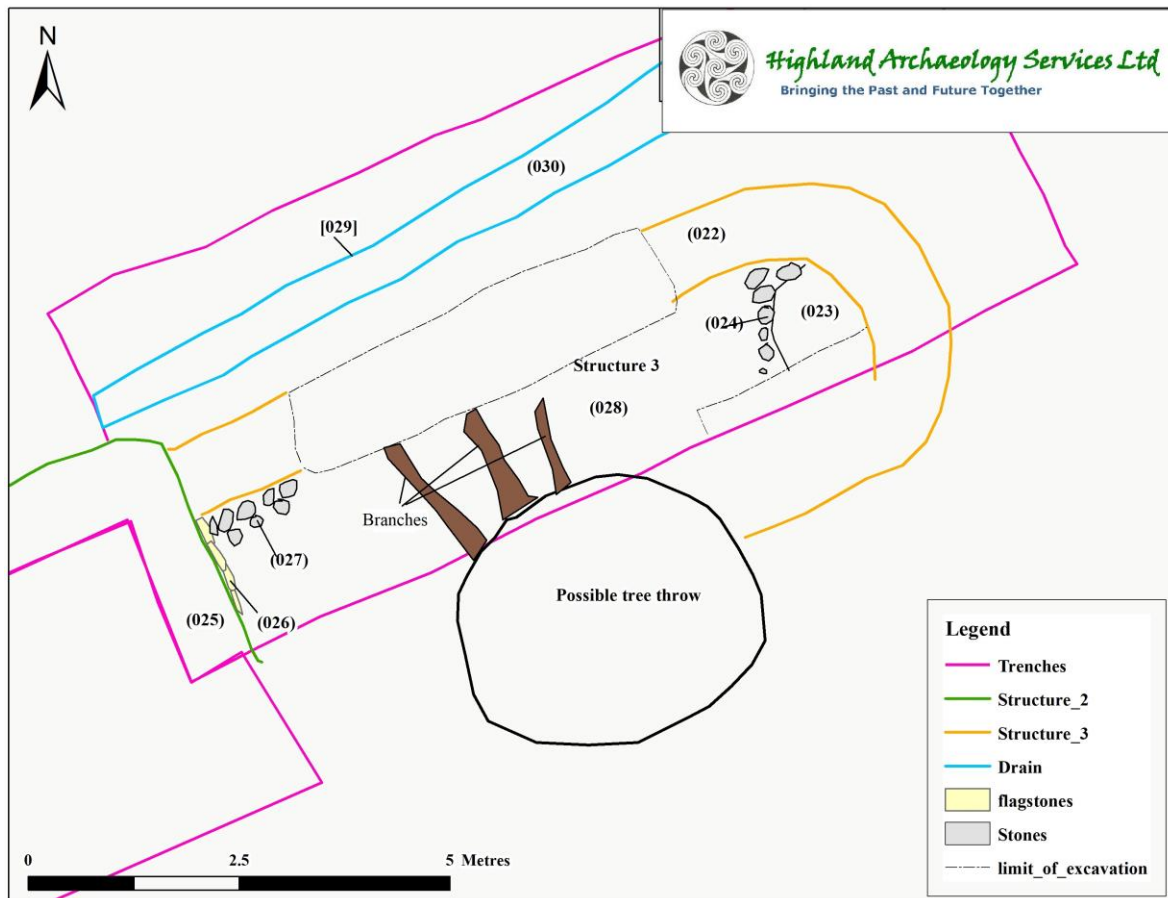
Figure 19: Trench 4 Plan

Trench 4 was opened up over the north eastern side of Structure 3 and the corner of structure 2 (see Figure 19 above). This trench sought to establish the nature of Structure 3 as well as the relationship between structures 2 and 3. The wall of structure 3 (022) abutted Structure 2 (025) however these stones were smaller than those in the rest of the structure and may have been the result of reconstruction at a later date (see Figure 20 below).

Visible within structure 3 at the eastern end of structure 2 was a foundation layer of flat stones (026) underlying the larger stones making up the gable of structure 2 (025) (see Figure 19 above). A number of large rounded stones as well as smaller angular stones were exposed on the eastern gable of structure 2 (025) which sat partly on (026) and partly onto the natural.

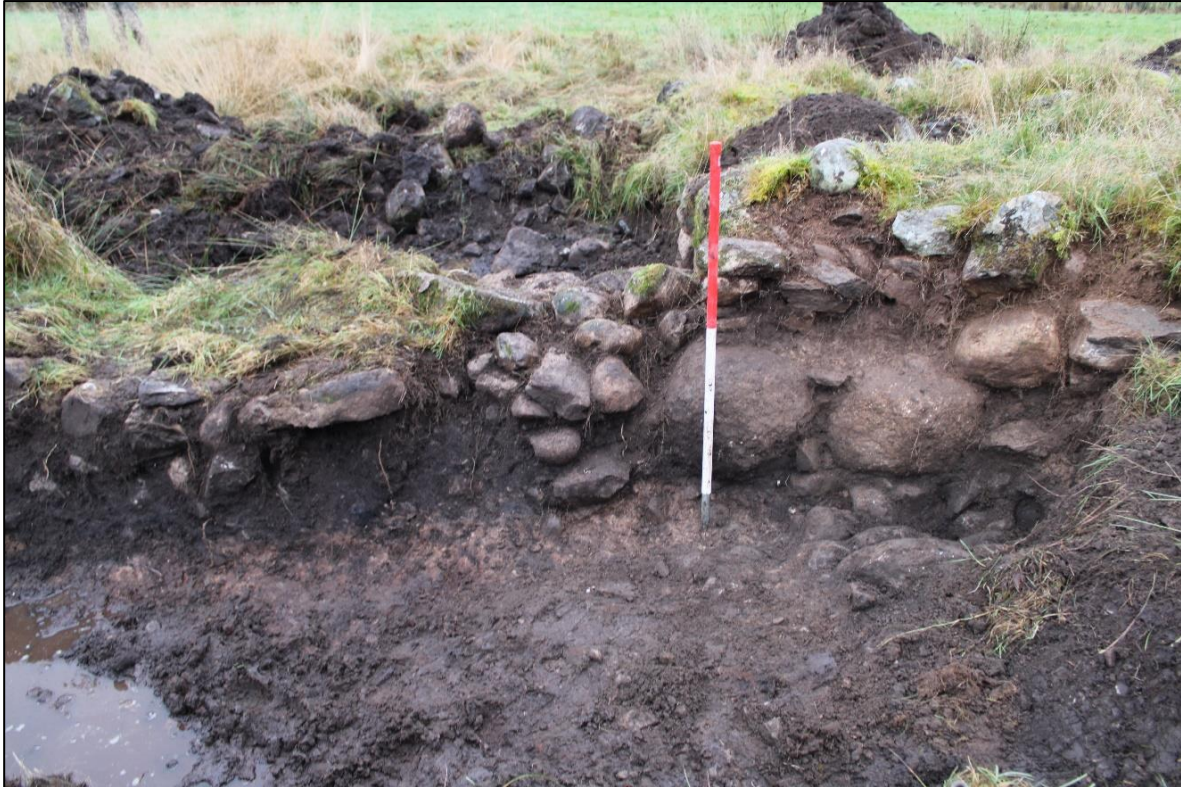
**Figure 20: Photo 5003, facing S, showing join between structures 2 (left) and 3 (right), 1m scale**

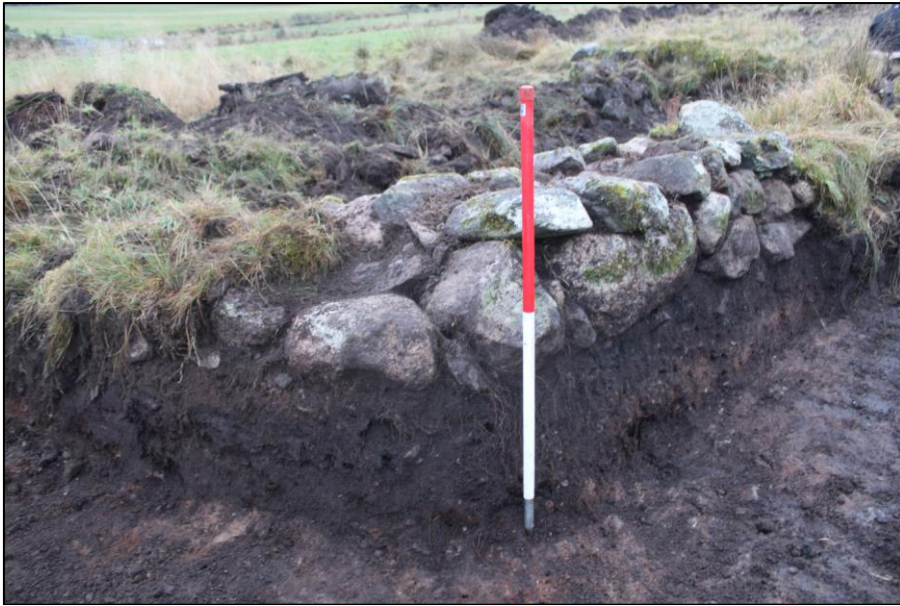
Structure 3 was found to comprised drystone walls (022), sturdily constructed with a mixture of rounded boulders and angled stones and built directly onto the topsoil (see Figure 21 and Figure 22 below). The wall may at some time have been reconstructed where it joins with structure 2. Within structure 3, at the eastern end, an orange clay packed around smallish angular stones (023) was uncovered. Beneath this were larger rounded stones (024), these appeared to form the foundation layer for the floor. A similar jumble of stones (027) was uncovered adjacent to the structure 2 wall, within structure 3 and this is likely to be the same as (024).

Figure 21: Photo 4988, facing SW, showing curved wall of eastern end of structure 3, 1m scale

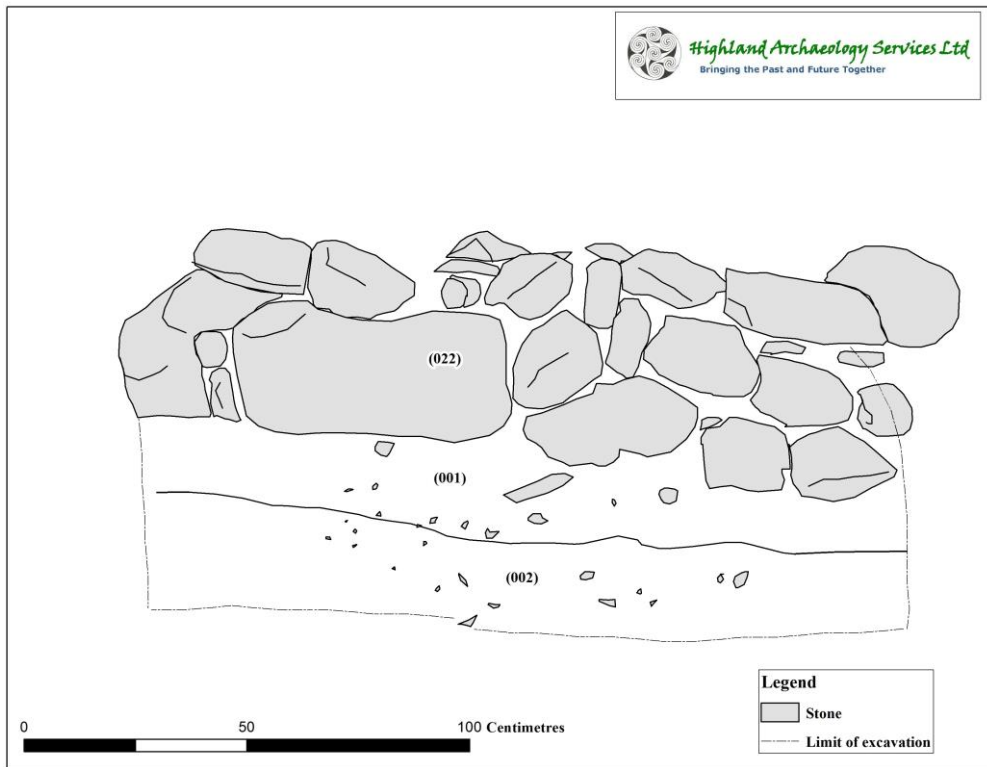
Figure 22: South facing section of east end of structure 3

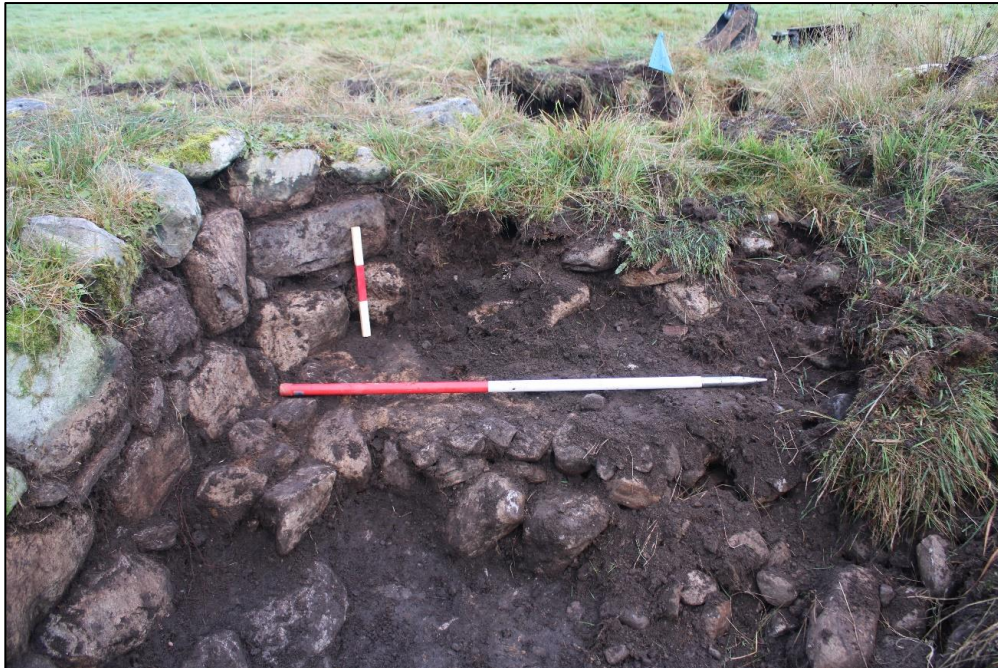
**Figure 23: Photo 4965, facing E, showing clay flooring and curved wall at east end of structure 3, 1m and 30cm scales**

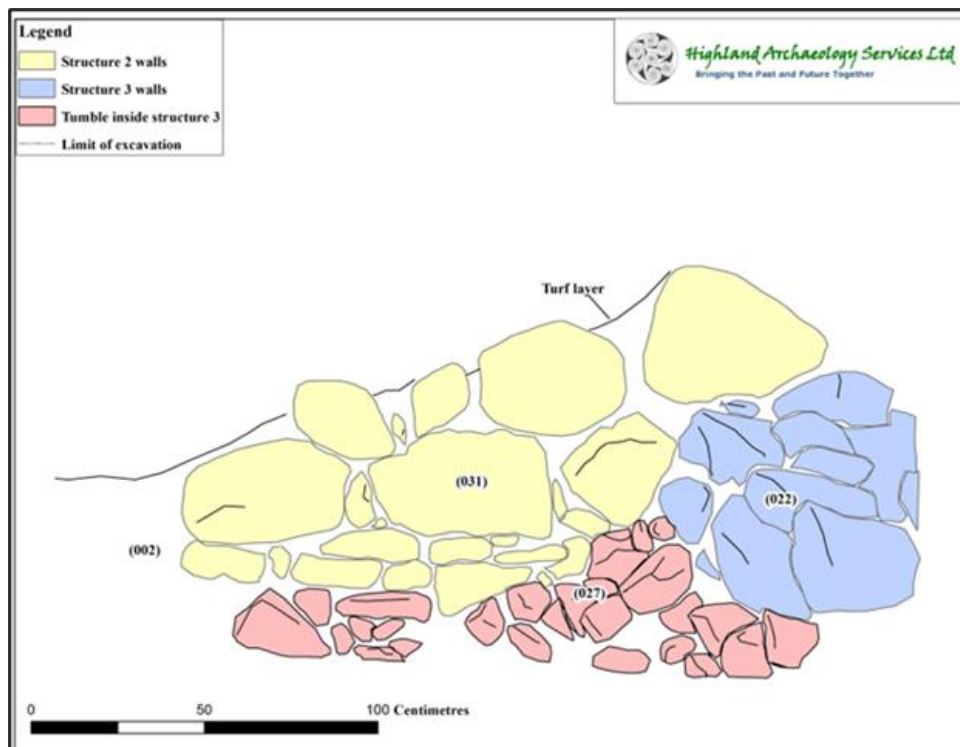
**Figure 24: Inside structure 3 showing jumble of stones (027) next to structure 2**

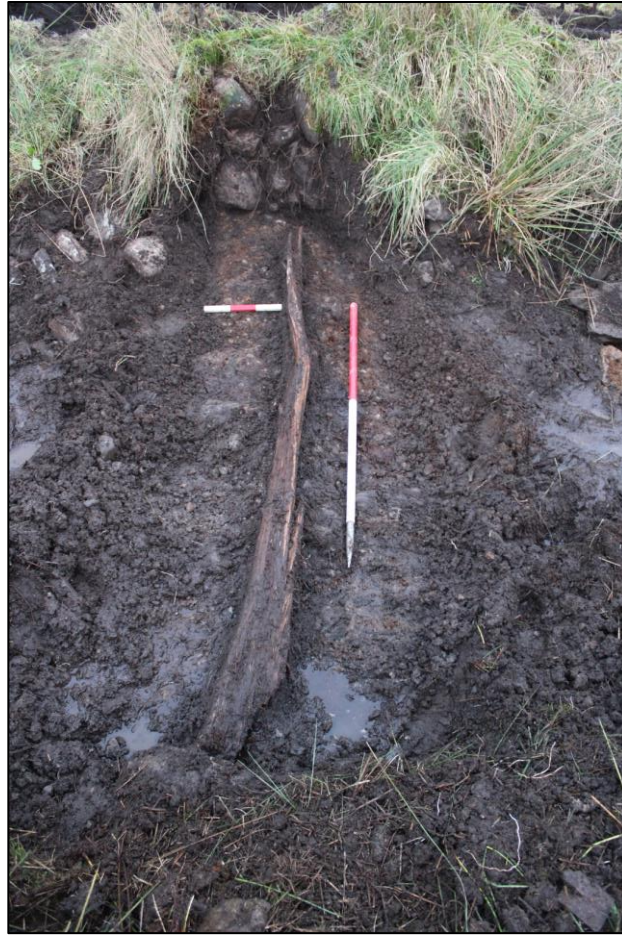
A clay rich dark brown soil (028) underlay (024), this directly over the natural subsoil and contained large pieces of wood, which were possibly roots or dumped branches (see Figure 25 below).

**Figure 25: Possible tree branch across structure 3, facing South, 1m and 30cm scales**

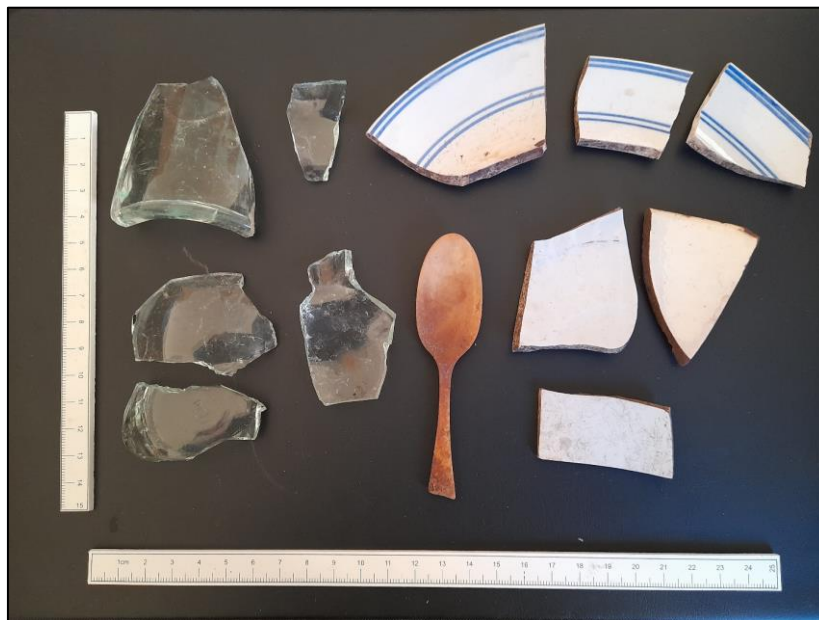
**Figure 29: Find No. 1: Selection of glass, ceramic and spoon**

A selection of ceramic, glass and a horn/bone spoon (see Figure 29 above) were retained as Find Number 1 from (012) overlying the flagstones in Structure 1. These all appear to be of a fairly modern date, i.e. late nineteenth and early twentieth century. The spoon which is most likely made from horn was traditionally made by travellers within the Highlands and may be evidence of trade and contact with this community.
