Inverness Campus Phase 2

Historic Environment Desk Based Assessment

AOC Project Number 70802

April 2025

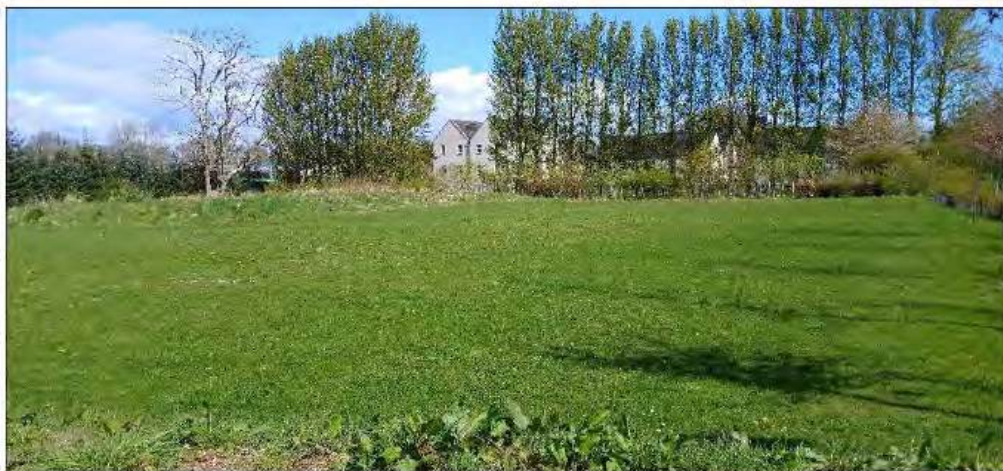
Plate 1: NNE facing view of Area 1

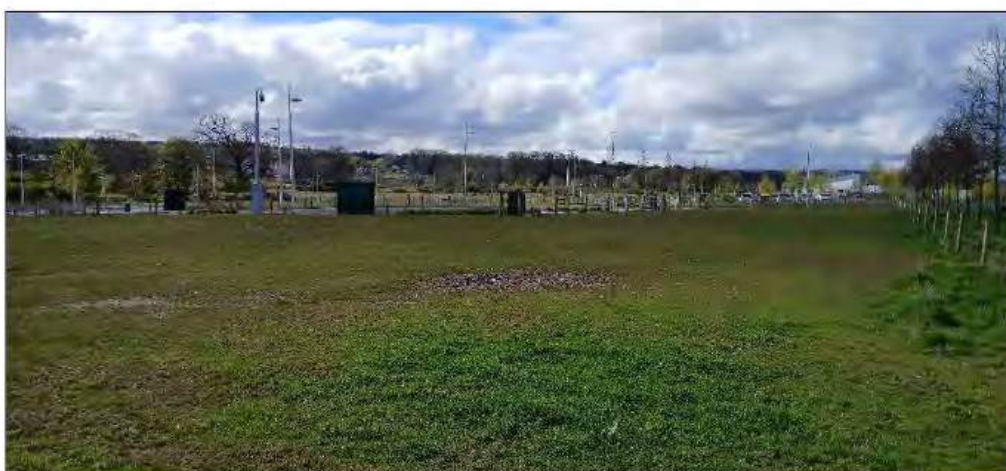
*Plate 9: SE facing view in Area 4 overlooking **Asset 16***

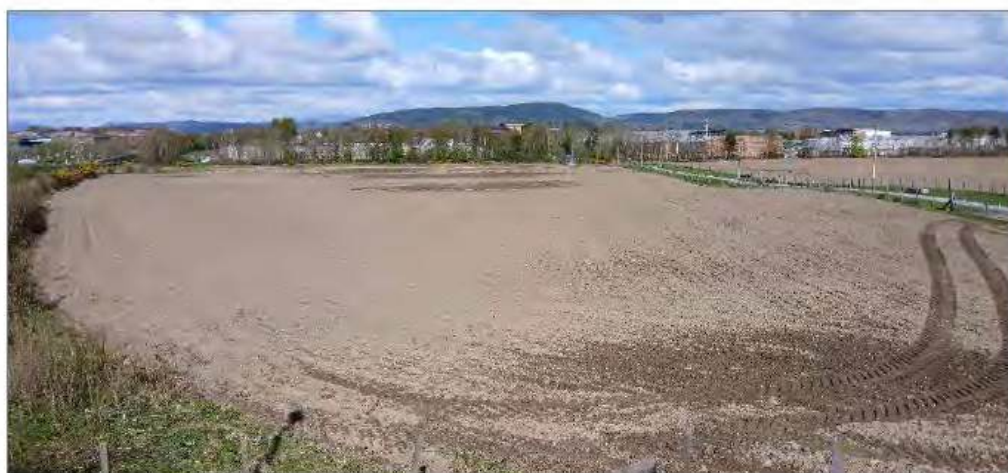
Plate 11: NW facing general view of field in Area 5

6.6 Area 5 comprised several fields on the north side of the railway line (**Plates 11-13**). These were all ploughed fields with no upstanding remains visible. The location of the Scheduled Monument was visited and found to have no visible surface remains (**Plate 14**). Likewise, no remains were visible at the locations of possible features identified on aerial/LiDAR imagery.

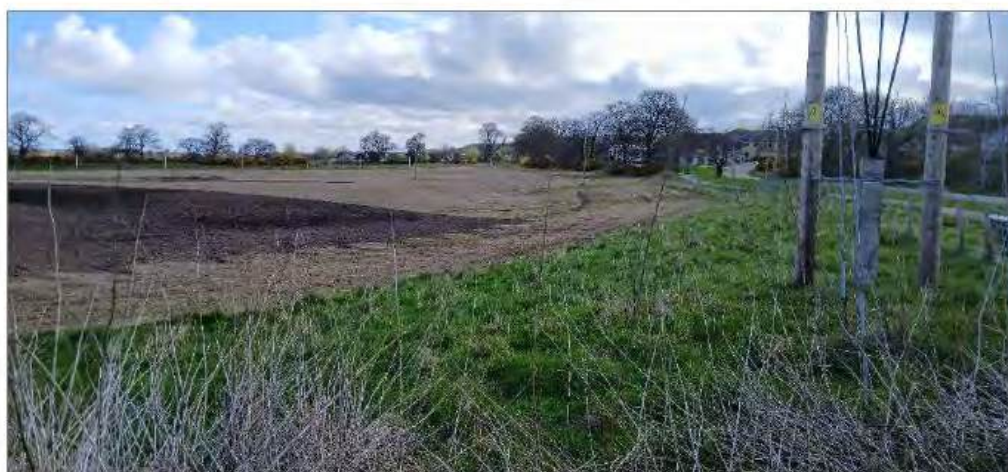
Plate 12: NE facing general view of field in Area 5

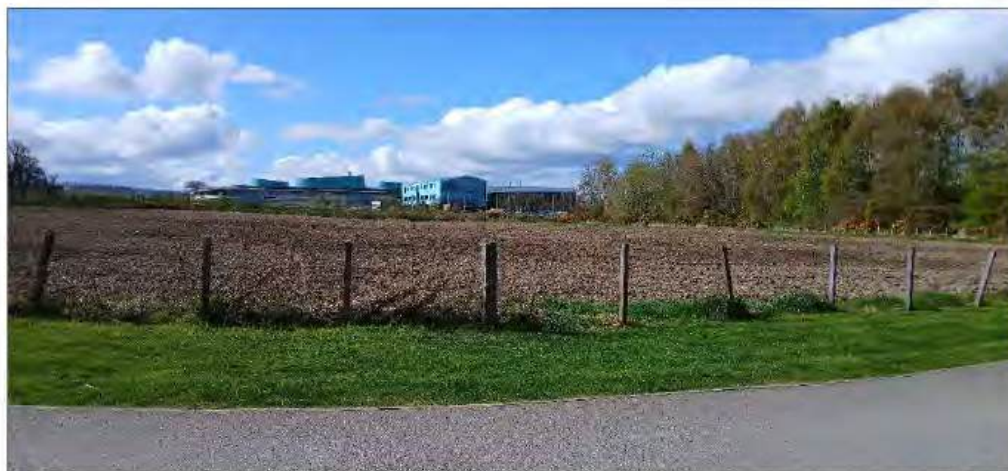
Plate 13: SW facing general view of field in Area 5

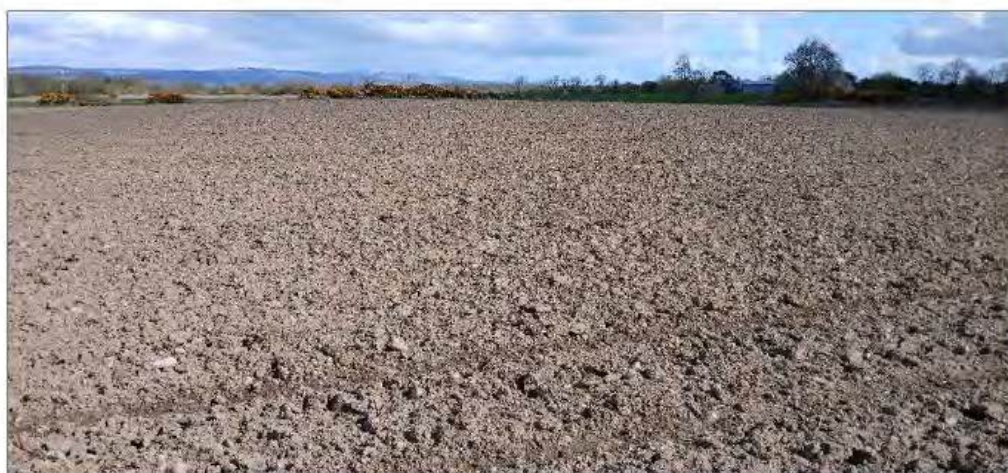
Plate 14: North facing view of location of Ashton Cottages ring ditch and pits Scheduled Monument (Asset 1)

- 5.1.6 The Scheduled Monument (**Asset 1**) in Area 5 comprises the unexcavated remains of a ring ditch and three pit circles to the west southwest of Ashton Farm Cottages (**Asset 34**) visible on aerial photography. The Scheduled Monument comprises two discrete areas (**Figure 2**), one circular on plan and the other rectangular, to include the remains described above and an area around it in which related material may be expected to be found. The presence of a double line of pits on one of the circles suggests there may have been more than one phase of building. As such, the monument may provide information on the duration of use of prehistoric settlement. The combined evidence from an aerial imagery analysis and a geophysical survey carried out by AOC in 2018 (**Event 128**) indicates the probability of a prehistoric settlement, likely to be of Bronze Age (c. 2500 – c. 800 BC) or Iron Age (C. 800 BC – AD 300) date, within the Scheduled Monument boundary and the surrounding area. The monument appears to be a good example of an unenclosed settlement, similar in character to others found along the coast of the Moray Firth. As a group, these assets could help enhance our understanding of the utilisation of the prehistoric landscape. The geophysical survey and aerial imagery analysis (**Event 128**) recorded also recorded a probable further round house (**Asset 210**) and further pit features (**Assets 210 to 212**) in Area 5. These are likely of archaeological origin given similar features in the area (**Asset 1**), although this cannot be confirmed unless more intrusive archaeological works are undertaken.
