Highlands and Islands Enterprise

Inverness Campus Phase 2

EIA Volume 2: Main Report

EIA Technical Annex D: Cultural Heritage

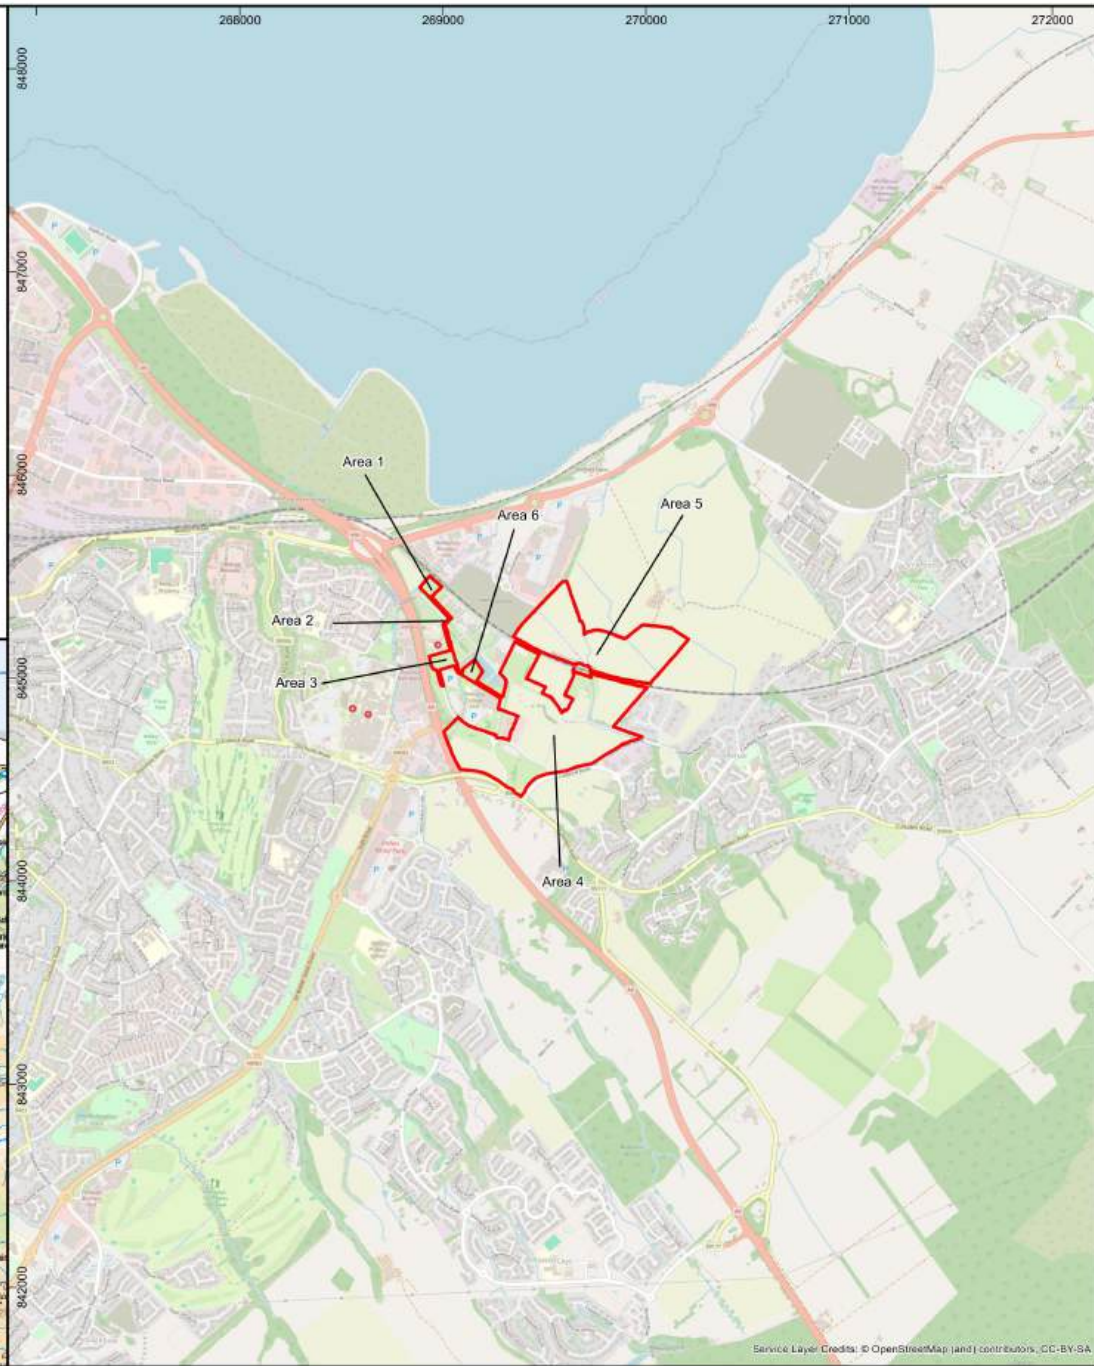
Figure 1

Site Location Plan

- 8.21 The Site (**Technical Annex D; Figure 1**), measures c. 56.5ha and it comprises six areas as well as routes between these areas. It is centred at NH 69507 44824 and is located across fields, car parks and roads within Inverness Campus to the south of the A96 and to the immediate north of the A9. Scretan Burn crosses Areas 4 and 5, and the Inverness-Perth Highland Railway line separates Areas 4 and 5.

- 2.1.1 The Site (**Figure 1**) measures c. 56.5ha and comprises six areas as well as routes between these areas. It is centred at NH 69507 44824 and is located across fields, car parks and roads within Inverness Campus to the south of the A96 and to the immediate north of the A9. Scretan Burn crosses Areas 4 and 5, and the Inverness-Perth Highland Railway line separates Areas 4 and 5.

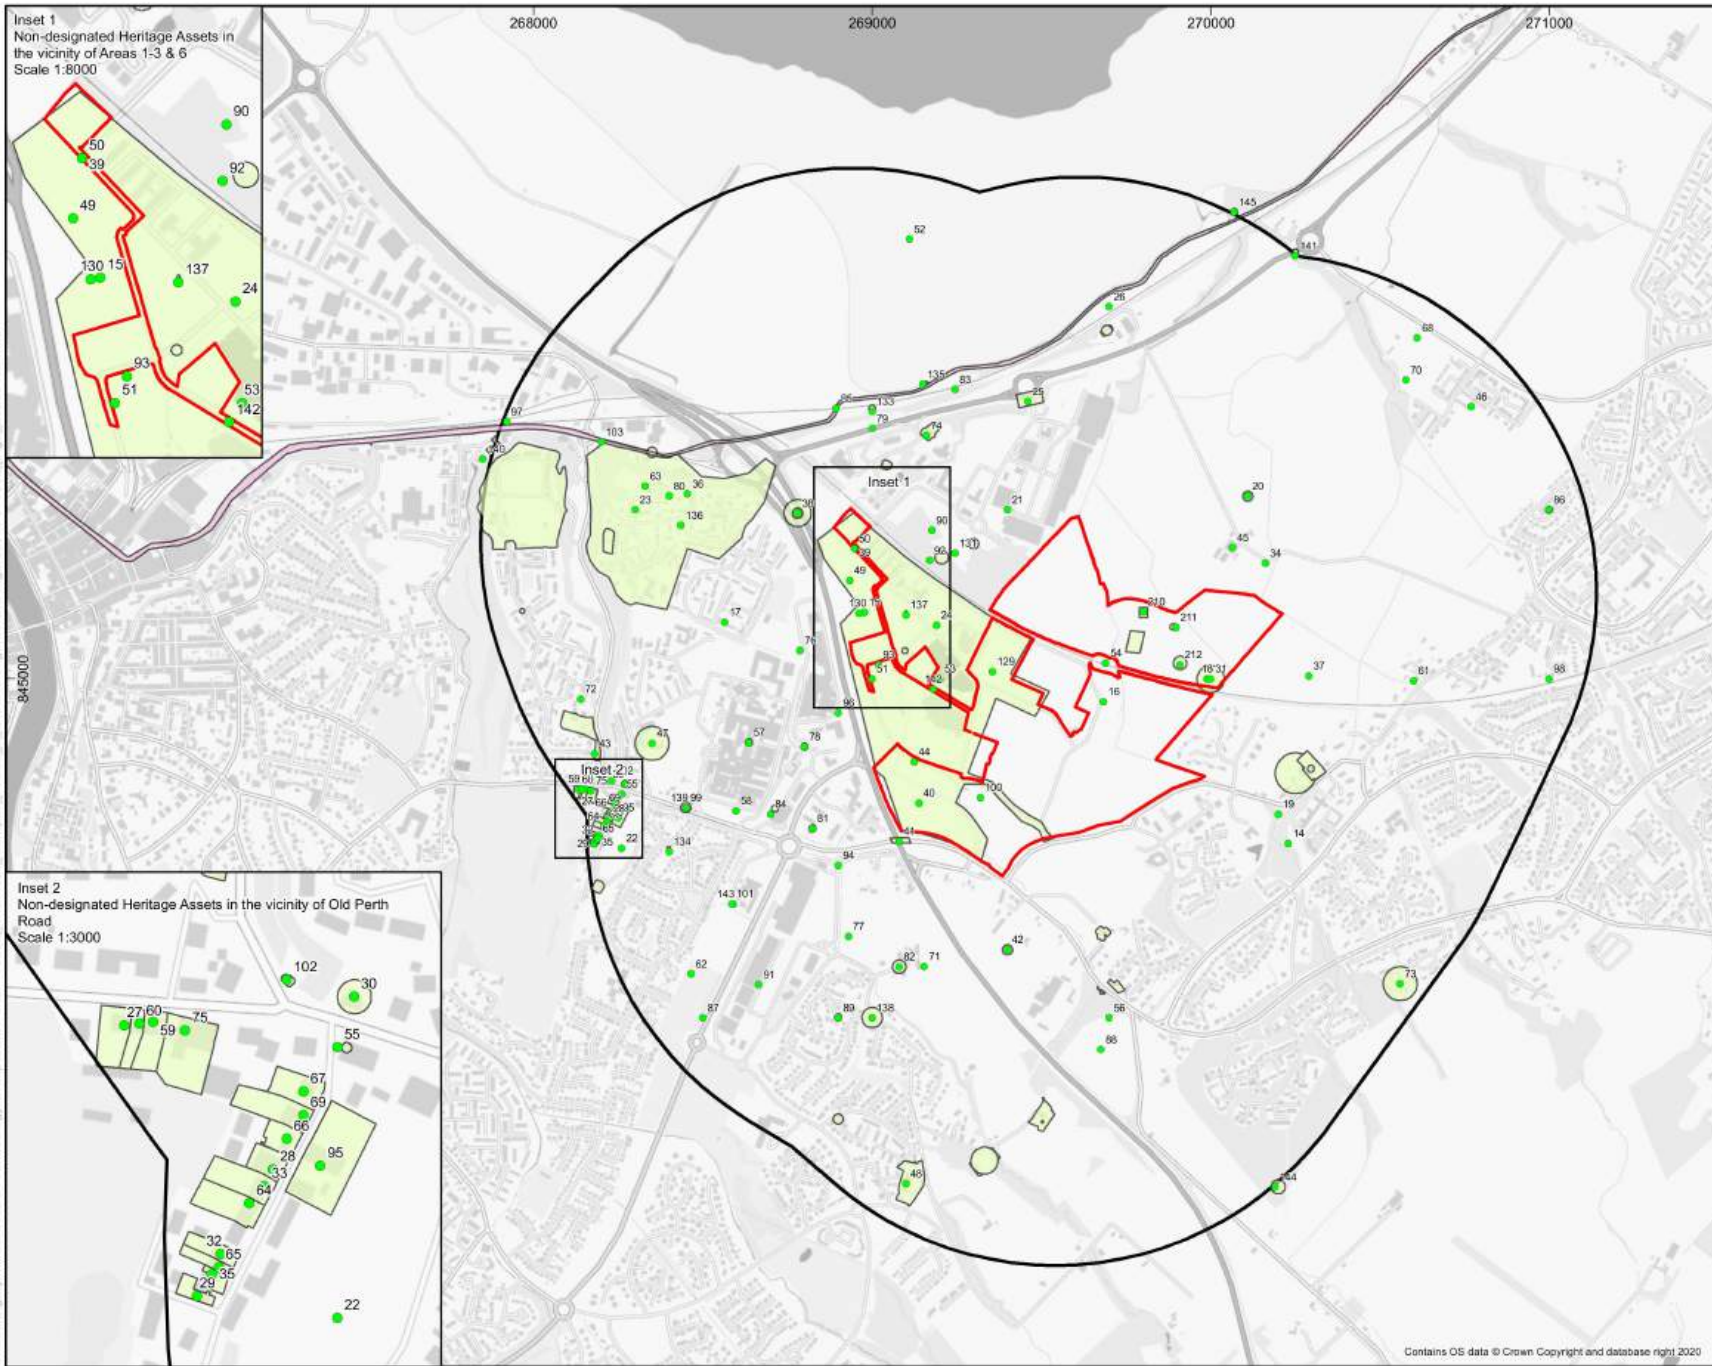
Figure 3

Non-designated Heritage Assets within 1km of the Site

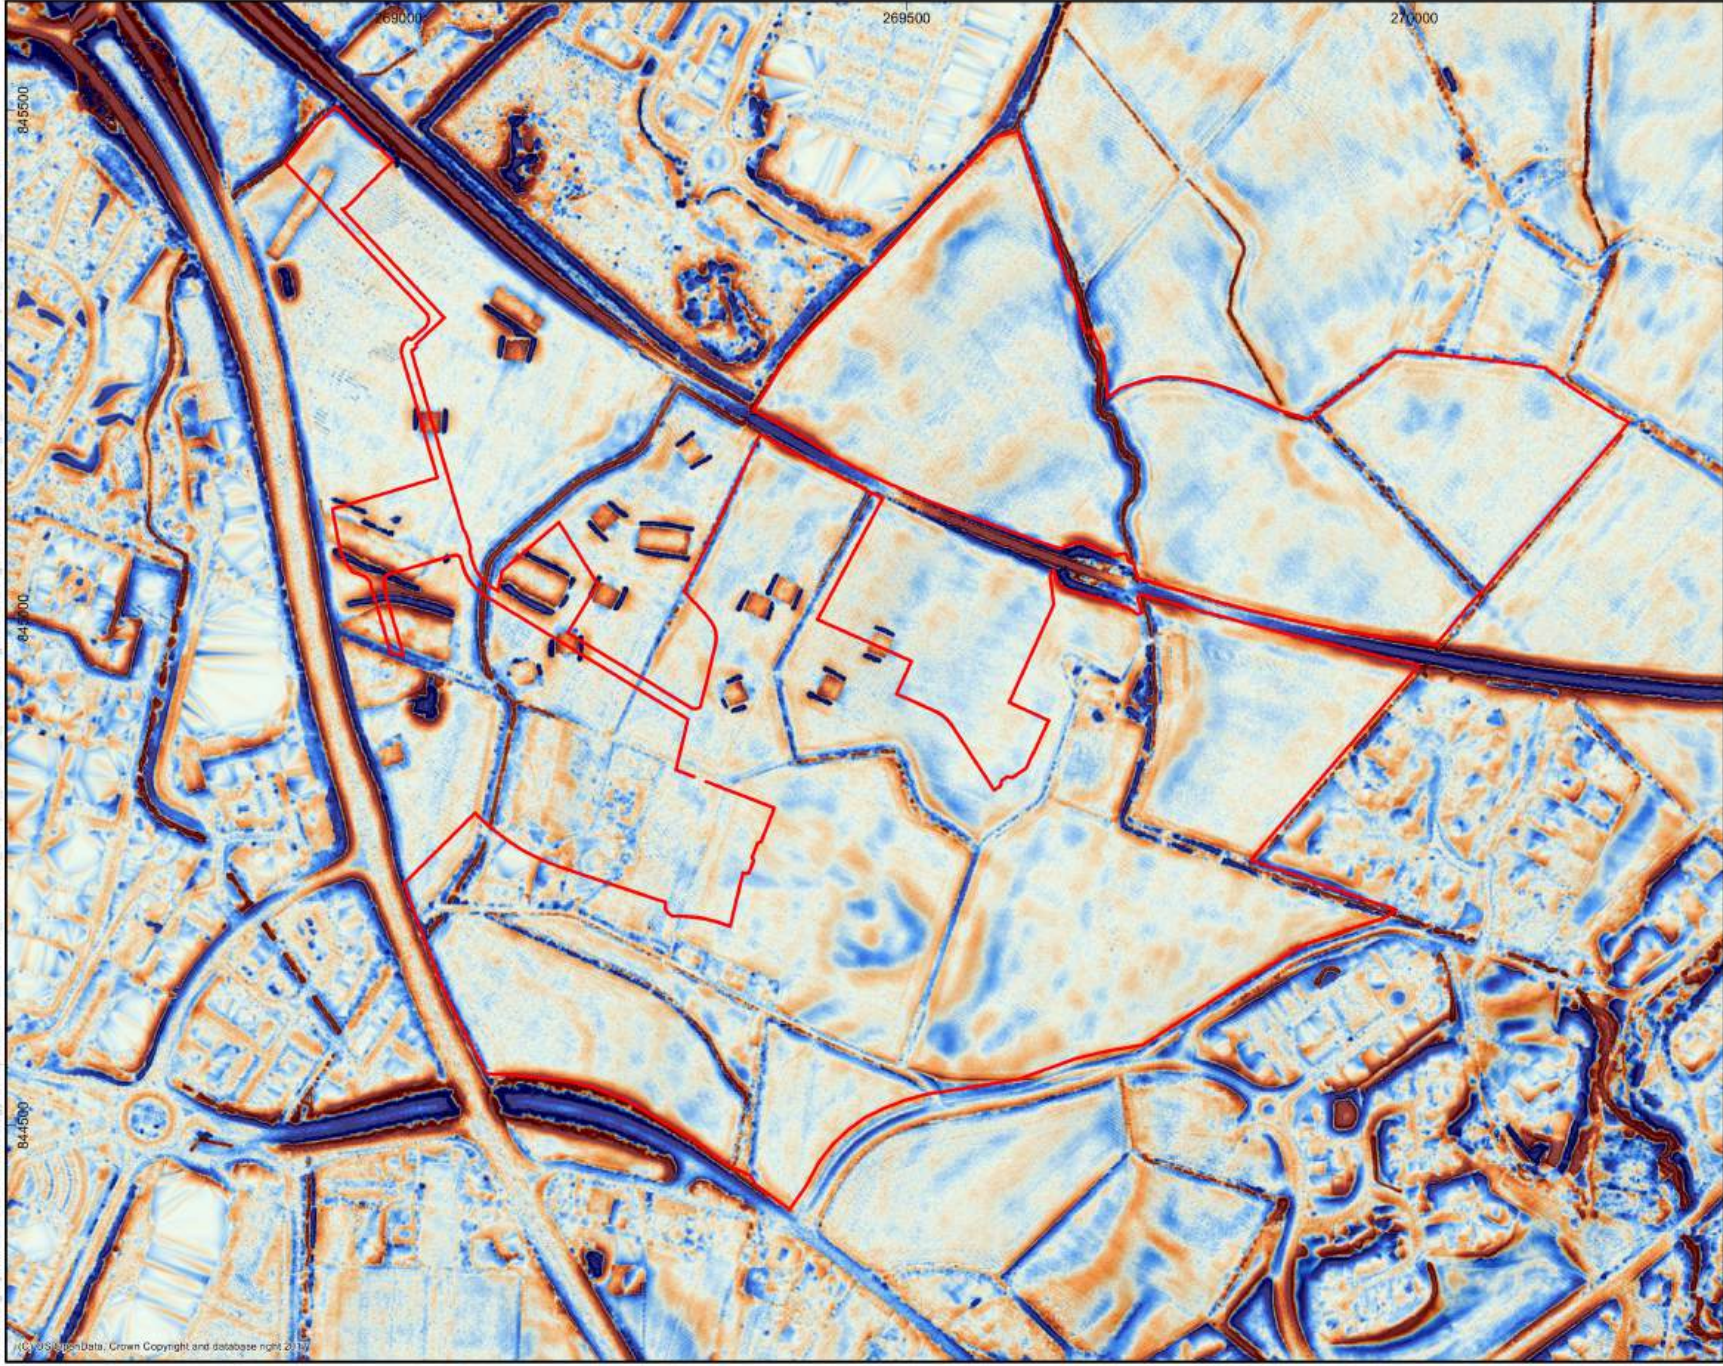
Figure 11

LiDAR
Simple Local Relief Model (SLRM)

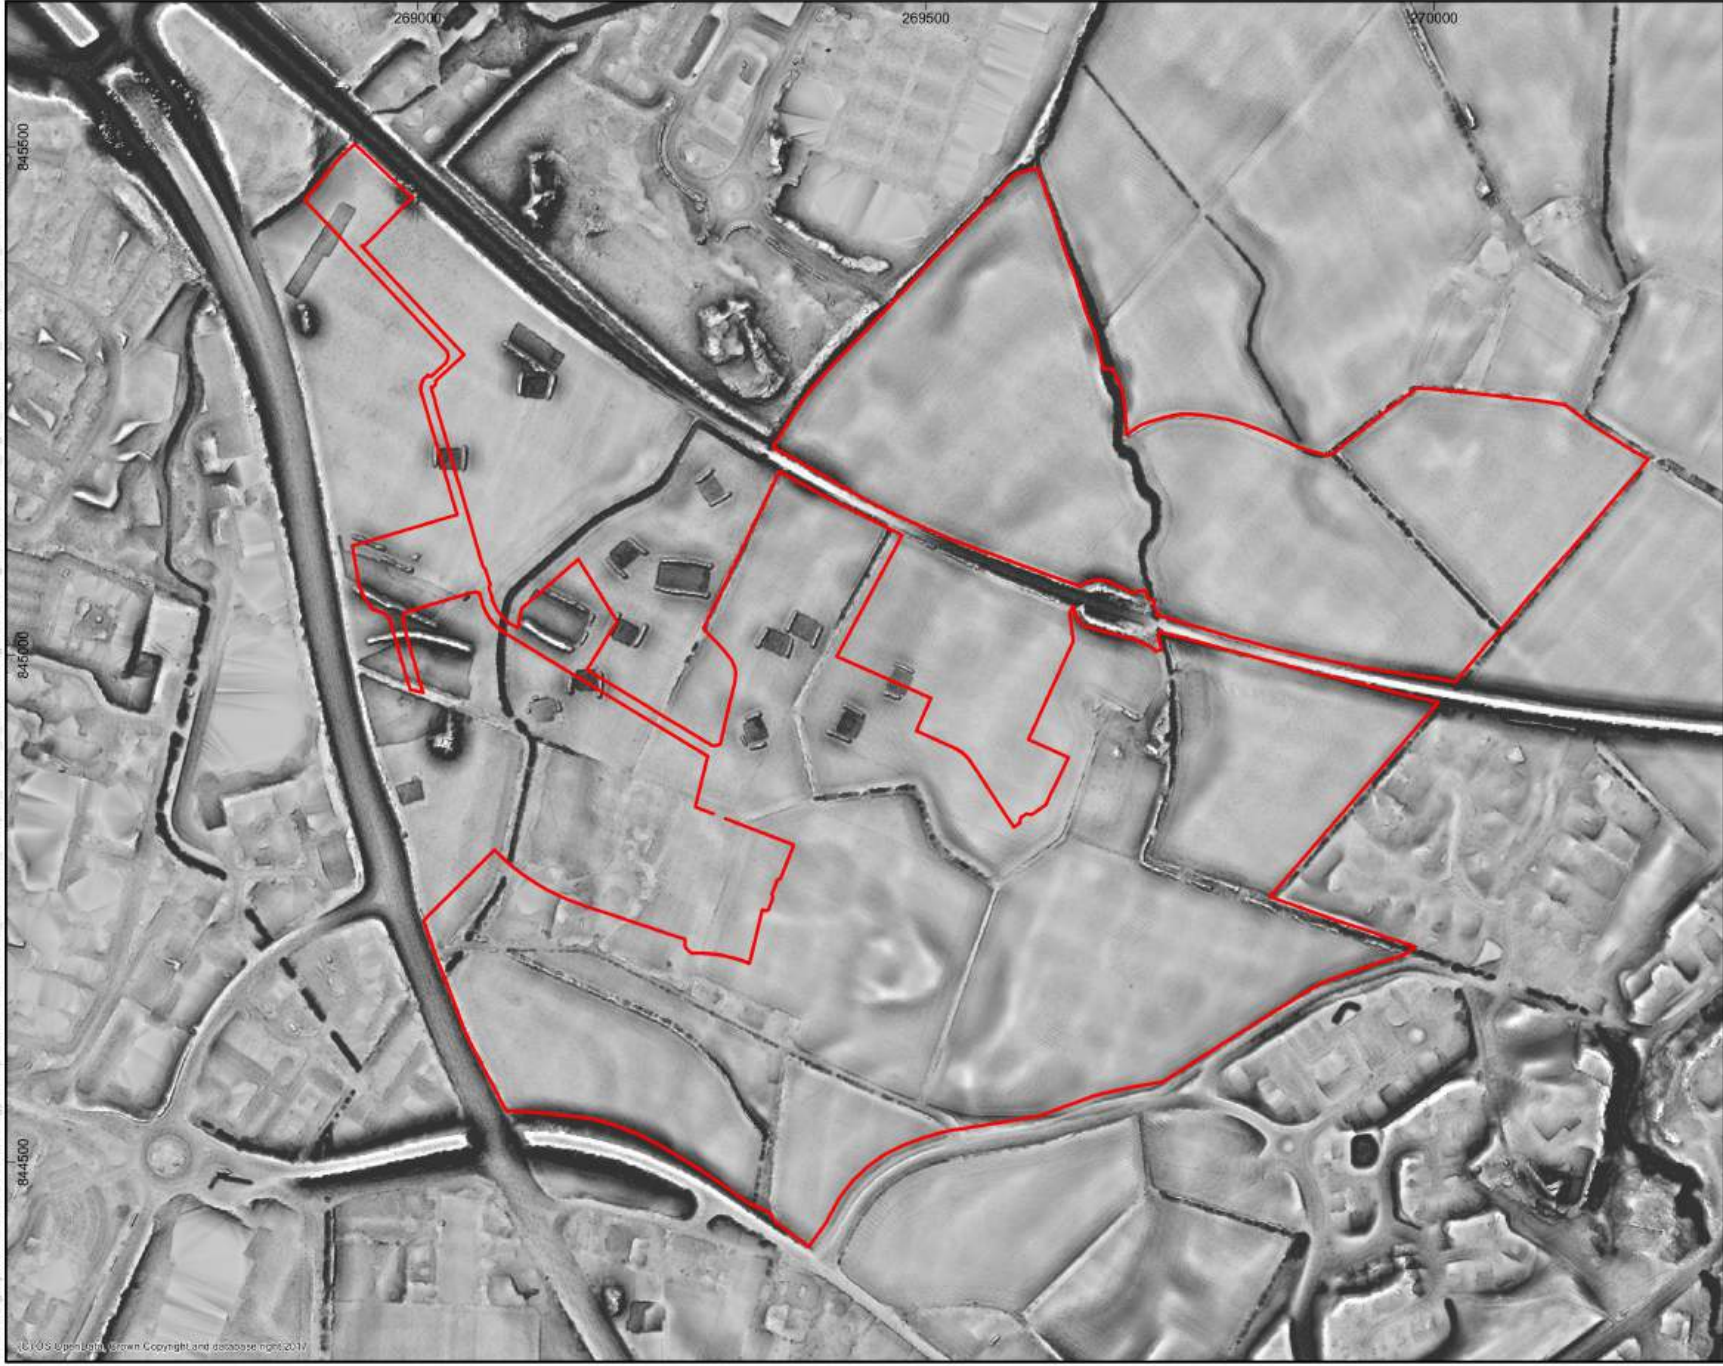
Figure 12

LiDAR
Visualisation for Archaeological Topography (VAT)

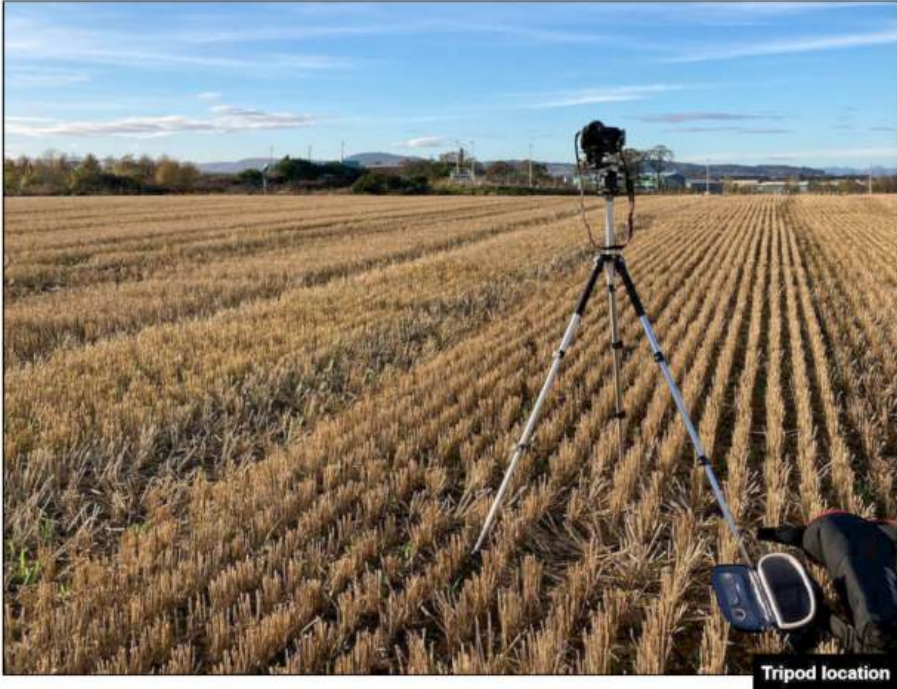
Figure 14a

CHVP1 Ashton Farm Ring Ditch
OS Grid reference: 269835E 845086N
Located within Site boundary: AOD: 35

This viewpoint is located within a field to the north of the railway and east of the footpath/cyclepath between the campus and the retail park. Parking is available within the campus nearby. Permission is required to access this location as it is in agricultural production.
