Report of Archaeological Desktop & Walkover Survey Dalraddy Quarry, Highland NH 848 / 073 (centred)

By Stuart Farrell B.A A.I.F.A F.S.A.Scot. September 2001

This report is for a desktop and walkover survey conducted on behalf of G F Job Ltd by the author for proposed sand and gravel quarry at Dalraddy, by Alvie, Highland.

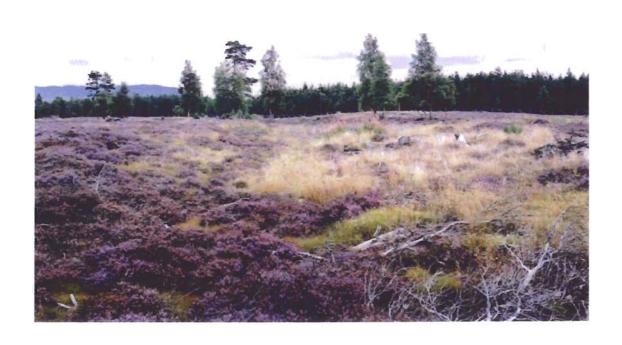
An inspection of the area centred at NH 848 / 573 showed no additional archaeological features to be visible. The military road was the only feature noted (NH 8430/0717 to NH 8484/0734) and survives as a shallow depression 4 metres wide with associated bank (See photos 1 & 2). There is currently no sign of any associated ditches or features of this stretch of road.

Top – Photo 1 – View of road facing east.

- Conduct an EDM survey of the stretch of road within the development area.
- Conduct a trial trenching of the road.
- Conduct a watching brief of the stripping of topsoil in the vicinity of the road to see if any drains or features survive under the heather.

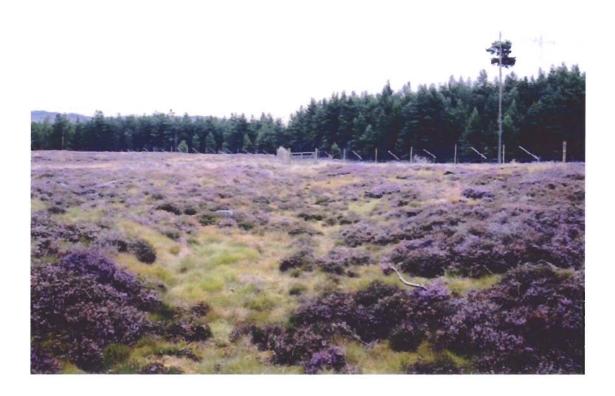
Between 1798 and 1813 the military road was superseded by the nearby B9152 The former military road was later utilised by the estate for use of forestry and access, as evident in the gate in the deer fence marking site boundary (See photo 2) to the east edge of the proposed development area.

Bottom – Photo 2 – View of road facing east – showing gate in fence.

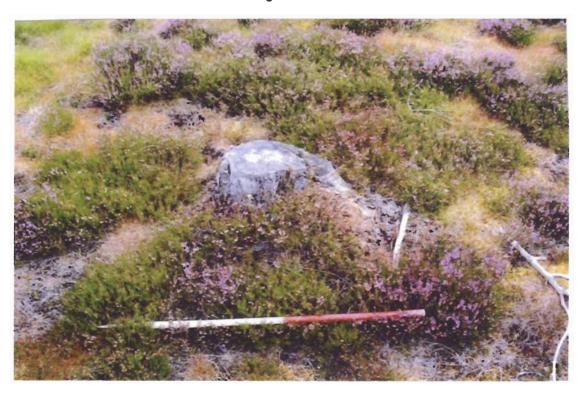
As noted by Logie (1997) there is traces of the road being formerly planted (See photo 3) and that to the west the line of the road is not so visible, being lost in an adjacent area of new woodland plantation.

Top – Photo 3 – View of stump in edge of road – scale 1m. Bottom – Photo 4 – View of road facing west.
