Croft 4, Gillen

Waternish, Isle of Skye

An
Archaeological Recording Brief
July 1999

A survey of the standing buildings and associated yards and enclosures prior to demolition and redevelopment.

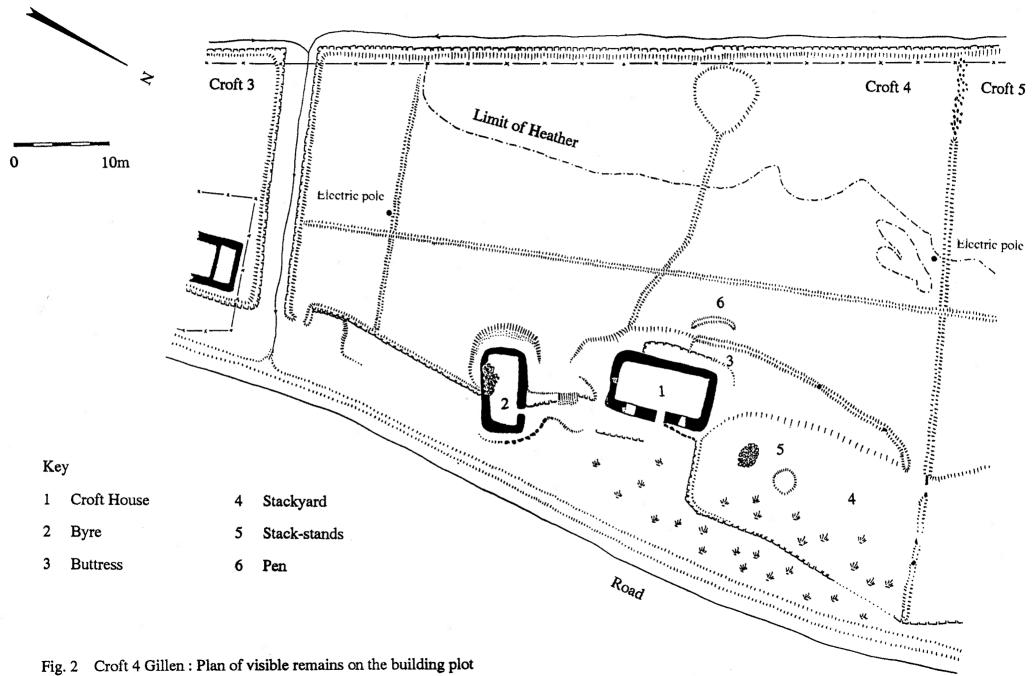
Fig. 2 Plan of Visible remains

The building plot in question lies on a gentle east facing slope at the upper east end of Croft 4, Gillen on the Isle of Skye. It measures some 70.00 metres long by 60.00 metres wide at the north end and 35.00 metres wide at the south end. The plot is currently unenclosed. The plot lies on the west side of the present township road some 70 metres north of the turning circle at the end of the road.

Within the confines of the plot are the remains of two buildings:-

- 1. The croft house
- 2. A byre

Both these structures are drystone built and are of locally won stone which has been rough dressed on one face. Almost all the pins have dropped out of the wall faces leaving voids between the facing stones. The wall cores, where visible are filled with a light brown to orange, friable, soil mixed with small stones. The wall cores are riddled with rabbit burrows. To the north of the house and running down to the road is an enclosed stackyard containing two stack stands. Immediately to the west of the house are the remains of a small turf walled pen. On the slope above, and to the west of, the house are the remains of field boundaries. All these elements are described in detail below.

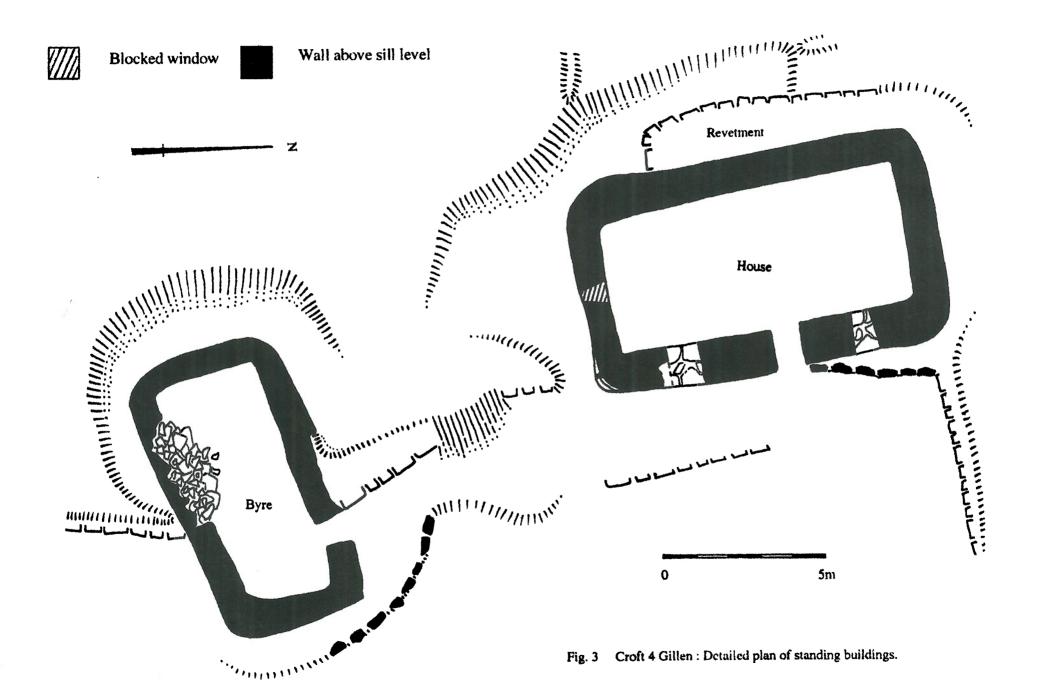
Fig. 3 Plan of House and byre

Building 1, the former croft house, lies on a NNW to SSE alignment and faces the road, being some 15.00 metres distant from the road edge. It lies on a negative platform cut into the gently sloping hillside. The building measures 11.40 metres long by 6.60 metres wide over walls which vary in width from 1.30 metres on the front (east) side to 0.80 metre at the south-east corner. The walls survive to a height of 1.75 metres for almost the entire circuit. This was probably the height of the original wall head. All the external corners are rounded with the south-east corner having a strengthened footing to prevent slippage down the slope. The internal corners are squared and well knitted together indicating a building of single period construction. The interior of the building is level and grass covered. The east facing wall has a door opening 0.90 metre wide which lies 3.60 metres from the north-east internal corner. The door is flanked, on both sides, by well made widow embrasures. The northern window embrasure measures 0.60 metre wide on the inside and 0.90 metre on the outside. The lintel is missing and the sill is 0.65 metre above current ground surface both inside and out. The southern window embrasure measures 0.95 metre on the inside, the outer part however has partially collapsed and it is not possible to measure the width. The surviving portions however suggest that this window was the same width in and out, unlike the

northern example. Again the lintel is missing and the sill is 0.55 metre above the current ground surface. A third window can be seen - blocked - in the south end wall of the house. This blocked window lies centrally in the length of the wall and measure 0.80 metre on the inside and 0.30 metre on the outside. There are no window openings in any of the other walls. There is no fire-place or chimney stack. To the rear (west side) of the house, and butting against the outer face of the wall, is a large, stone built, buttress. This buttress stands to half the height of the wall.

The byre lies on a platform cut into the east facing hill slope, at right angles to, and 9.00 metres to the south of ,the house on a WSW to ESE alignment. It measures 9.10 metres long by 5.00 metres wide over walls which vary in width from 1.30 metre at the south-east corner to 0.65 metre at the north-west corner. The walls, which are dry stone built, stand to a maximum height of 1.75 metres - probably the original wall head. A section of the internal face at the south-western end of the south wall has collapsed inwards revealing the earth core of the wall. All the external corners, except the north-east, are rounded. The north-east corner is squared and more strongly built - perhaps to give strength to the nearby door opening. The internal corners are all squared, the two east internal corners however are not true right angles the south-east corner being about 105 degrees and the north-east corner 85 degrees. This difference in angle results in the gable wall decreasing in thickness from south to north. The door opening lies in the north wall 2.00 metres from the east end and is 0.70 metre wide on the inside and 1.00 metre wide on the outside. There are no window openings. The interior is level and grass covered except for that part covered by fallen walling.

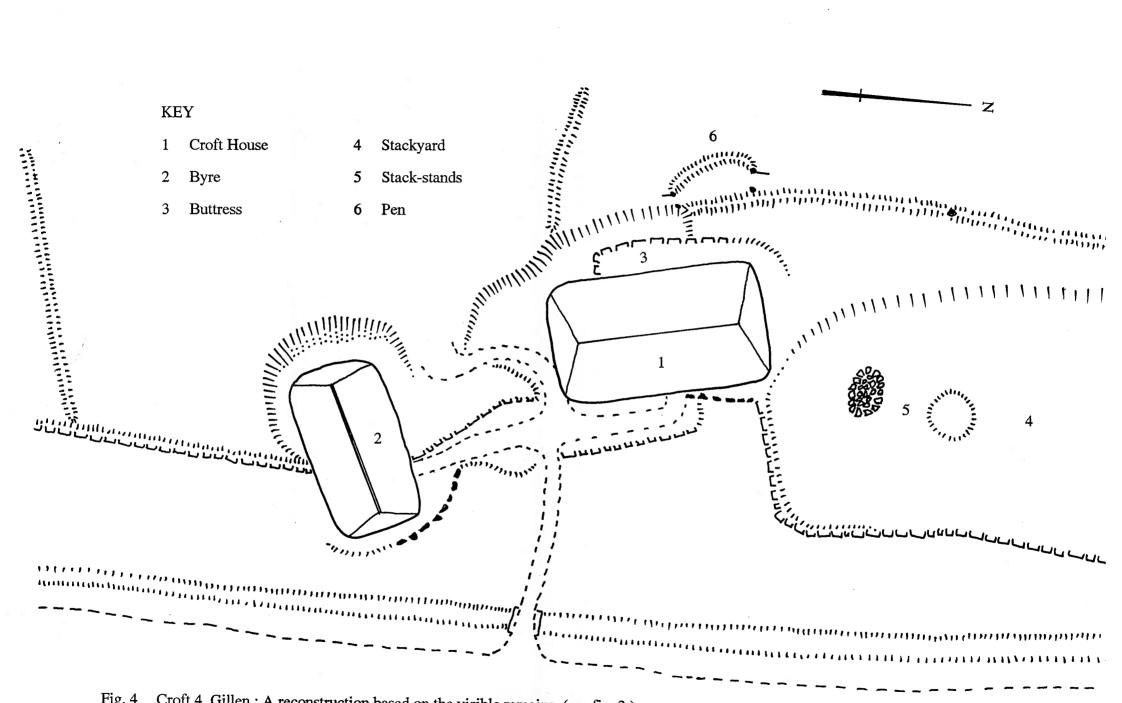
Fig. 4 Croft 4, Gillen: A reconstruction based on the visible remains. (see fig. 2)

The buildings on croft 4 appear, from available evidence, to be of one period and to have been conceived and constructed as a single unit*. At some time during the life of the house a buttress was added to the outer face of the rear (western) wall and the small window in the south end was blocked. Local records** state that the Macleod family left Croft 4 in 1930 and moved to Croft 6 just 100 metres to the north. Croft 4 was probably abandoned at this time and has been slipping into dereliction ever since. At some time after the abandonment of Croft 6 a wire fence was erected across the slope behind the house. The fact that this wire fence runs from croft 4 through croft 5 too croft 6 may indicate that the MacLeod family continued to farm the land on croft 4, along with crofts 5 and 6 after they moved.

An archaeologist should be present to record photographically, and if necessary by measured drawing, all features exposed when the buildings are demolished and foundation and service trenches are dug.
