An Archaeological Field Survey  
of the Settlement at  
Unimore, Morvern, Argyll

Jennifer G. Robertson MA PhD FSA Scot.

August 1993

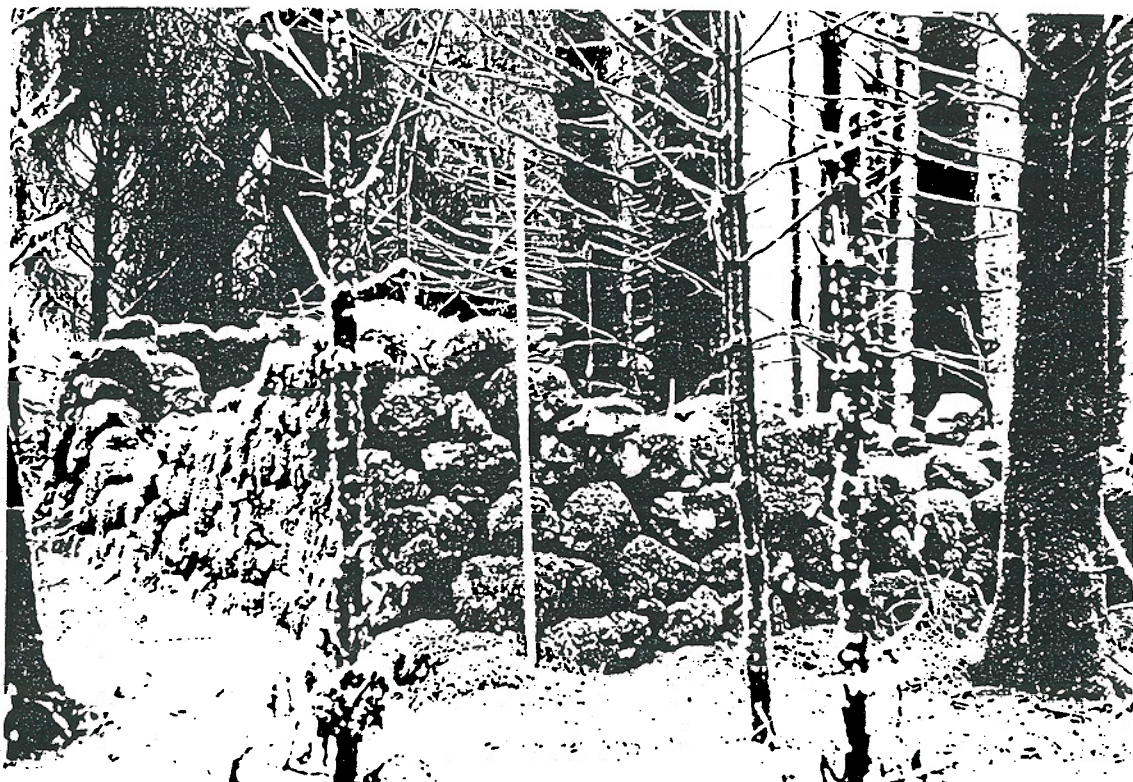
Photo 1

No. 6 House and yard

sound-angled rectangular building of dry stone coursed masonry. The massive walls of large blocks have a pronounced batter, tapering from 1.20m wide at the base to  $\approx$  0.80m near the top. The NE corner is the best preserved, surviving to a height of 1.82m, possibly wall-head level. The building probably comprised a beehive house divided by 4 rock-sockets.

Three rock-sockets survive in the S wall, all  $\approx$  0.50m above present floor level.

- a) 0.20m wide, 1.05m from E end.
- b) 0.30m wide, 5.50m from E end.
- c) 0.20m wide, 7.40m from E end.

A fourth slot was probably situated  $\approx$  3.70m from the E end in a now damaged part of the wall.

An entrance, 1m wide, opens through the N wall, 4.70m from the E end.

A low wall consisting of a single course of stones curves southwards and eastwards from the SW corner to define a yard 10m long.

Dimensions: L 10.20m x W 5m W of wall 0.80-1.30m  
H 1.82m max.

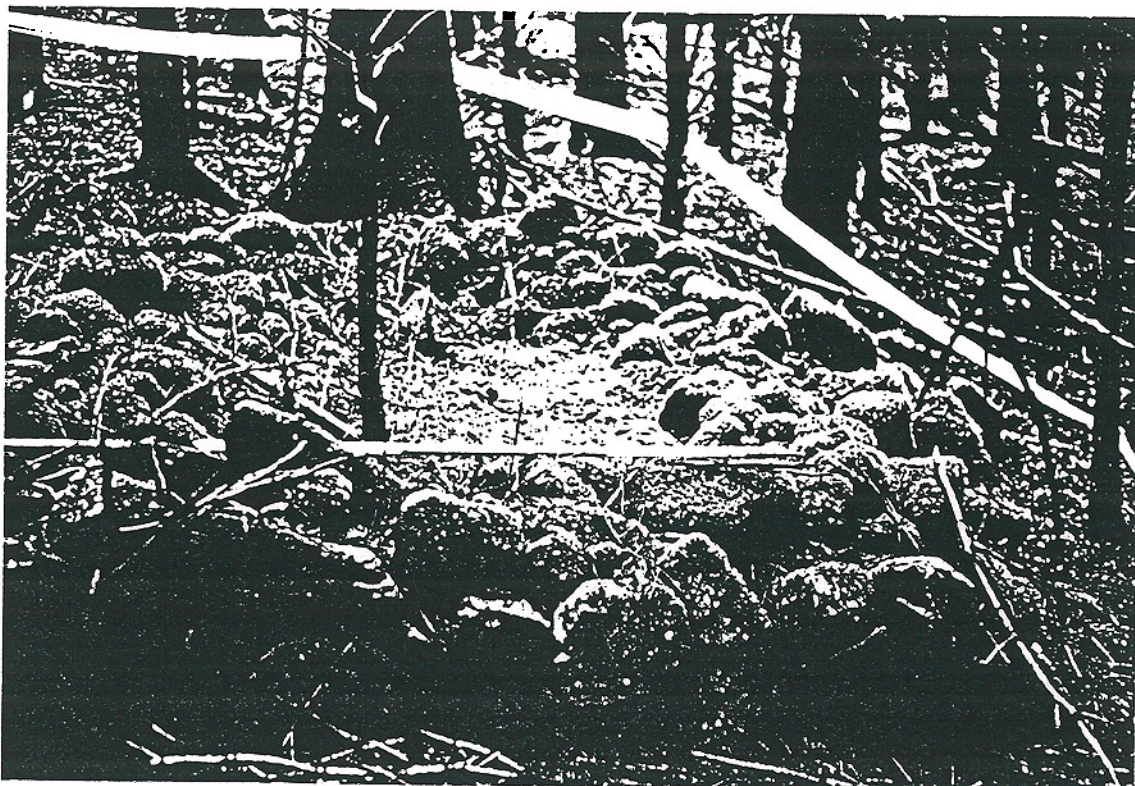
Photo 14

No. 19. ?House

Round-angled rectangular building terraced into the slope. It consists of dry-stone coursed masonry now ruinous with a thick cover of moss. The S wall is the best preserved, surviving to a height of 0.80m. The N wall is reduced to a height of 0.30m.

The building is terraced into the slope.

Dimensions: L 7.90m x W 4.75m ext. W of wall 0.65m

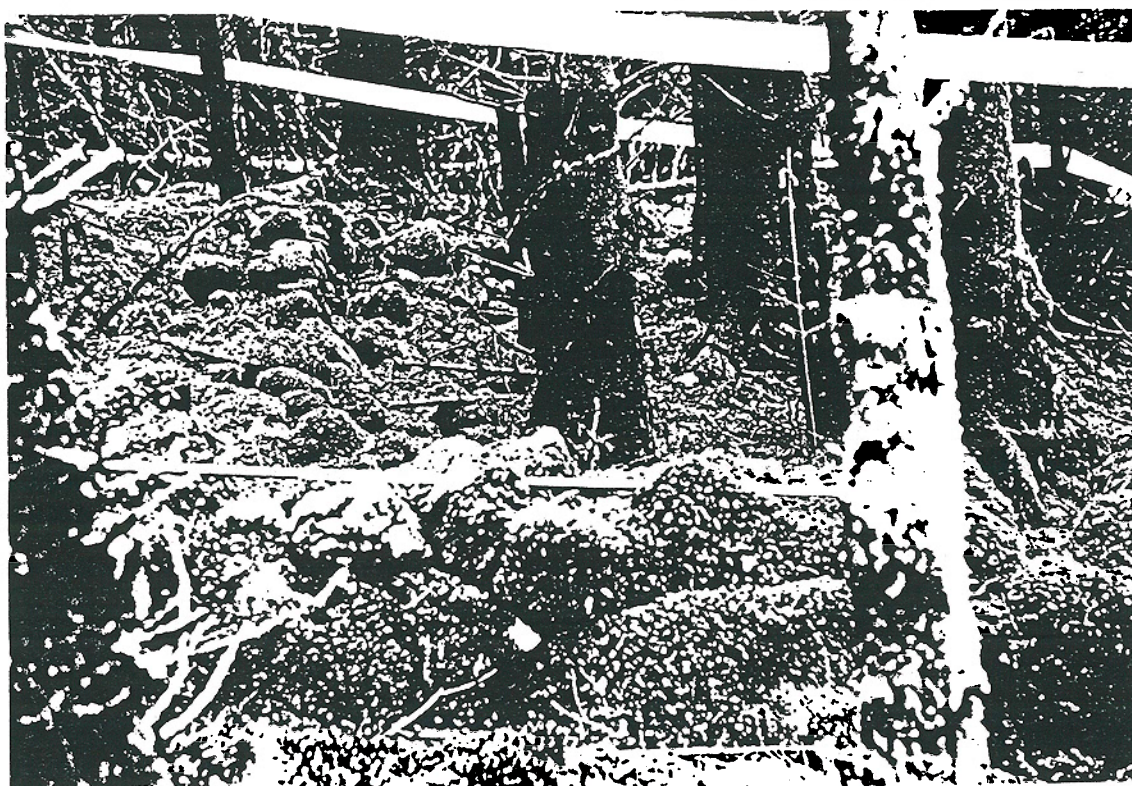
No.20. House

Round-angled rectangular building, terraced into the slope. It consists of dry-stone masonry, now ruinous with a thick cover of moss. The S wall is the best preserved, surviving to a height of 1.30m, while the N wall is reduced to a height of 0.35m. The building probably comprised a 5-bay house, divided by 4 cruck-couples. Three cruck-slots survive in the S wall, all 0.50m above the present floor level.

A fourth slot was probably situated ca. 6.90m from the W end in a now damaged part of the wall.

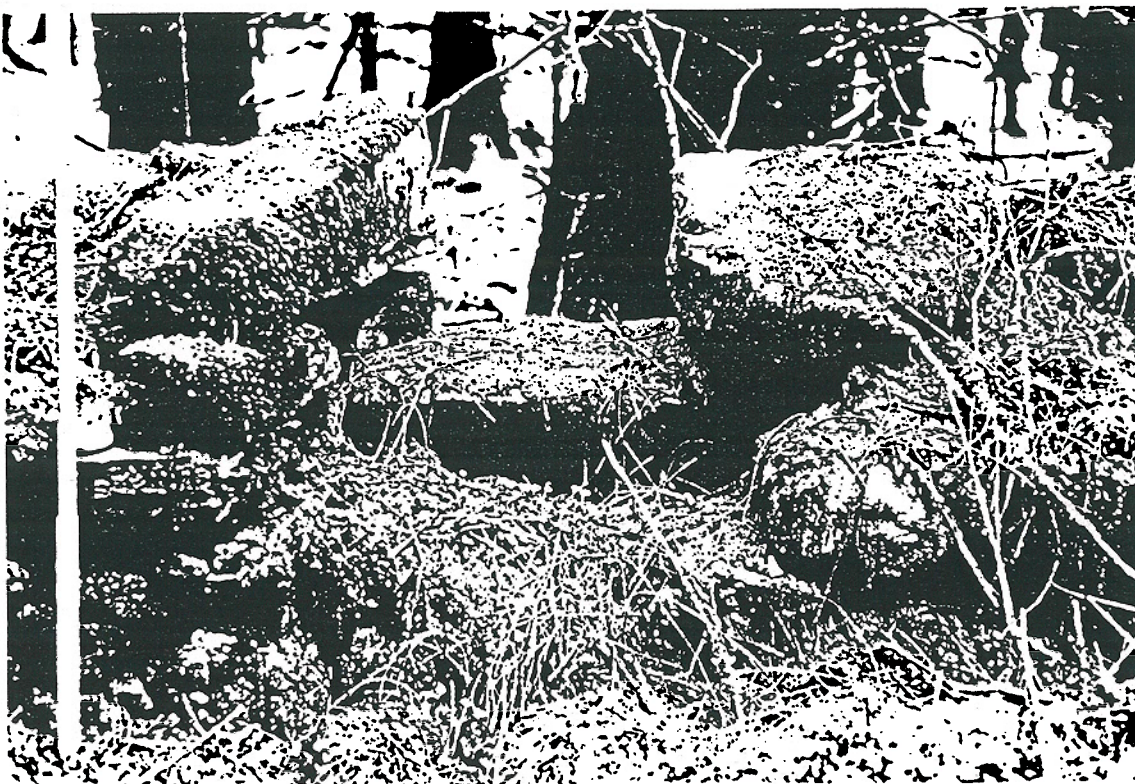
Photo 23

No. 25. House

Round-angled rectangular building set on level ground. It consists of dry-stone coursed masonry atop a basal course of very large blocks. The E end is the best preserved, surviving to wall-head level at the NE and SE corners at heights of 1.65m and 1.78m respectively.

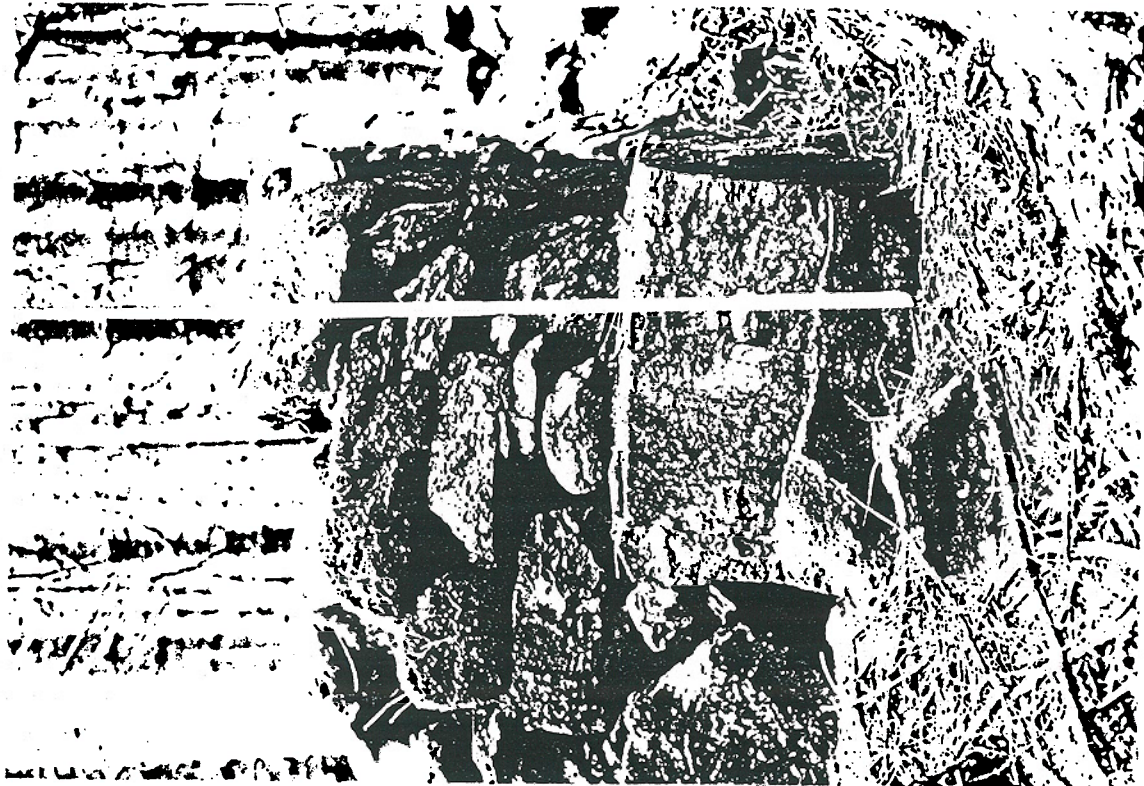
No. 40. Kaillyard

Large trapezoidal enclosure terraced into the slope and built-up from below on the E side to produce a level interior. It is defined by a coursed wall of small rubble on the N and W sides. The S and E sides are defined by a sharp break in slope revetted in stone to a height of 1.20m. At the NE corner the enclosure abuts the winnowing barn No. 39.

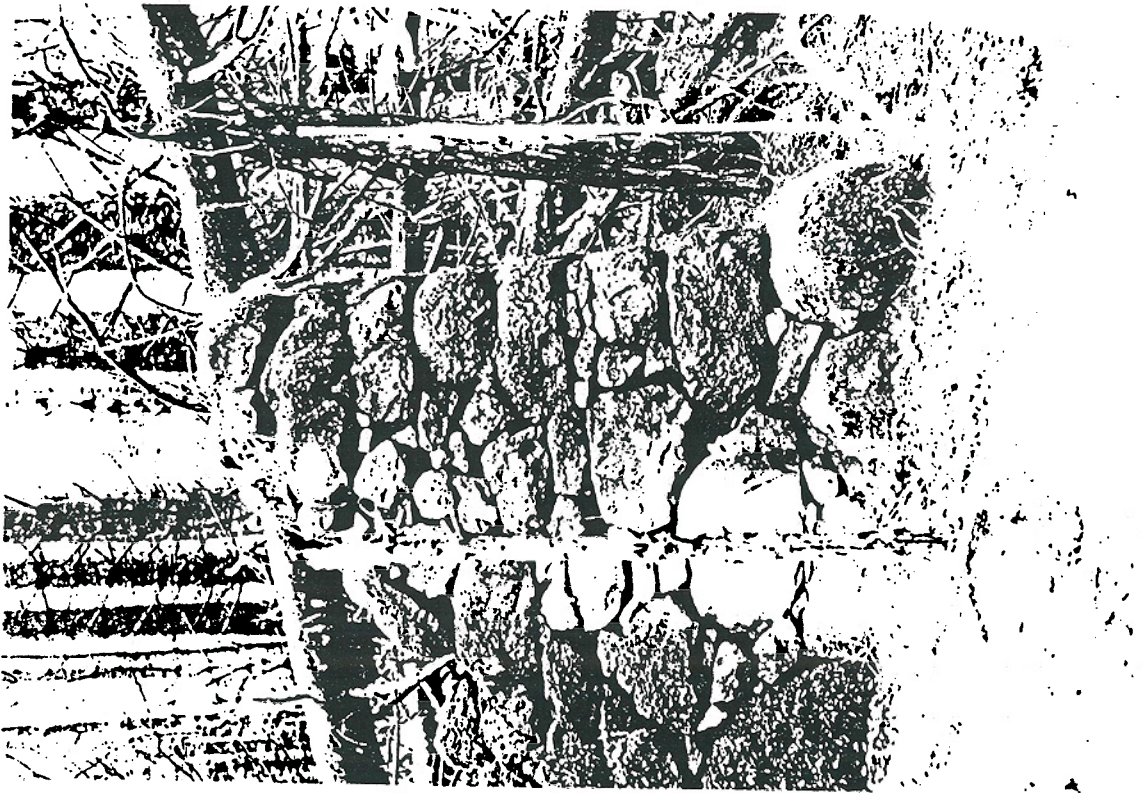
No. 43. House

Round-angled rectangular building terraced into the slope. It consists of dry-stone coursed masonry, not so massively-built as the adjacent No. 42 and now ruinous with a thick cover of moss. Interpretation is severely hampered by fallen trees. The end walls are the best preserved, surviving at the NE corner to a height of 1.40m. Traces of end-wall slots are visible but they have been displaced by internal collapse of the walls. An entrance, now 1.50m wide, opens in the S wall, 3.90m from the E end. A level terrace 1.10m-2.10m wide, curves round the E end, leading into the kaillyard No. 45.

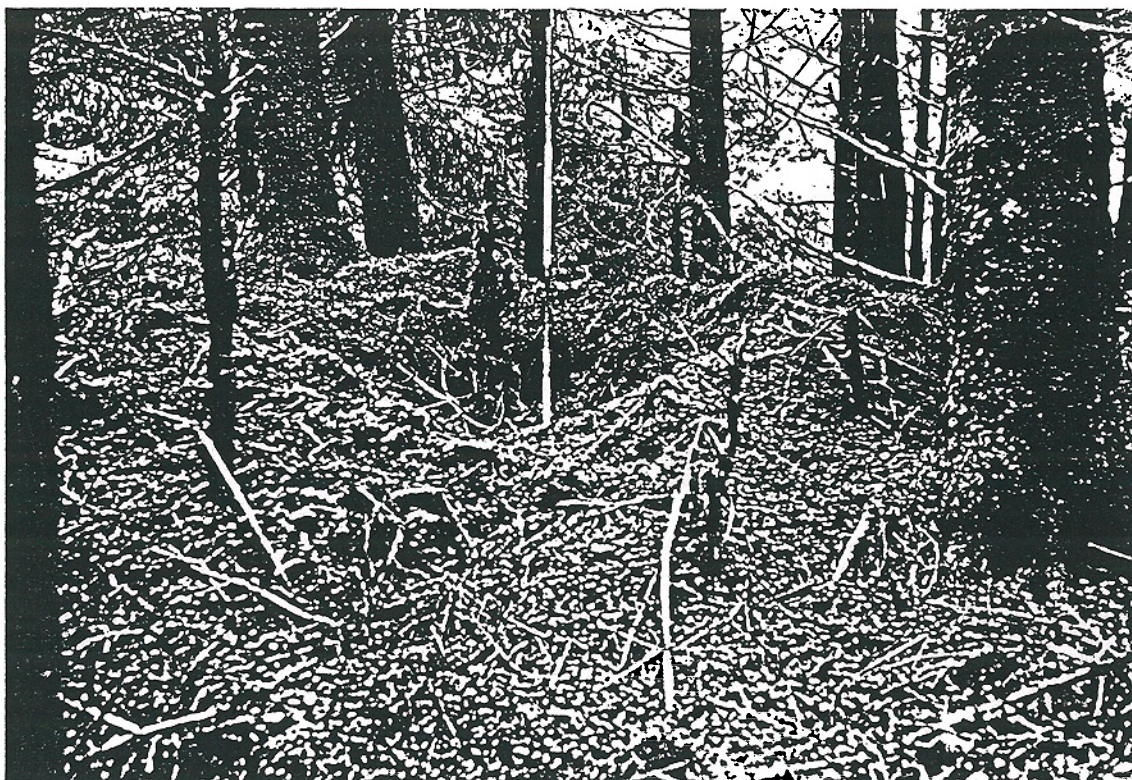
Photo 49

No. 48. ?Wheel pit

Sub-rectangular pit cut into the river bank opening onto the stream. The sides seem to have been revetted with stone but are now heavily overgrown. This may have been the lower chamber of a horizontal mill, probably originally with a wooden superstructure, which has now perished or been removed. It was fed by the leat, No. 49, running from the NW.
