# Report of Archaeological Recording September - December 2003 1-3 Bridge Street, formerly Ashers Bakery, Nairn NH 8856 / 5661 (centred)

Client: Tulloch Homes Ltd

Planning Application No: 03/00037/FULNA

By Stuart Farrell B.A A.I.F.A F.S.A.Scot. December 2003

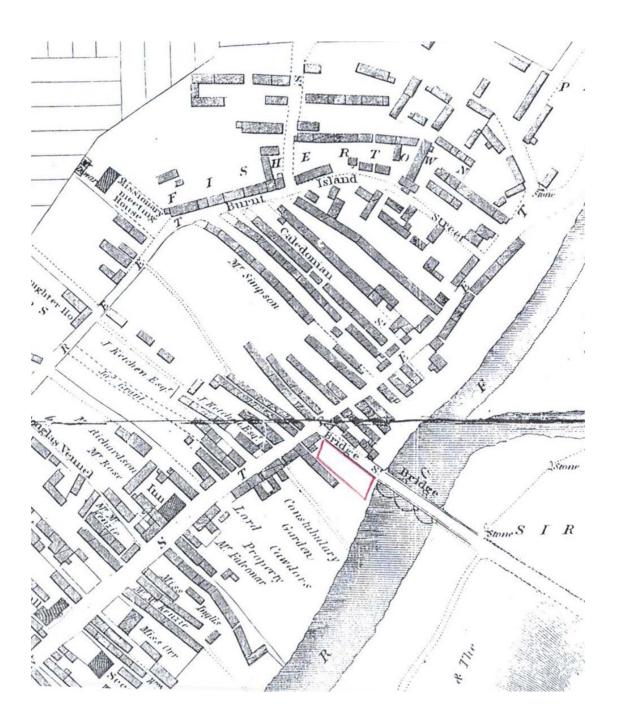
Figure 3 – John Wood's Plan of Nairn 1821

The earliest town plan of Nairn is John Wood's plan of 1821 (see figure 3) where nothing is depicted to the development location (not even the nearby ford crossing). By the Ordnance Survey town plan of 1869 (see figure 4) a L-shaped building fronting Bridge Street with a number of smaller structures to the rear and E of the building is depicted. To the south is marked a rectangular building named as 'Bristol Cottage' with a set of steps to the river edge. The 1<sup>st</sup> edition of 1874 (see figure 5) shows the same features at a smaller scale.

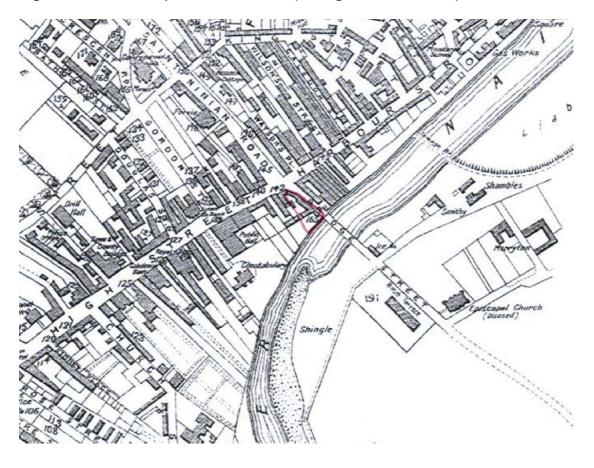
Figure 6 – Dallas' Map of Nairn no date (Enlarged from c1:2500)

Two maps of the town to the late 19<sup>th</sup> century include Dallas's (see figure 6) show the L shaped range but not Bristol Cottage, although numbered 165 a key in not available. Fraser's map of Nairn (see figure 7) shows the L- shaped range to possibly be of 4 buildings with Bristol Cottage to the south with a number of small structures east by the river.

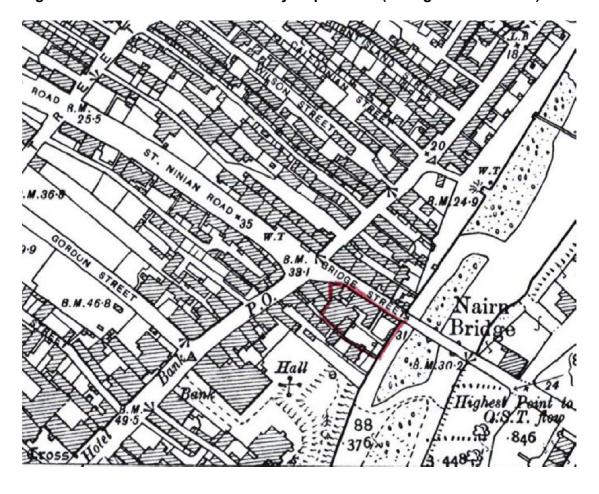
Figure 8 - 2<sup>nd</sup> edition Ordnance Survey Map of 1905 (Enlarged from 1:2500)

By the 2<sup>nd</sup> edition Ordnance Survey of 1905 (see figure 8) an addition has been made to the rear of the L shaped building, a new building fronts Bridge Street. By the Ordnance Survey of 1964 (see figure 9) the site is comprised of 4 buildings marked 3-13 with bakery to rear, and building to E by bridge numbered 11 with open ground to the SE corner. By the latest Ordnance Survey plan of 1972 (see figure 10) the site is depicted as one building marked bakery with 11 Bridge Street to E.

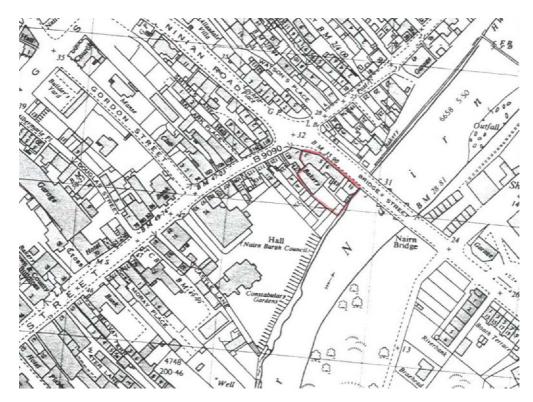
Figure 9 - Ordnance Survey Map of 1964 (Enlarged from 1:2500) © Crown Copyright - Licence 100041016

There are no planning records for 9 or 11 Bridge Street. (See OS map of 1964 – figure 9).

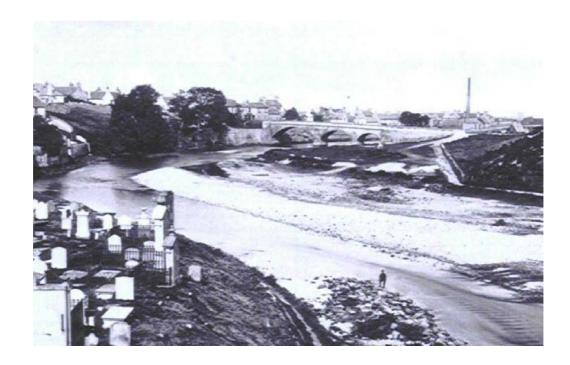
Figure 11 - View from railway Viaduct c1890. ⊚ RCAHMS

Of two views of the river, one from circa 1880 (see figure 11) shows open ground to the east that by the early 20<sup>th</sup> century (see figure 12) a flat roofed building is visible by the river edge. This building is more clearly visible on photograph of circa 1931 (see figure 13) and on an aerial photograph of the same period (see figure 14). Views of the front of the shop are very scarce with one view from 1935 (see figure 15) of the shop front that was unchanged until the 1950's; this view of

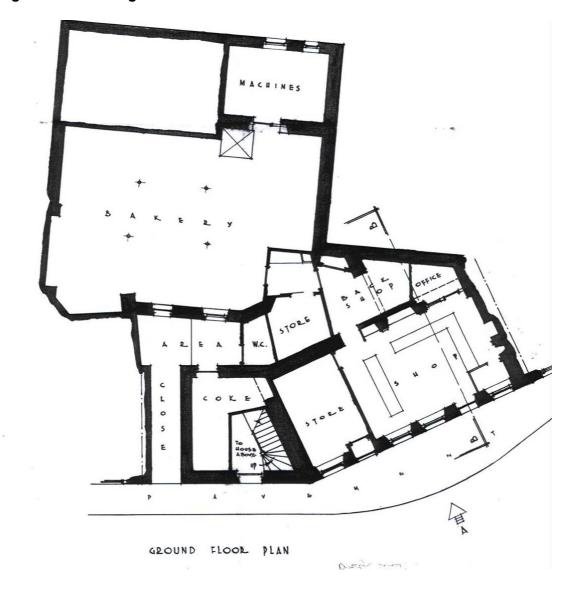
Figure 17 – Existing Ground Plan 1953 scale 1/8"- 1ft.

Drawings are available for major alterations conducted in 1953 (see figures 17-21) when the existing house above the bakery shop was converted into a coffee shop and the frontage of the shop was altered to an open shop front with large plate glass windows. Internally the building was altered to the removal of stores and the creation of toilets and office space. It is interesting to note that the shop front seems to have been unchanged from the photograph of 1919 (see cover) and that the new frontage remained the same until the shop closed (compare with photograph 1).

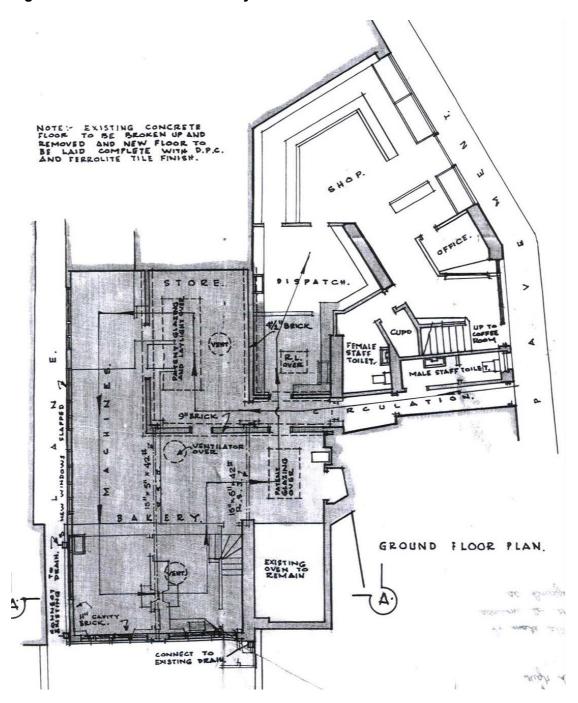
Figure 22 – Ground Plan of Bakery 1960 scale 1/8"- 1ft.

Drawings are again available for alterations made to the bakery roof in 1960 (see figures 22-24) where the roofline was raised and new concrete floors constructed noting the removal of the existing floors.

Internally the ground plan of the bakery is almost unchanged since 1960 (see figures 22 and 25) with the bakery to the rear of the building. Area marked as store on figure 22 is a walk-in refrigeration unit; ovens still insitu with 1 in same position as marked on figure 22 (see photograph 6 for 2<sup>nd</sup> see photograph 7) with entrance along corridor to Bridge Street. Shop on ground floor extended with removal of office to form coffee shop, with modern lift shaft in area of dispatch (this was because 1<sup>st</sup> floor changed recently to form bakery preparation area). Toilets in same place as depicted on plans. Former shop to NE (see figure 25) used as storage and delivery area. Shop to NE corner has cast-iron columns and panelled staircase to 1<sup>st</sup> floor. A rear stair (see photograph 8) also led to the 1<sup>st</sup> floor and attic rooms.

Work upon the removal of the bakery to the rear, revealed a former rear doorway and chimney block of brick with modern cement pointing (where recess is marked on figure 22) in area of oven no.2. The rear of the original building had seen a number of alterations with guttering replaced with plastic pipes and additions of flat-asphalted roofs. Bakery to south side of site as depicted on figure 24 with metal-framed skylights and windows.

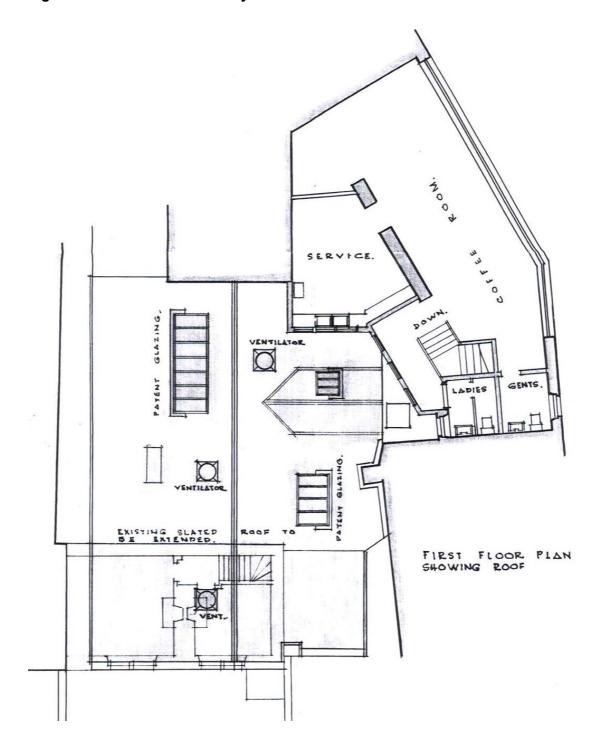
Figure 23 – Roof Plan of Bakery 1960 scale 1/8"- 1ft.

On the 1<sup>st</sup> floor above shop, former coffee shop (see figure 23) was changed to form preparation area with the installation of plastic melamine walling (see photograph 11) though the staircase from the refurbishment in the 1950's was

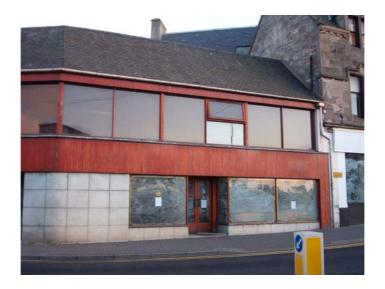
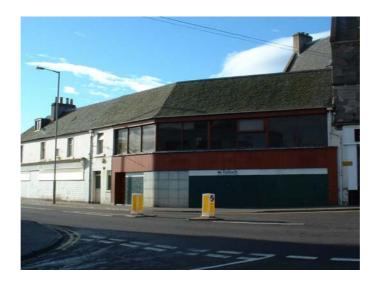
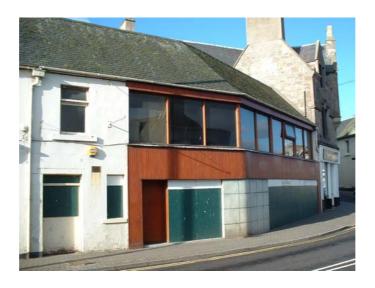
$\begin{array}{lll} \mbox{Photo 1-Top -} & \mbox{View of shop } \mbox{\o} \mbox{ A Barron September 2003.} \\ \mbox{Photo 2-Middle -} & \mbox{View of shop facing S.} \\ \mbox{Photo 3-Bottom -} & \mbox{View of shop facing southwest.} \end{array}$

The existing north facing building is 2-storey (see photographs 1-3) slated with double glazed smoked windows to ground and 1<sup>st</sup> floor with shop entrance on ground floor. With attic window to NE corner, with cast-iron guttering and down pipes. Moulded cornicing above former window frontage along Bridge Street. The east elevation also of 2-storey with 2 attic rooms (see photographs 4 and 15) with later flat roof extension with sash and case windows. To the east by the riverside is a set of disused steps (see photograph 5).

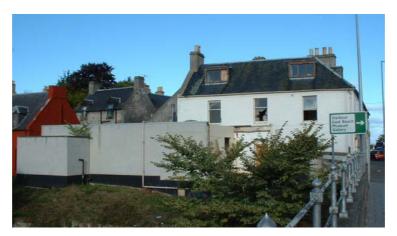
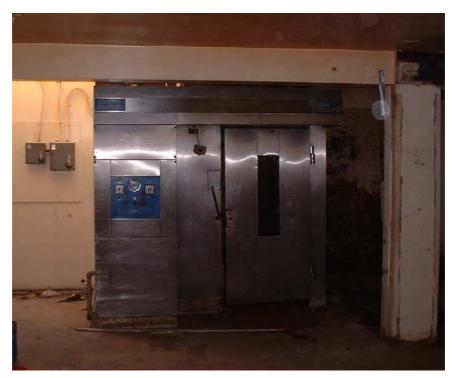
Photo 4 – View of east range of buildings facing W. Photo 5 – View of steps down to river. Photo 6 – View of oven in Bakery.

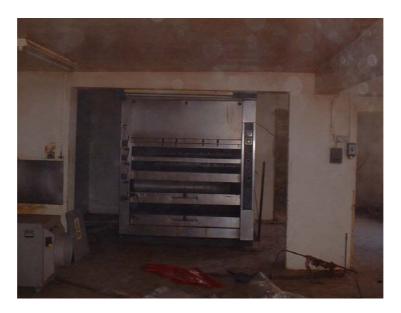
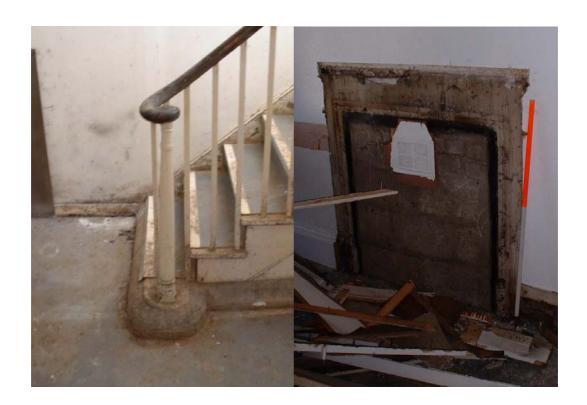
Photo 7 – View of oven in Bakery. Photo 8 – Detail of cast-iron banisters. Photo 9 – View of removed fireplace 1<sup>st</sup> floor – scale 1m.

still extent (see photograph 10). Rooms on 1<sup>st</sup> floor to NE being used as offices and changing rooms, with mixture of both modern and old fittings including modern chip-board counters and modern light fittings. One fireplace was removed prior to photographic survey taking place (see photograph 9). Loft area to the rear of the bakery (as depicted on figure 18) used as store for packaging materials and disused equipment. Attic spaces above NE corner are former bedrooms (with mixture of wallpapers, cupboard by door - in NE room - and blocked up fireplace in room to NE corner (see photograph 13). Some graffiti of initials found in attic room to south (see photographs 12 and 14). All rooms recently used for storage of disused bakery equipment and crockery from former coffee shop.

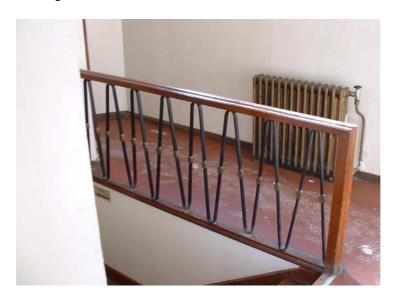
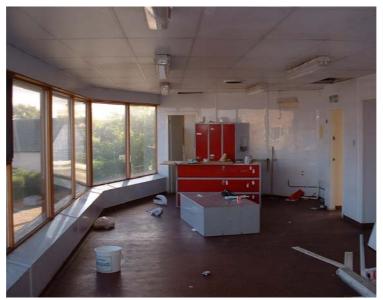
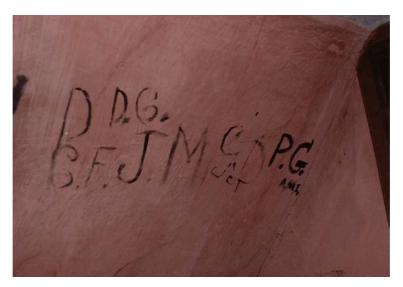
Photo 10 – Detail of stairs to 1<sup>st</sup> floor. Photo 11 – View of 1<sup>st</sup> floor above shop facing E. Photo 12 – Detail of graffiti on wall.

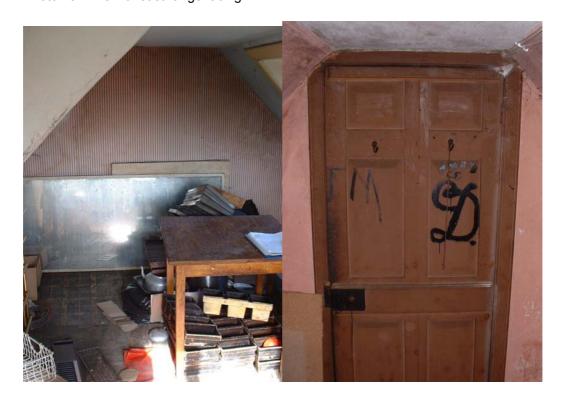
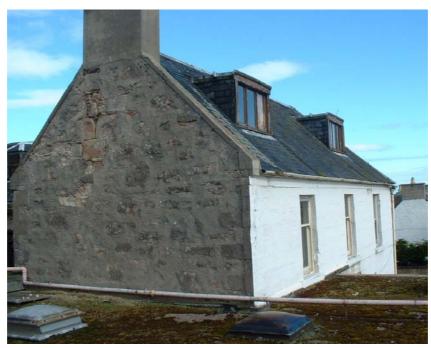
Photo 13 – View of attic room 1<sup>st</sup> floor. Photo 14 – Detail of graffiti on door. Photo 15 – View of east range facing N.

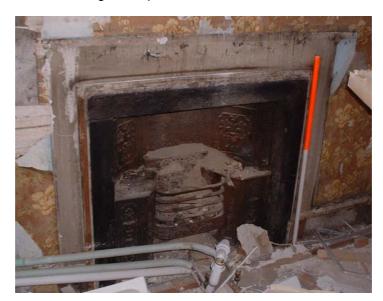
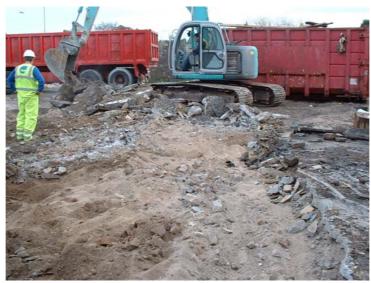
Photo 16 – Detail of fireplace revealed 1<sup>st</sup> floor – scale 1m. Photo 17 – View of demolition in progress – removal of concrete facing east. Photo 18 – View of site facing west upon site clearance.

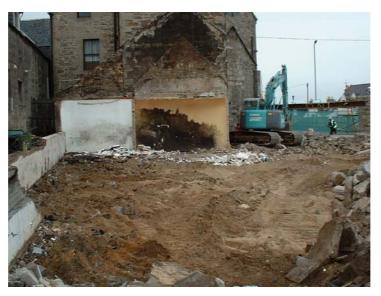
Removal of the concrete floor to an average depth of 110mm, though in certain areas especially along the south wall this deepened to 160mm (see photograph 17) revealed natural yellow-brown sand below over most of the site, especially to the bakery and shop areas. Work also revealed 2 cellars (see figure 26) the largest of these was 2.3m deep the other 1.4m deep. Work to the east end of the buildings (in the area of flat roofed single storey extension) revealed a reinforced concrete foundation situated above a former access road of tarmac and an oil storage tank (see figure 26). This later reinforced concrete was raised almost 0.7m so that floor level was same as existing street level. In some areas of the site, especially under the ovens and the refrigeration unit, there was polystyrene insulation under the concrete atop the natural sand. (Noted on drawing of 1960 – see figure 22 – that existing concrete floors were to be lifted and replaced). Removal of the sandstone at the shop front revealed that it was modern in date with concrete under the sandstone with no indication of any earlier frontage.

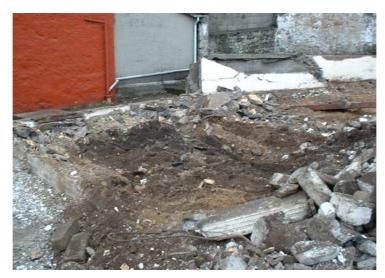
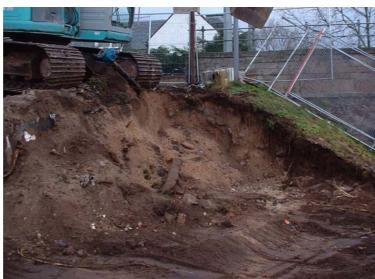
Photo 19 – View of garden soils to south side of site.

Photo 20 – View of natural ground to NE corner of site facing north.

Photo 21 – Detail of trench to south showing garden soils on natural – scales 1m.

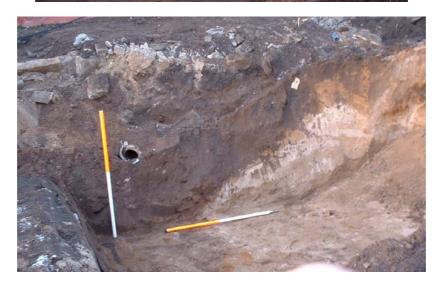
A single trench 1.2m wide and 8m in length (though this was divided by a concrete foundation for the road) was made through this garden soil (see photograph 21) in the area of proposed foundation trench along the southern edge of the site. This revealed that the garden soil was heavily cut with services (see figure 26) and was on a steep slope eastwards towards the river (see section in photograph 21). There was no indication of any cut features into the natural sand underlying this deposit.
