**THE ARCHAEOLOGICAL EVALUATION AND
ASSESSMENT OF A CRANNOG SITE IN LOCH
ACHAIDH NA H-INICH, PLOCKTON, SKYE &
LOCHALSH DISTRICT**

The Archaeological Evaluation and Assessment of a Crannog Site in Loch Achaidh na H-Inich, near Plockton, Skye & Lochalsh District.

NGR NG 8117 3096

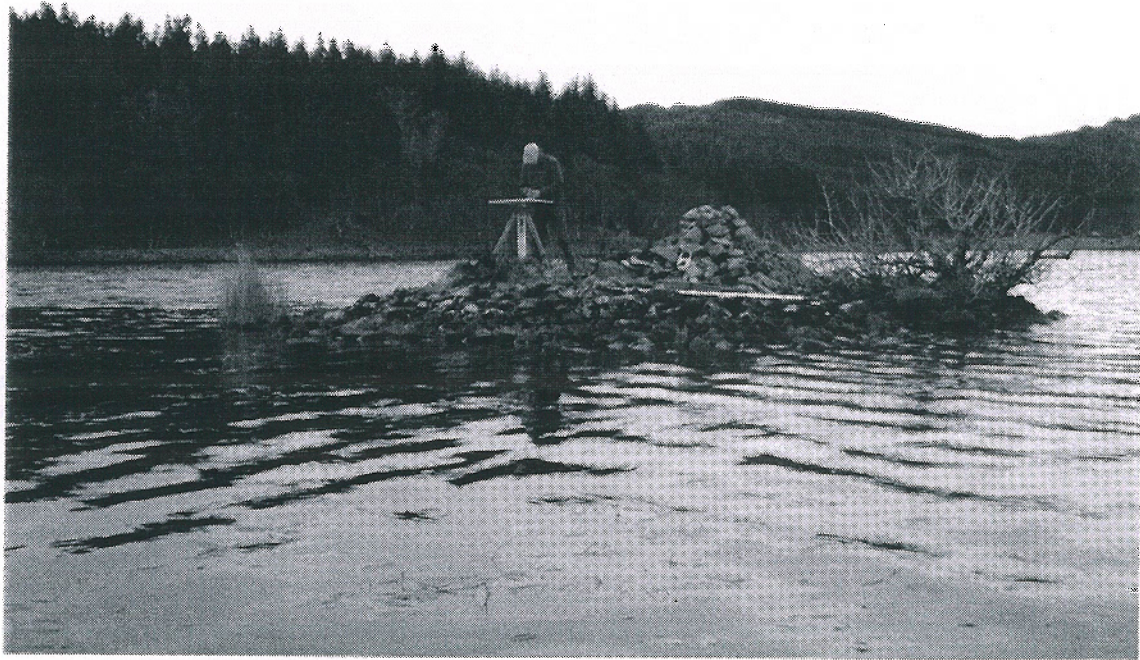
Fig.3 – Survey Station in position on the Crannog

- 4.1 The archaeological survey and evaluation of the site was carried out between the 22nd November and 3rd December 2002, in fine and dry weather. The island was accessed using a small fibreglass rowing boat, with the main survey station positioned on the island (see Fig.3). The measured survey was conducted using a Wild RK 1 Self-Reducing Alidade and Plane Table, in conjunction with a 3 metre long Range Scale. This equipment was used to record surface and submerged features on site, the submerged readings being taken by a dry-suit clad assistant utilising mask and snorkel equipment.

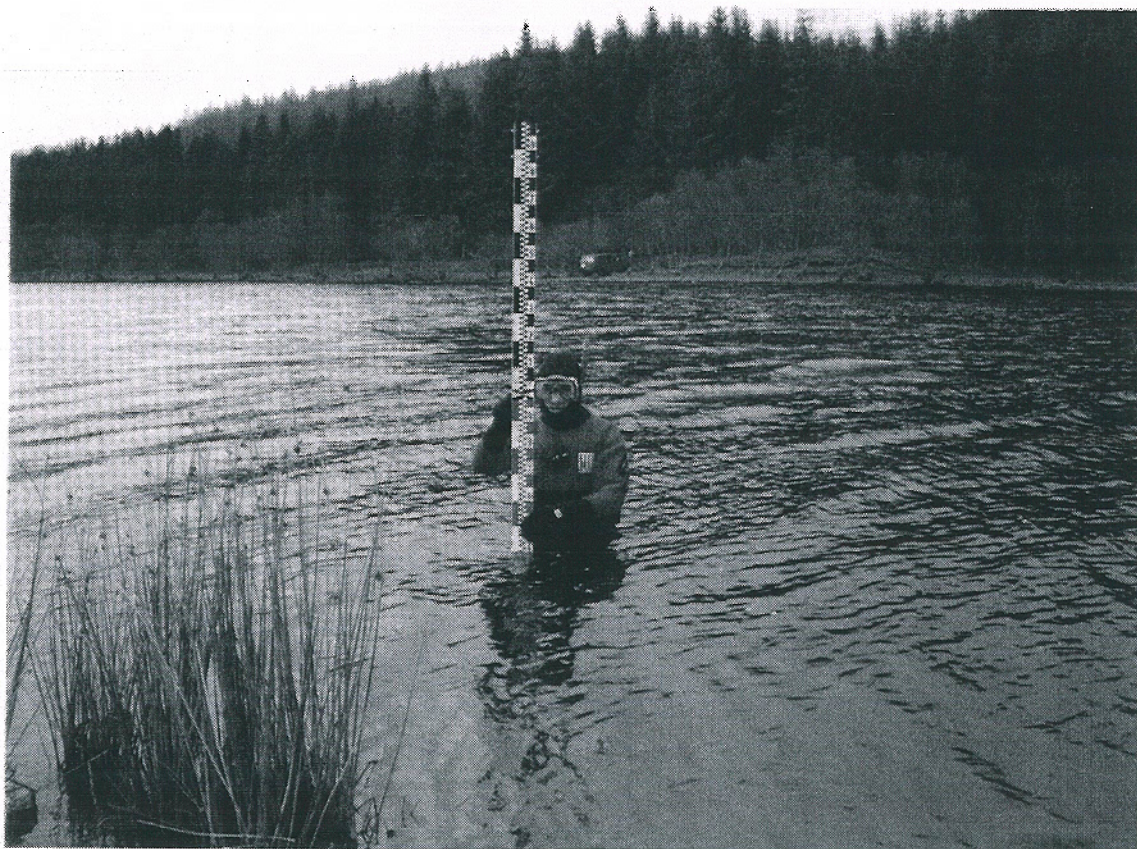
Fig.4 – Surveying the submerged features of the Crannog

- 4.2 A tendered/roped diver carried out the underwater assessment and survey of the site, the diving generally taking place in water with a maximum depth of 2 to 3 metres. The visibility underwater was generally good, being in the region of 2 to 3 metres, although the fine sediments comprising the lake-bed are prone to disturbance. However, it was noted that the particulates in suspension soon fine down after activities underwater ceased. The water temperature averaged 5.2 degrees Celsius during the underwater survey and evaluation work.

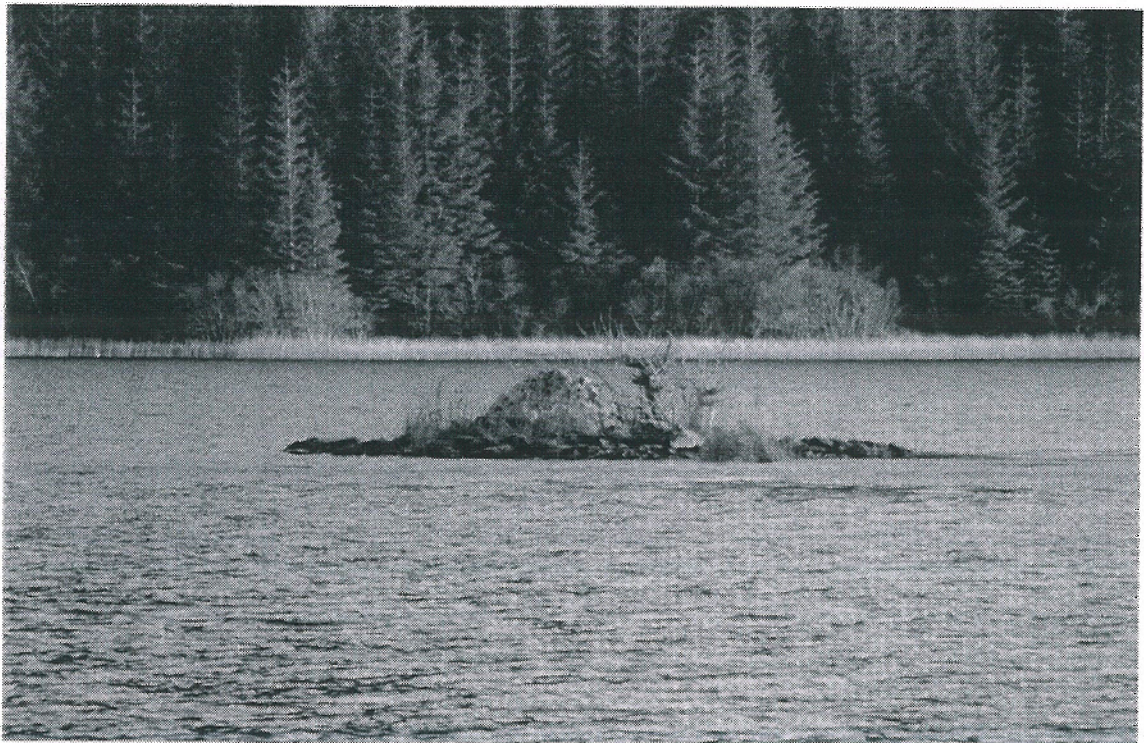
Fig.5 – Photographic Image showing the location of the Site

- 5.2 The site in question is a small artificial island lying 75 metres from the north shore of the loch, the visible remains consisting of a small rocky platform some 5 metres in diameter with a smaller cairn of stones at its centre (see Fig.8). A ring of surrounding weed some 15 metres in diameter indicated the presence of additional sub-surface features, lying just below the artificially raised surface of the loch (see Fig.5).

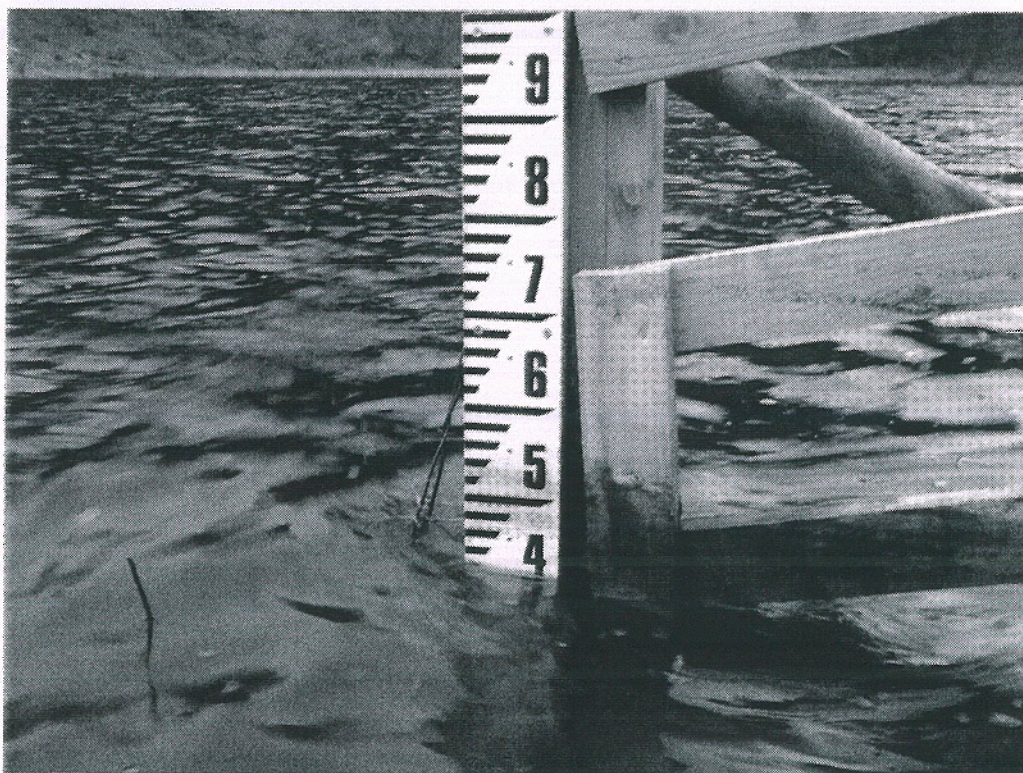
Fig.9 - Photographic Image of the in-situ Depth Gauge for the Loch, showing the reading of 420mm taken on the day of the Site Survey

- 5.3 At the time of the survey, the water gauge situated by the outflow of the loch recorded a level of 420mm (see Fig.9). The above water features of the site

6.1 The survey was carried out on a calm day with the water level at 420mm on the loch's depth gauge. However, water levels encountered on subsequent visits to the site have been adjusted, so as to conform to that of the first visit (i.e. 420mm on the lochs water level gauge).
