**KINTAIL & WEST AFFRIC
ARCHAEOLOGICAL SURVEY**

VOLUME 2

The National Trust for Scotland

Jonathan Wordsworth and Jill Harden

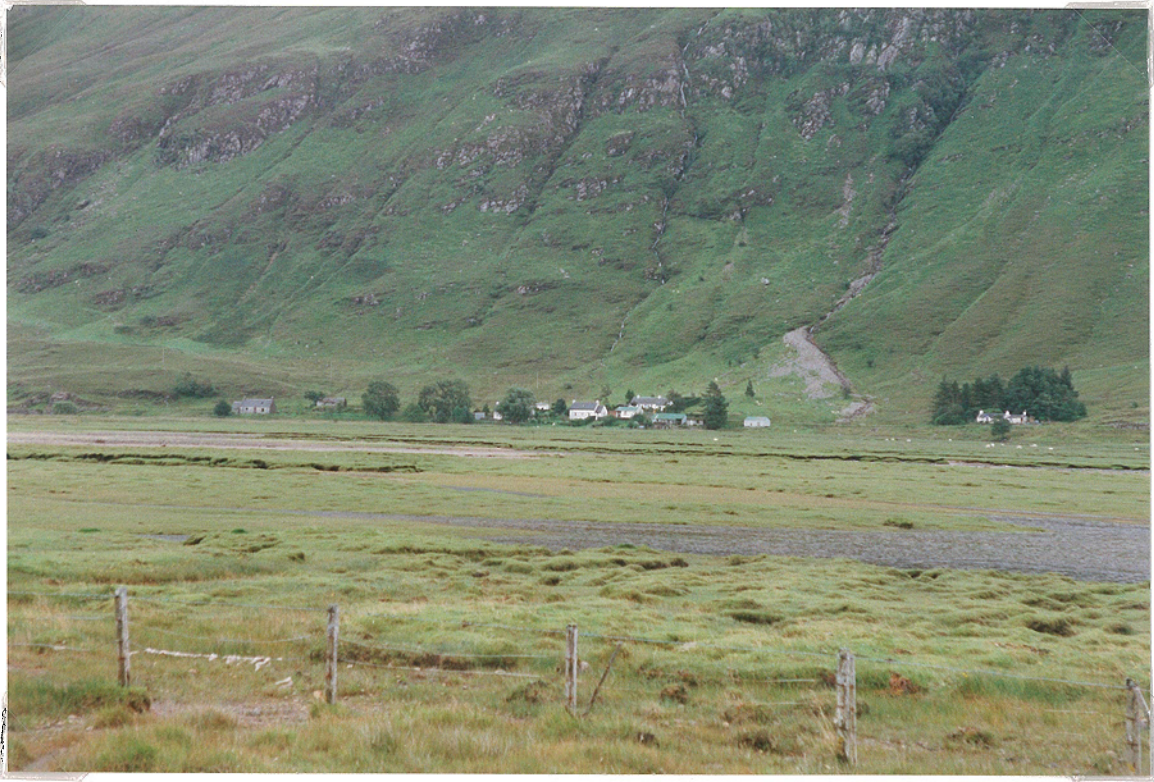
51

The name Carn-gorm does not appear on the 1st edition 1874 OS map, although it is used in the 1861 census. The settlement seems to have consisted 5 roofed buildings in 1874 and 12 roofed buildings in 1902.

Roy's survey of c1750 does not record a township here and it seems that this may be a settlement that developed during the 19th century following the displacement of cottars and crofters when sheep farming was introduced.

Condition: n/a*Interpretation:* No*Management needs* Photo in the spring once every 5 years to maintain record of change by tenants/owners.

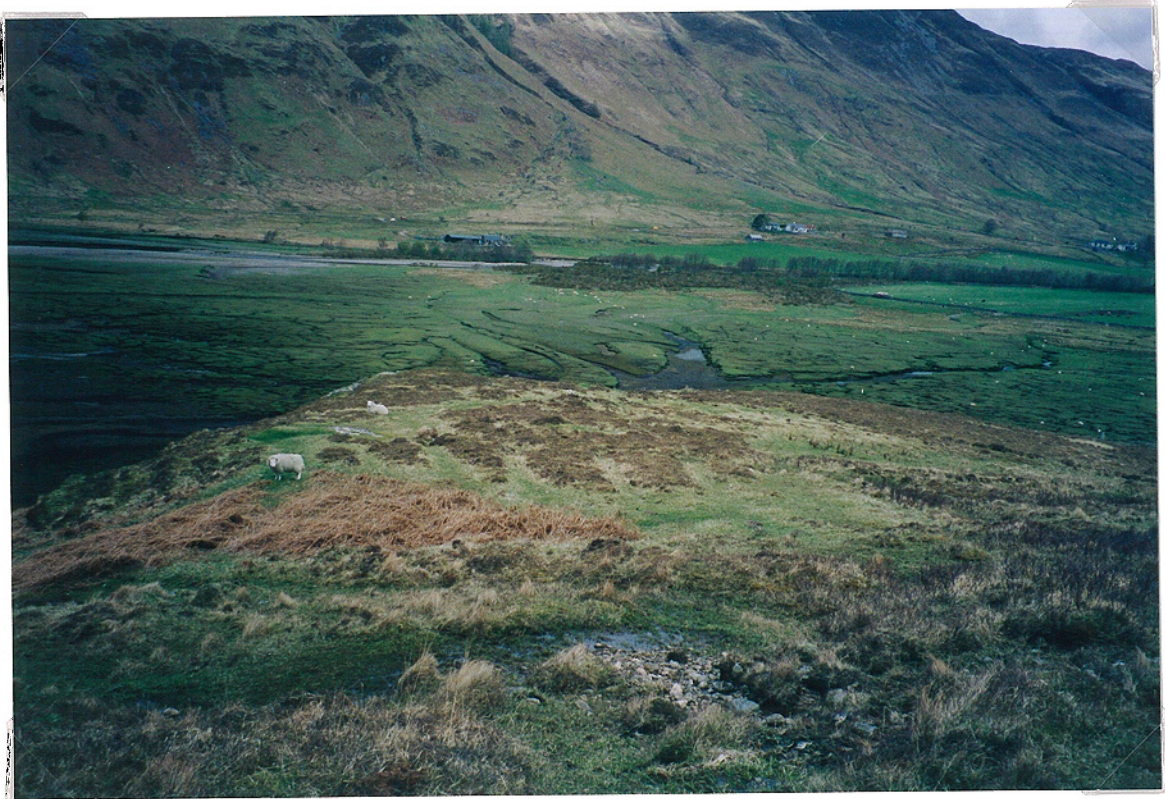
52

Site description: A small patch of rigs measuring c20m N/S by c18m E/W is visible on a knoll. They are c2m wide from ditch centres. They may have been truncated by turf cutting.

Condition: Stable*Interpretation:* No

Management needs Photo in the spring every 5 years - if change is noted between photos the management needs should be discussed with the NTS archaeologist.

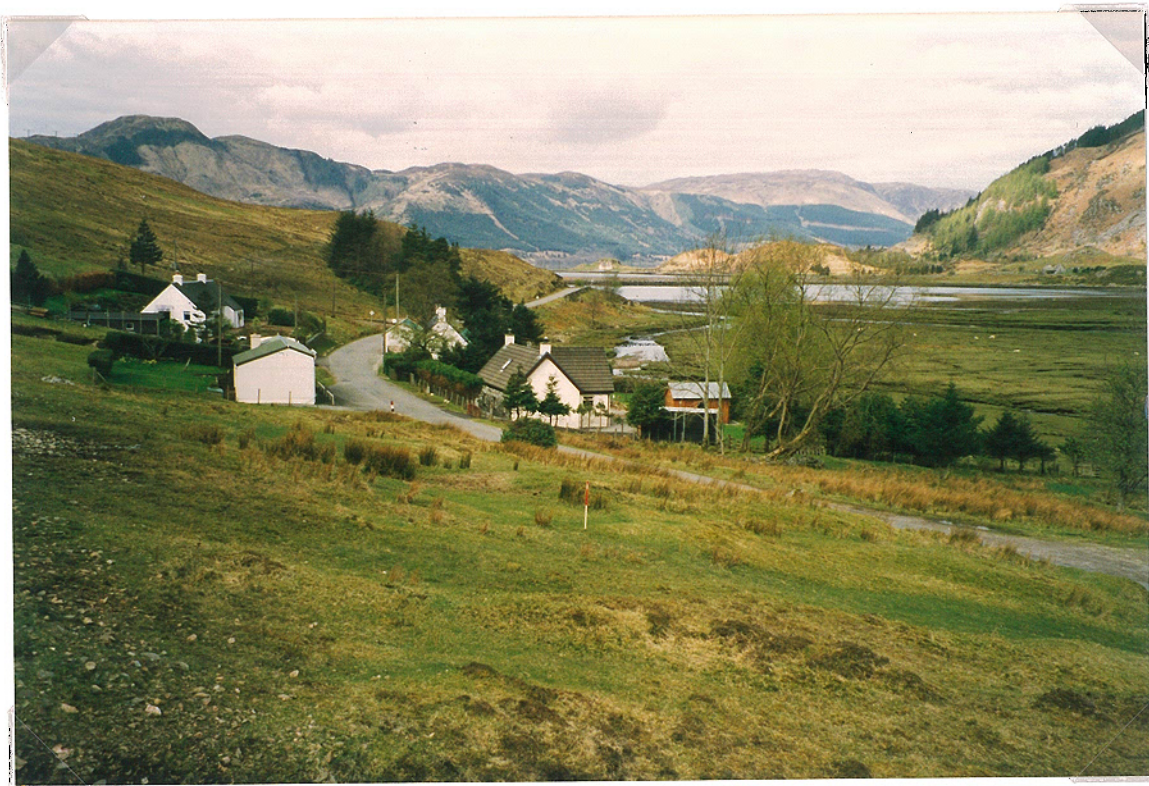
54

Condition: Minor threats from overgrazing

Management needs This former building site is being damaged by overgrazing, causing poached ground. It should be monitored every year, and photographed in the spring every 5 years - if change is noted between photos the management needs should be discussed with the NTS archaeologist.

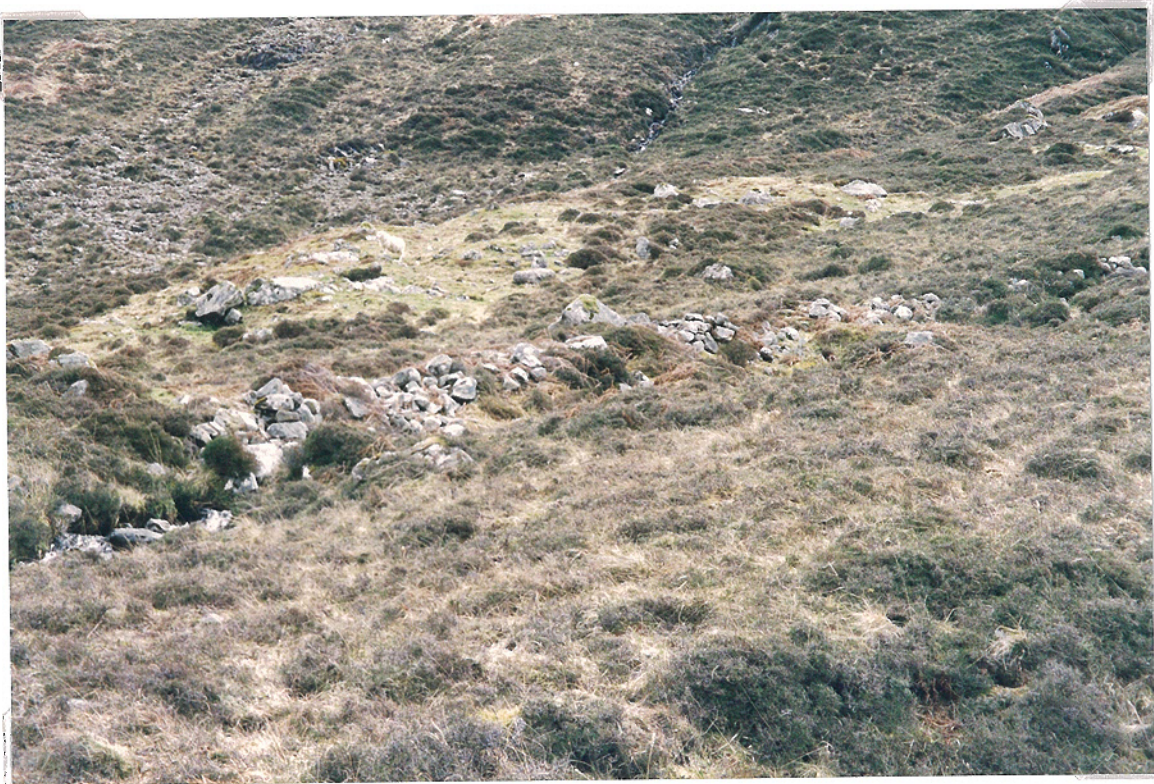
56

Site description: Two rectangular structures are sited here on either side of an un-named burn. One is c10m long by c3.5m wide over walls c0.7m wide and c0.4m high. It is aligned SW/NE. The other is a smaller structure, c5m long by c3m wide over walls c0.8m wide up to 1.6m high. It is aligned W/E. These buildings are said to have been demolished c30 years ago. They are now almost hidden amongst trees and shrubs.

Condition: Major threat from trees and shrubs

Management needs Photo in the spring every 5 years - if change is noted between photos the management needs should be discussed with the NTS archaeologist.

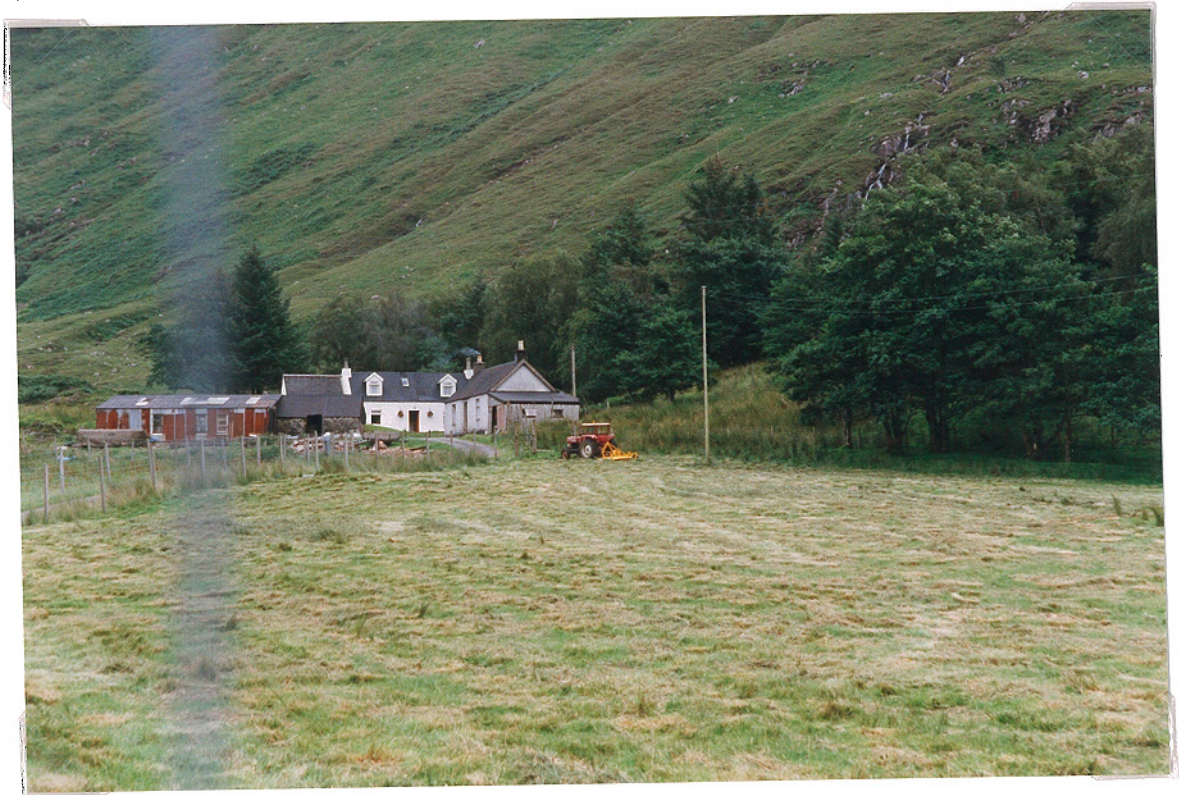
58

Condition: Future threat from the construction of more telecommunications masts on the site

Management needs A detailed survey should be undertaken of the site to assess whether parts of the site should be reinstated and protected from further damage. It might even be appropriate to excavate the site, to assess its true nature and to recover all remaining archaeological material before it is further damaged.

The site should certainly be photographed in the spring at least every 5 years - if change is noted between photos the management needs should be discussed with the NTS archaeologist.

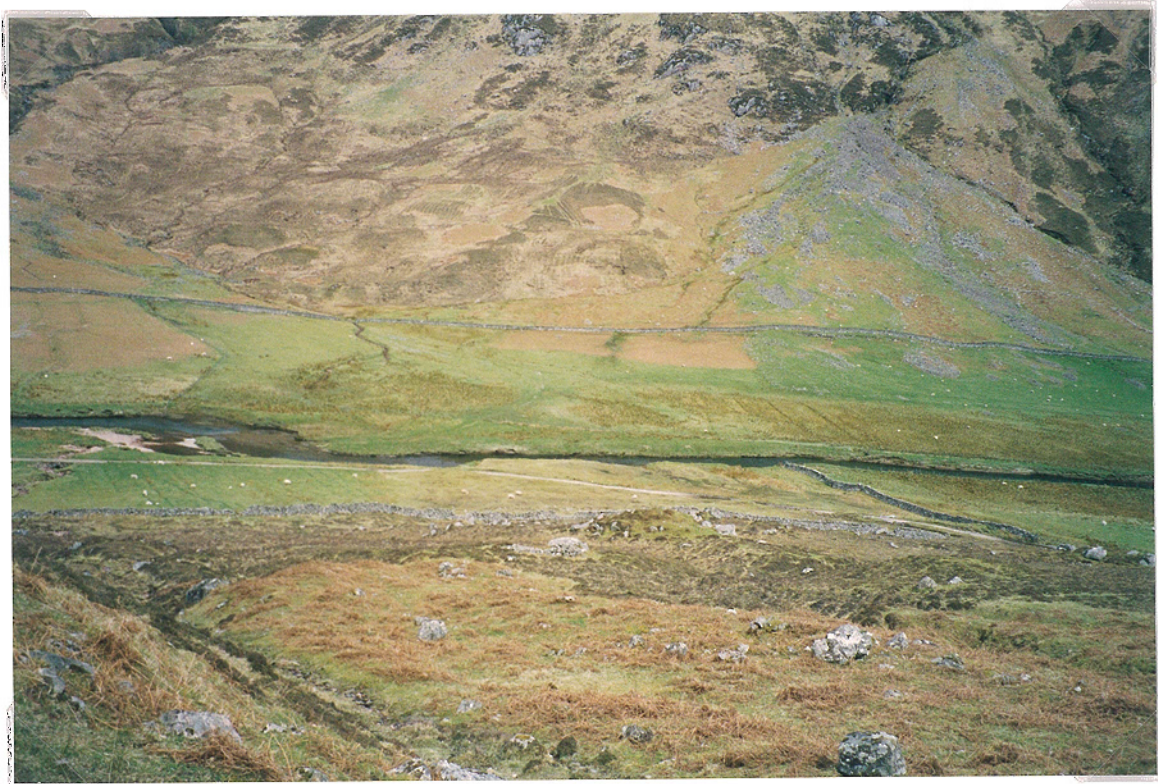
62

Site description: In an area of rocky ground associated with two small burns there is a round-ended drystone walled structure. It measures c5m by c3m and is aligned NW/SE with an entrance facing E. The walls survive to c0.3m high and c0.8m thick. Additional chambers c3m long over the walls abut either end of this building.

If found in isolation these would be described as part of a shieling but from their location they appear to be part of the township that lies to the SE. The boulder construction suggests they may have been used as sheds or pens for animals rather than as dwelling places.

Condition: Minor threat from bracken

The site should certainly be photographed in the spring at least every 5 years - if change is noted between photos the management needs should be discussed with the NTS archaeologist.

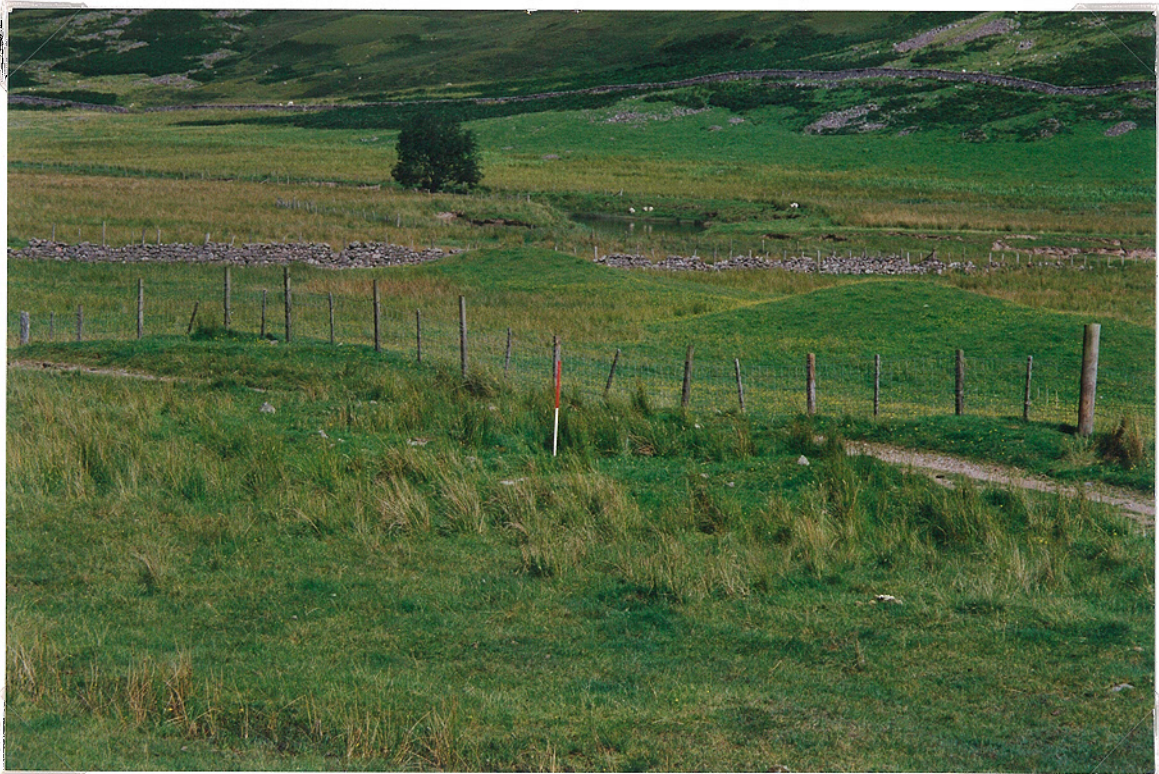
64

Site description: A possible platform for a structure, aligned NW/SE is c7m by 4m. A smaller ?turf walled round-ended structure lies 10m to the SE measuring c5m by c2m across walls up to 0.3m high and c0.6m wide. It is aligned NNW/SSE. There are faint signs of stone footings here. The grass in the interior of this structure is distinctly more verdant.
A third structure was noted at NG97791994 just by the track. This structure is c8m by c4m over walls c1m wide and up to 0.4m high. It is aligned NW/SE. Its shape is uncertain but it may have been round-ended.
The remains of rigs can be seen running NE from these structures and up to the modern track. The rigs are superceded by the stone dyke which crosses the area.
These structures may be part of a southern extension of the township of Glascorey.

Condition: Future threat from stone robbing

The structure by the track should not be used as a source of cobbles for repairing the track or any of the stone dykes and its condition should be monitored annually. The site should certainly be photographed in the spring at least every 5 years - if change is noted between photos the management needs should be discussed with the NTS archaeologist.

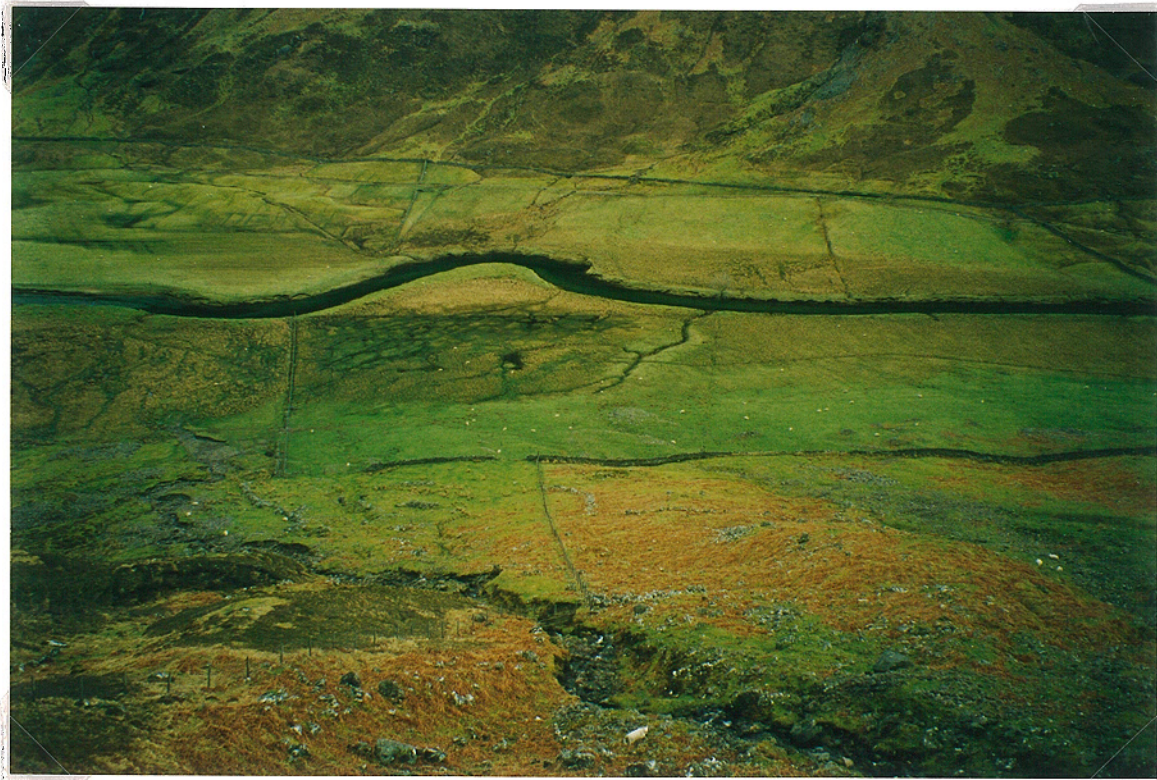
66

Site description: A drystone enclosure 800m by 150m lies on the S side of the river Lichd. The walling c0.7m wide and c1.2m high is well constructed and largely intact, though it has been partially replaced by post & wire fencing. This enclosure was presumably built in the sheep farming days of the early to mid-19th century.

Condition: Stable

Management needs A detailed EDM survey and further documentary research should be undertaken of the area, to cover the township of Glascory.
It may be appropriate to maintain this enclosure dyke but before any work is undertaken advice should be sought from the NTS archaeologist.
The site should certainly be photographed in the spring at least every 5 years - if change is noted between photos the management needs should be discussed with the NTS archaeologist.

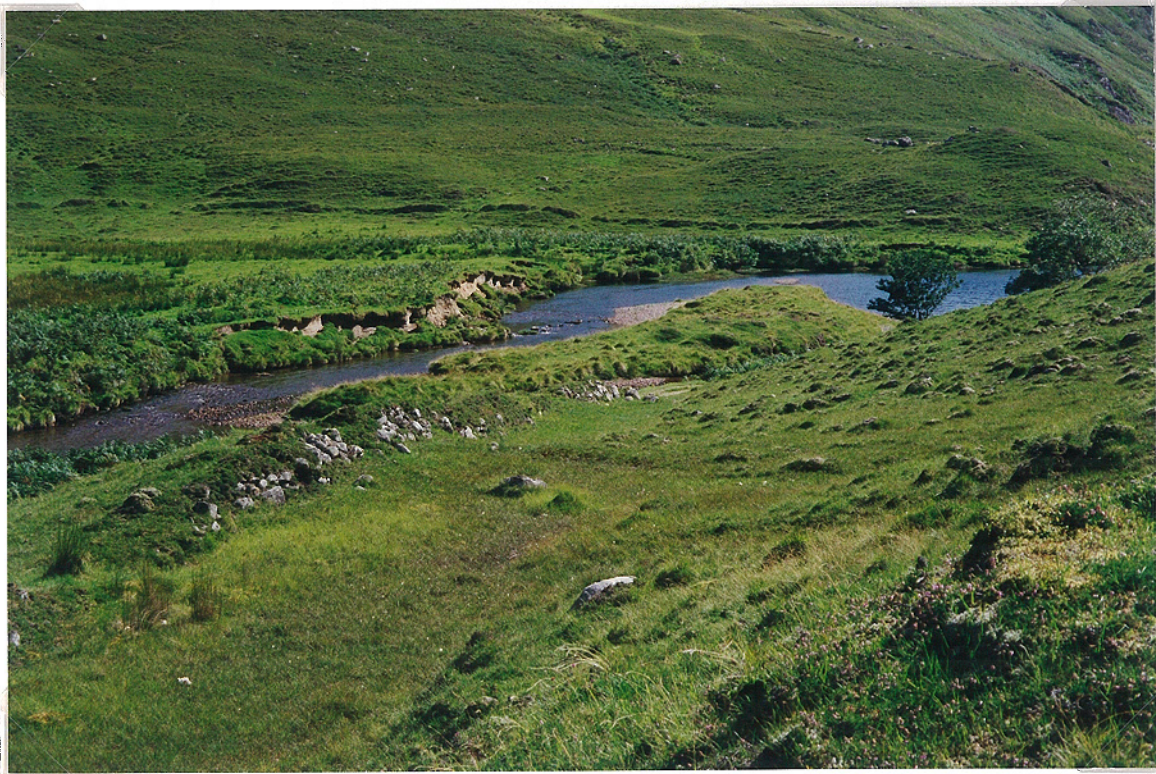
69

Site description: A stone faced bank c1.5m wide and up to 1m high continues the line of the later stone dyked enclosure [KIN066] for some 100m to the SE. There is no physical link between these features, probably because the original dyke has been washed away by the burn. This is presumed to be part of the enclosure associated with Glascorey and cleared in the early 19th century for sheep farming. It is possible that this was the head dyke defining the arable ground from the pasture.

Condition: Stable

The site should certainly be photographed in the spring at least every 5 years - if change is noted between photos the management needs should be discussed with the NTS archaeologist.

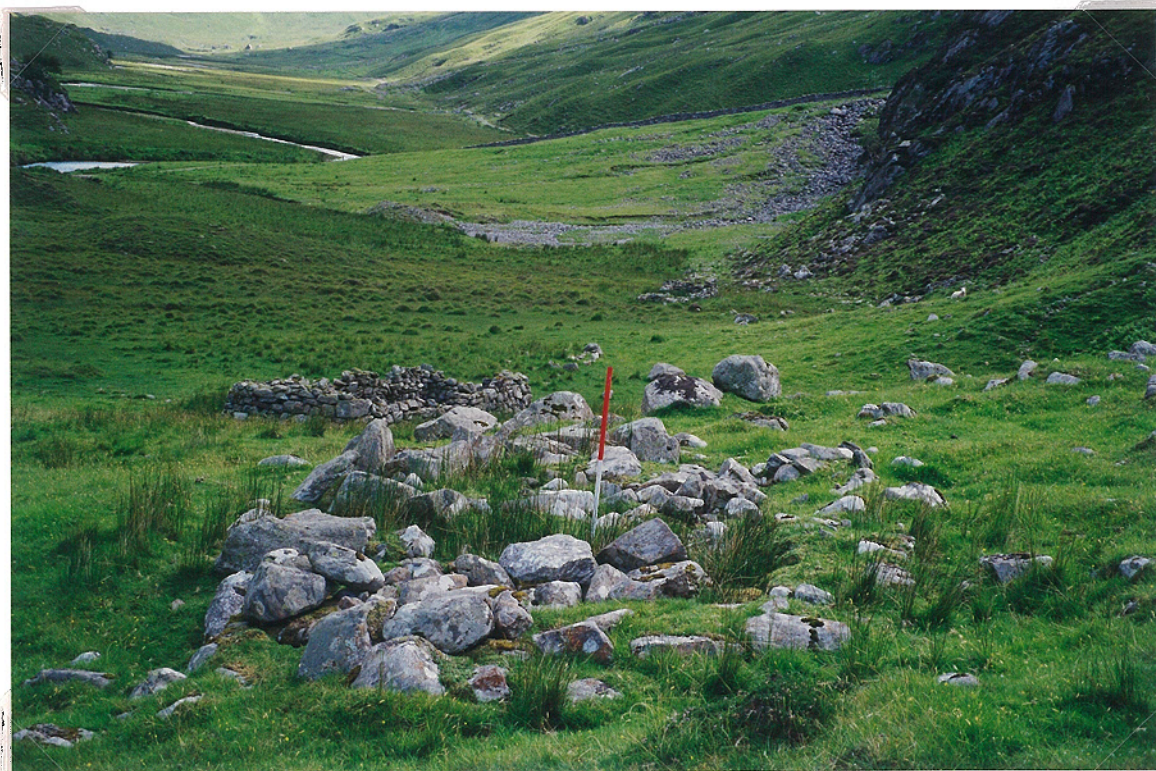
71

The remains of 5 drystone structures were noted here, all aligned approximately NW/SE. Only 2 unroofed buildings were shown in 1902 but 4 are recorded on the 1971 OS map. The structure lying c20m to the NW of the burn is round-ended measuring c6m by c3m with boulder walls up to 1m high and c0.7m wide, though these have largely collapsed. Some 17m to the SE of the burn is a collapsed structure measuring c4m by c3m over walls c0.65m thick and c0.2m high, with an entrance on the NE side. This had not previously been mapped. Some 30m further to the SE is a substantial structure measuring c9m by c4m with walls of undressed drystone construction c0.7m wide, surviving up to 1m high. There is a single entrance on the NE. The structure is round-ended on square footings. There are no sign of cruck slots. The fourth structure c15m to the SE only survives to its footings and measures c6m by c3.5m over walls c0.65m wide and c0.2m high. It is possibly square-ended. The fifth structure c33m to the SE is c6m by c3m with walls c0.7m wide and up to 0.7m high. It was originally round-ended but has been partially altered and robbed out at the W. These are probably the remains of a small pre-19th century township.

Condition: Stable*Interpretation:* No*Management needs* The site should certainly be photographed in the spring at least every 5 years - if change is noted between photos the management needs should be discussed with the NTS archaeologist.

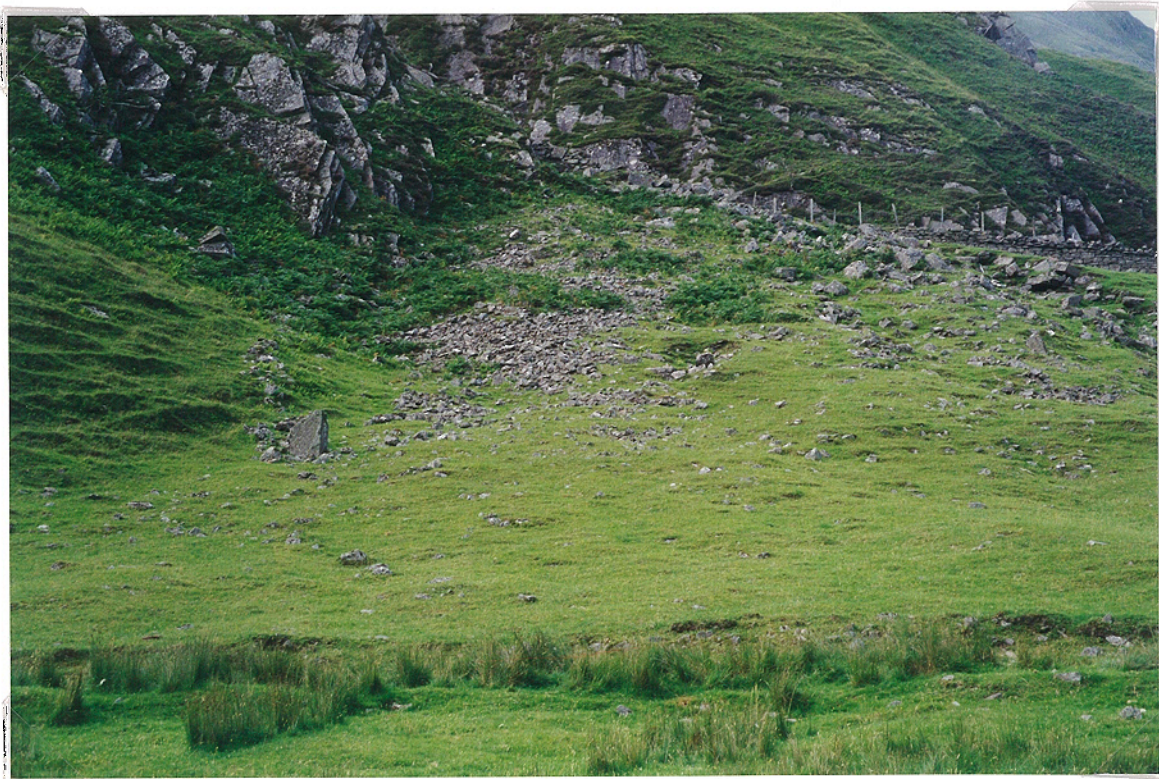
73

Site description: A substantial drystone dyke runs NE/SW over the grass-covered scree spread on the S side of the Eas Druim na Staidhre. This still forms a boundary restricting access to S end of Glenlichd. It was probably first built in the early or mid-19th century, possibly replacing the dyke KIN073. The dyke has recently been restored (NTS volunteers?) presumably because of flood damage.

Condition: Stable

Management needs The site should certainly be photographed in the spring at least every 5 years - if change is noted between photos the management needs should be discussed with the NTS archaeologist.

It may be appropriate to repair the drystone dyke again in the future but if so a full photographic record should be undertaken first and details of the proposed work should be discussed in advance with the NTS archaeologist.

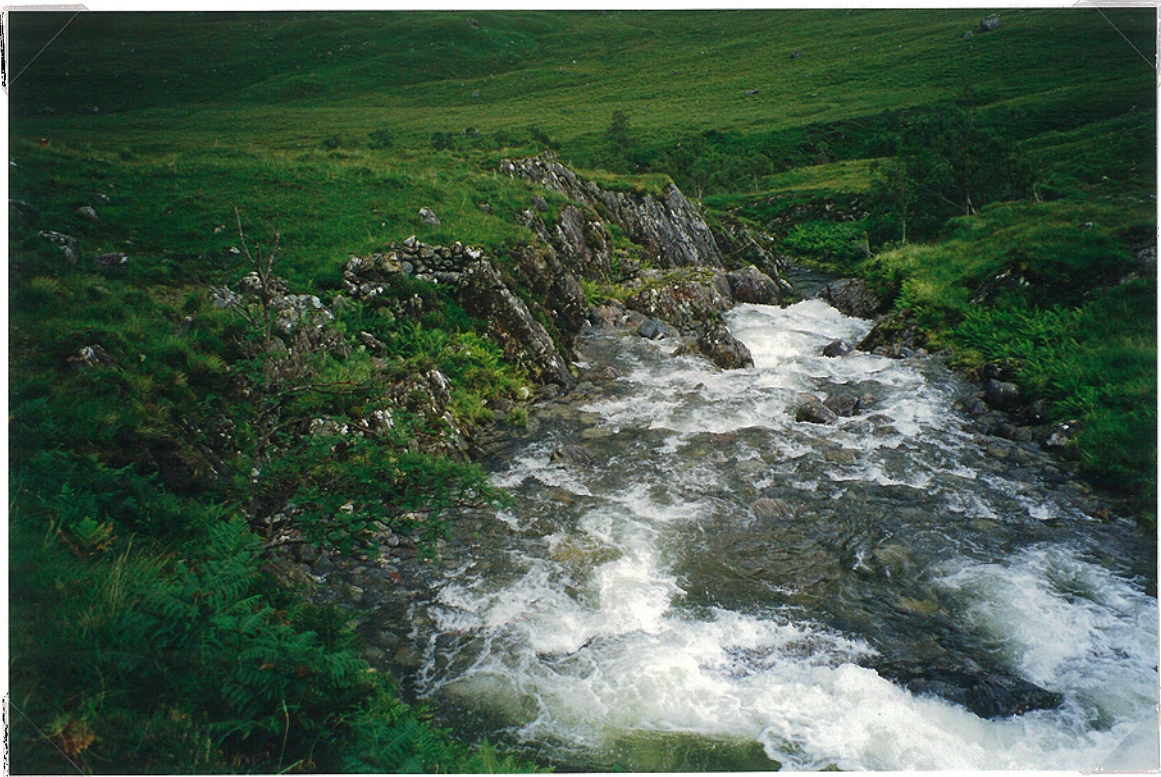
86

A 9m stretch of collapsed drystone walling c0.4m wide and c0.5m high lies on the N bank of the Allt an Lapain just to the W of a small waterfall. No structure is associated with this and no other stretches were seen. This dyke was probably built to prevent stock gaining access to the burn at this point. It may have been built in the 19th century after the sheep runs were established.

Condition: Minor threat from burn

Management needs The site should certainly be photographed in the spring at least every 5 years - if change is noted between photos the management needs should be discussed with the NTS archaeologist.

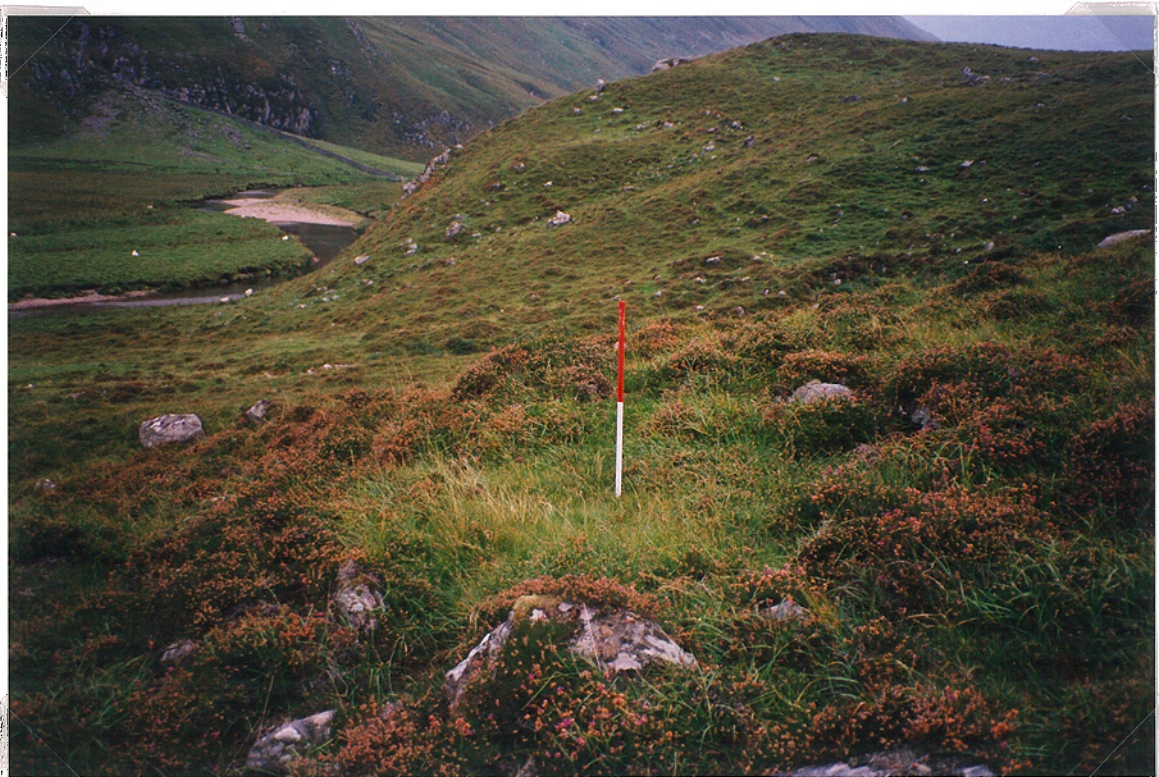
111

Condition: Stable

Management needs The site should certainly be photographed in the spring at least every 5 years - if change is noted between photos the management needs should be discussed with the NTS archaeologist.

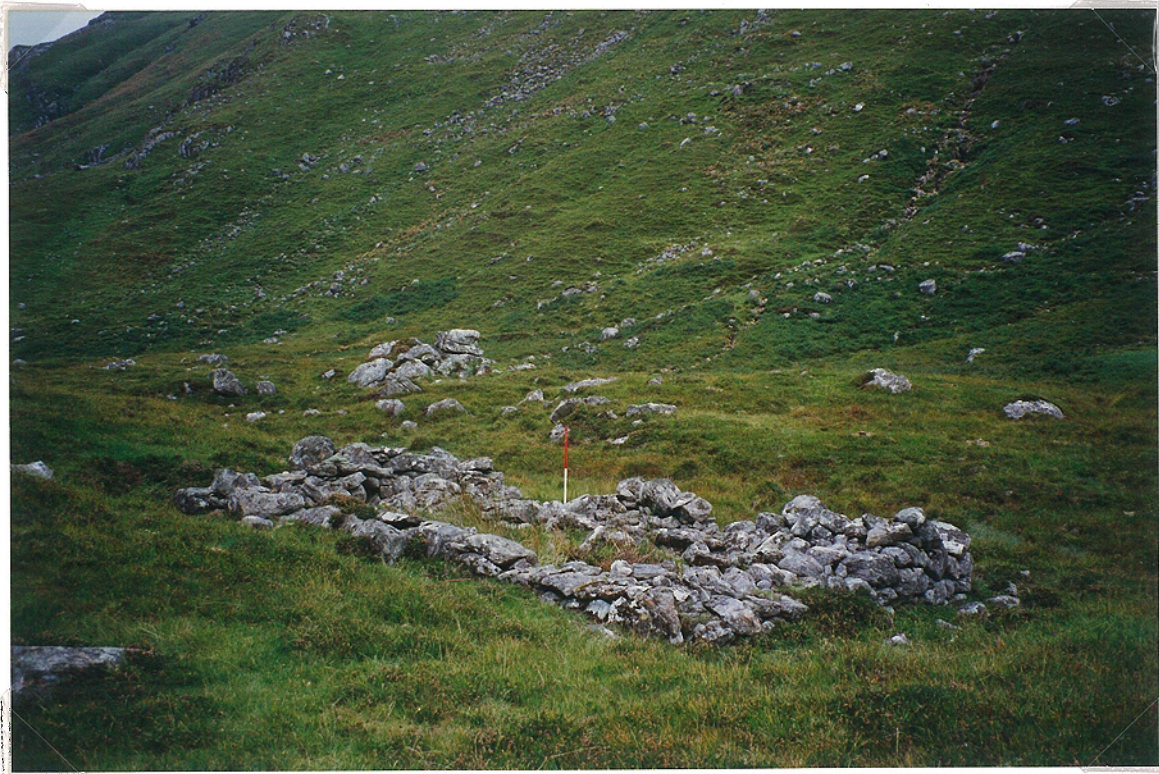
113

Site description: A round-ended drystone structure c8m by c4.5m over walls spread in places to c0.9m wide and c0.7m high and aligned E/W sits on a slight grassy terrace overlooking an unnamed burn. The walls have been partially robbed to build a secondary structure c1m square internally with walls c1m high and c0.5m wide.

Condition: Stable

Management needs The site should certainly be photographed in the spring at least every 5 years - if change is noted between photos the management needs should be discussed with the NTS archaeologist.

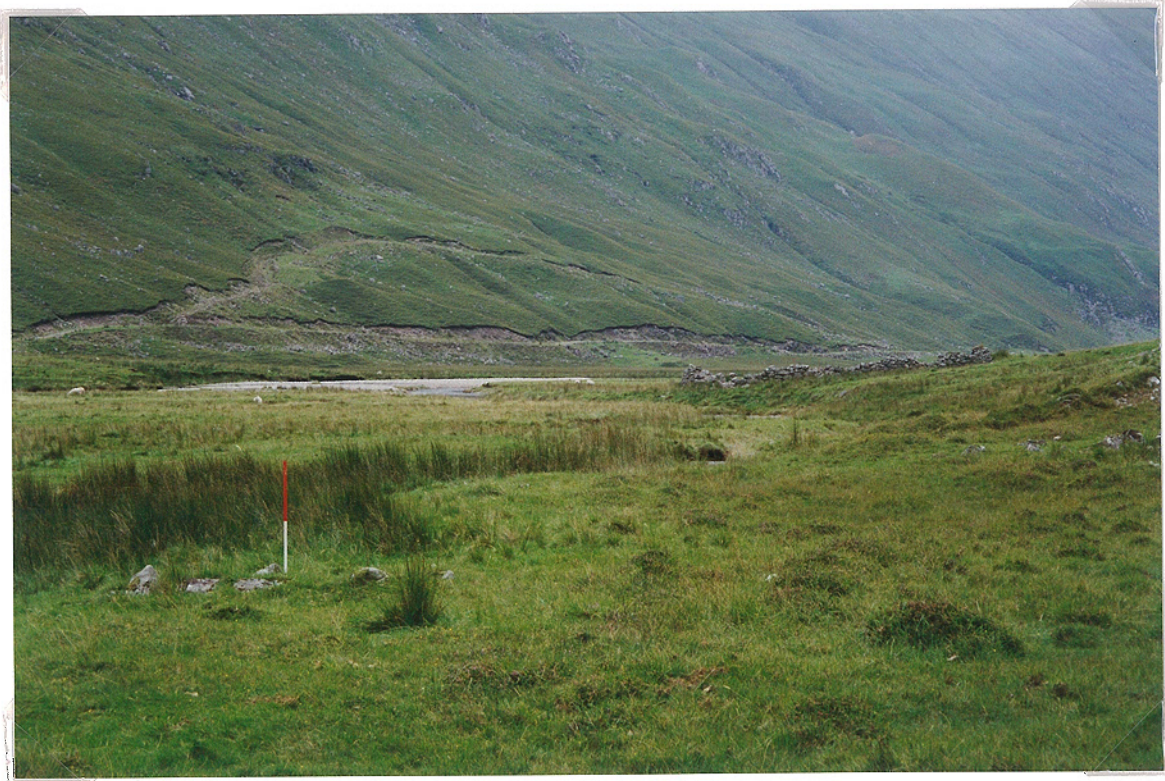
115

Site description: A series of turf dykes spread to c1.2m wide and up to 1m high follow the burn immediately N of KIN113 and also appear to define a field to the W on the flatter ground by the river. An isolated broad bank c1.5m wide and c0.6m high runs for c50m N/S.

Condition: Stable

Management needs The site should certainly be photographed in the spring at least every 5 years - if change is noted between photos the management needs should be discussed with the NTS archaeologist.

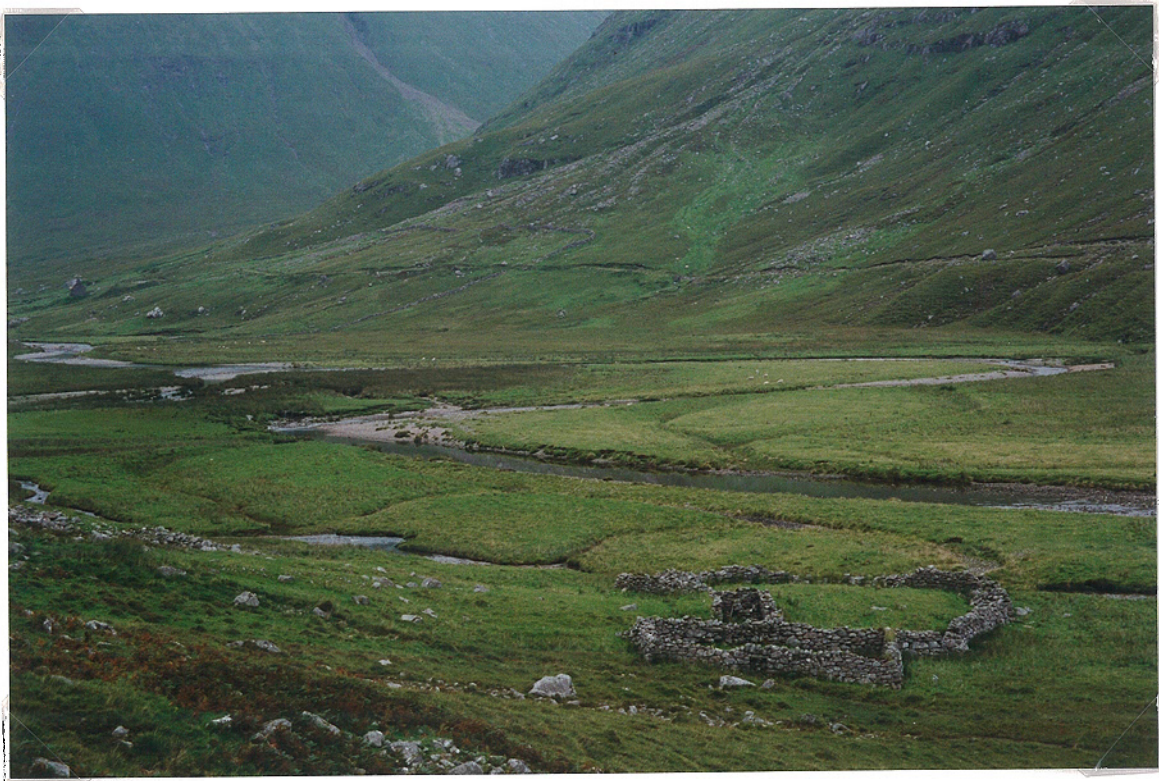
116

Site description: Due N of a decayed iron fence and immediately to the E of a small channel running NW into the river Croe are a series of low grass covered hollows. The southernmost is almost certainly a structure measuring c6m by c3m. The other 4 on both sides of the channel may also be the remains of structures of indeterminate sizes.

These features could be the decayed remains of a former shieling.

Condition: Stable

Management needs The site should certainly be photographed in the spring at least every 5 years - if change is noted between photos the management needs should be discussed with the NTS archaeologist.

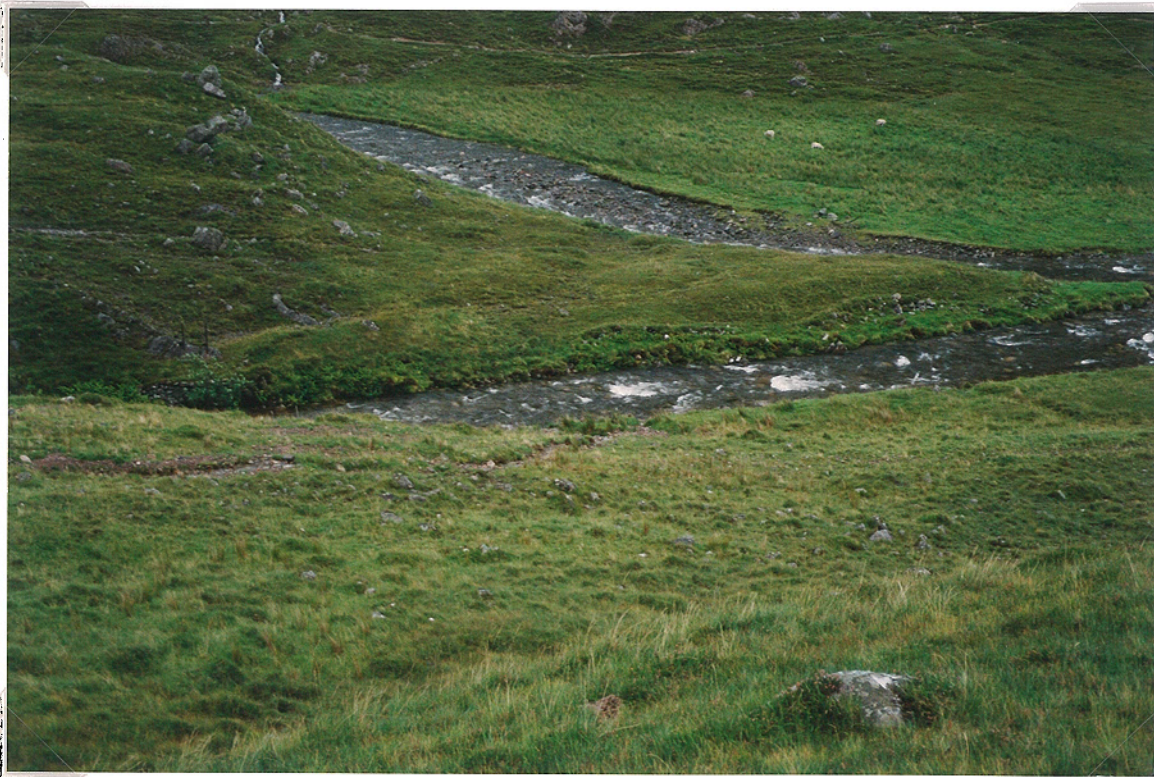
123

Condition: Future threat from visitor use

Management needs Photo in the spring once every 5 years - if change is noted between photos the management needs should be discussed with the NTS archaeologist.

Increased visitor use may cause erosion around the two sides of the bridge and this may require monitoring and eventual ground reinstatement.

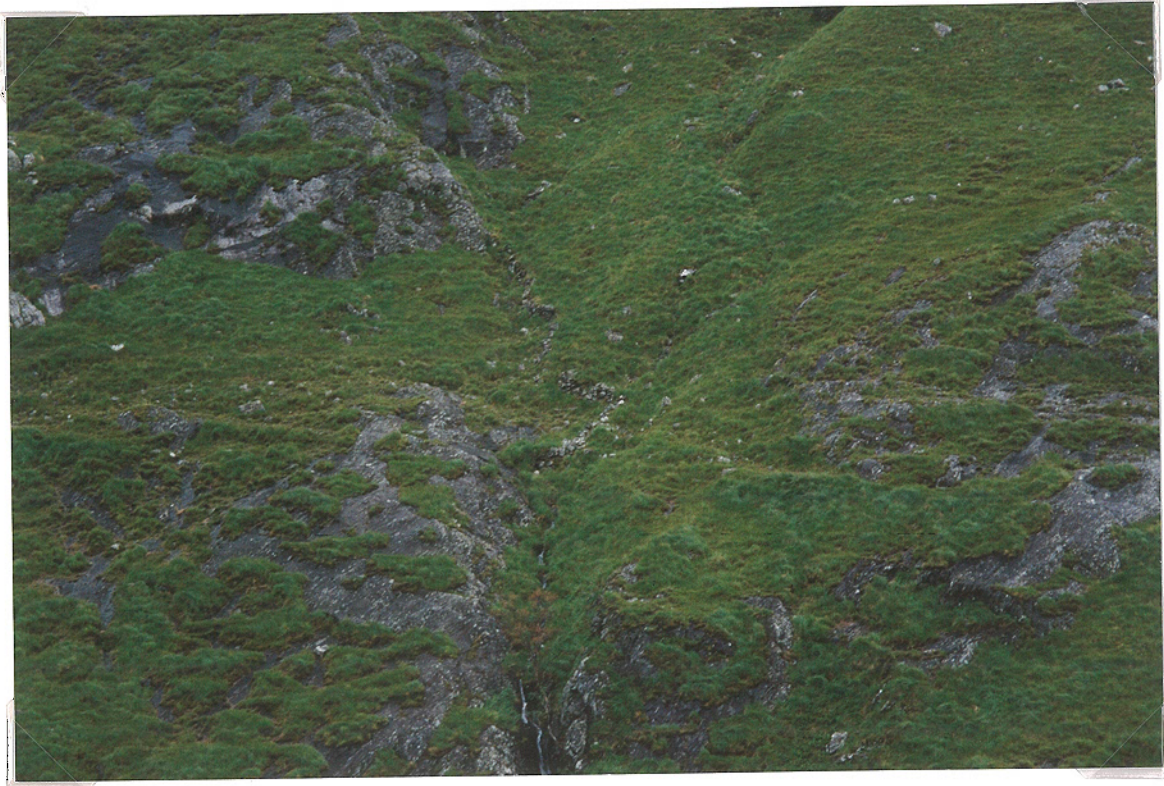
Site description: A 50m length of dyke c0.8m wide and c0.4m high recorded here is also shown on the 1971 OS survey. It was not recorded on the 1st or 2nd edition OS maps.
