**KINTAIL & WEST AFFRIC
ARCHAEOLOGICAL SURVEY**

1997

VOLUME 3

The National Trust for Scotland

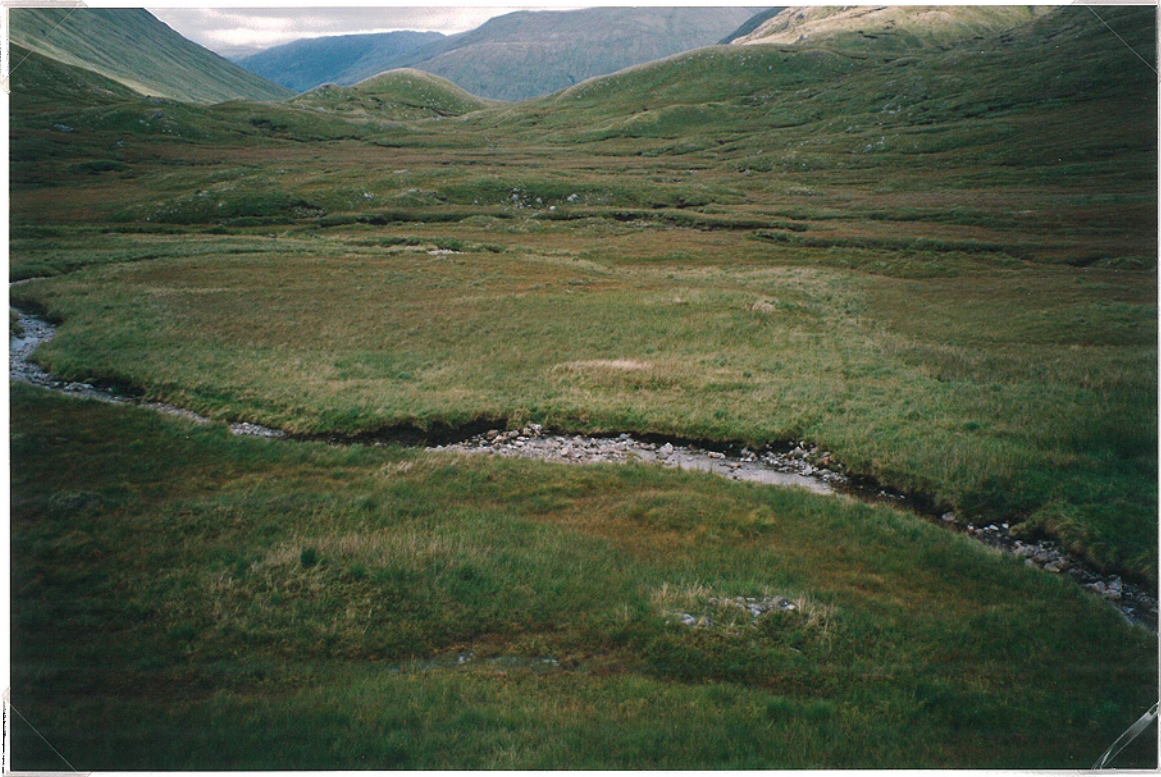
131

OS grid: NH02602048 *Site name:* Alltan Nighean Alasdair
NMR no: *Parish:* Glenshiel
HC SMR no: *Local Authority:* Highland: Lochalsh
NTS no: KIN131 *Site type:* shielings
Designations: *Importance:* locally important
Other refs: *Vegetation:* rough grassland

Site description: Some 200m S of Loch a' Bhealaich on the S side of the Alltan Nighean Alisdair are the possible stone footings for a turf walled shieling c5m by c3m aligned WNW/ESE with stones protruding from the grass. A tiny stone walled structure c0.5m wide at the S widening to c1m wide at the N internally, with walls c0.6m wide and c0.2m high, is sited nearby to the W. About 7m to the E is a mound measuring c5m by c4m aligned more N/S. There are other mounds in the vicinity that may also once have been structures. These are too overgrown to be confirmed as 'real' features.

This is a small group of shielings. The feature to the W might have been used as a still site and perhaps even after the shieling was abandoned as it is the most prominent feature in the group.

Condition: Stable

Management needs Photo in the spring once every 5 years - if change is noted between photos the management needs should be discussed with the NTS archaeologist.

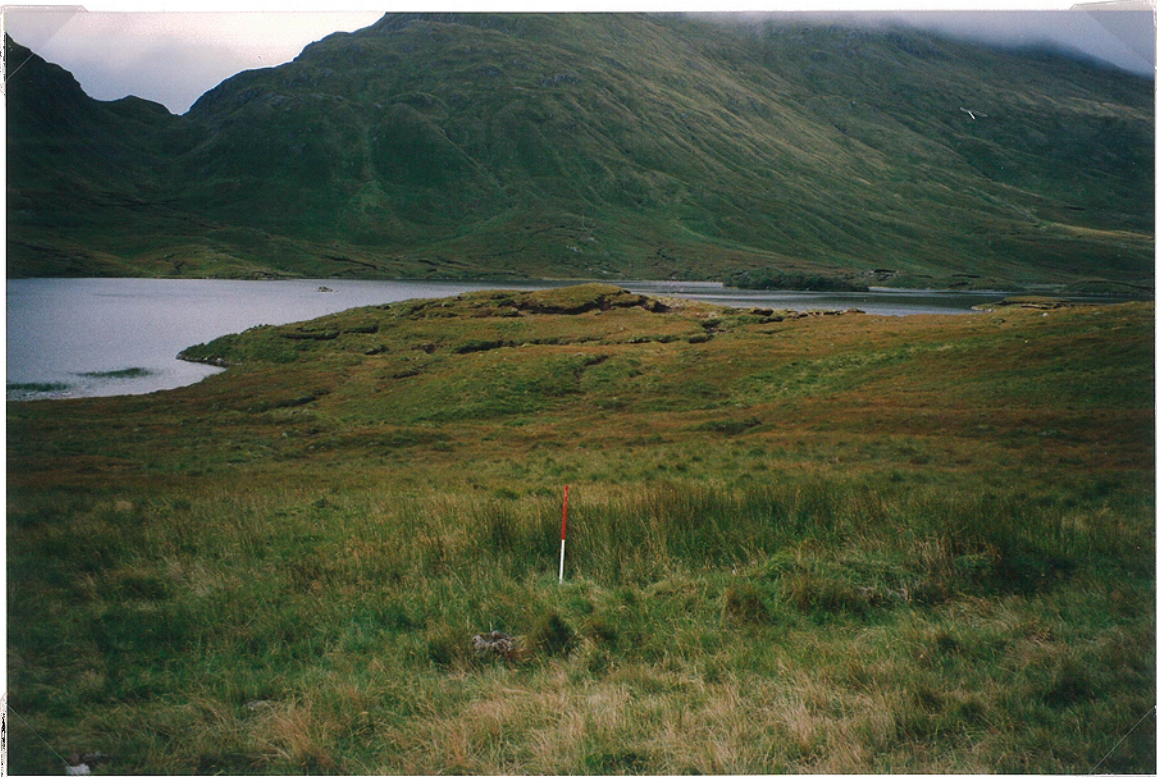
132

OS grid: NG02752107 *Site name:* Loch a' Bhealaich
NMR no: *Parish:* Kintail
HC SMR no: *Local Authority:* Highland: Lochalsh
NTS no: KIN132 *Site type:* ?shieling, ?deer watcher's bothy?
Designations: *Importance:* locally important
Other refs: *Vegetation:* grassy flush with rushes
Land use: grazing by deer
Management: monitor once every 5 years

Site description: To the W of the path recorded on the 1971 OS map and S of an unnamed burn are the turf capped footings c0.8m wide and c0.3m high of a structure c8m by c3m aligned N/S. Some 50m to the SE built against a large boulder c4-5m in diameter are the remains of a trapezoidal drystone structure c5m and c3m long by c4m wide. The irregular stone walls are up to 0.5m high and c0.7m wide.

Condition: Stable

Management needs Photo in the spring once every 5 years - if change is noted between photos the management needs should be discussed with the NTS archaeologist.

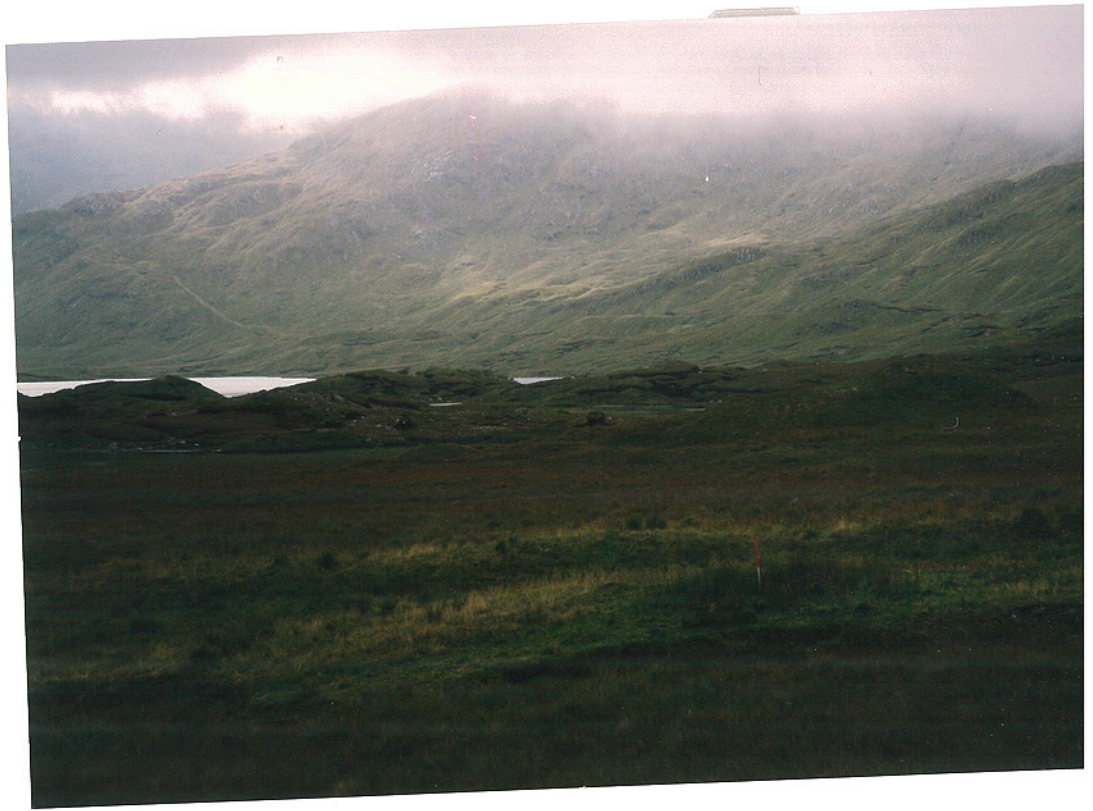
133

Site description: An oval of stones c4m by c3m and c0.6m wide and c0.2m high defines the edge of a rush-covered slight knoll besides an unnamed burn. About 12m to the W is another group of stones, though these may be a natural flood deposit. This is likely to be a shieling site but it is very ill-defined.

Condition: Minor threat from flood damage

Management needs Monitor to prevent flood damage. The site should certainly be photographed in the spring once every 5 years - if change is noted between photos the management needs should be discussed with the NTS archaeologist.

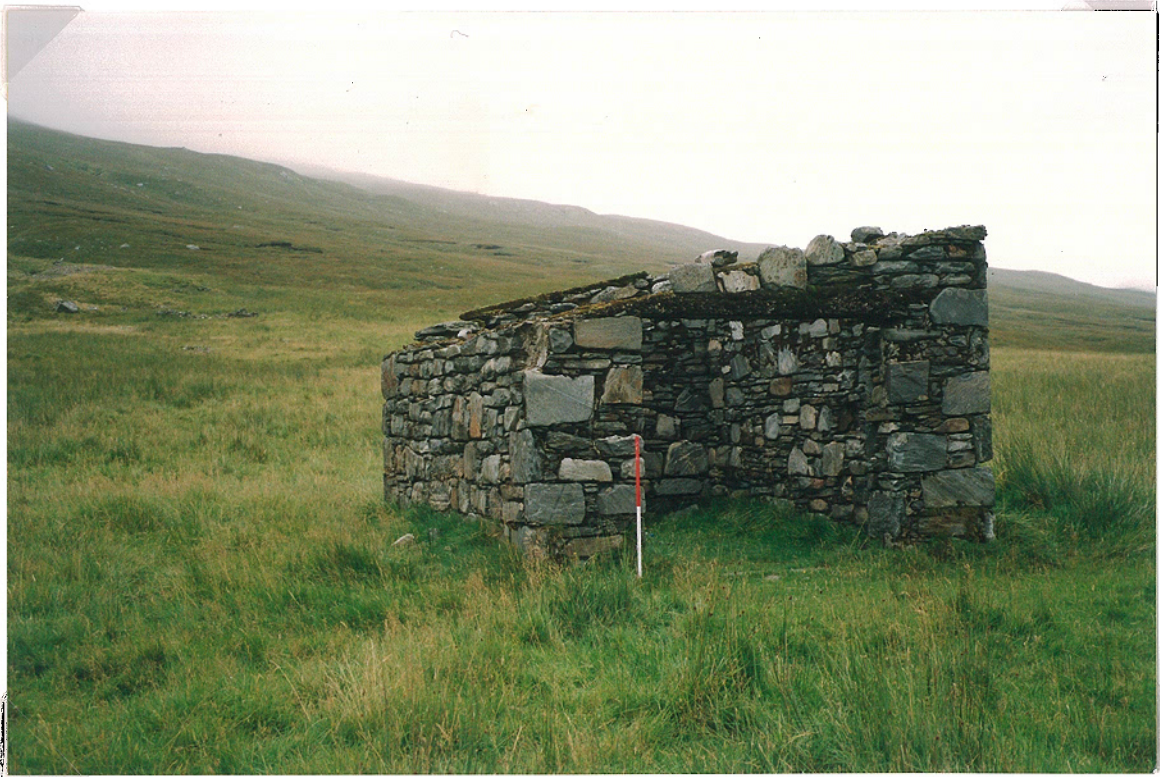
135

Site description: On the N shore of Loch Gaorsaic are the remains of a building c3.5m wide by c5m long with walls c0.6m wide. The doorway, fronting the loch, is 1.8m wide by c1.8m high. The walls appear to have been made of poured concrete. The roof slopes from N to S from c2.5m high to c1.75m high. Former timbers from this building have been burnt.

Condition: Stable

Management needs Photo in the spring once every 5 years - if change is noted between photos the management needs should be discussed with the NTS archaeologist.

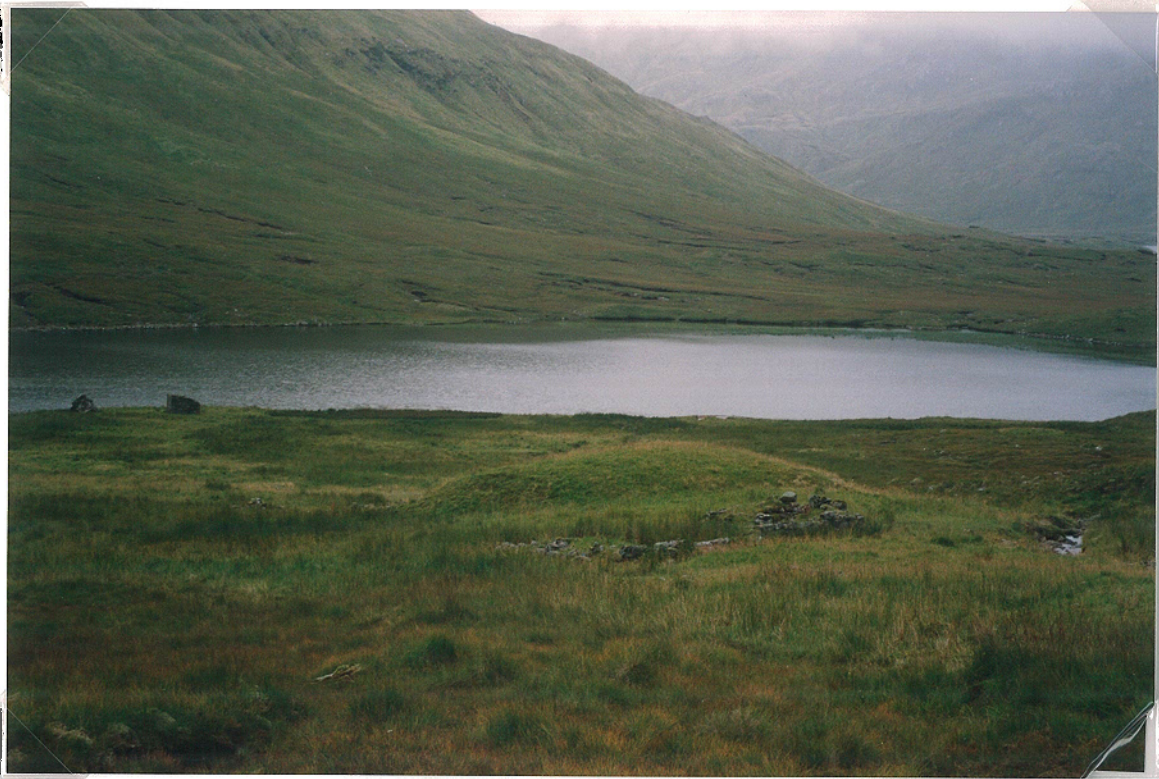
136

Site description: A group of 3 structures was noted here. The largest building is aligned NNE/SSW and measures c11m by c5m over stone walls c0.8m wide and surviving no more than c0.5m high. It is round-ended. Traces of mortar render survive in places externally. A secondary chamber c3m long is at its E end. About 20m to the SE and built against a large natural knoll is a drystone building c8m by c4m over walls c0.7m wide and up to 1m high. Some 30m to the SE of this is a third building measuring c8.5m by c5m. The walls of this building are ill-defined as 3 secondary structures c1-1.5m diameter with walls c0.6m wide and c1m high have built out of its robbed walls. In front of this building are the remains of a patch of rig cultivation 14m E by 10m N/S. The rig measures 2m in width.

Condition: Stable

Management needs Photo in the spring once every 5 years - if change is noted between photos the management needs should be discussed with the NTS archaeologist.

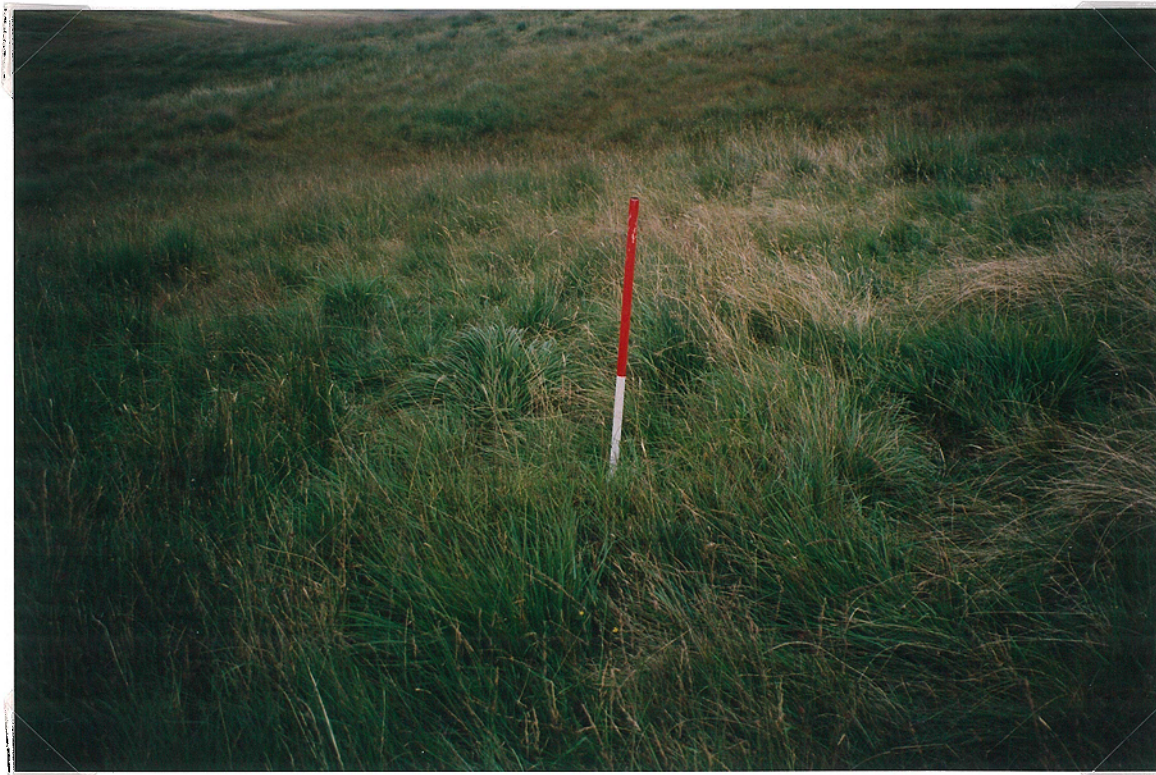
139

Site description: On the S side of an unnamed burn there is a rectangular chamber c1m wide with walls c0.6m wide and c0.4m high which has been built against 2 large boulders. An irregular stone dyke c0.6m wide and c0.2m high forms an enclosure c1.1m long by c1-3m wide around this chamber. Though in a grassy flush potentially suitable for a shieling, no other buildings or structures were noted.

Condition: Stable

Management needs Photo in the spring once every 5 years - if change is noted between photos the management needs should be discussed with the NTS archaeologist.

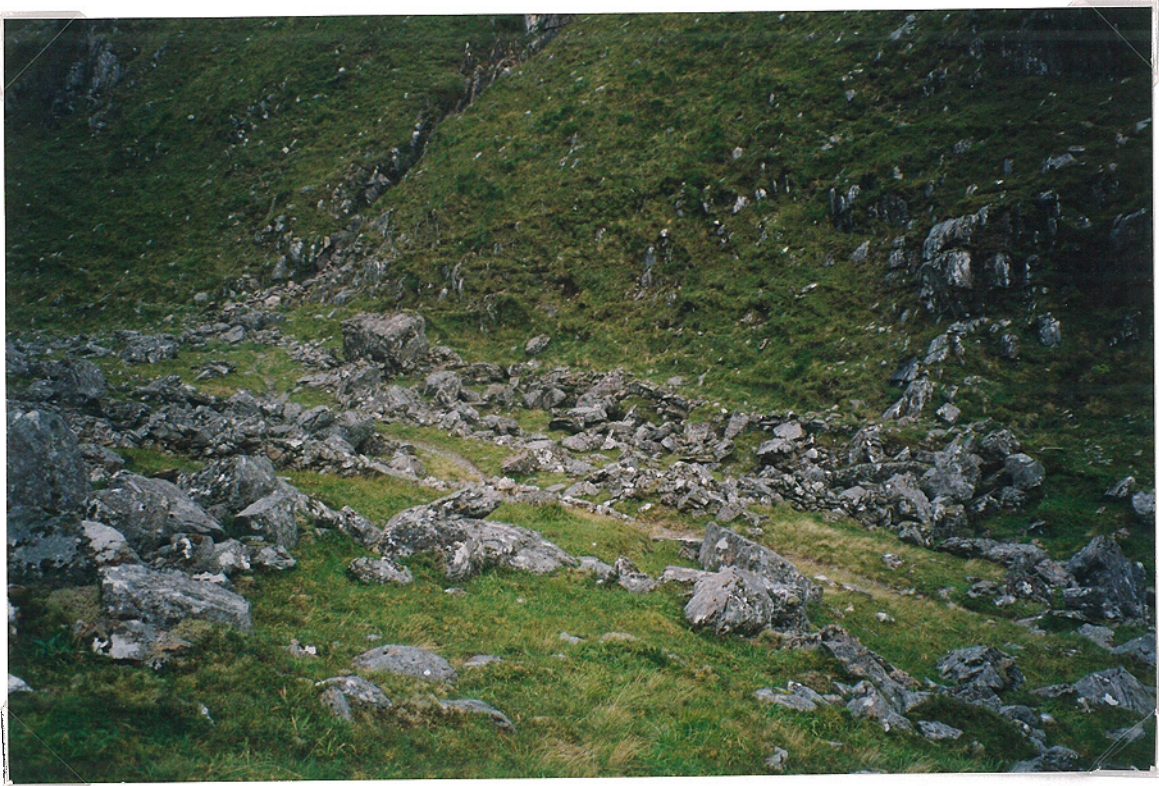
144

On the basis of 1 rusted iron post the revetting wall would appear to be part of a now removed wire fence, not elsewhere recorded. It is similar to, though more substantial than, the dyke at Abhainn Gaorsaic (KIN141). If contemporary with this fence these features are probably late in the sequence here. Not being shown on the 1st or 2nd edition OS maps the fence must have been built after 1902. These features could have aided in the gathering/herding of sheep.

Condition: Stable*Interpretation:* No

Management needs Photo in the spring once every 5 years - if change is noted between photos the management needs should be discussed with the NTS archaeologist.

At some stage the rusty tins should be cleared from the site

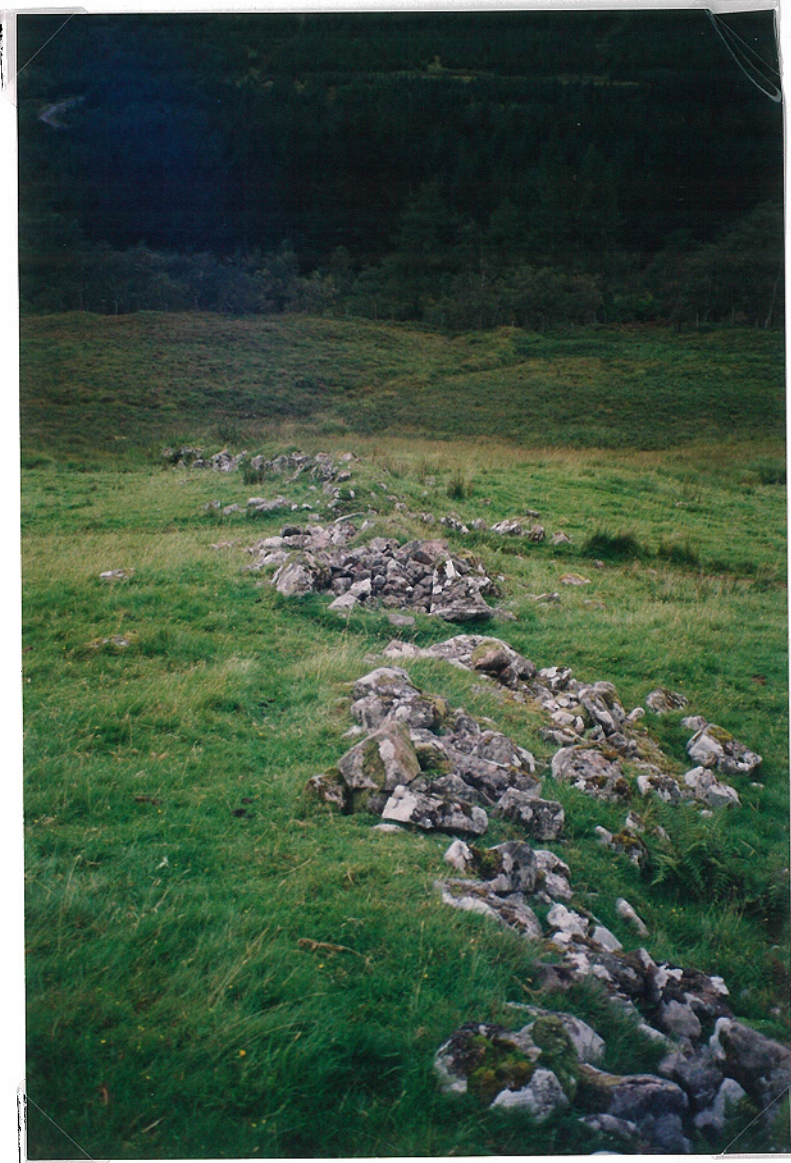
149

Condition: Minor threat from bracken, future threat from forestry

Management needs It might be appropriate to control the bracken by spraying with an approved chemical every 5 years or so. Whatever the decision, the site should be photographed in the spring once every 5 years - if change is noted between photos the management needs should be discussed with the NTS archaeologist.

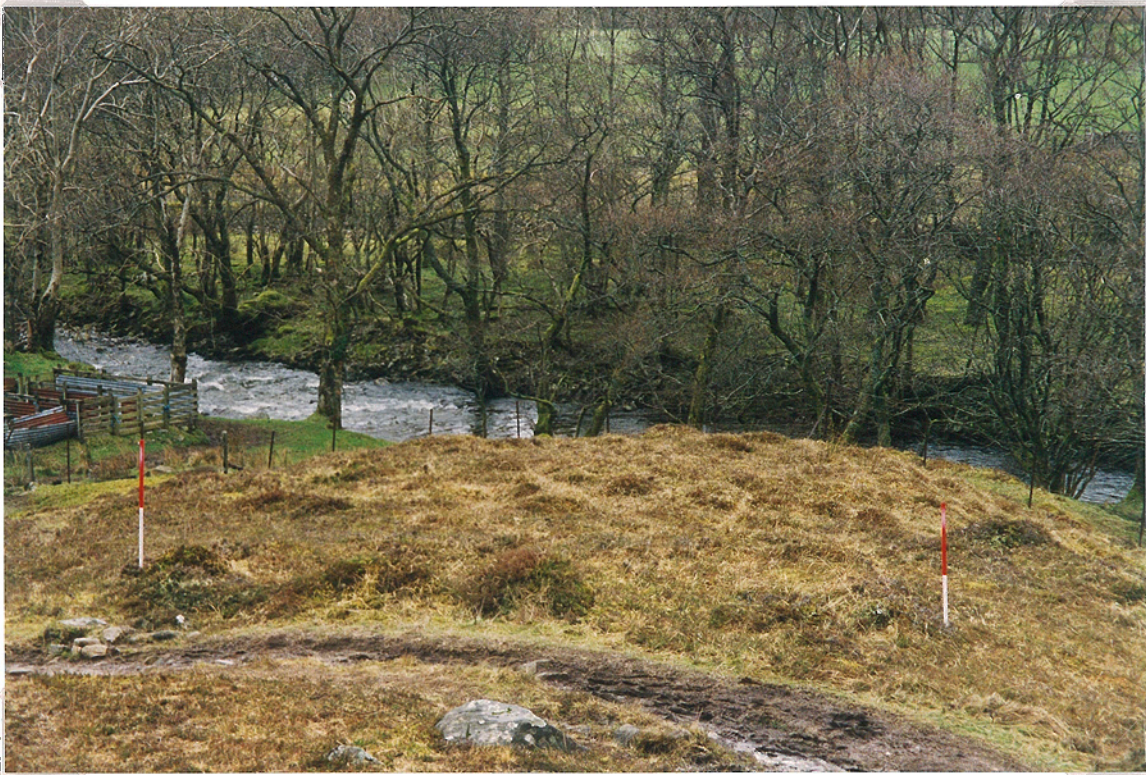
151

Condition: Future threat from forestry

Management needs An unplanted area at least 15m wide around this feature should be left in the proposed area for planting. This unplanted stretch should be regularly weeded so that there is no damage from tree roots or regeneration.

Photo in the spring once every 5 years - if change is noted between photos the management needs should be discussed with the NTS archaeologist.

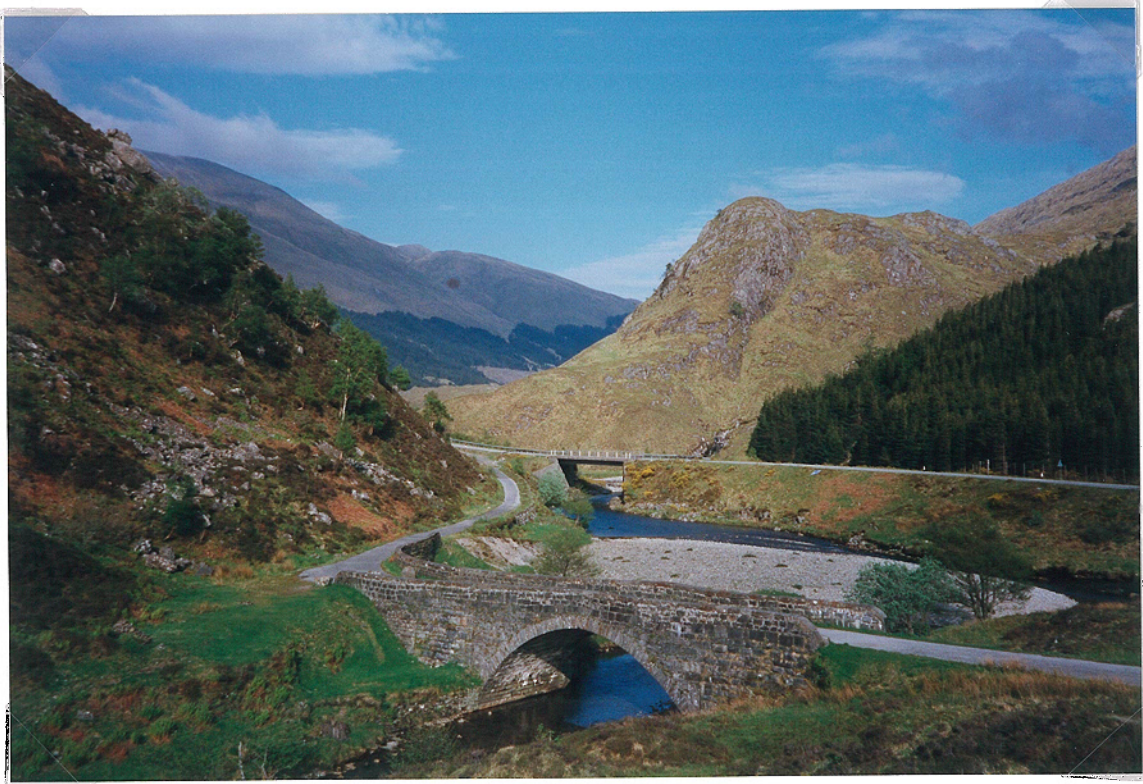
171

Site description: The interior of this sheepfold has a level platform c8m by c3m that during the site visit was interpreted as a structure. The sheepfold survives in good condition and retains creeps in its N & E walls. The S wall appears to have been removed since 1902, unless the structure was completely rebuilt.

Condition: Stable

Management needs Photo in the spring once every 5 years - if change is noted between photos the management needs should be discussed with the NTS archaeologist.

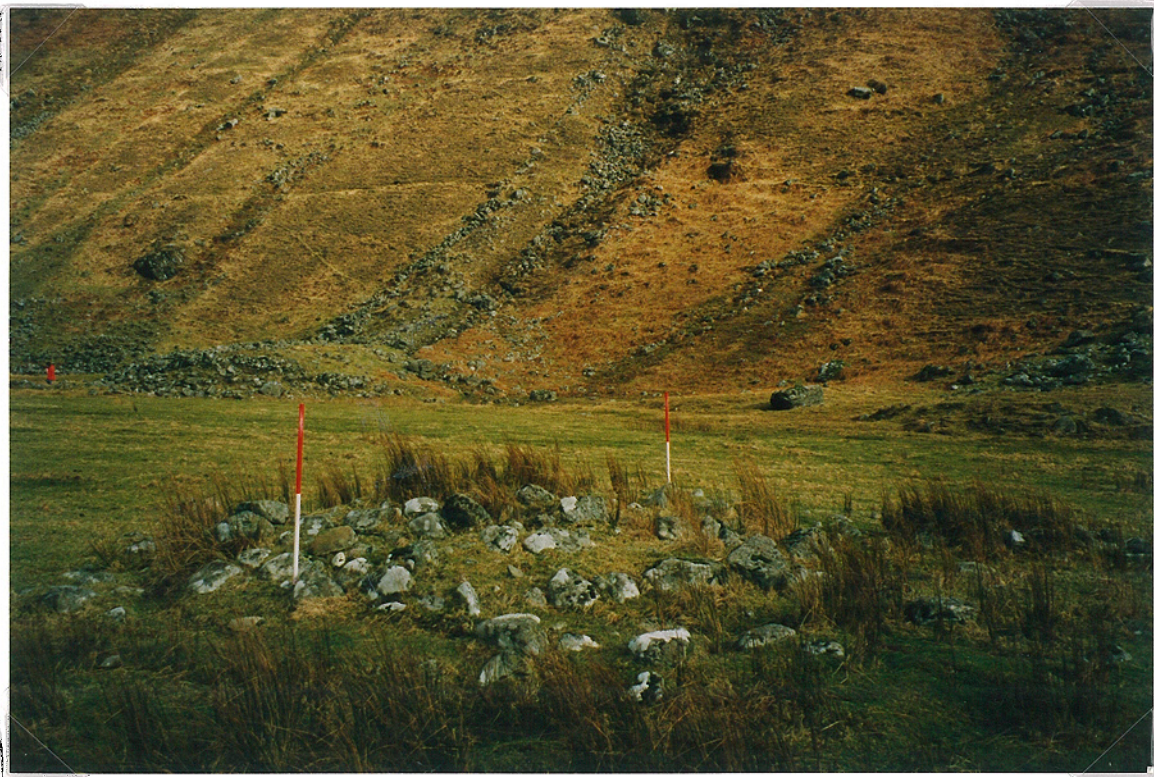
173

KINTAIL data**1997 onwards***OS grid:* NG96891448 *Site name:* Alltan na Ba Duinne*NMR no:* NG91SE003 *Parish:* Glenshiel*HC SMR no:* *Local Authority:* Highland: Lochalsh*NTS no:* KIN172 *Site type:* structures*Designations:* *Importance:* locally important*Other refs:* *Vegetation:* bracken, rough grassland*Land use:* grazing by deer/sheep*Management:* monitor once every 5 years

Site description: Here are 2 round-ended drystone structures aligned roughly ENE/WSW with entrances through the WSW gable. They are similar in size, measuring c 6.5m long and c3m wide over walls c0.9m wide and up to 0.9m high. The structure to the SE has been subsequently subdivided to create a smaller structure with at its WSW end. A possible third structure lies to the W and is also apparently a round-ended drystone structure. Most of this structure has been eroded by the burn, so that only a corner c1m wide is visible. Along the edges of the Allt na Ba Duinne the remnants of stone dykes or banks can be seen. It is not clear if these were built torevet the banks of the burn or to control stock. Only one building is shown unroofed on the 1st and 2nd edition OS surveys, but two are shown on the 1971 OS map. These are presumably stores or sheds connected with Achnagart Farm.

Condition: Minor threat from bracken*Interpretation:* No

Site description: Lying to the E of Cnoc an Fhuar-thuill and the burn Allt Achadh nan Gart on a natural terrace are the remains of a rig system covering an area c90m by c35m. The remains of a turf dyke can be seen on the E side running in a NW direction until it disappears near the burn. In the centre of the E side of the rigs a stone dyke c0.5m high and c0.7m wide runs to the E up the hill. Further to the S beyond the visible rigs a sinuous turf & stone dyke c0.2-0.3m high and c0.3m wide can be traced. On the SW edge of the visible rigs are the remains of a round-ended drystone structure c6m by c3m over walls spread to c1m wide and c0.7m high. It is in very poor condition and may consist of 2 linked smaller structures. A circular store? c1m diameter lies immediately to the S of this. This area is presumably part of Achnagart. It may date to after the sheep were introduced but is more likely to have formed part of the joint township of Achnagart and therefore to have been constructed and abandoned by the early 19th century. It is the only significant area of rig surviving at Achnagart.

Management needs Photo in the spring once every 5 years - if change is noted between photos then management needs should be discussed with the NTS archaeologist.
If agreed the bracken should be sprayed with an approved chemical on a regular basis to control it.
