**Construction of permanent access routes for removal of
timber at Syre, Strathnaver, Sutherland**

Planning ref. nos. 03/00304/FULSU and 03/00305/FULSU

Archaeological Watching Brief

Construction of Access Routes for removal of timber at Syre, Strathnaver, Sutherland, Planning ref. nos. 03/00304/FULSU and 03/00305/FULSU: Archaeological Watching Brief

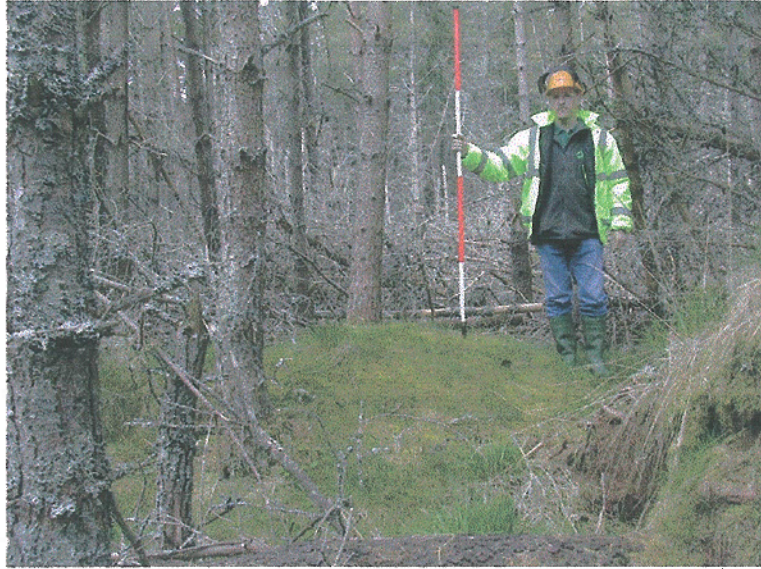
1. Field Clearance cairn before commencement of Watching Brief, view from NE
2. Field Clearance Cairn, eastern half removed, view from NE.
3. Field Clearance cairn, east half removed down to subsoil, view from SE
4. Field Clearance Cairn, section cleaned to show stones and dark soil fill lying directly on the subsoil.
5. Hut circle, view from SE showing entrance. This photograph taken after the completion of work on the area of hardstanding.
6. Section at edge of area of hardstanding. The hut circle is within the standing trees in the background.

This was entirely covered with vegetation, mostly mosses, and had been planted with trees. The removal of these by pushing them over with the digger bucket caused the lifting of the mat of vegetation and a thin layer of pine needle debris. The pulling up of the tree roots also caused the cairn to partially break apart. Of what remained, half was removed by the digger to allow an examination of a cross section. This was cleaned by trowel to investigate any soil deposits beneath the cairn.

The cairn was found to consist of generally large stones, some up to 0.5m in length. There appeared to be no upper layer of smaller stones from a second phase of field clearance. The stones were intermixed with a loose black soil. This soil and the stones directly overlay the orange-brown sandy subsoil.

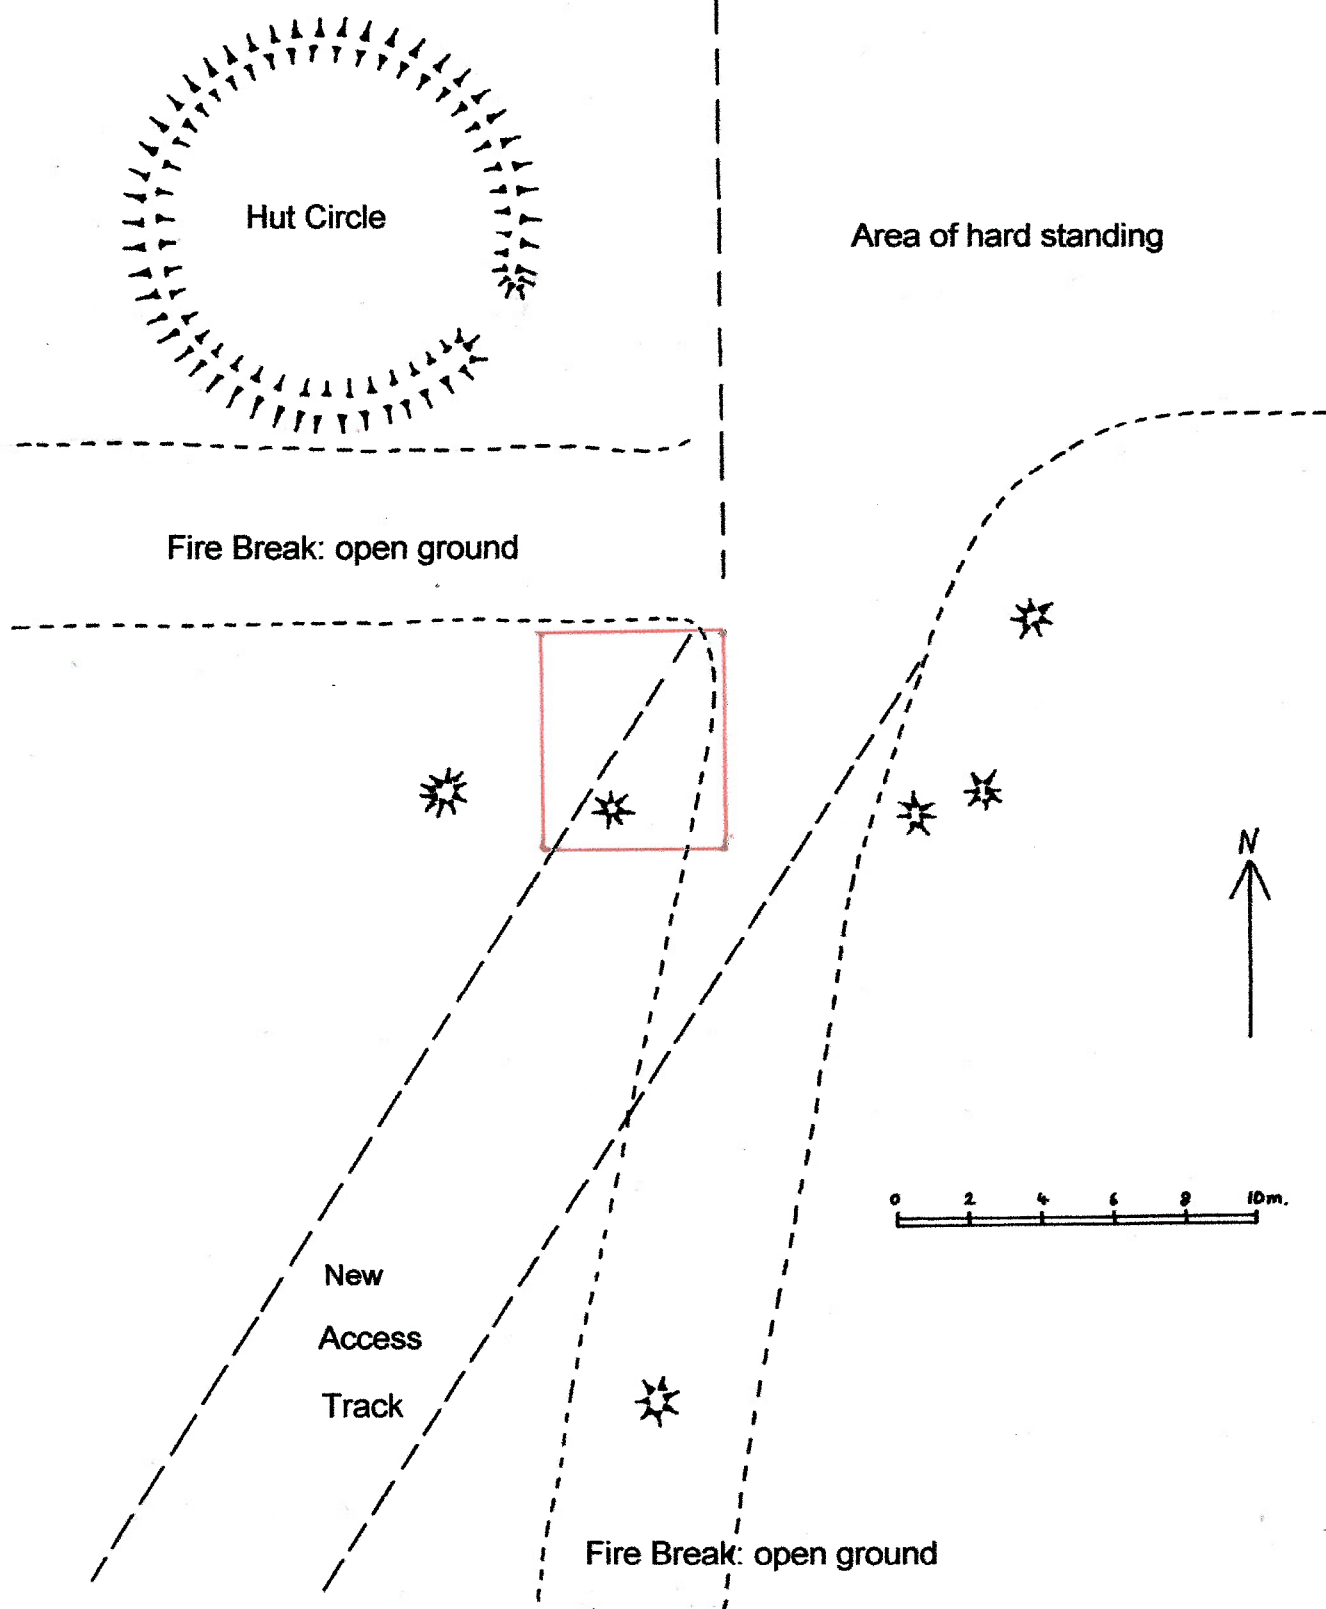
Sketch Plan

Area of watching Brief

Field Clearance cairn

This was carried out on May 18th 2004 in dry and clear weather conditions. At this stage the access track had been completed as far as an area of hardstanding east of the hut circle. Only a short section was monitored, including one field clearance cairn, as the section further south, where the route deviated from the open ride into standing trees, was awaiting felling. It was ascertained in consultation with representatives of Forest Enterprise that no other field clearance cairns would be destroyed by later work. It was also agreed that the other field clearance cairns in the vicinity would be marked before work commences on the next section of track to prevent accidental damage.
