## **An Archaeological Survey of Balnacruie of Deishar Farm, Boat of Garten**

*with an assessment of the archaeological value of this farm and proposals to improve the management of this archaeological resource.*

**Wordsworth Archaeological Services**  
4 Balbeg, Balnain, Glenurquhart  
Inverness-shire IV3 6XQ  
(tel 01456476 288)

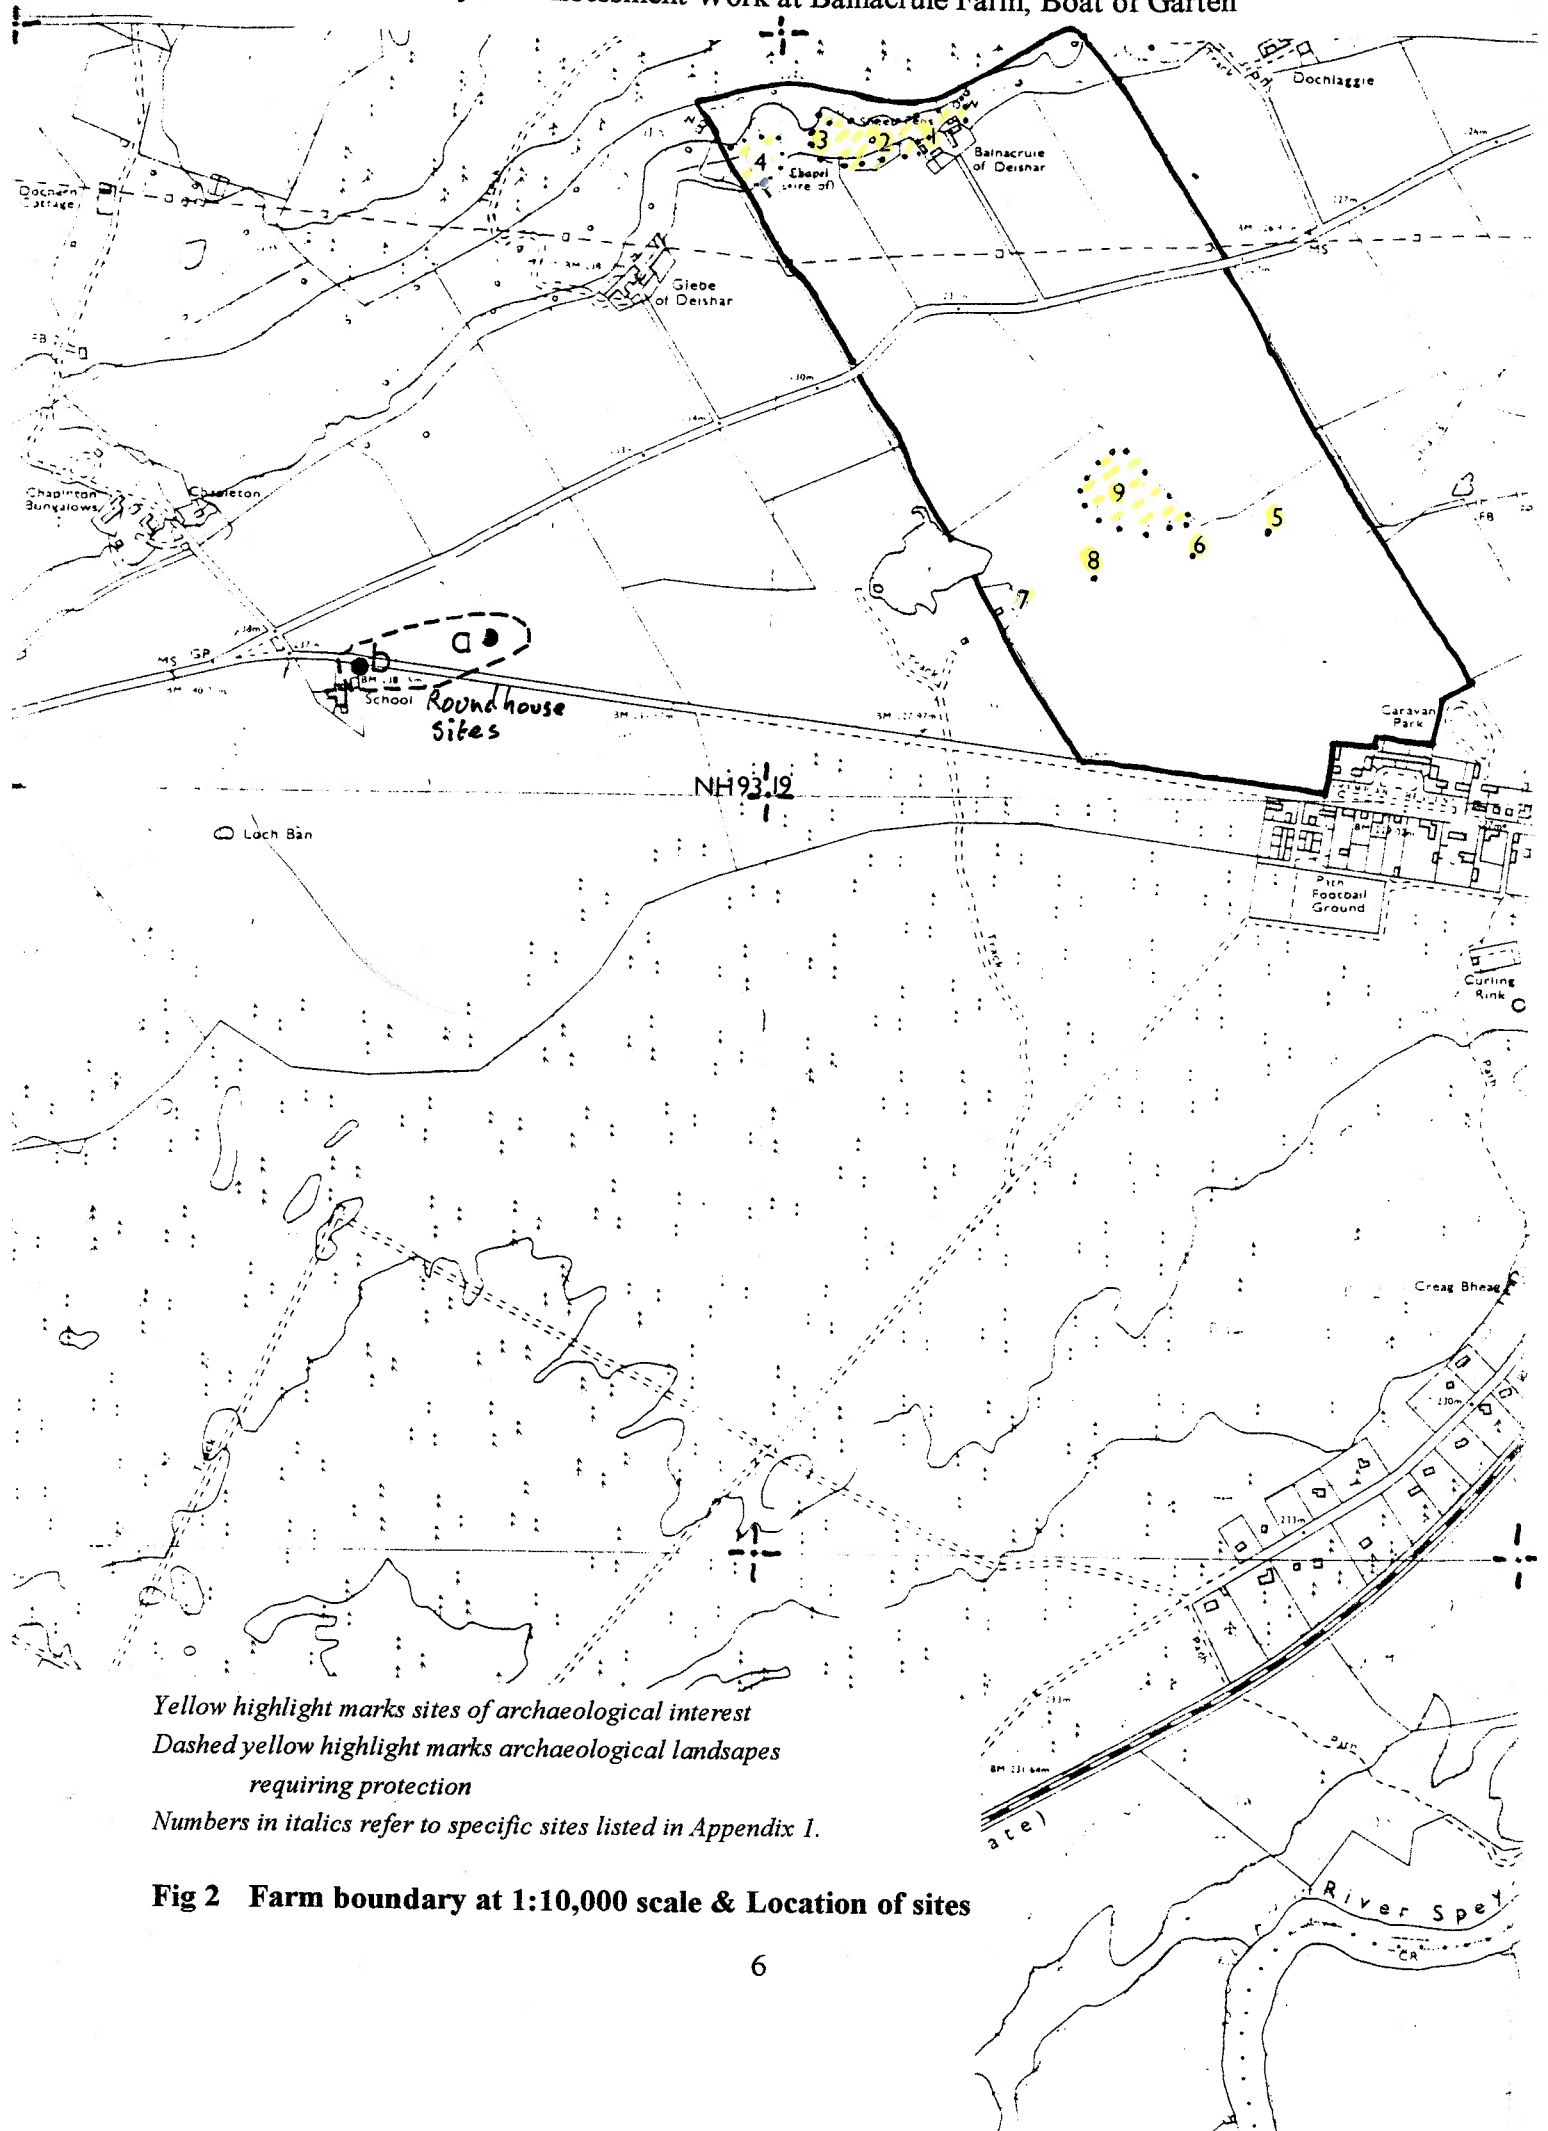
**Fig 2 Farm boundary at 1:10,000 scale & Location of sites**

*Yellow highlight marks sites of archaeological interest*  
*Dashed yellow highlight marks archaeological landscapes requiring protection*  
*Numbers in italics refer to specific sites listed in Appendix 1.*

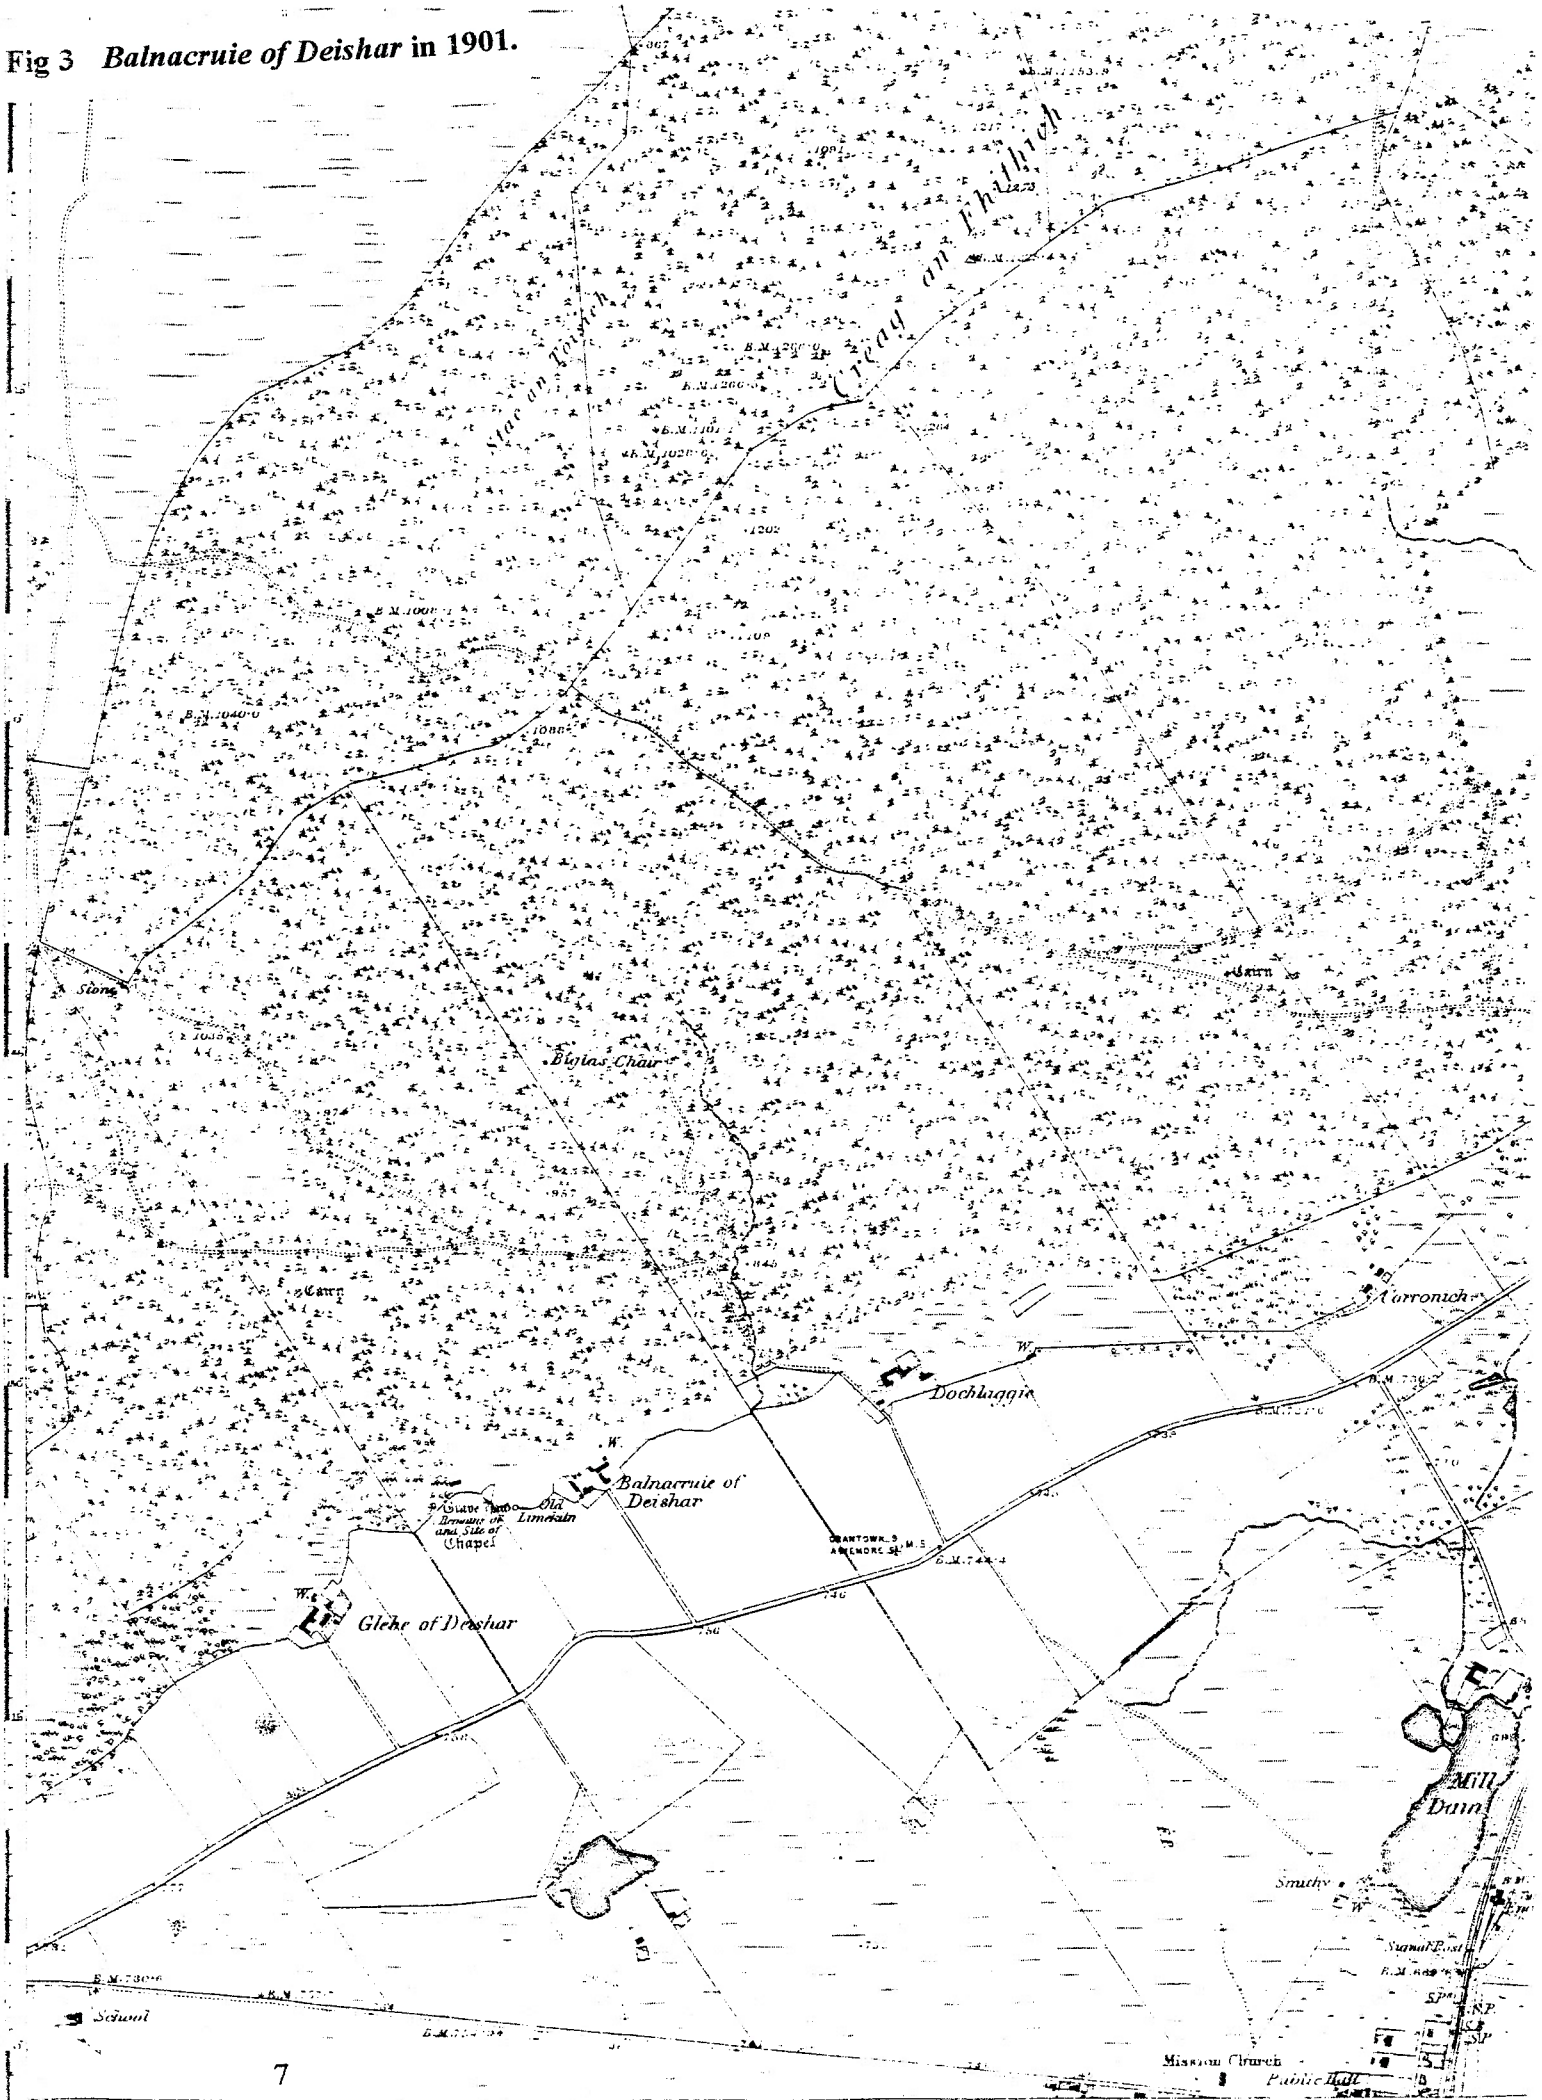
Fig 3 *Balnacruie of Deishar in 1901.*

**Description:** The surviving farmhouse is the remnant of a formerly extensive range of buildings as can be seen on Figs 3 & 4. The farmhouse itself appears to have been built or rebuilt between 1871 and 1903, as it was not shown in its present form on the earlier OS map. To the NE of the farmyard was an L-shaped range of buildings, presumably barns that no longer survive and this area is currently used as a fank. To the North of this 2 small buildings, B & C, still survive in fragmentary form. Building C may have been a horse mill. Further West was D, another small structure, possibly a lime kiln, though not listed as such on the OS map. Enclosure E, probably a stock pen, may have formed the West boundary of Balnacruie Farm.

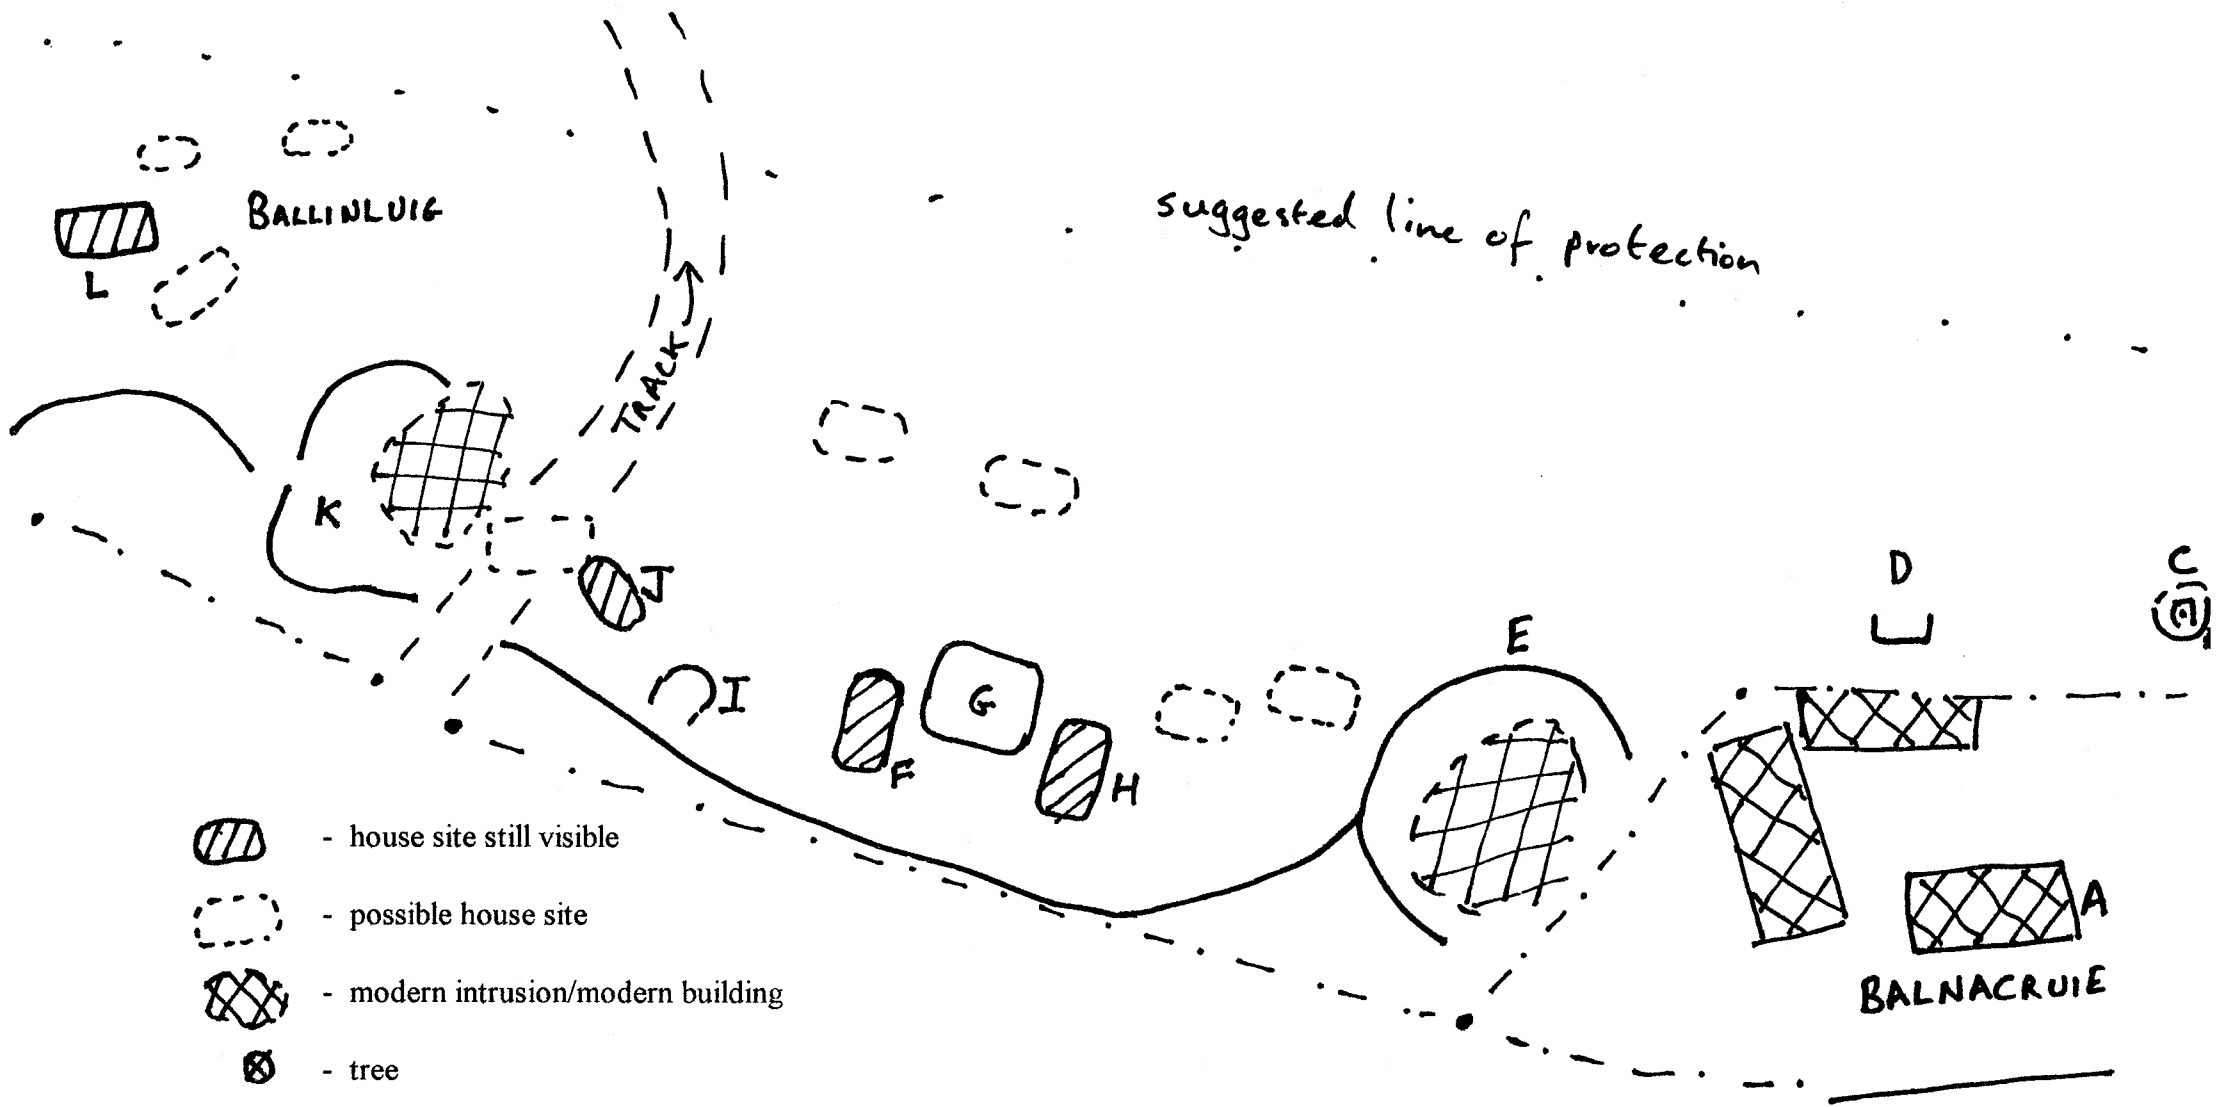
Fig 4 Sketch plan of former settlements at *Balnacruie* and *Ballinluig*  
Not to scale

**Description:** The stone footings of two longhouses F & G, 10m by 4m, lie to the South of a rectangular enclosure H, 10m square. The sites of other buildings are suggested by roughly rectangular hollows on both sides of the modern track as shown on Fig 4. The South boundary is formed by an irregular earth and stone dyke as shown on the earlier OS maps. This is partly masked by field clearance stones dumped over the fence.

**Description:** As shown on Fig 4, a limekiln, I, appears to separate Ballinluig from the unnamed settlement at site 2. The kiln was a rounded rectangle 1.25m wide by c3m long. As can be seen from the photograph it has been filled in with farm rubbish which has recently been cleared out. The two houses, J, shown to the West on the 1st OS edition, can only be partly traced on the ground, possibly because this is now an access route from the field to the hill behind. There is some vehicle erosion in this area (see photograph).

The boundary wall continues to survive on the outside of the modern fence on the line shown on Fig 4.

1. The main area to be protected lies at the North of the farm where there is a continuous stretch of settlement remains from *Balnacruie* to the former settlement at *Ballinluig* (see Fig 4). Already some damage has occurred here from the wearing of tracks and the dumping of materials and it will need sensitive management to preserve the surviving remains. Arrangements should be made so that continued access to this area is not to the detriment of the archaeology.
