SECOND WORLD WAR AIRFIELDS AT TAIN AND FEARN, EASTER ROSS

A Report to Highland Council by the ASH Consulting Group

July 1999

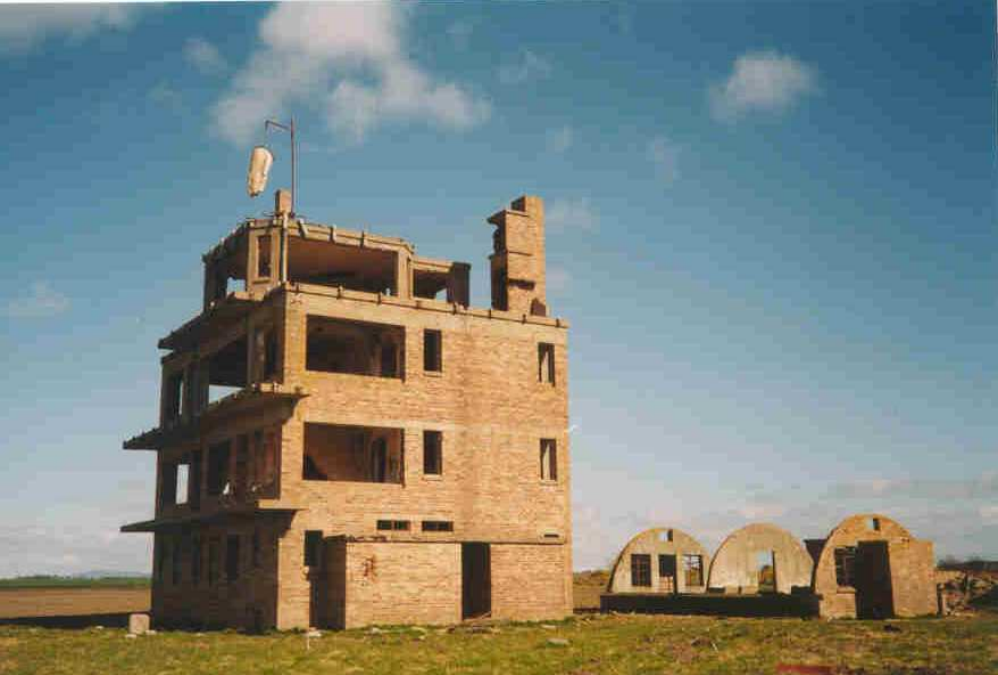
Photo 2
Control Tower viewed from the south

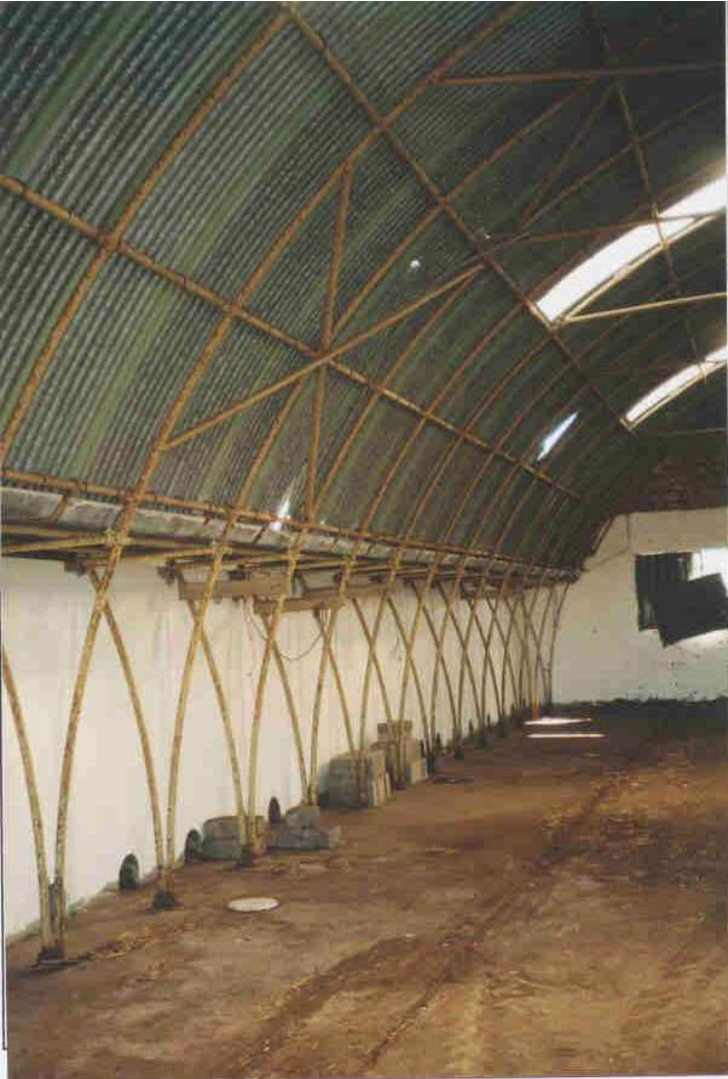
Photo 5
Torpedo sheds interior showing valley gutter

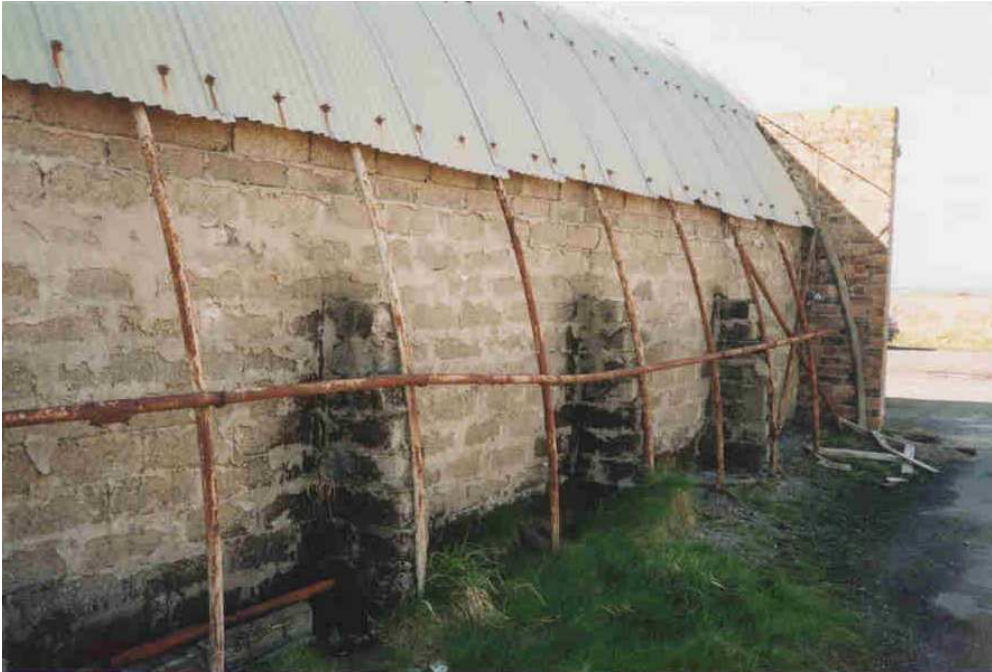
Photo 6
Torpedo sheds
exposed framework on north wall and non original blockwork walls

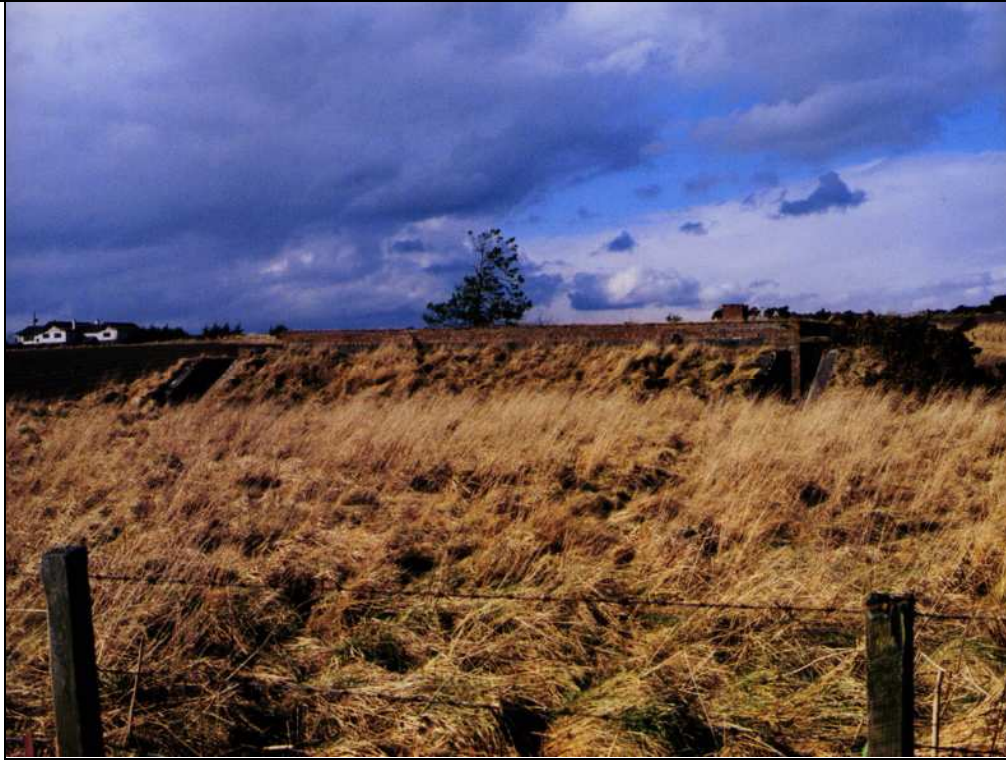
Photograph G59: Operations block

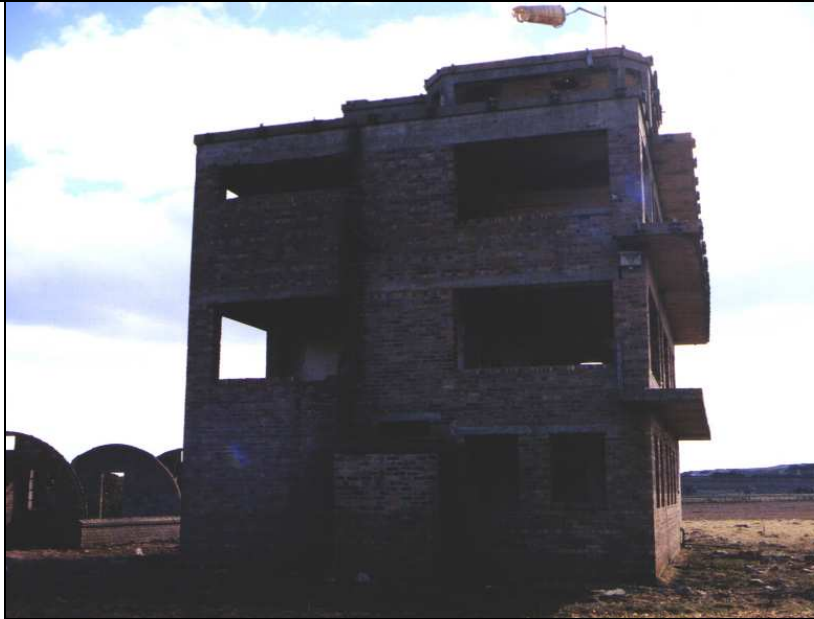
Photograph A6: Control Tower: north elevation

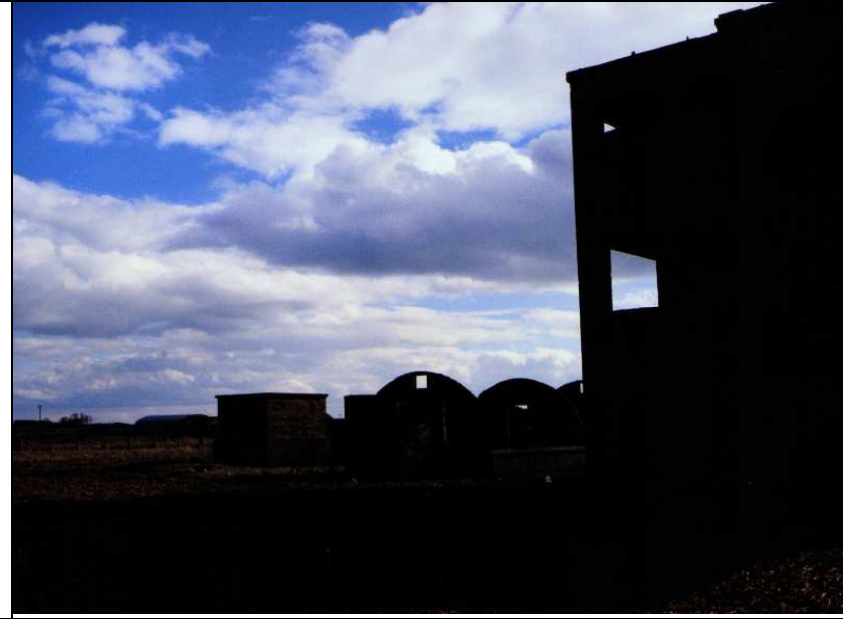
Photograph A7: buildings adjacent to Control Tower – north elevation

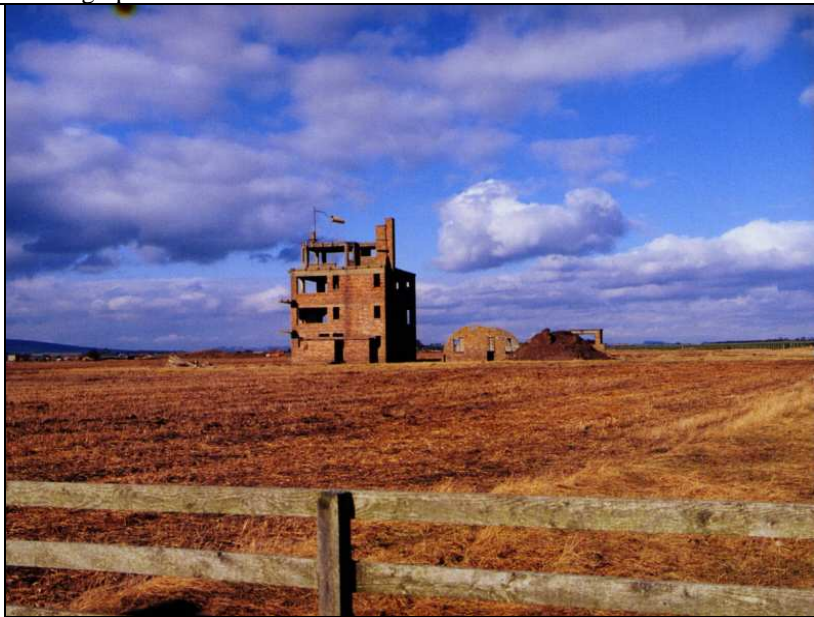
Photograph A8: Control Tower west elevation

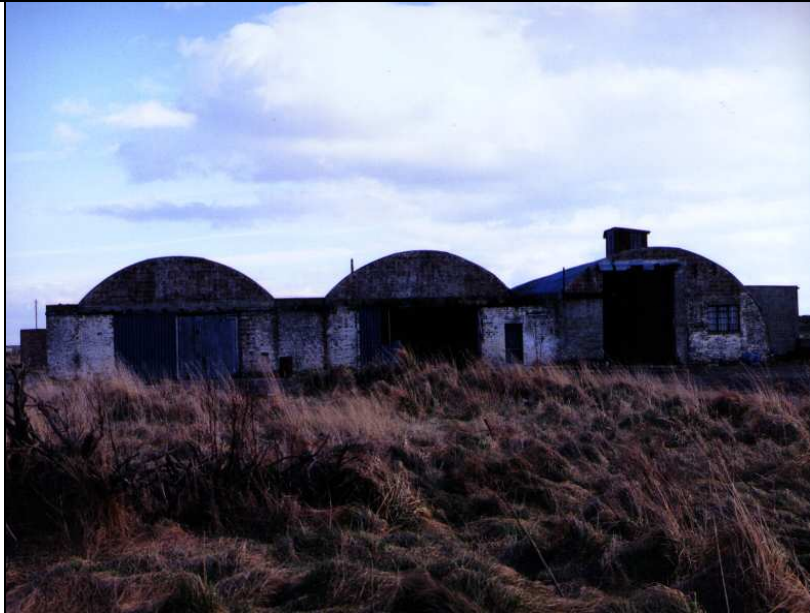
Photograph A9: Torpedo shed west elevation

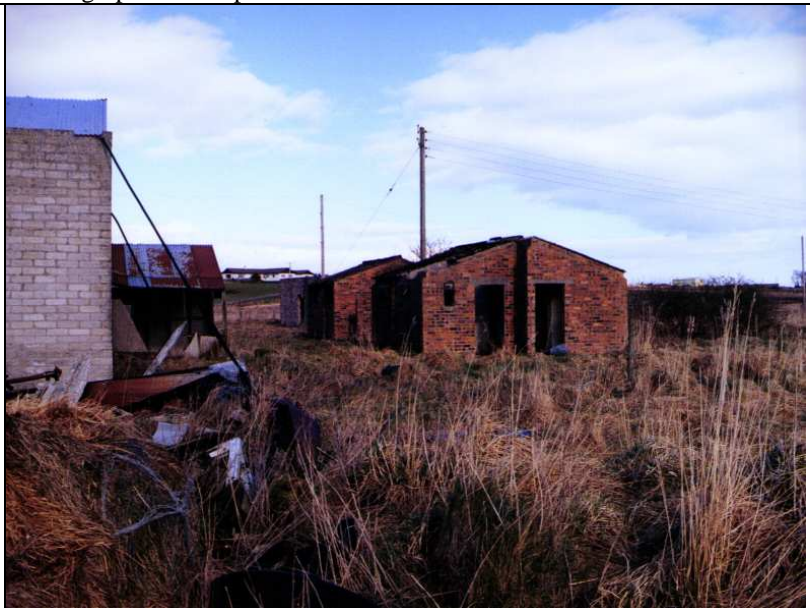
Photograph A11: Ablutions blocks adjacent to torpedo shed
FEARN AIRFIELD – PHOTOGRAPHIC SURVEY AREA A/G

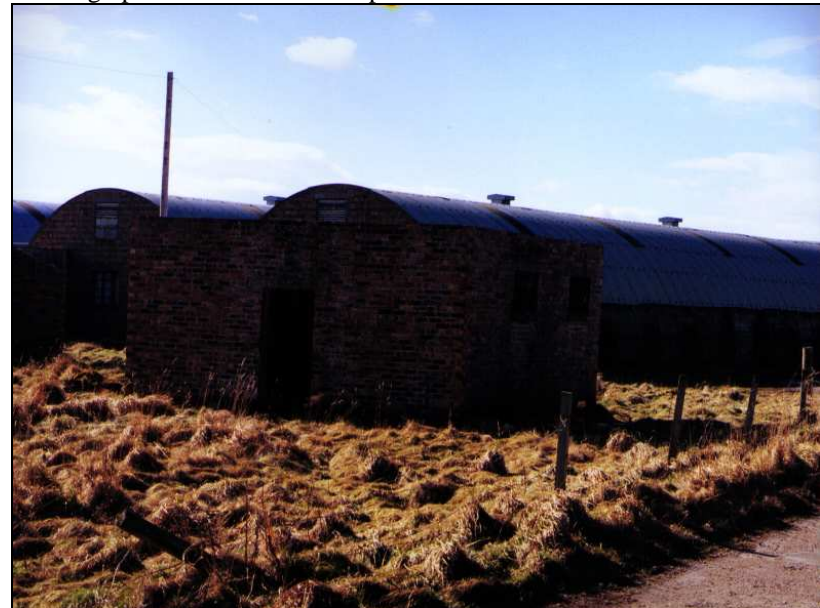
Photograph A12: Torpedo shed from access road

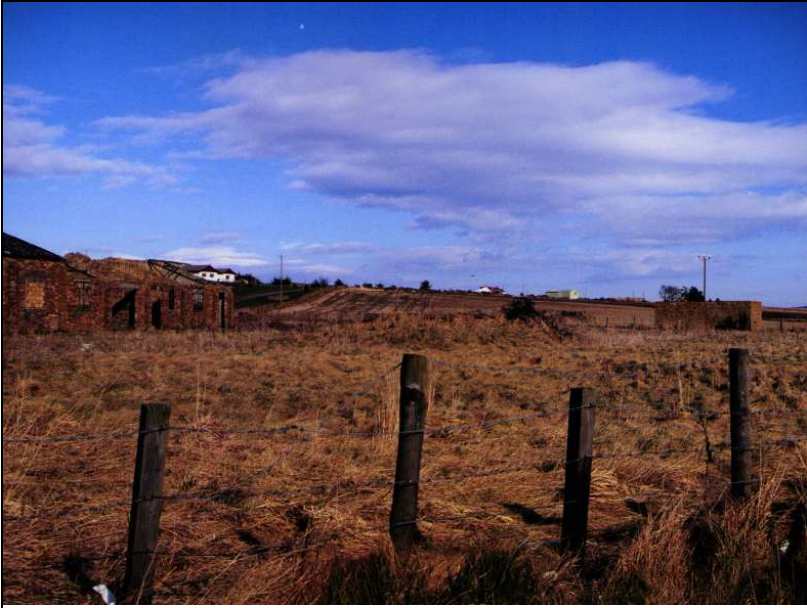
Photograph A20: view of technical building from the west
FEARN AIRFIELD – PHOTOGRAPHIC SURVEY AREA A/G

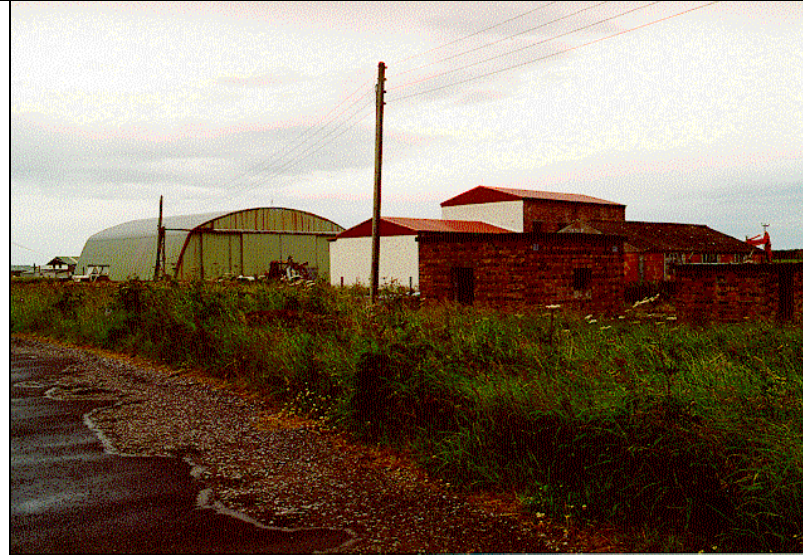
Photograph A23: hangar in use

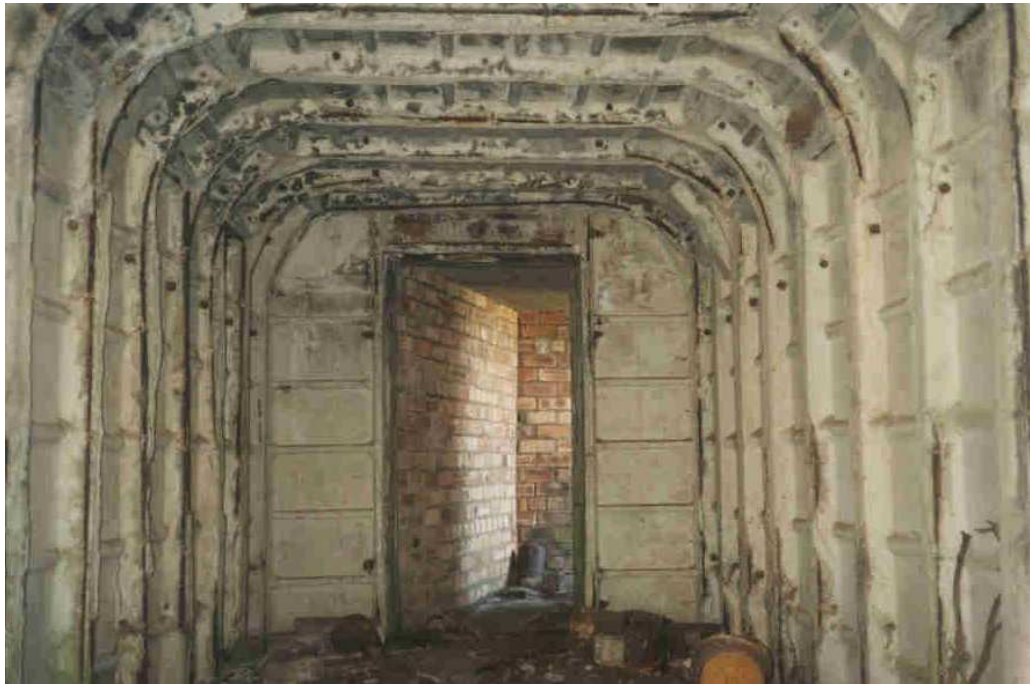
- 11.10 There are some 5 or 6 of these scattered around the airfield. Two were inspected at O.S. ref. points NH 847756 and NH 843763 and one of these is shown on photograph no. 8.

Photograph 8
Underground shelter - interior

- 11.18 These underground shelters within the earth mounds surrounding aircraft hardstandings would, if made structurally safe for public access, form interesting features for public access and interpretation. Development of at least one of these should be considered as part of any interpretation development and it is recommended that the remainder be secured to prevent public access. Securing of these structures would require to include the capping of ceiling vents which currently pose a potential hazard to members of the public and to animals.
- 11.19 The underground shelter illustrated in photograph no. 8 is probably the most appropriate for development as it lies close to the control tower area and within the Technical Area which has several other buildings and structures of potential interest.

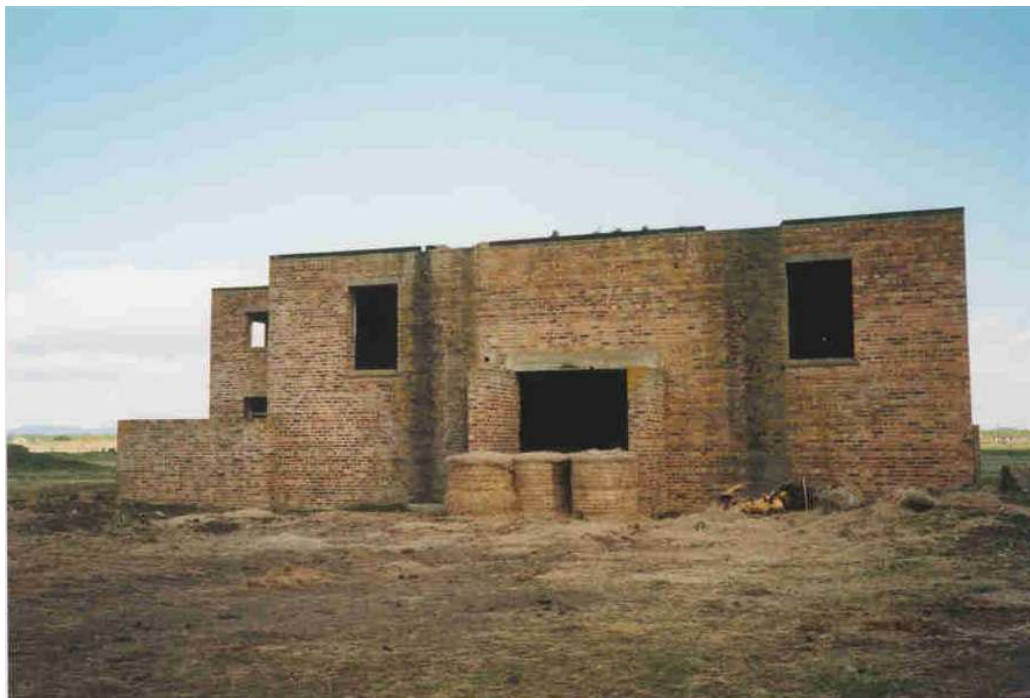
- 11.2 This building, illustrated on Photograph no. 9, is located at O.S. Ref: NH 849756 and was subject of a structural survey by A.F. Cruden Associates in April 1999.

- 11.5 The brickwork was generally in good condition with only local weathering of individual bricks. There was a vertical crack from one of the arched openings in the rear wall to a window above, and also a horizontal crack near the wallhead level in the west corner.
- 11.6 The steelwork in the roof beams and staircase was in sound structural order but heavily rusted in parts. The soffit of the concrete roof and floor slabs was spalled, with reinforcement visible in a number of areas.

- 11.7 The building is structurally in reasonable order and could be made wind and watertight relatively easily. The spalling concrete on the underside of the roof slabs is a potential safety hazard and will progressively become worse over the next few years.

Photograph 9
Engine Test House – view from south west

- 11.8 This building is in a reasonable state of repair and is currently used for agricultural storage. If the airfield were to be developed for interpretation, this building would form an important component of such a development set within its context of the technical area with a variety of other buildings and structures including aircraft pens and hardstandings.
- 11.9 The building could be made wind and water tight relatively easily and continued use for agricultural storage would not be incompatible with interpretation if, for example public access were to be limited to the upper viewing room on the northern side of the building.

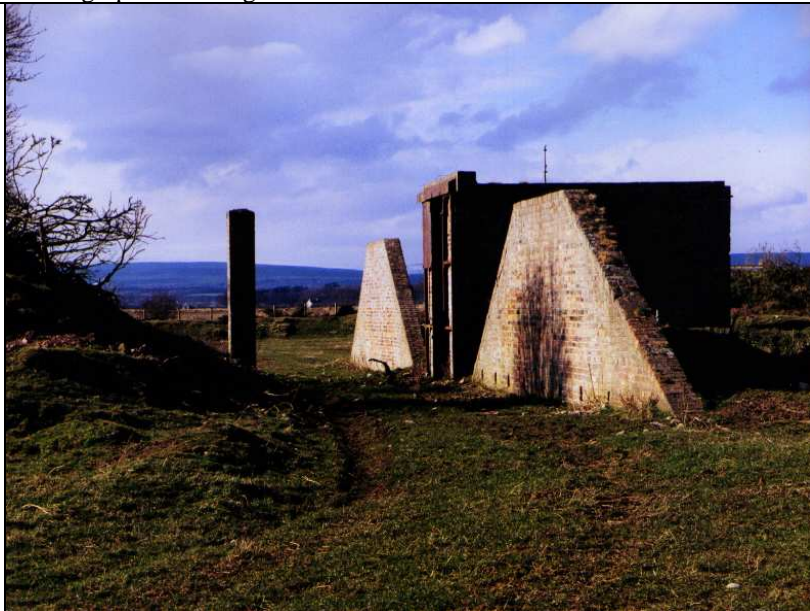
Photograph D42: bomb store with soil removed from behind blast walls
FEARN AIRFIELD – PHOTOGRAPHIC SURVEY AREA D

- 13.15 In the short term, it is recommended that the blast walls behind which soil has been removed be either backfilled with new material or demolished in the interests of safety. No other works are anticipated as being required to make the area safe for authorised public access. The two brick built stores are in fair condition and should be boarded up to ensure that they are wind and water tight until a future use can be determined.

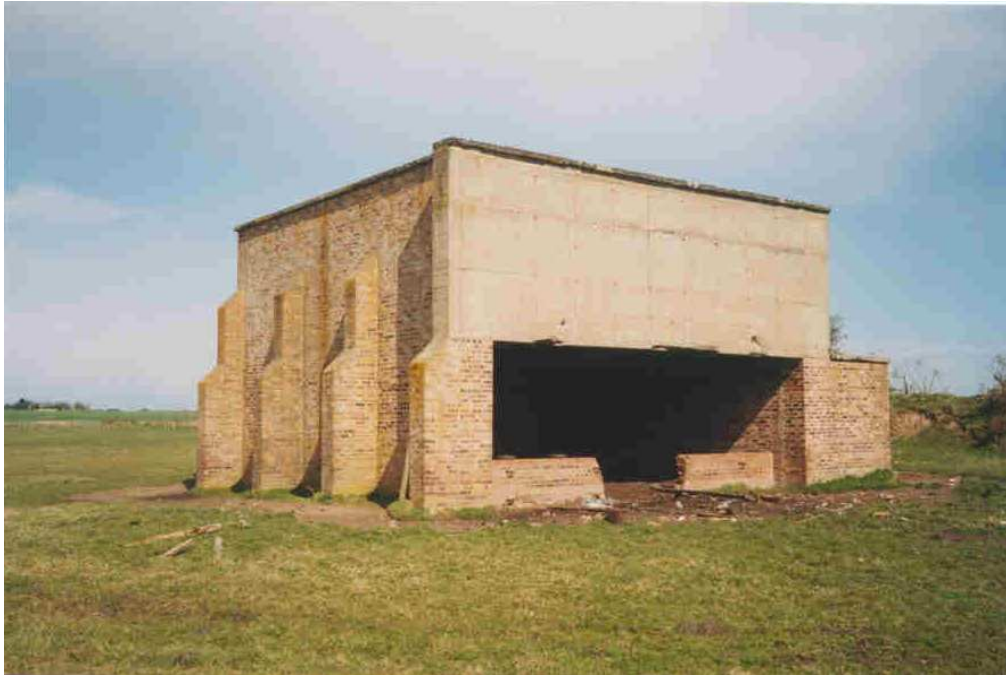
Photograph 16
Stop Butt - view from south west

14.4 The brickwork external walls are in very good structural condition with only some local weathering of individual bricks. An opening has been formed in the front 1 metre high wall to allow the shell to be used for agricultural purposes. The concrete wall above the front opening has several areas of impact damage from cannon shells. The impact has been sufficient to cause bursting of the concrete on the interior face of this wall.

14.5 The soffit of the concrete roof slab and the sides of the supporting beams have been affected by concrete carbonation with areas of exposed reinforcement where the concrete has spalled off.

- 14.6 Areas of spalling, loose concrete present a hazard from falling concrete.

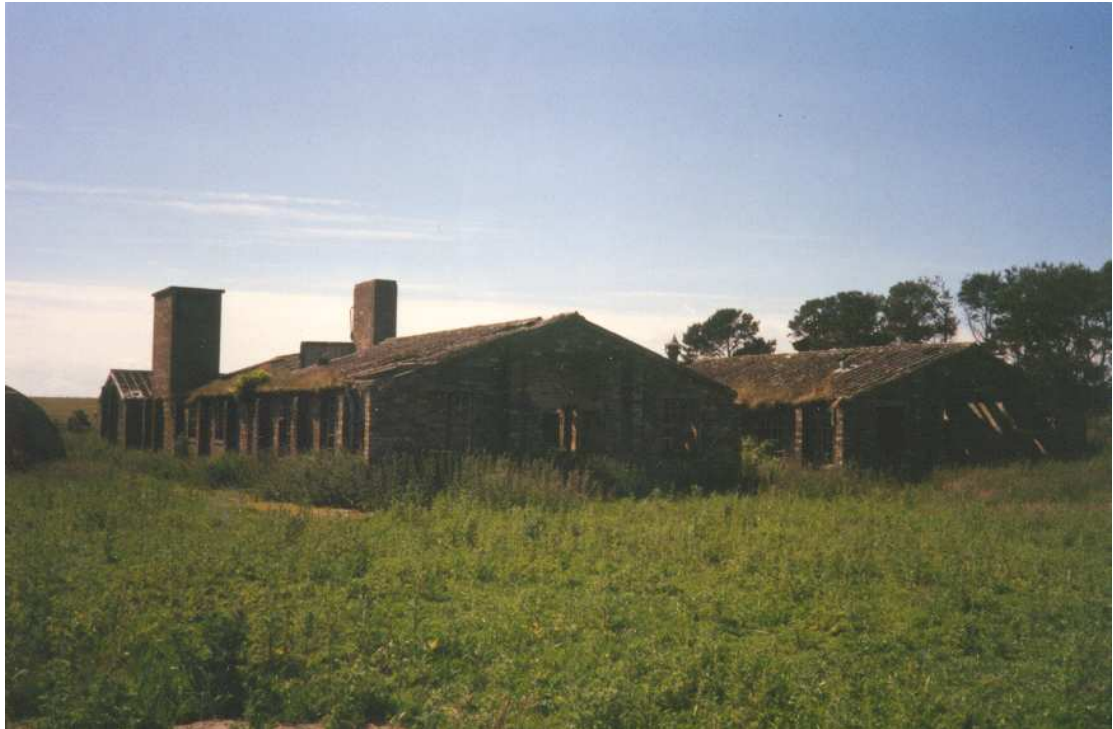
- 15.40 This building is situated at O.S. Ref: NH 8563 7694, is illustrated on photograph no 21 and was surveyed by AF Cruden Associates in June 1999.
- 15.41 This building consists of two single storey, pitched roofed buildings parallel to each other, linked by a central flat roofed section. A third staff accommodation building lies to the rear of the canteen with its axis at 90° to the main building.
- 15.42 The principal buildings are both 28'0" wide internally with the eastern unit being 70'0" long and the western one 85'0" long, and projecting 15'0" behind the eastern one. They are separated by a 12'0" wide gap in which the flat roofed linking section is centrally located.

Photo No 21
Canteen Building NH 8563 7694
General view from the north

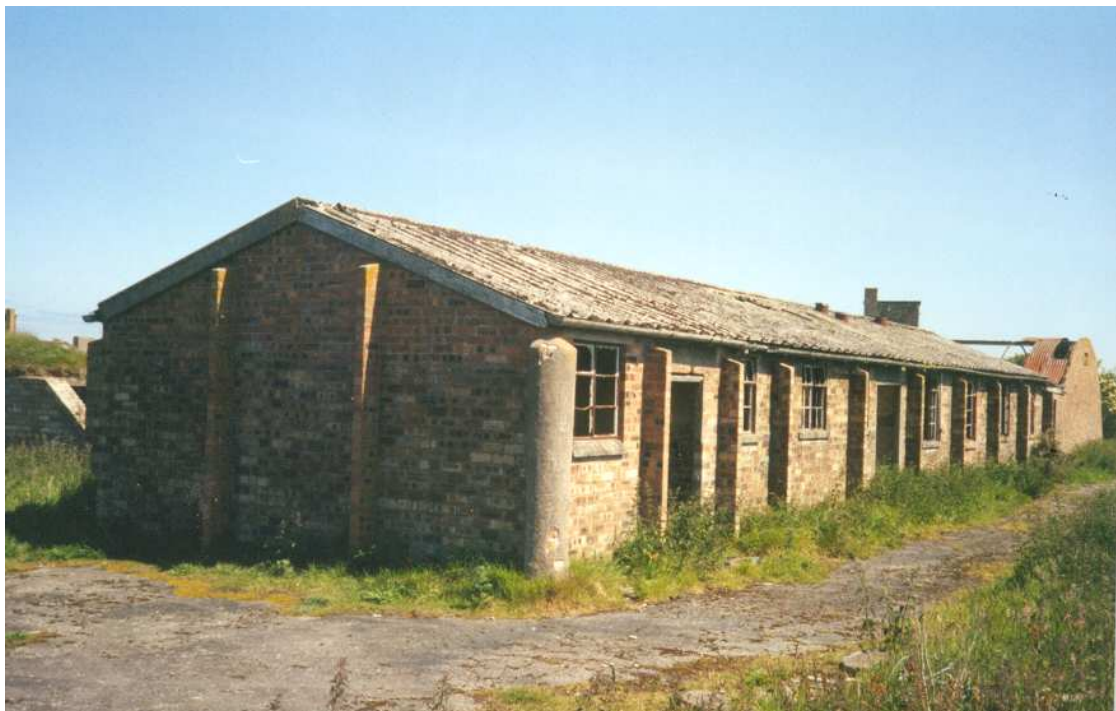
- 15.50 The stores were surveyed by AF Cruden Associates in June 1999, are located at O.S. Ref: NH 8568 7694 and illustrated on photographs 22 and 23
- 15.51 The stores comprise two buildings linked to form an L shape. One lying W-E is a single storey pitched roof building 18'0" wide by 78'6" long - this is internally subdivided into various storerooms and offices. Linked to its east gable but lying on a N-S axis, the second building is a semi-circular Nissen hut originally 142'0" long by 24'0" wide. This Nissen hut section was divided into two sections by a central brickbuilt section which appeared to have been a garage for a large vehicle (fire engine?). The Nissen hut to the north of this brickwork section has been removed from site leaving only the concrete base slab extant.

Photo No 22
Stores Building NH 8568 7694
West gable and south elevation

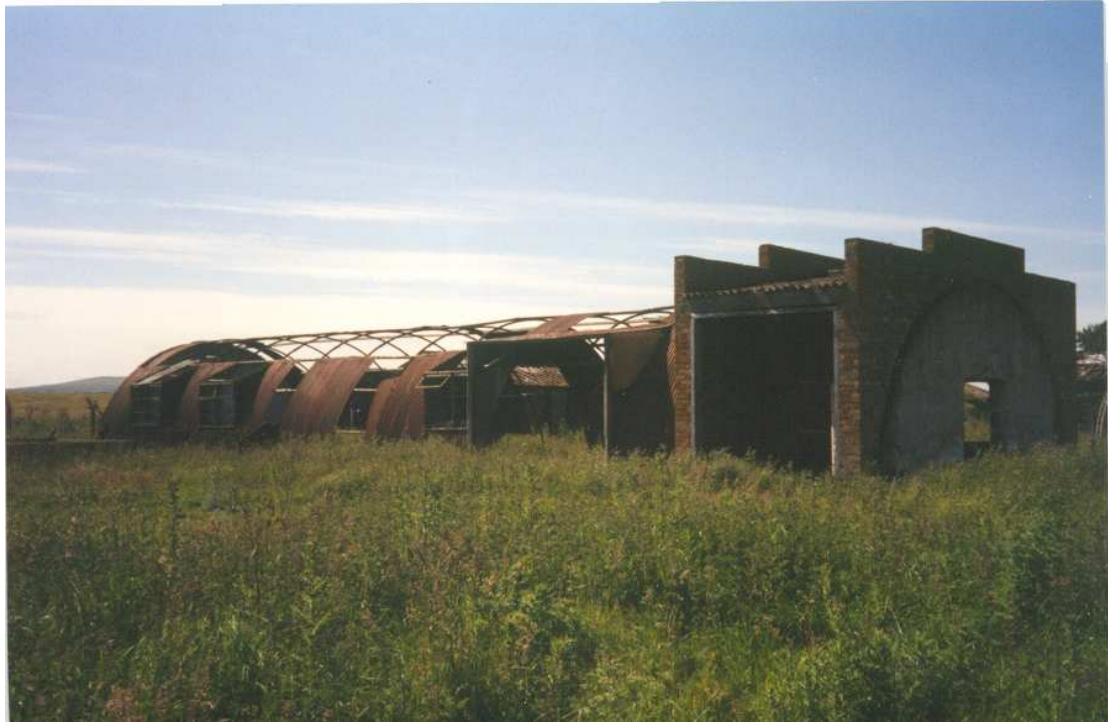
Photo No 23
Stores/Workshop Building NH 8568 7694
Nissen Hut section viewed from the N.E.

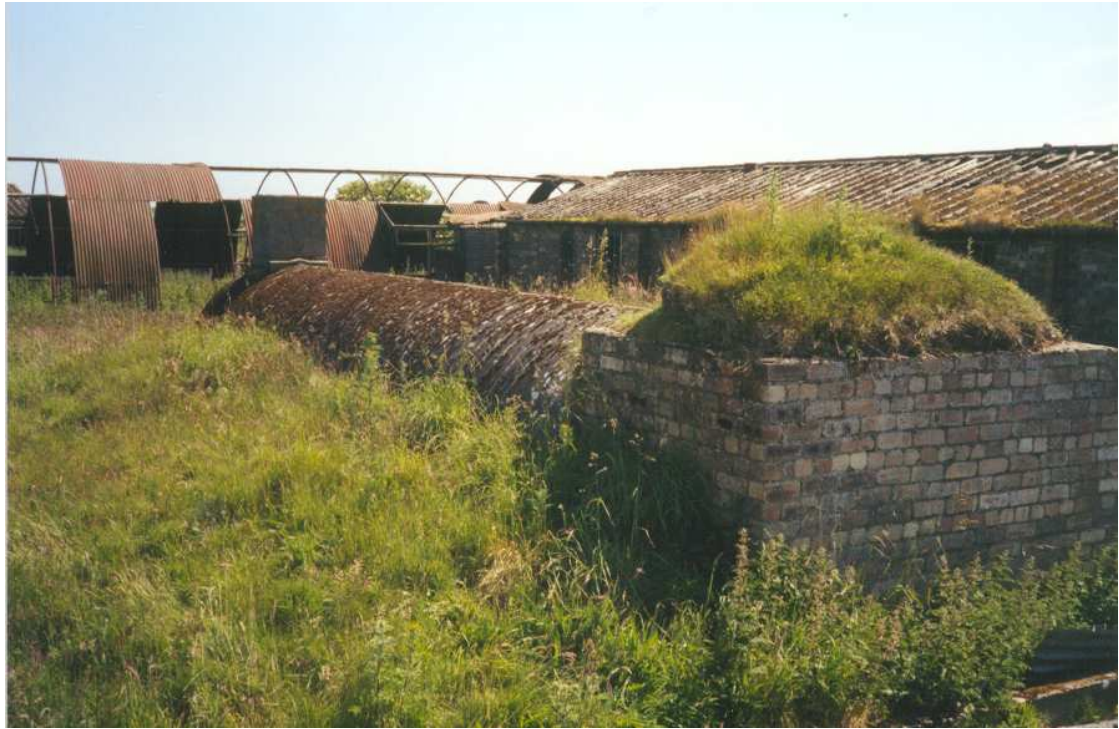
- 15.60 This structure is located at O.S. Ref: NH 8565 7695 and is illustrated on photographs 24 and 25. The survey by AF Cruden Associates was undertaken in June 1999.
- 15.61 A semi-buried reinforced concrete shelter some 30'0" long with a brickwork shielded entrance in the West gable. Internally the arched cross-section is 7'0" wide at the base and 7'0" high at the apex. There is a 2'0" square vent and emergency exit located in the roof at the end opposite the access doorway.

Photo No 25
Air Raid Shelter NH 8565 7695
View from the N.W.

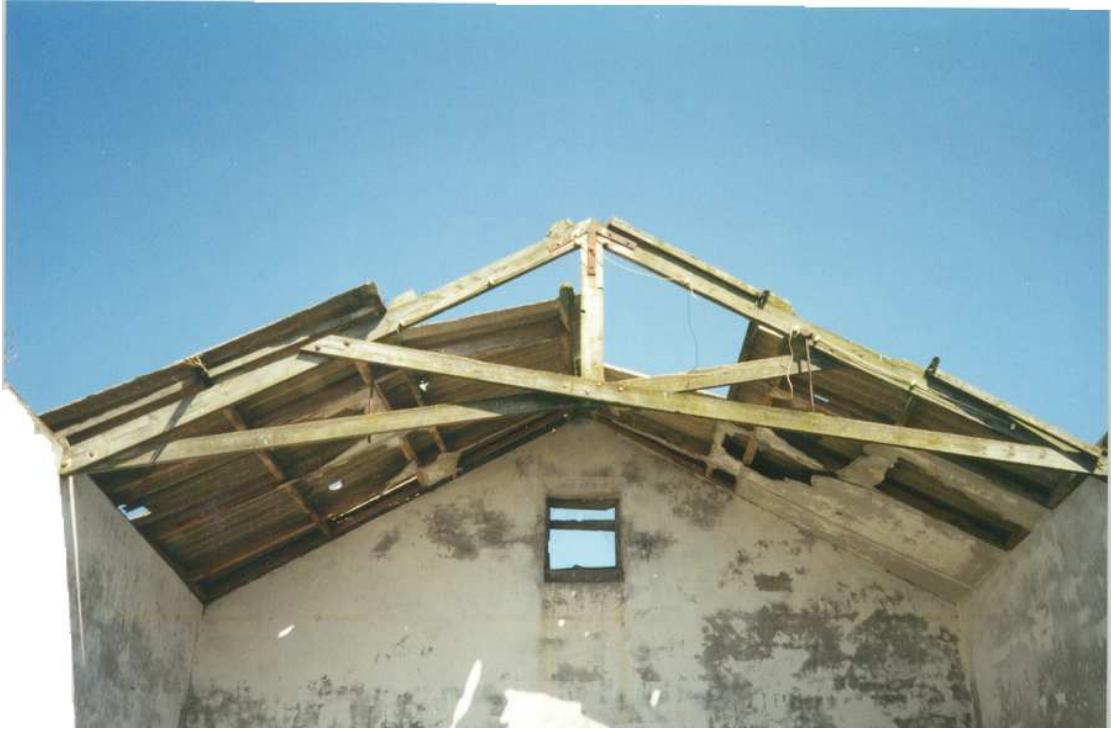
- 15.66 This building is located at O.S. Ref: NH 8562 7711, is illustrated on photographs 26 and 27 and was surveyed by AF Cruden Associates in June 1999.
- 15.67 This pitched roofed building is 22'0" wide by 34'0" long and is 15'9" high from floor to wallhead level.
- 15.68 Onto its western gable there is a flat roofed, two storey, full width extension some 5'6" long which provided an entrance foyer on the ground floor and a small balcony/projection area at first floor level. Access to the first floor was via a flight of external concrete steps. A very large opening has been knocked through the east gable wall to provide access to store a large vehicle (probably a combine harvester) within the building.

- 15.72 We are of the opinion that the building is in a dangerous condition and requires prompt action to make it safe. The east gable is unstable above the slapped out opening and we also consider the unpropped east gable above the balcony area to be unstable in high winds. These could be removed but this will then remove their propping action to the longitudinal walls which in turn will become unstable. In our opinion the building would be safest demolished to ground level.

Photo No 29
Cinema Building NH 8562 7711
Roof Construction

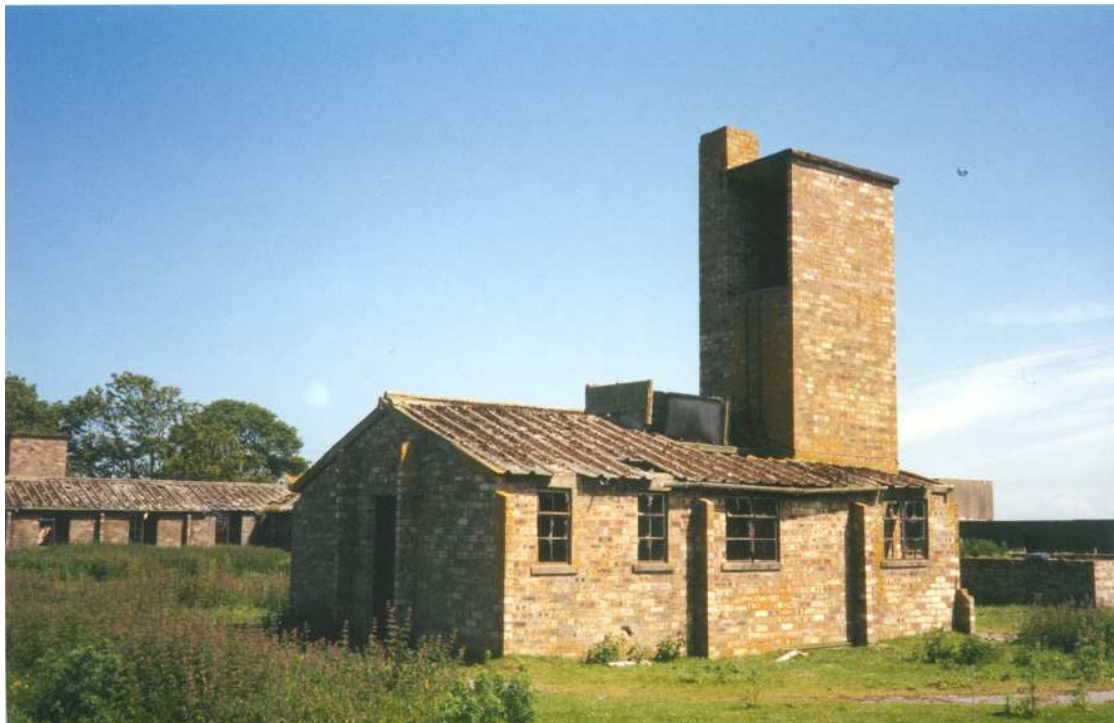
- 15.82 This building was surveyed in June 1999 and is located at O.S. Ref. No. NH 8560 7707 and illustrated on photographs 30 and 31.
- 15.83 Of the two ablution blocks identified at this camp, this one is in the best condition. The second block, some 50 metres to the east, is mostly demolished, with only the water tower still standing.
- 15.84 This is a single storey, pitched roof building measuring 18'0" long x 19'0" wide externally. It has a brick built water tower approximately 25'0" high at its southern end together with a brickwork chimney for the boiler. There is also a large vent built up from the centre of the roof above the showers area.
- 15.85 Internally the building provides 3 individual bathrooms, 4 shower cubicles and 2 toilets, together with a boiler room.

- 15.87 The concrete floor and brickwork walls of this building are all in good condition but the asbestos cement cladding and timber supports to the roof are in poor condition.

- 15.88 Fragments of asbestos cement are scattered throughout the building and some small sections of asbestos lagging are still evident on the pipework within the building. These all present a low risk asbestos hazard.

Photo No 30
Ablutions Block NH 8560 7707
View from the West

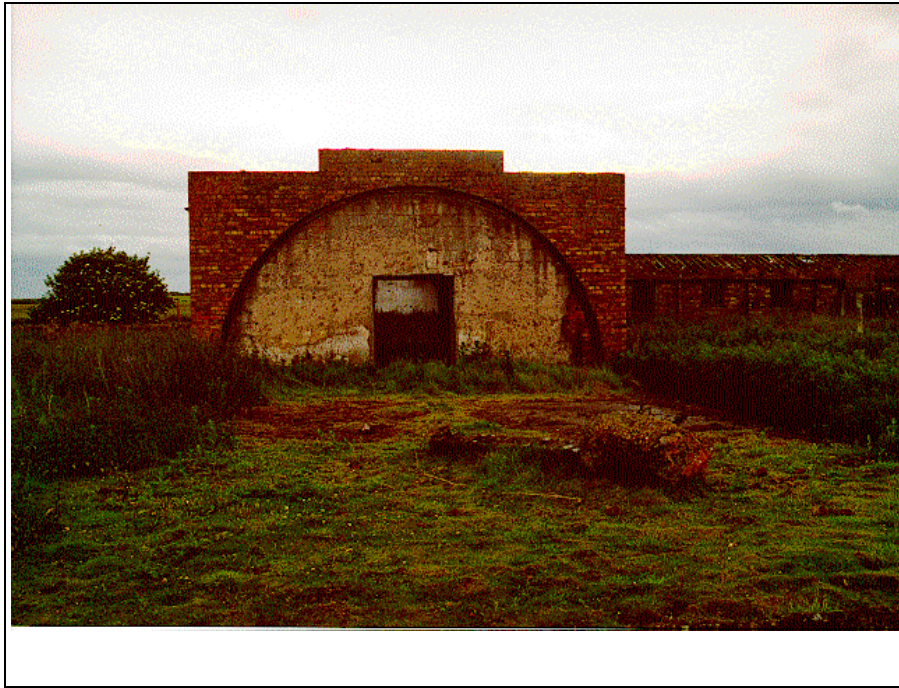
Photograph W44: Brick gable end to former nissen hut

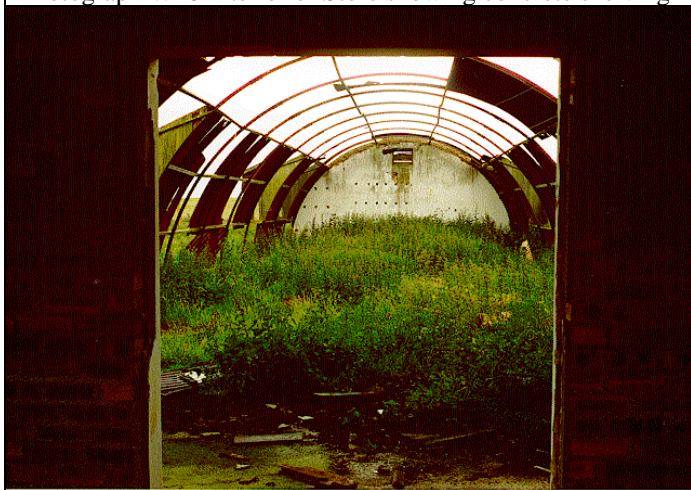
Photograph W45: interior view of nissen structure

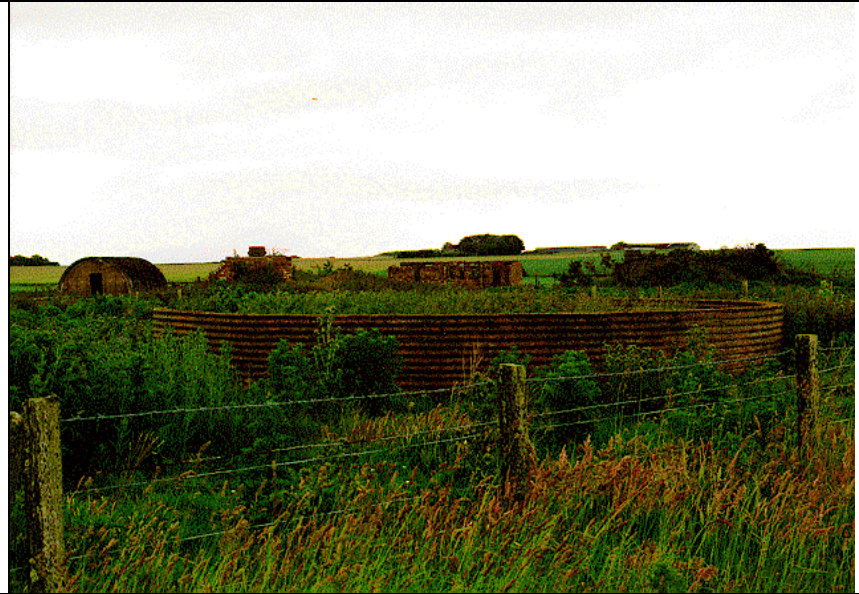
Photograph H8: watertank, the Wrennery

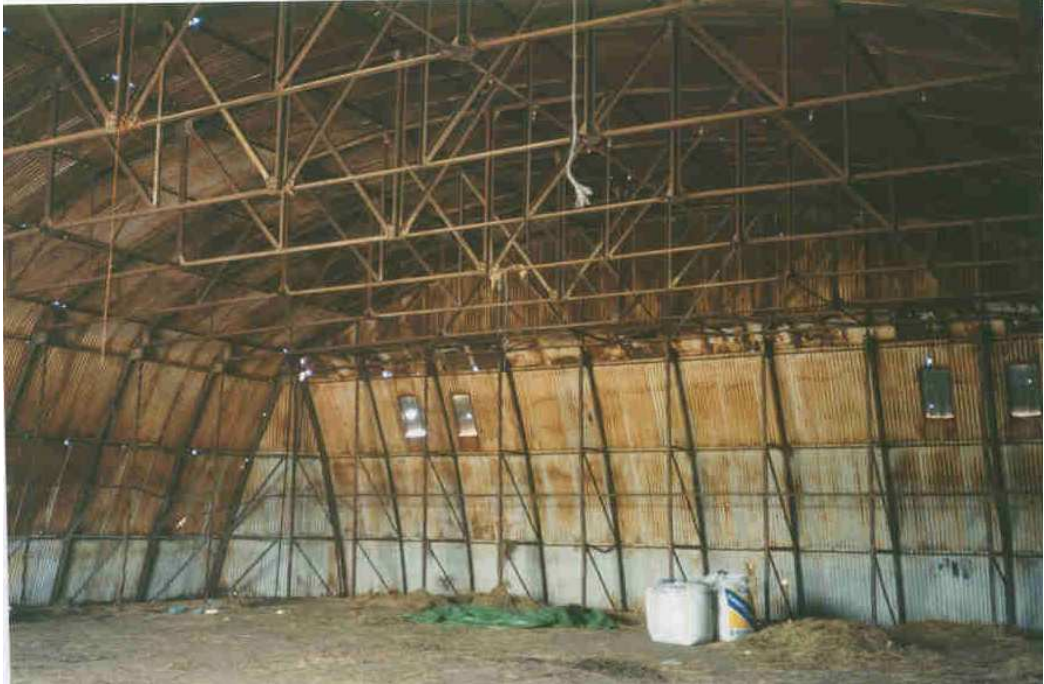
Photograph 12
Hangar NH 840 751- interior

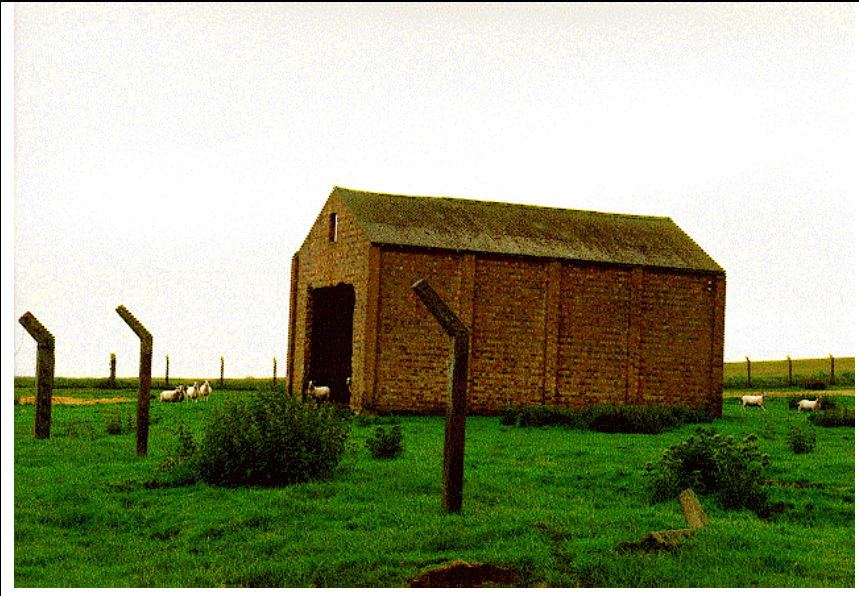
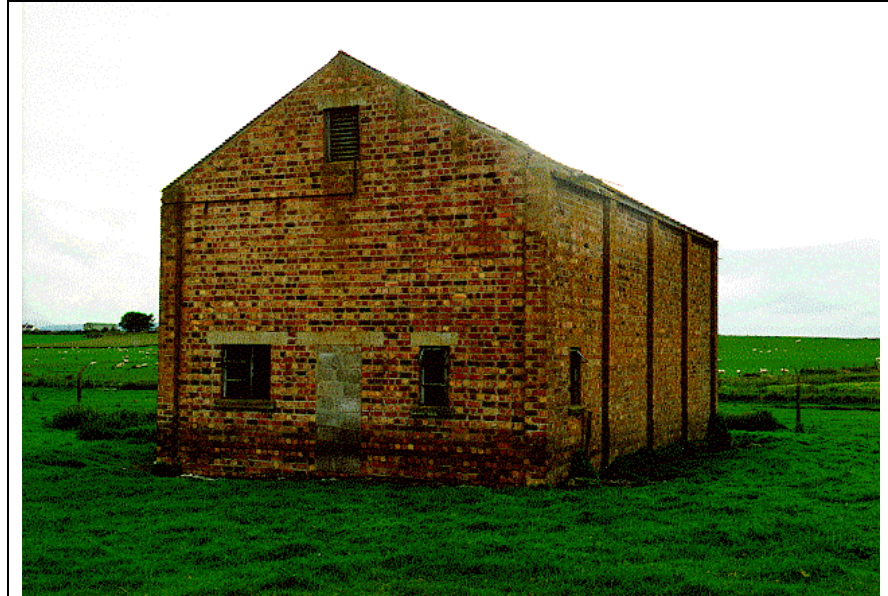
- 17.2 One of the two buildings which survive are a brick built fire engine house which lies near the access track which runs between this camp and the camp at Loans of Tulloch. This building is in a reasonable state of repair and is similar, although slightly larger than the one in area C.

Photograph J6: fire engine building view from north west

Photograph J7: fire engine building view from north west

Photograph J19: fire engine building

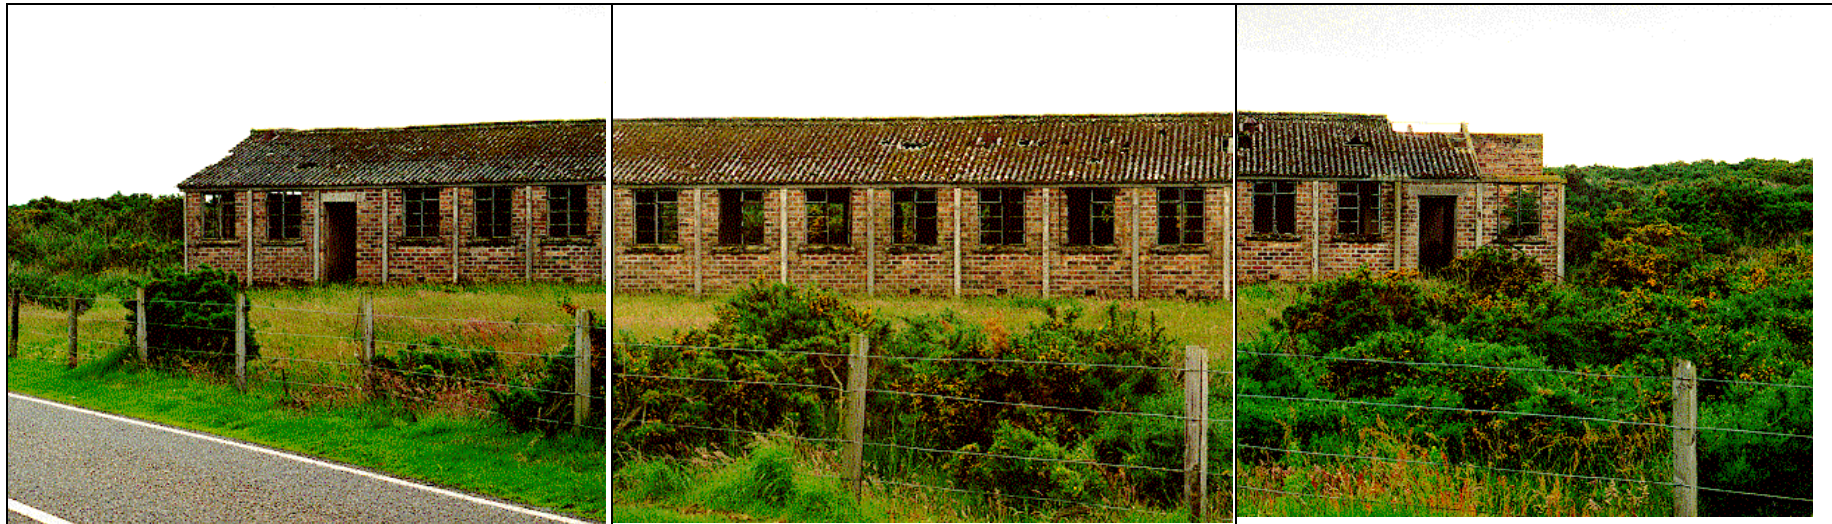
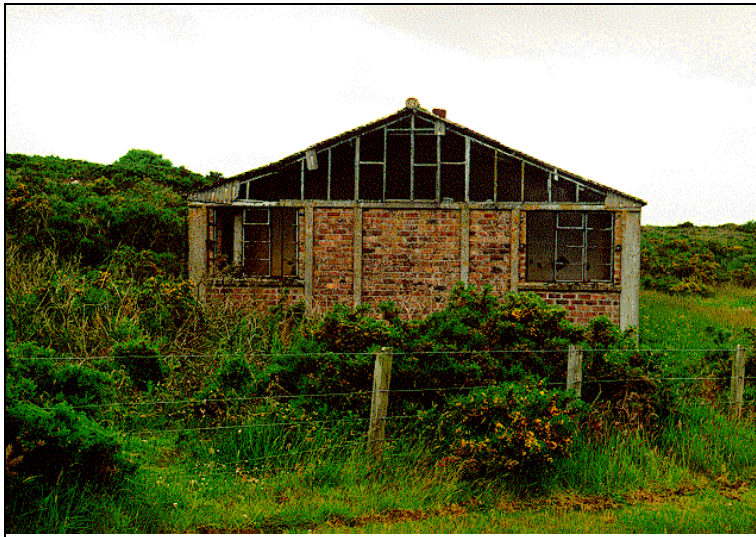
- 17.3 The other building is a long single storey brick storeroom which may have housed offices. The asbestos roof is in a poor state of repair and the building is surrounded by gorse and other vegetation. Part of the site on which this building sits has been quarried for sand and gravel and it can be assumed that the remains of other buildings and structures were demolished prior to or during quarrying operations.

Panorama J8/J9/J10: stores building northern elevation

Panorama J11/J12: stores

Photograph J13: stores building – east elevation

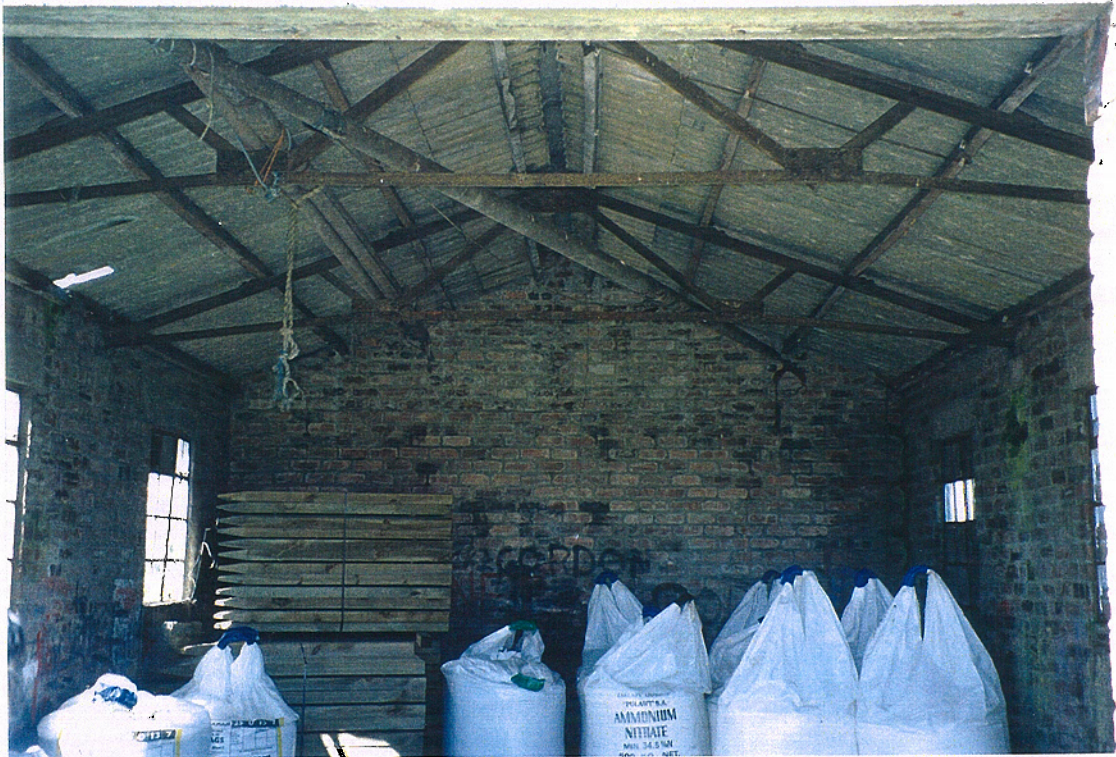
Photograph No. 33C
Looking NW at roof of Building C.1
