SECOND WORLD WAR AIRFIELDS AT TAIN AND FEARN, EASTER ROSS

A Report to Highland Council by the ASH Consulting Group

July 1999

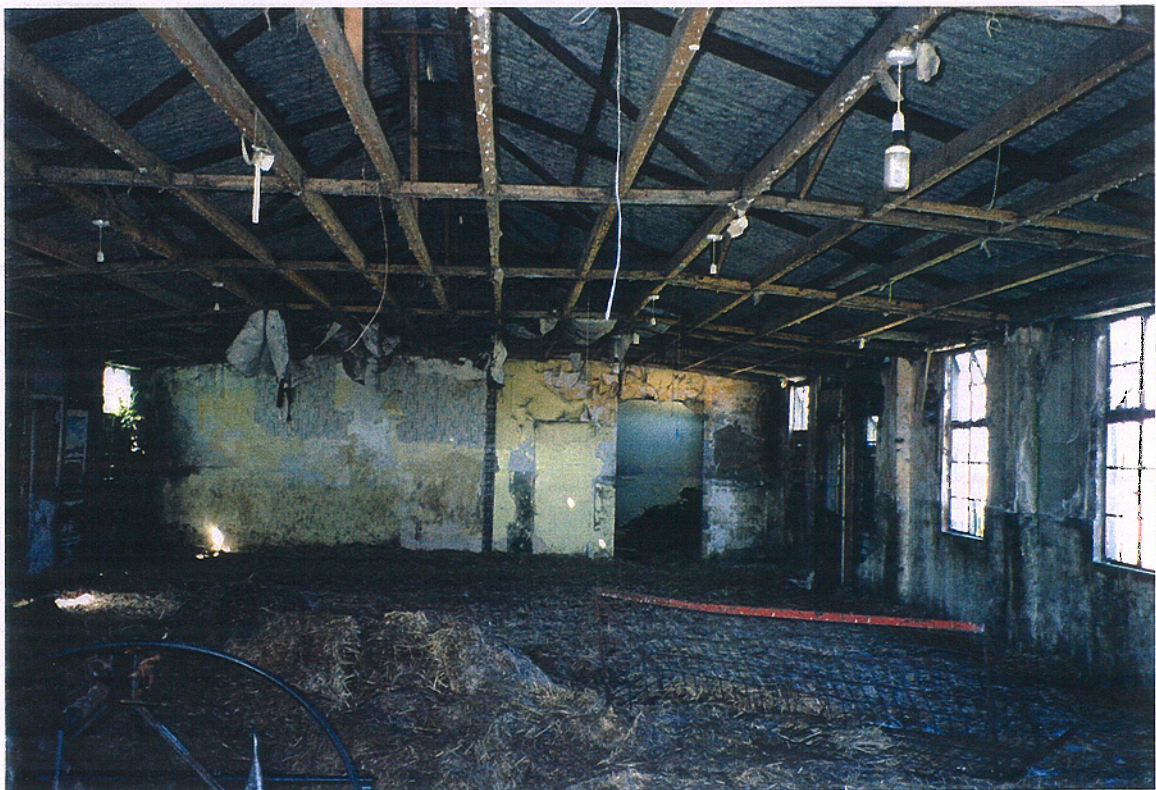
Photograph No. 36C
Looking NW at interior of S end of Building C.3
