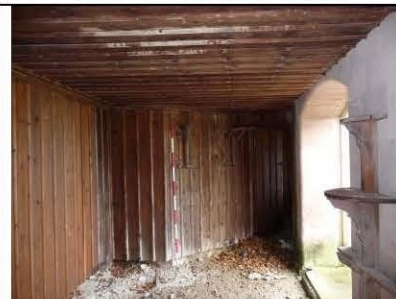
Building Element	Item	Significance	Reason		Image
Room LG 09	Late 18 <sup>th</sup> century back entrance?	EXCEPTIONAL	Entrance door and tri-partite surround on westwall built in the style of the 1780. Evidence for fine work of the late 18 <sup>th</sup> century		
Room LG 10	Modern partitioned space	MARGINAL			
Room LG 11	Build of 1894 and later	MARGINAL			
Room LG 12	Modern build but with fine sandstone staircase	SOME			
Loggia	Main room.	EXCEPTIONAL	Alpine style loggia with north facing views towards loch Ness, flanked by the two towers provided panelled rooms for storage of hunting equipment and game. Secret doors to LG2 with modern PVC glass doors to rear. Fitted with semi-circular shelving.

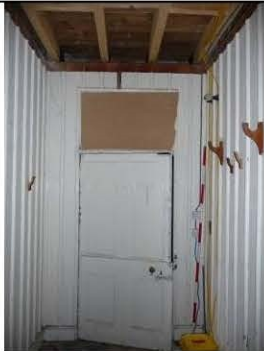
Building Element	Item	Significance	Reason		Image
			fireplaces, plaster cornice work, skirting board and 6 ½ " tongue and groove floorboards.		
Room G 01	Entrance Door	EXCEPTIONAL	Single door pre-dating works of 1894 and with central vertical rebate to give appearance of late 18 <sup>th</sup> / early 19 <sup>th</sup> century twin doors. 4 panel door, painted black on exterior and white in the interior.

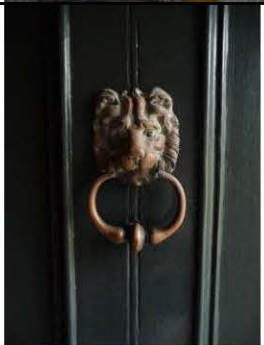
Door Furniture	EXCEPTIONAL	Lion Head knocker, brass door handle, door bell and internal lock case. Recent draught proofing of no interest.

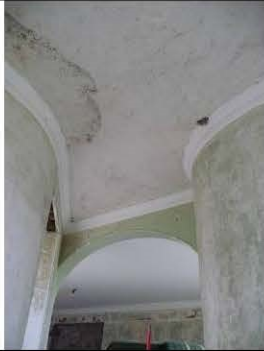
Building Element	Item	Significance	Reason		Image
	Archway into G11	CONSIDERABLE	Archways are a continuing theme throughout the house and so should be retained. It also introduces a less rigid formal line before entering curved projecting towers.

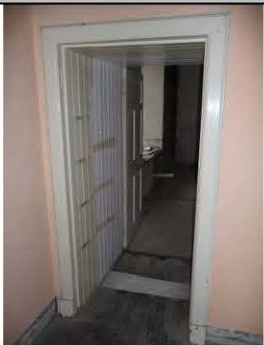
Building Element	Item	Significance	Reason		Image
Room G 07	doorway to G8	EXCEPTIONAL	Two doorways with adjoining tongue and groove lined corridor, required because of former chimney stack in the separating wall which would have originally housed a range.

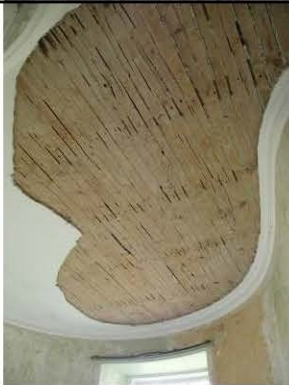
Ceiling	CONSIDERABLE	Part of Carruther's design, coving emphasises the curved shape of the room

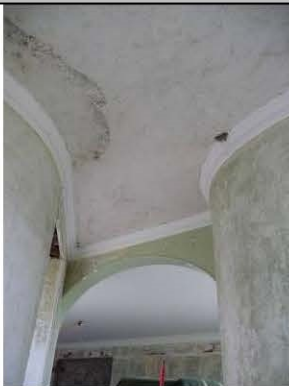
Building Element	Item	Significance	Reason		Image
	Arched entrance	CONSIDERABLE	Twinned with opposite arched entrance to G10. Continues the arched theme present throughout the house and the gently curving nature of Carruthers's design	Retain

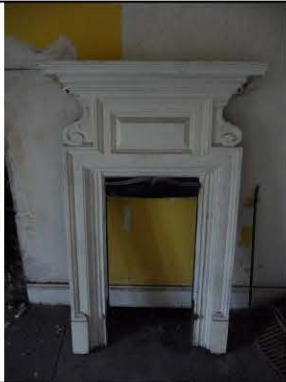
Building Element	Item	Significance	Reason		Image
	coving, skirting		reintroduce smooth lines and to create a quality finish. Coving is intact. 50% skirting intact.		
	Fireplace	CONSIDERABLE	Another Victorian element and part of overall design

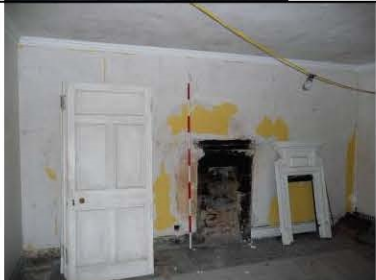
Doors in storage	CONSIDERABLE	Nine doors in storage; a mixture of four and five panel doors

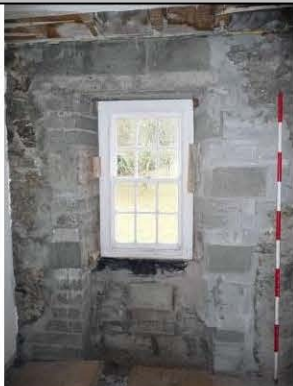
Building Element	Item	Significance	Reason		Image
Room FF 06	Window	EXCEPTIONAL	Possible modern sash in south wall, in mid 19 <sup>th</sup> century style -

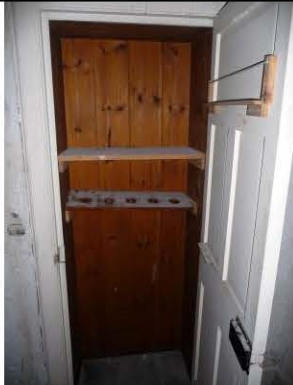
Finishings	CONSIDERABLE	Finishings are required to reintroduce smooth lines and to create a quality finish.		
Room FF 09	Fitted cupboard	CONSIDERABLE	Part of original design. Pine with fittings. Five panel door with brass handle and lock cover.

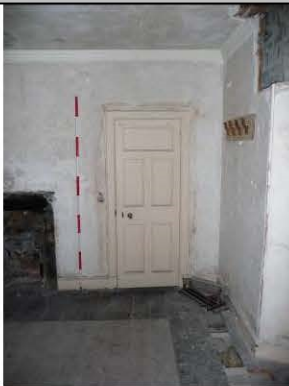
Building Element	Item	Significance	Reason		Image
	Coat hooks	CONSIDERABLE	Four coat hooks in the same arts and crafts style as in entrance hall (G1)

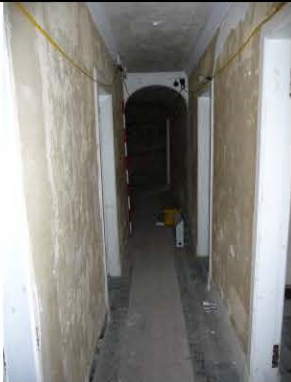
Finishings	CONSIDERABLE	Finishings are required to reintroduce smooth lines and to create a quality finish.		
	Floorboards	CONSIDERABLE	Same 6 ½ inch wide floorboards used throughout the house – boards marked where runners were located and varnished along edges

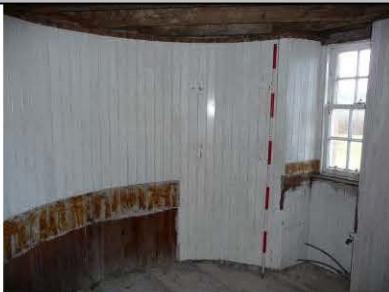
Building Element	Item	Significance	Reason		Image
	Tongue and groove boarding	SOME	tongue and groove boarding a popular Victorian and arts and crafts method of finishing walls in kitchens and bathrooms. Former sink fittings etc of no interest. Boarding originally unpainted. Victorian styles could be varnished or scrubbed white.

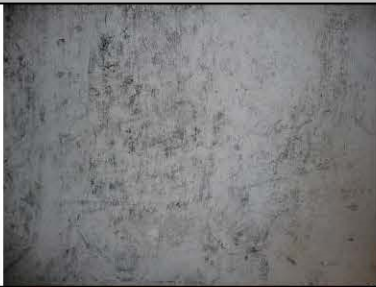
Building Element	Item	Significance	Reason		Image	
Room SF 06	Surviving pencil sketches on several walls associated with scheme of 1893.	SOME	Added historic interest
