Oswald Lane, Cromarty

Archaeological Watching Brief

Report No.	HAS150104
Site Code	HAS_COL14
Client	C and C Keith
Planning Ref	11/01283/FUL
OS Grid Ref	NH 78930 67489
Date/ revision	22/01/2015
Author	John Wood

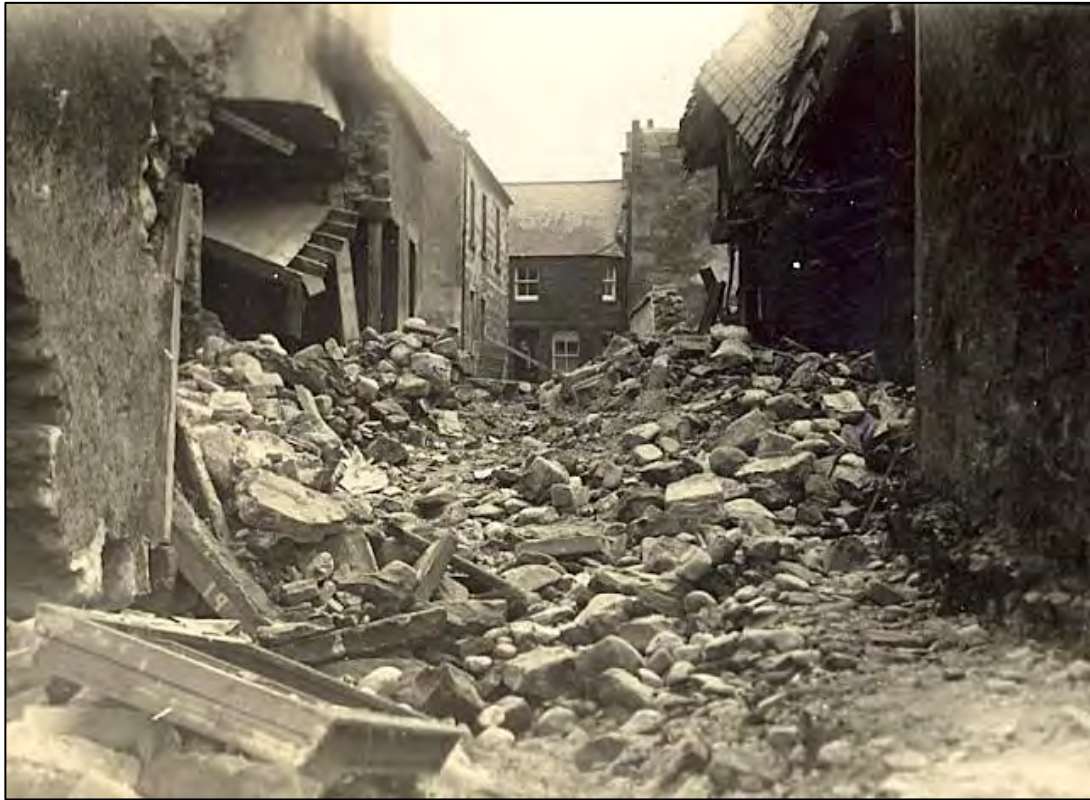
Plate 1 Oswald Lane from the north, following the 1940 flood
(Courtesy of <http://www.thecromartyarchive.org>)

The watching brief revealed the west (retaining) wall [4], coal cellar [8,9,10] and fragmentary evidence of the north gable [6] of a house on this site (House A). This appears to correspond to a building shown on the 1938 Ordnance Survey revised 6-inch map, which according to the photograph (Plate 1) had already been demolished before the 1940 flood. The south gable line was not found and apparently lies outwith the development footprint. There had been some rebuilding done to the back wall apparently during the life of this building or perhaps as part of a more general rebuilding. This repair appeared to be lime mortar bonded [4]. There was no dating evidence to indicate when this house was built.

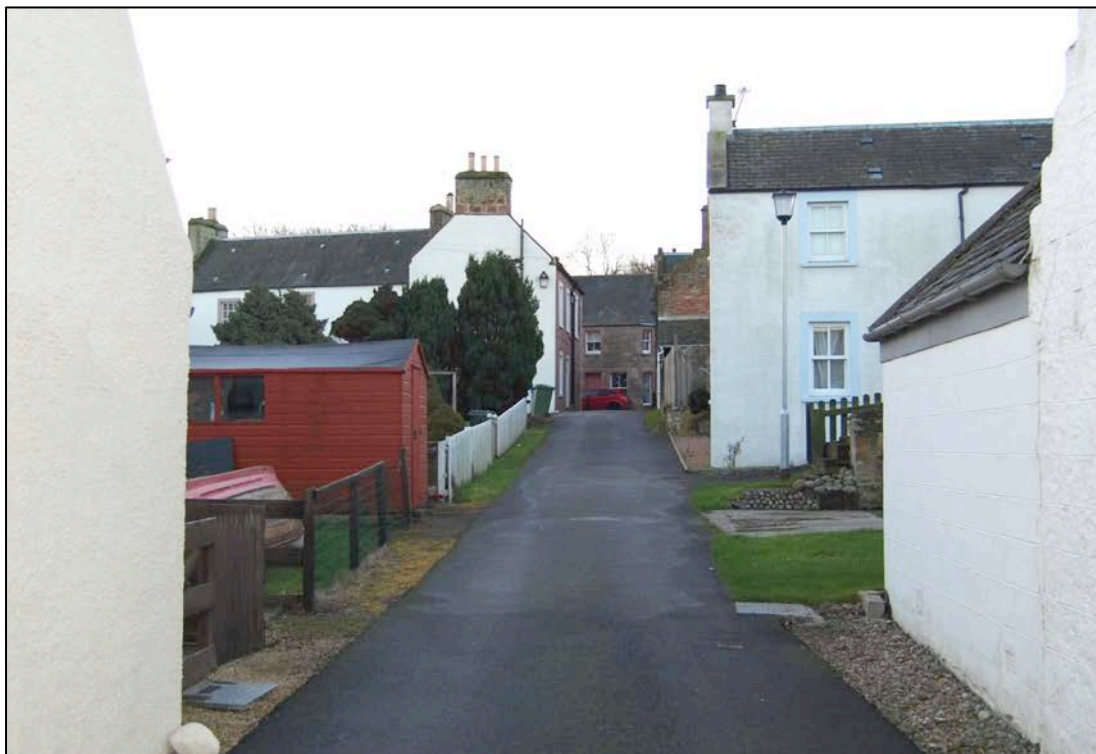
Plate 2 Oswald Lane from the north, December 2014
