Plockton Harbour CIC Equipment Store

Plockton, Balmacara Estate

Photographic Building Survey

Historic Building Survey Report

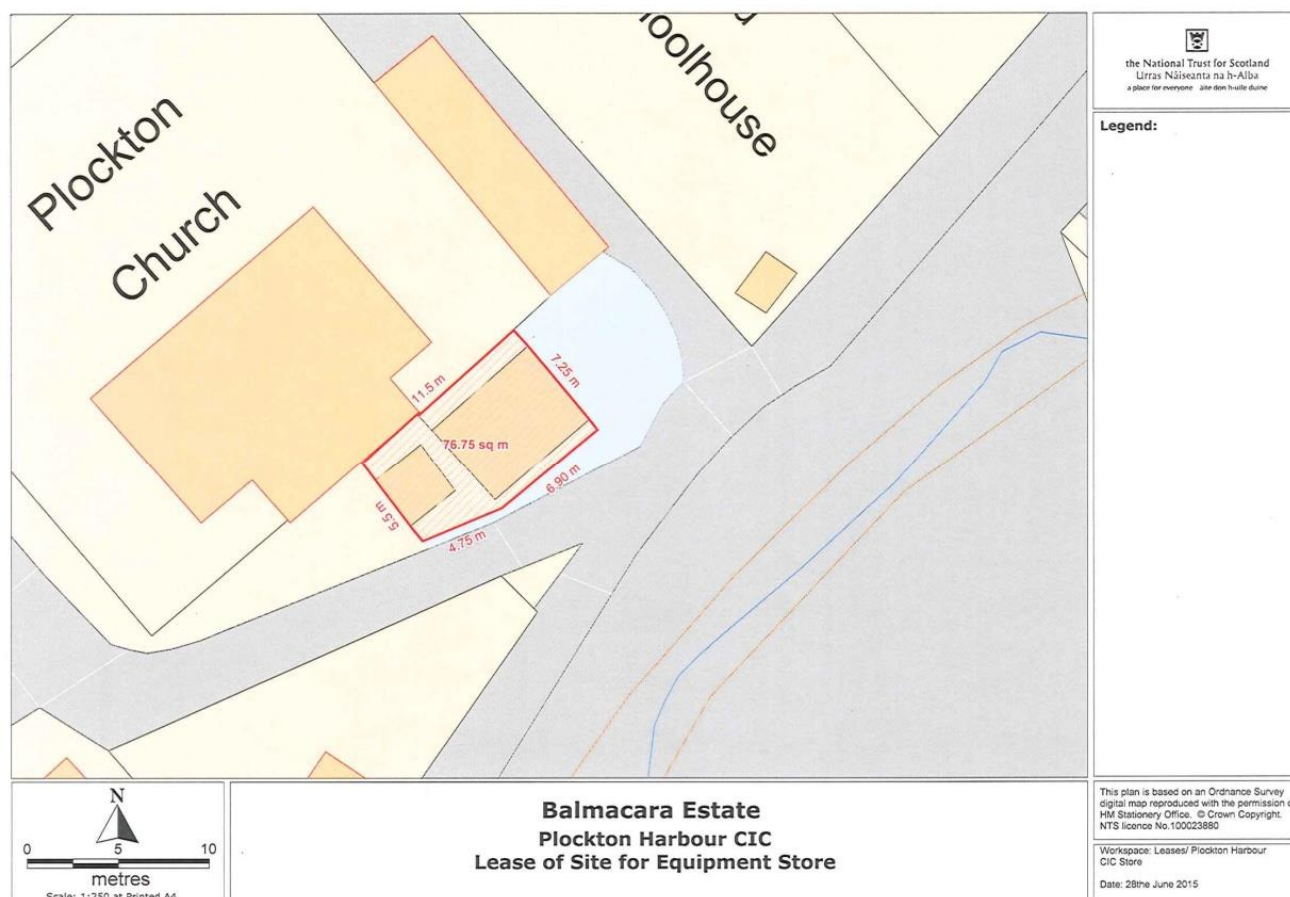
Figure 1: Bound in red: the two buildings surveyed, the cabin to the left and the garage to the right (map courtesy of the National Trust for Scotland)

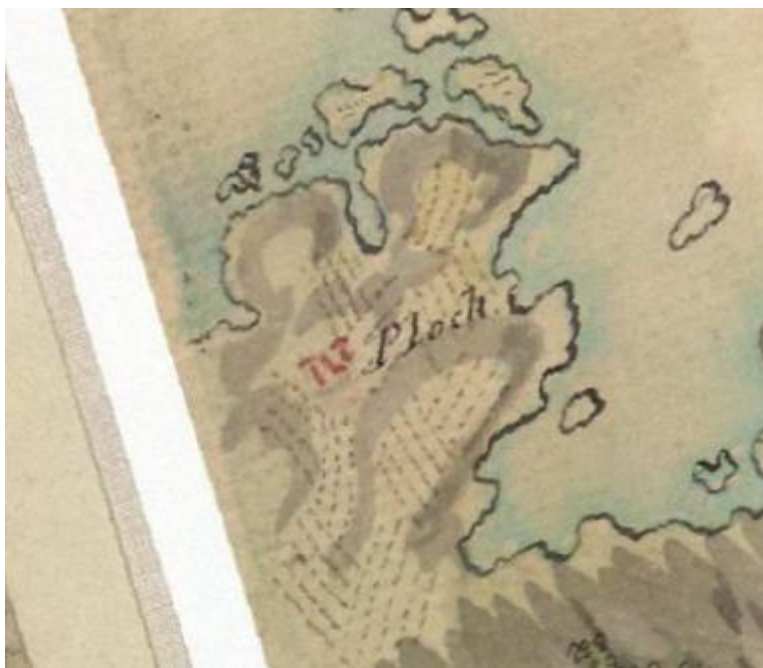
Figure 2: Extract from William Roy Military Survey of Scotland

Plockton first appears in the available cartographic records as *Plock* on Roy's Military map (**Figure 2**). The buildings cannot be discerned from the layout of the village, and the settlement itself seems to be situated further west than the modern day village.

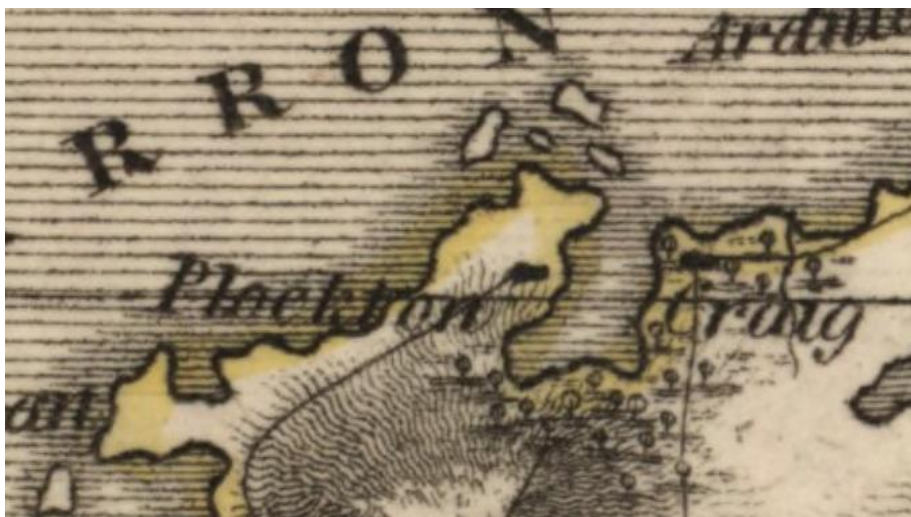
Figure 3: Extract from Thomson's map

While Plockton appears written as it is today by the time of Thomson's *Atlas*, the layout of the town is indiscernible (**Figure 3**).

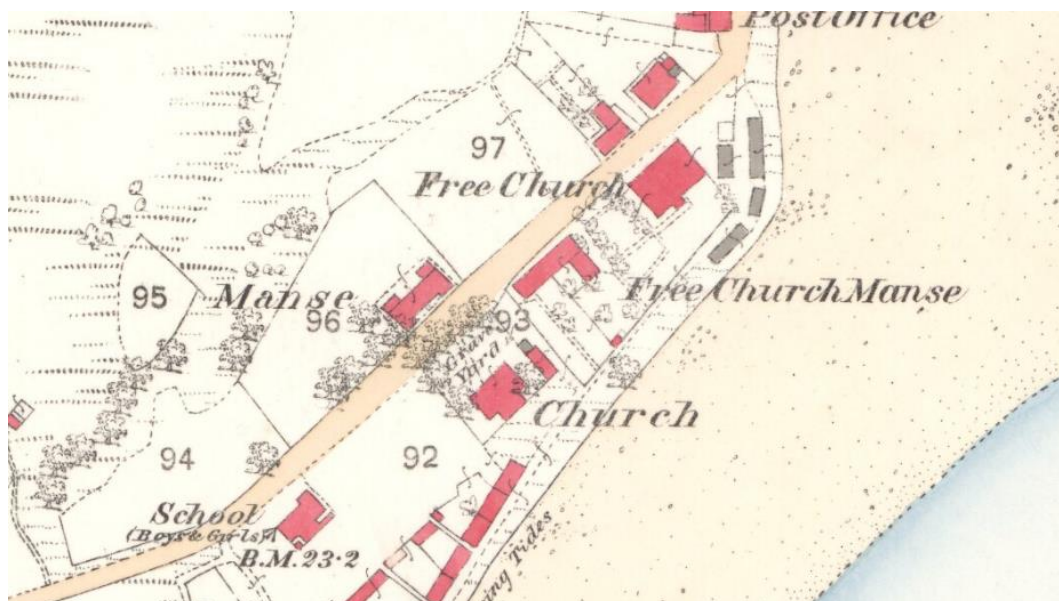
Figure 4: Extract from the First Edition OS map

The First Edition map shows the Church, but no structures that could be interpreted as the cabin or garage (Figure 4).

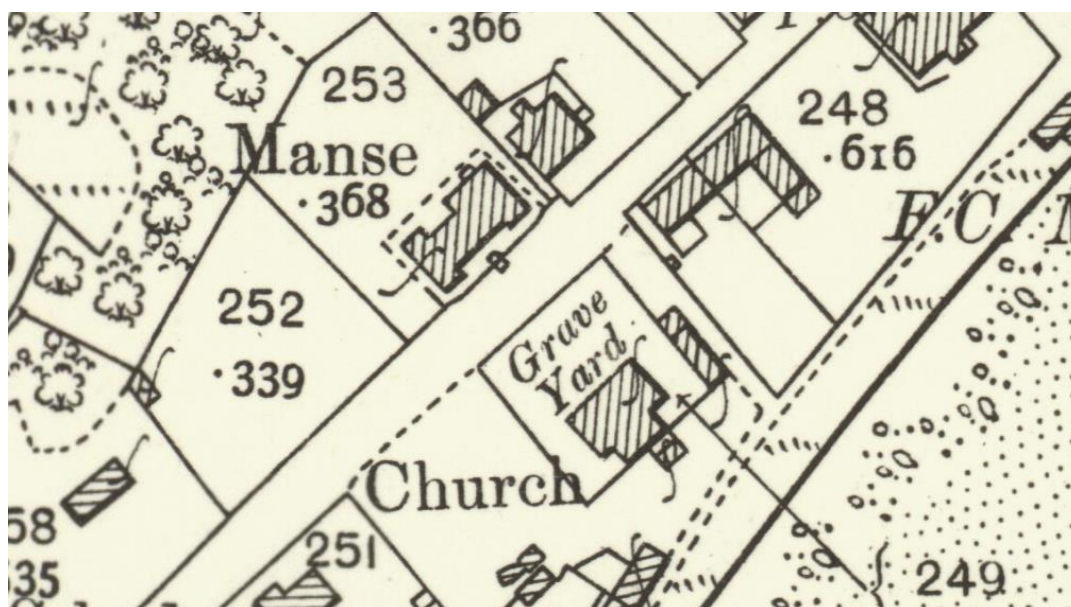
Figure 5: Extract from the Second Edition OS map

There is evidence for a roofed structure situated to the south-east of the Church (**Figure 5**). This is most likely the tin bothy, which would provide a potential construction date range between 1875 (the date of survey for the First Ordinance Survey Map) and 1902 . the date of this map's revision.

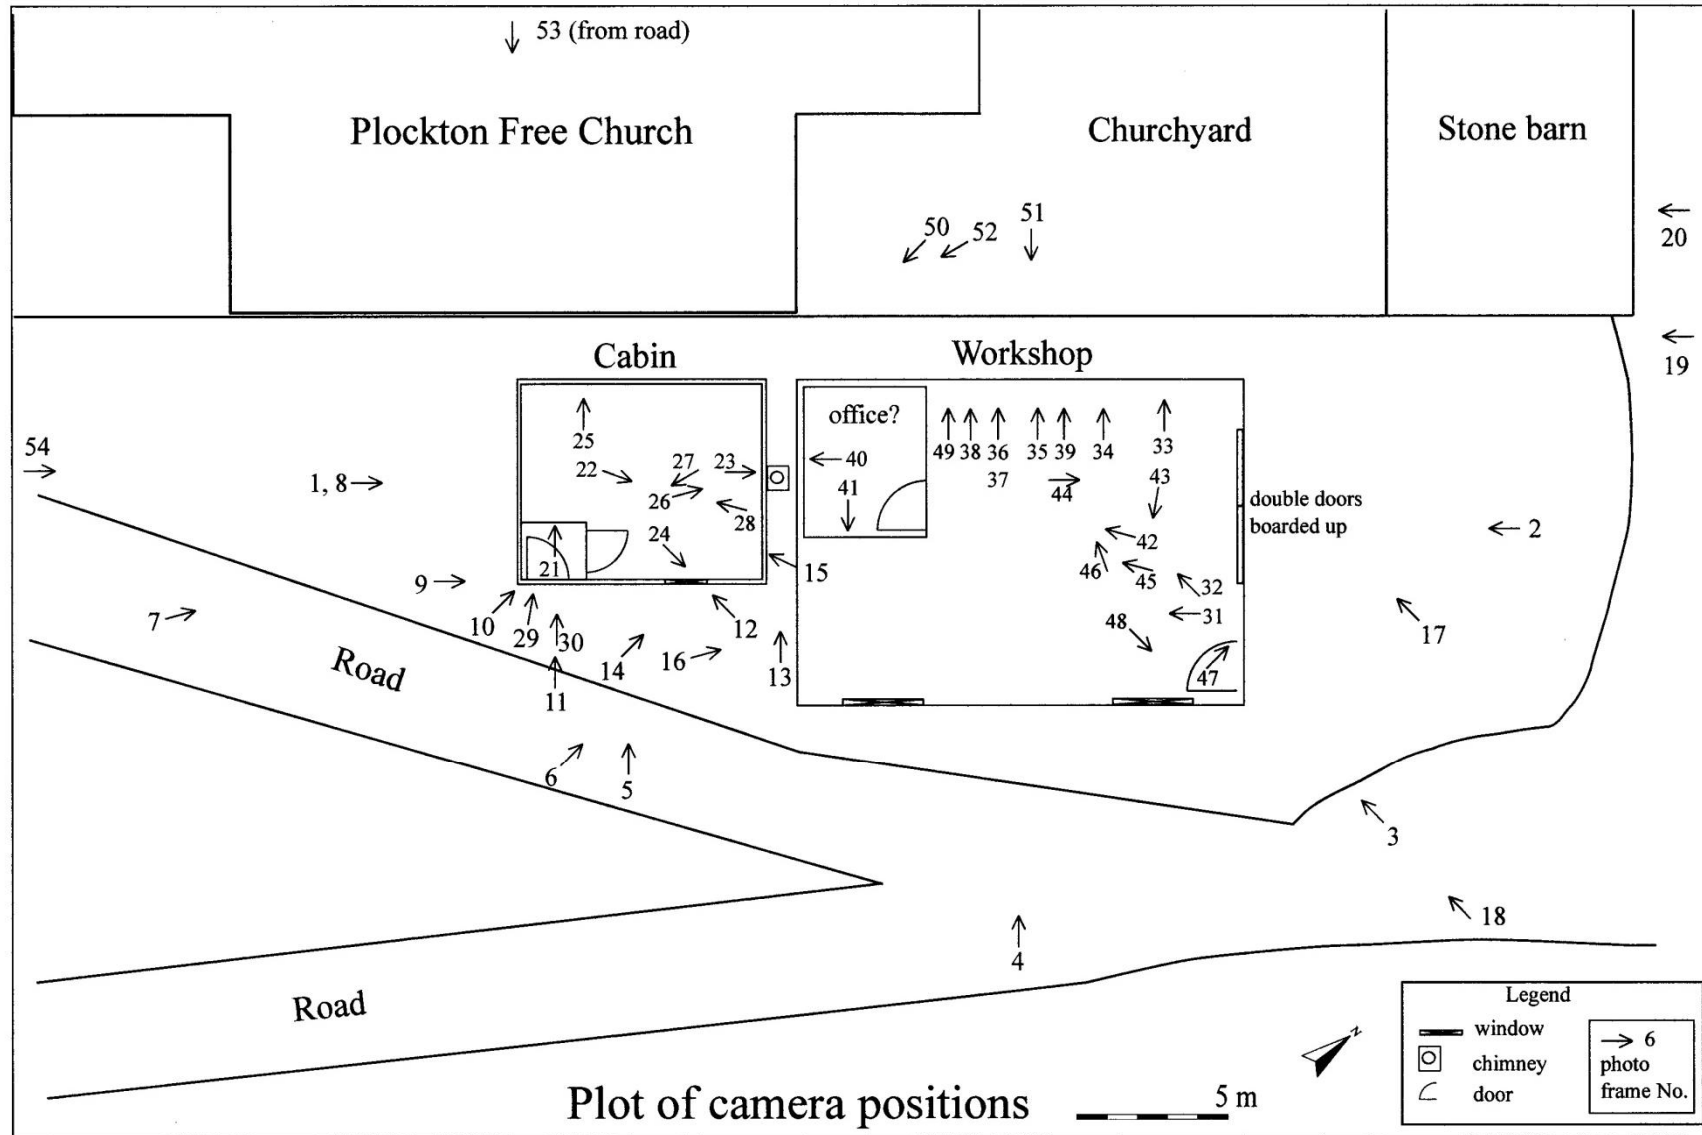
Figure 6: Plan of the photograph positions
