**Prehistoric Round House Structures in Wester Ross,
and in Selected Areas of Skye**

**Collation and Analysis of Detailed Data
with regard to distribution, construction and landscape settings**

Undergraduate Dissertation

University of Aberdeen

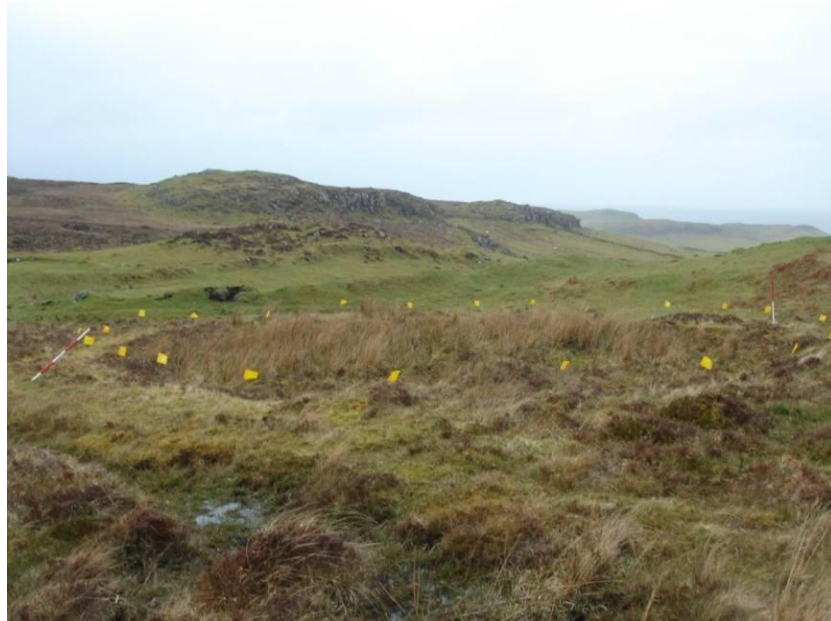
Plate 1 **Roundhouse site at Hinnedal Bridge, Skye. Yellow flags indicate shape**

2.5.2 A photograph showing the shape of a roundhouse wall outlined by yellow flags is shown in Plate 1.

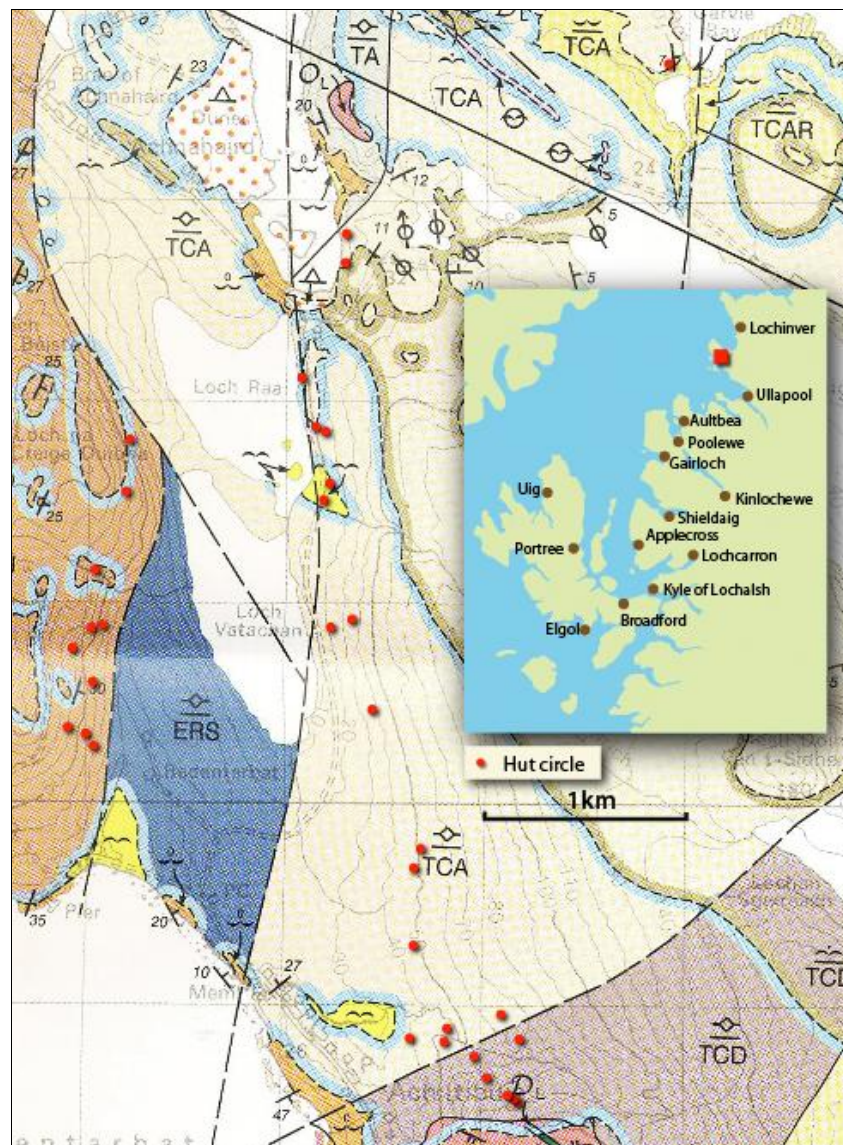
Figure 11 (C)BGS/NERC, Part of Sheet101W, Achiltibuie

3.2.3.3.1 The pattern on the Achiltibuie map (OS map Figure 4) is slightly different. The geological map in Figure 11 shows that the western sites on Lochs Vatachan and Raa are mostly within or very near areas of glacial till (thick pale blue lines), sitting on bedrock of medium grained red sandstone (brown). The Loch Raa eastern sites are at low level in small areas of glacial till and alluvial deposits (yellow). The sites east of Achiltibuie township are situated on two types of red sandstone (beige) with indications on the map that there are some glacial deposits, and also peat cover. House sites have avoided the hard quartzite rocks (blue).

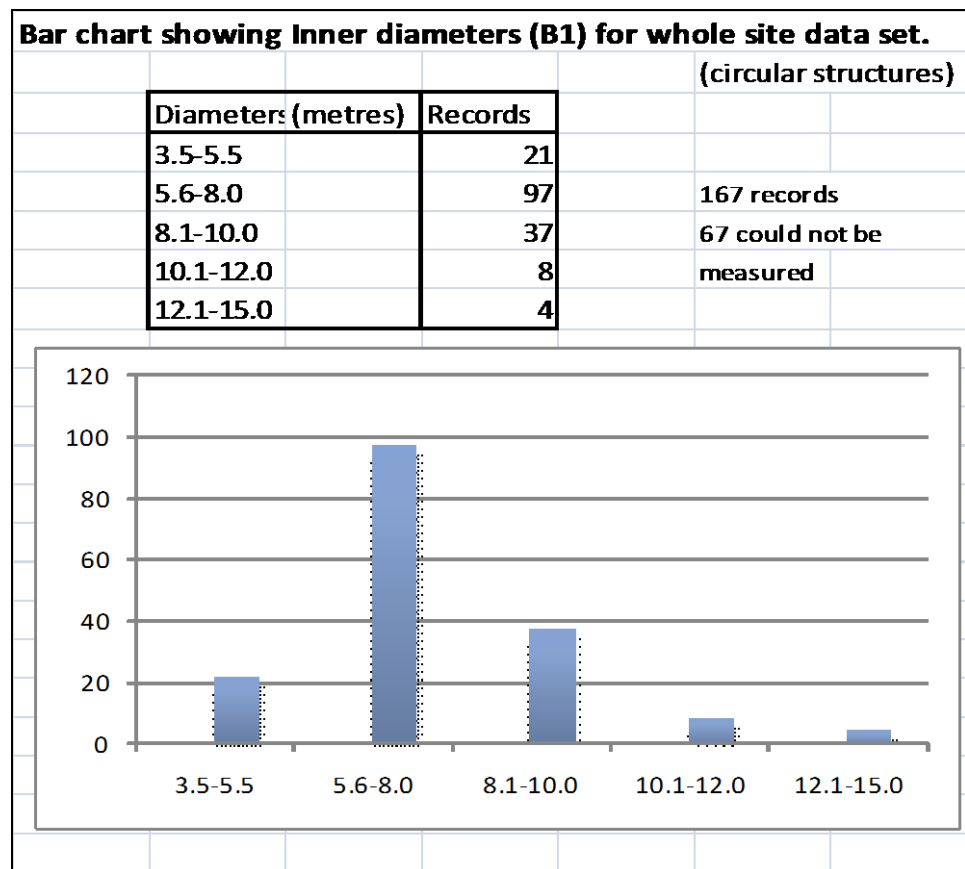
Figure 16 Inner diameters

3.5.1.3.2 With 5 ranges as shown below (see Figure 16) the chart indicates that 97 roundhouses have an inner diameter of between 5.6m and 8.0m, 58% of those recorded.

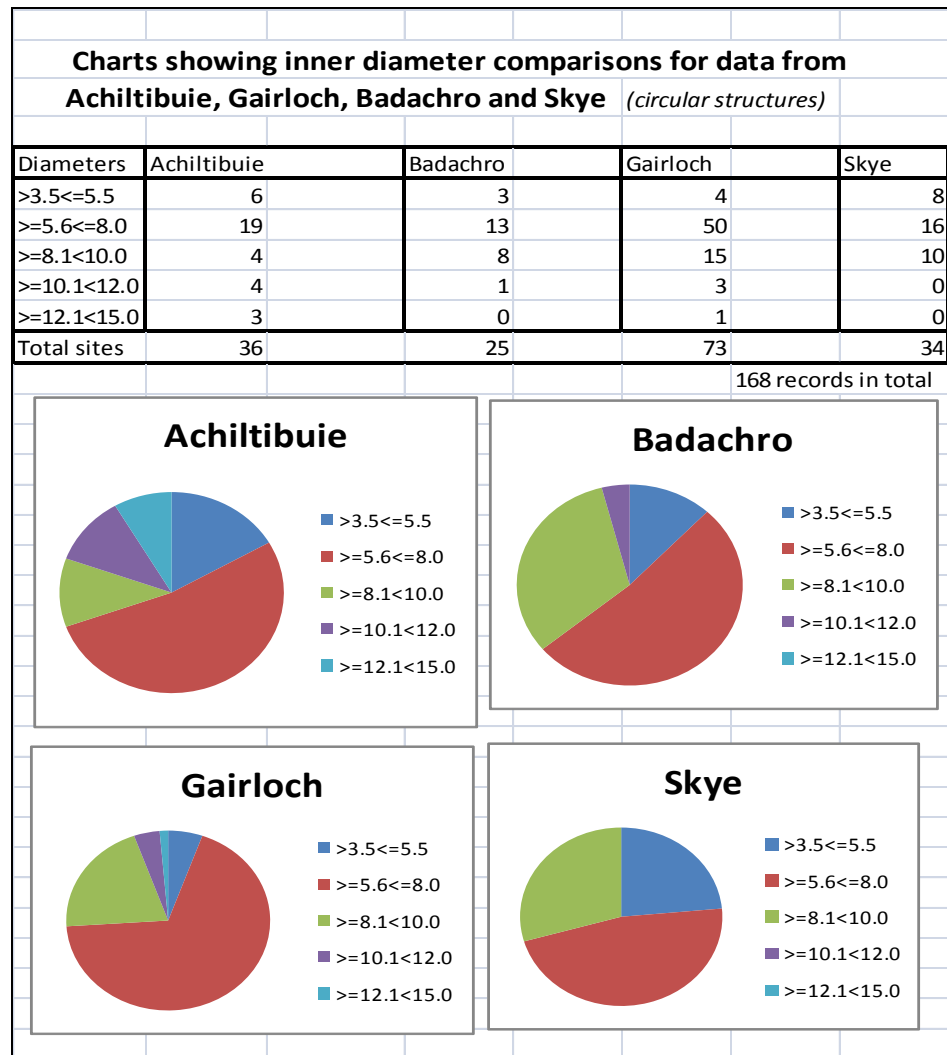
Figure 17 Inner Diameter Comparison between the four areas for circular sites

3.5.1.3.3 Inner diameters are now compared using data from the four areas, see Figure 17.

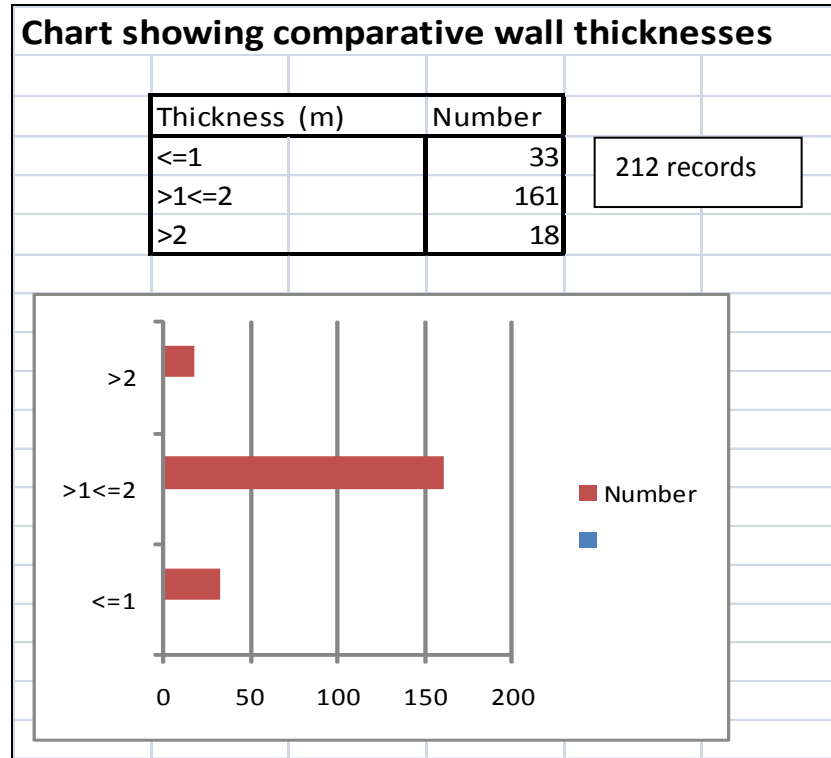
Figure 19 Comparative wall thickness

3.5.1.4.2 Wall thickness was measured at the most intact section of walling, see Figure 19.

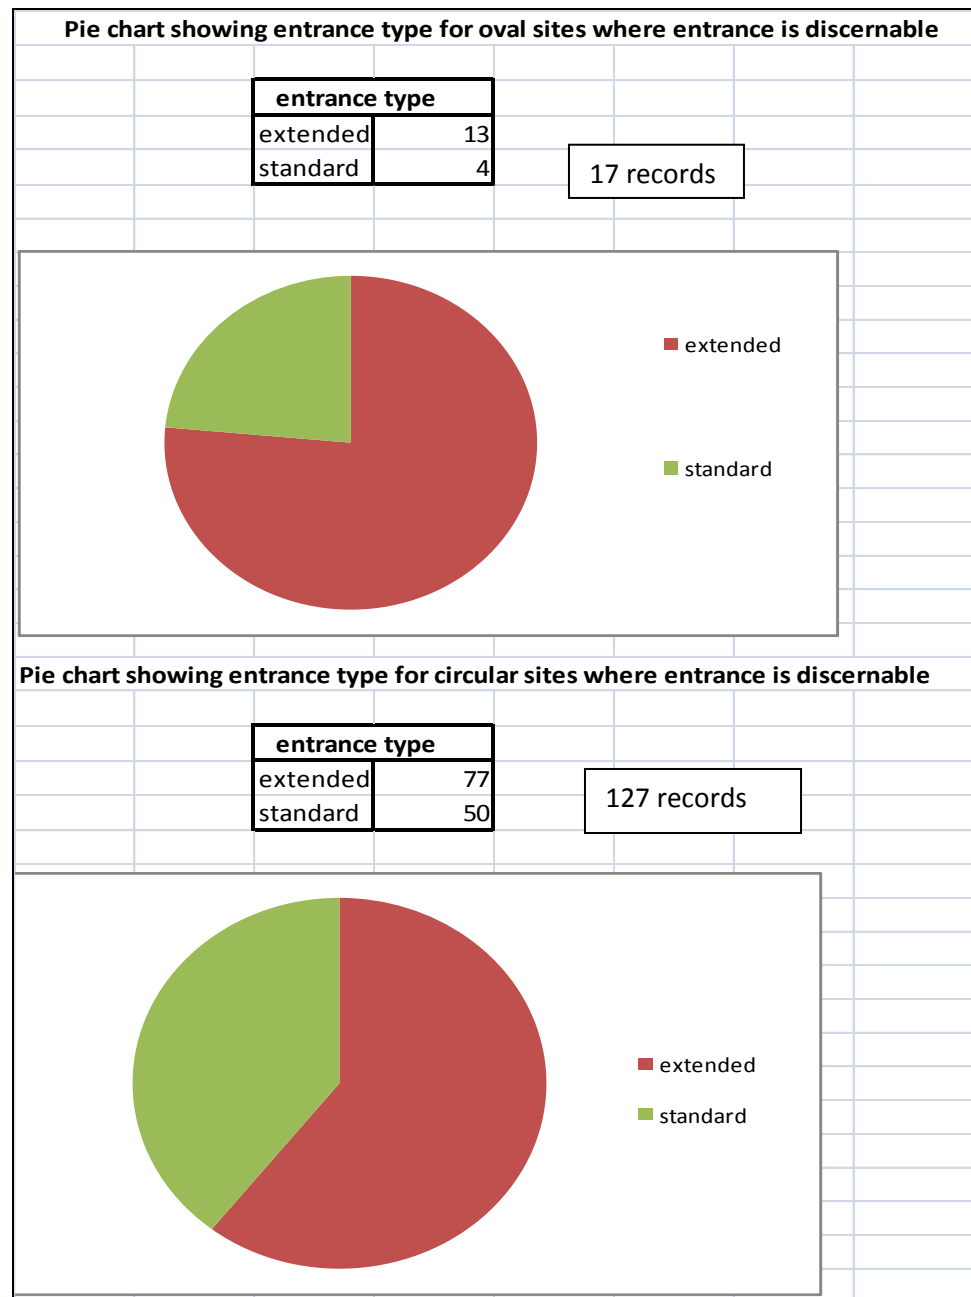
Figure 20 Entrance type

3.5.1.4.7 Figure 20 shows entrance types both for oval and for circular sites.

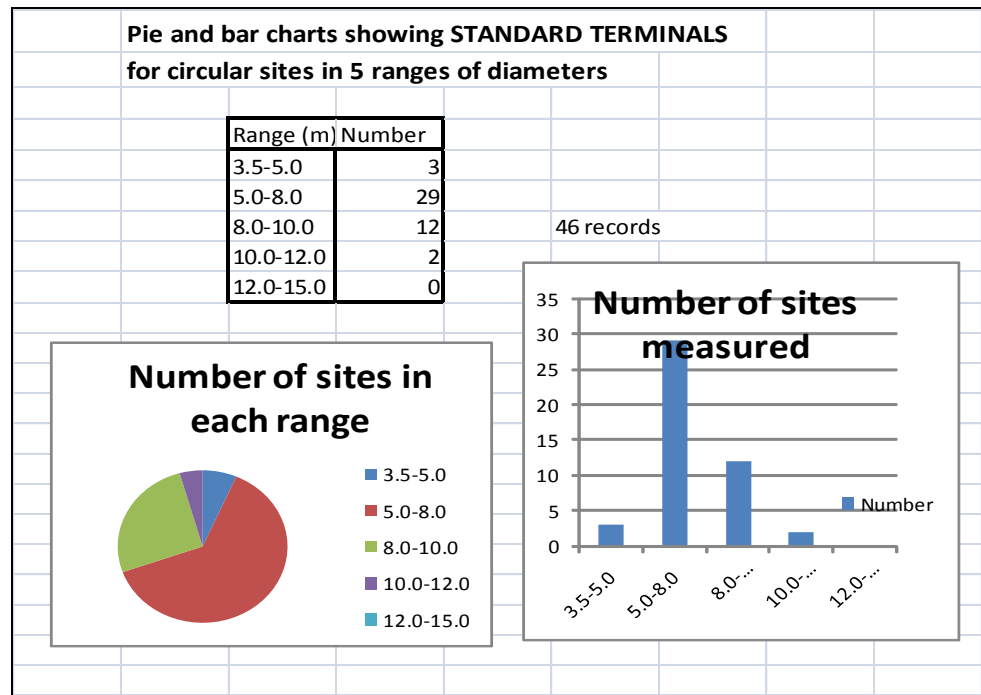
Figure 21 Standard terminals

3.5.1.4.9 Another approach to comparison of terminals is to look at standard and extended terminals for circular sites using 5 ranges of inner diameters, see Figure 21.

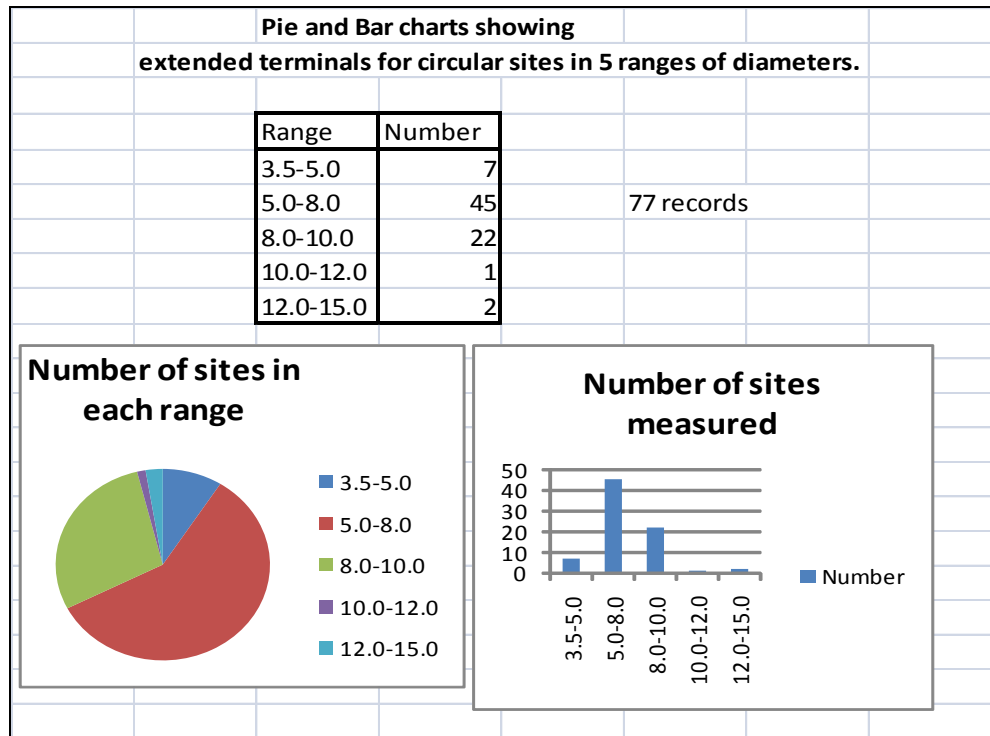
Figure 22 Extended terminals

3.5.1.4.10 This can be compared with a chart showing extended terminals for circular sites using 5 ranges of inner diameters, see Figure 22. The pie charts show similar proportions of each type of terminal for each diameter range.

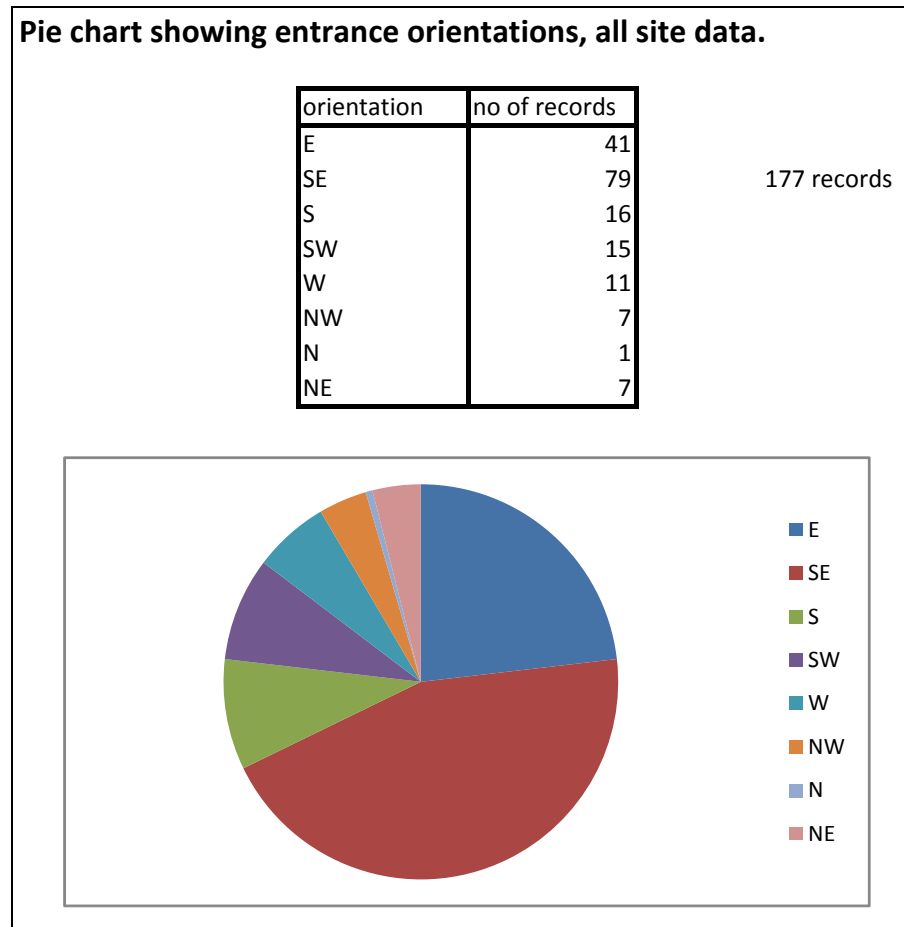
Figure 23 Entrance orientation

3.5.1.5.1 The entrance orientation could be identified for 87% of sites, shown in Figure 23.

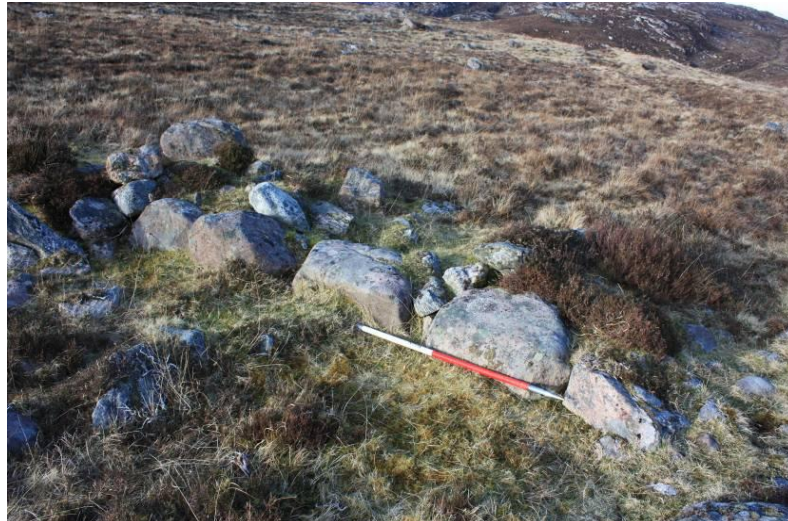
Plate 3 **Showing the inner face of a double skinned wall, Creag Bo Maoile, Gairloch & Poolewe (MM008)**

4.5.4.3 This information gives us an understanding of the strength of the building structure. Most of the double skinned walls showed evidence of infill of stones and turf. This design would have created a strong stone wall capable of supporting roof timbers. It would have provided good insulation. The roof could have overlapped the outer wall and allowed rain to run into an outside gully, or it could have been constructed so as to let rain run into the wall infill. The same type of wall structure continued until the 'black houses' of the nineteenth century, although the shape of the houses altered over the centuries through circular to sub-circular and rectangular, (Holden 2004).

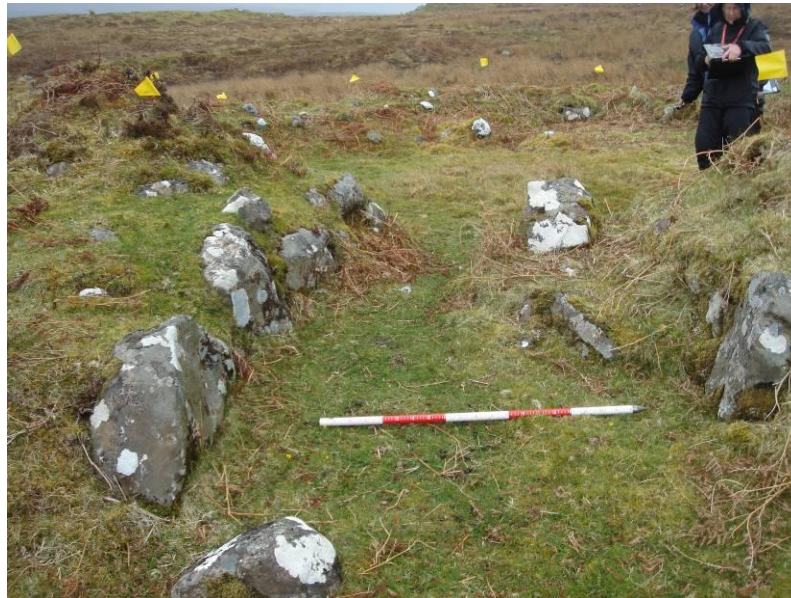
Plate 4 Long entrance passage showing extended wall terminals, Hinnisdal Bridge Skye, (site EB203).

4.5.5.1 Standard and extended terminals were examined, (see section 3.5.1.4.6, Figures 20, 21, 22, and Plate 4). The results are not very informative, apart from showing that more sites have extended terminals than have standard. The charts in Figures 21 and 22 show that the proportions of either standard or extended terminals seem to match the proportions in the different diameter ranges. To obtain some more useful information a comparison of terminals should be made between individual clusters of sites. A terminal comparison should also be made with inner diameters and wall thickness, possibly finding that similarity of structural styles matches a terminal type. Plate 4 shows a site at Hinnisdal Bridge, Skye, where extended wall terminals are marked by a long entrance passage.

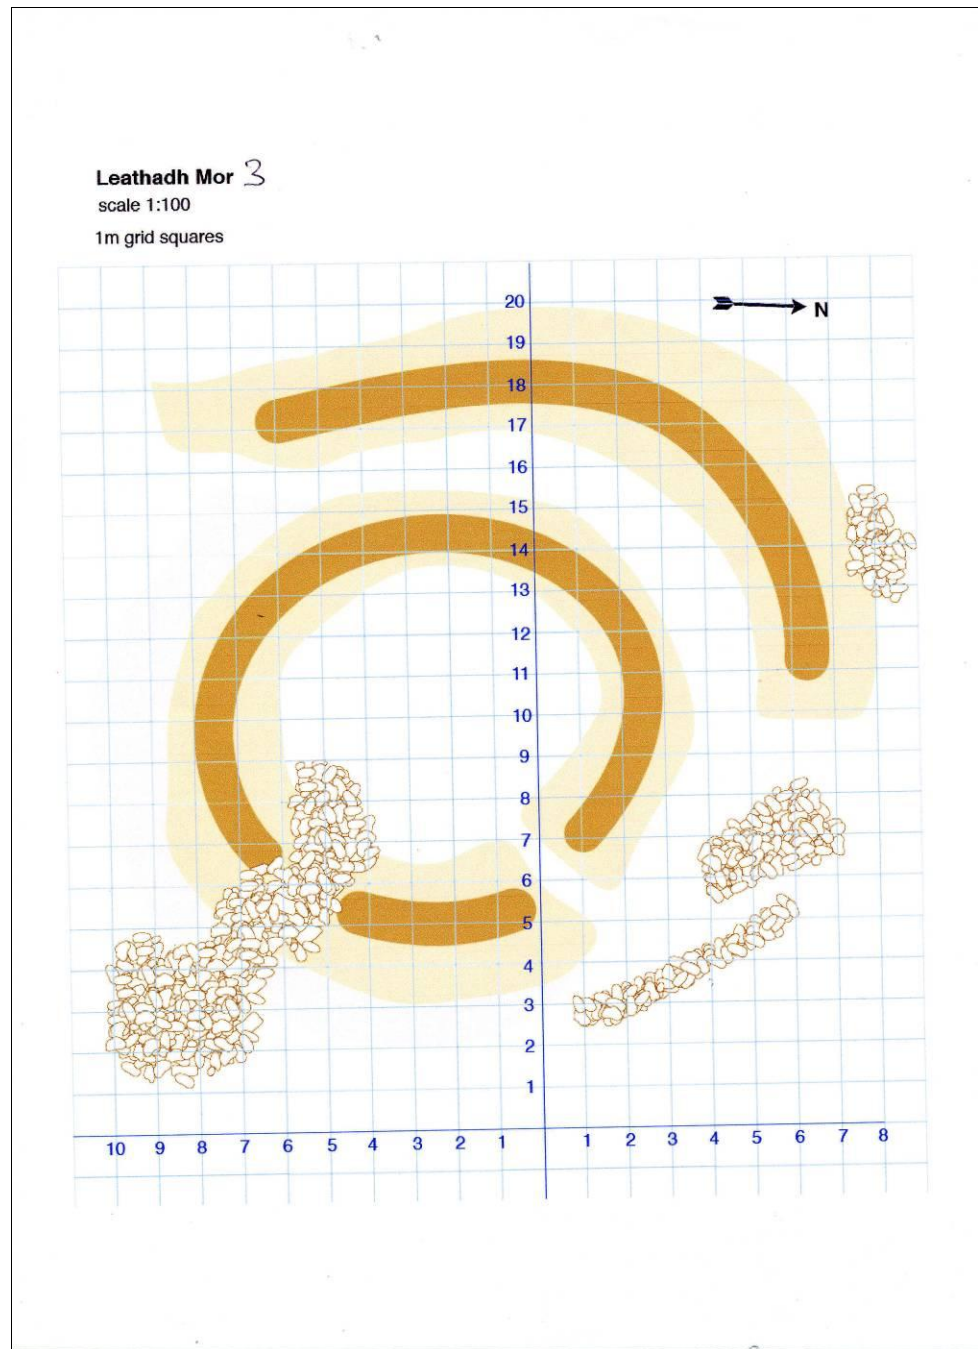
Figure 46 Site AMC103, Leathad Mor

B **Tape and offset survey, Leathad Mor, Gairloch & Poolewe**
