SMR FIELD VERIFICATION

Site Name and Location: Caisteal Dubh Nan Cliar		Date: 3.03.04	Initials: JGR
Site Type: Tower-House		Grid Reference: NM 4733 6313	
SMR no: NM46SE0002	NMRS no: NM46SE 2	Source & date of source: OS, 1970; RCAHMS, 1980.

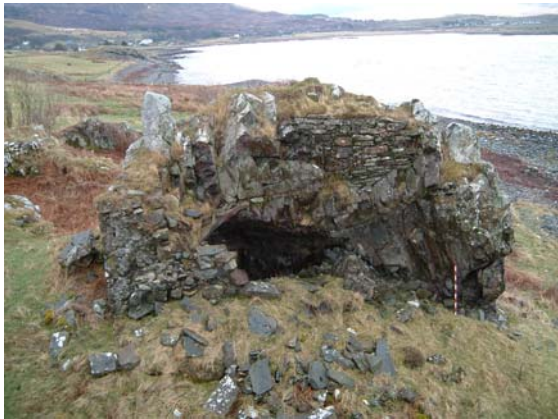
This ruinous structure, situated on a small rocky knoll on the shore of Kilchoan Bay, was visited by RCAHMS in 1971 (published in RCAHMS, 1980, 190). The chamber beneath the SW portion of the tower is still extant, including fragments of masonry walls on the NW and SW sides. The roof of slab-lintels, supported on corbel courses, also survives but the remains of a rebated entrance-doorway in the SE wall, recorded by the RCAHMS, have collapsed. A fragment of mortared masonry lies on its side on the SE side.

Caisteal Dubh Nan Cliar tower-house, from SW.

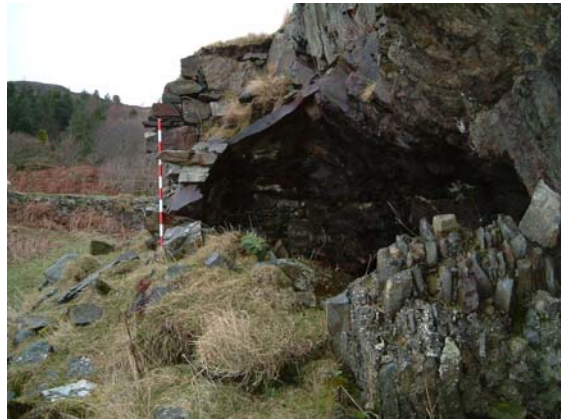
Caisteal Dubh Nan Cliar tower-house, from SE. Collapsed SE wall at front right.
