SECOND WORLD WAR AIRFIELDS AT TAIN AND FEARN, EASTER ROSS

A Report to Highland Council by the ASH Consulting Group

July 1999

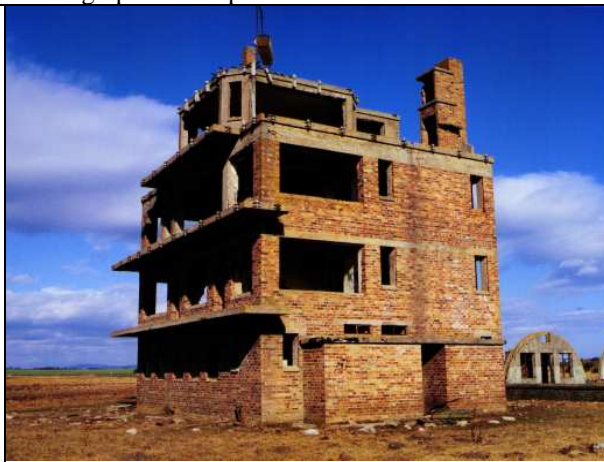
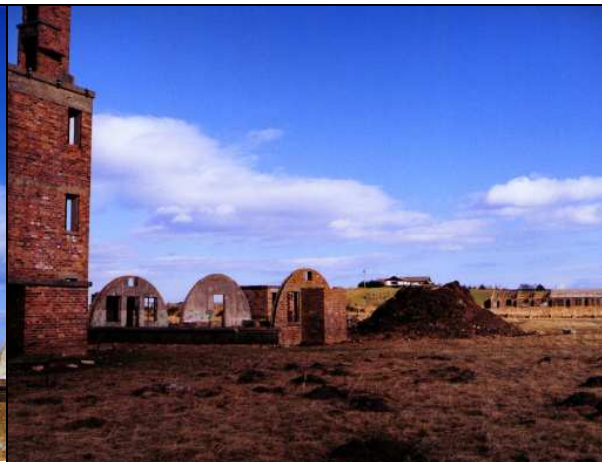
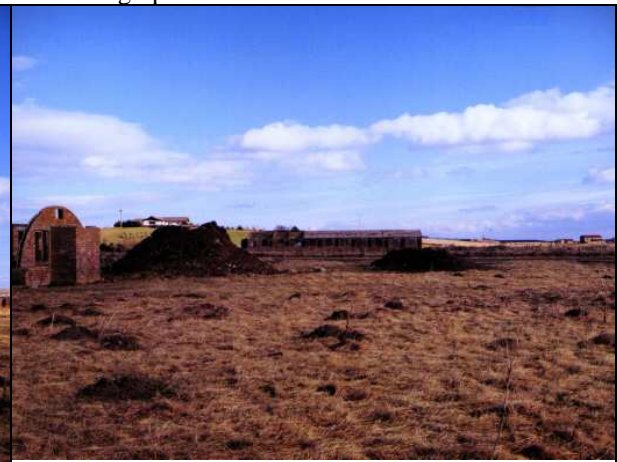
Panorama A3/A4/A5: Control Tower and adjacent buildings
FEARN AIRFIELD – PHOTOGRAPHIC SURVEY AREA A/G

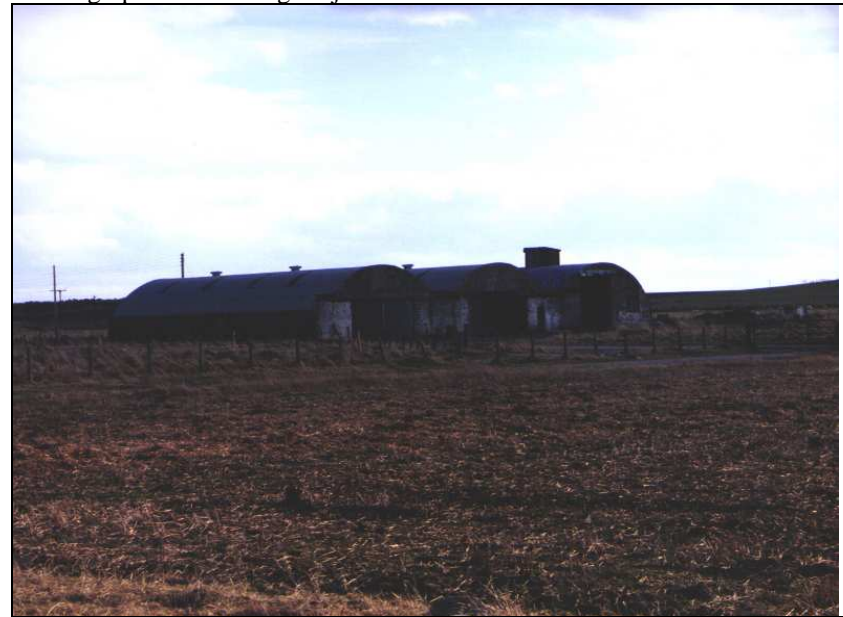
Photograph A9: Torpedo shed

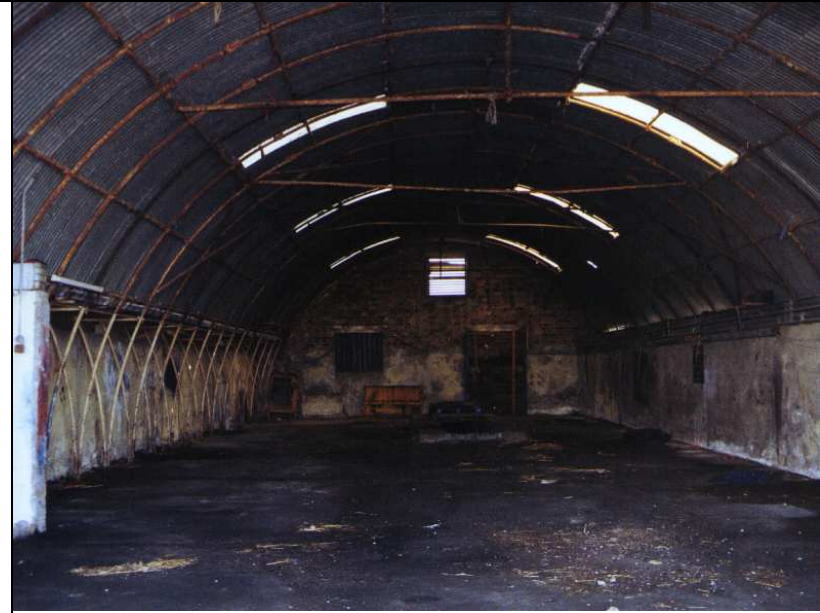
Photograph A10: Interior of Torpedo shed

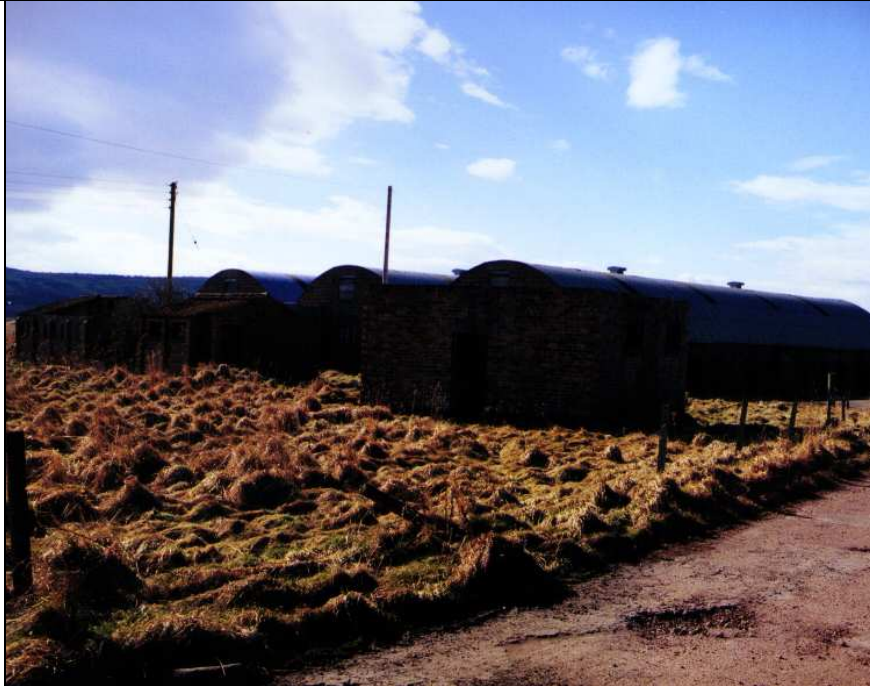
Photograph A13: Torpedo shed with ablutions blocks in foreground

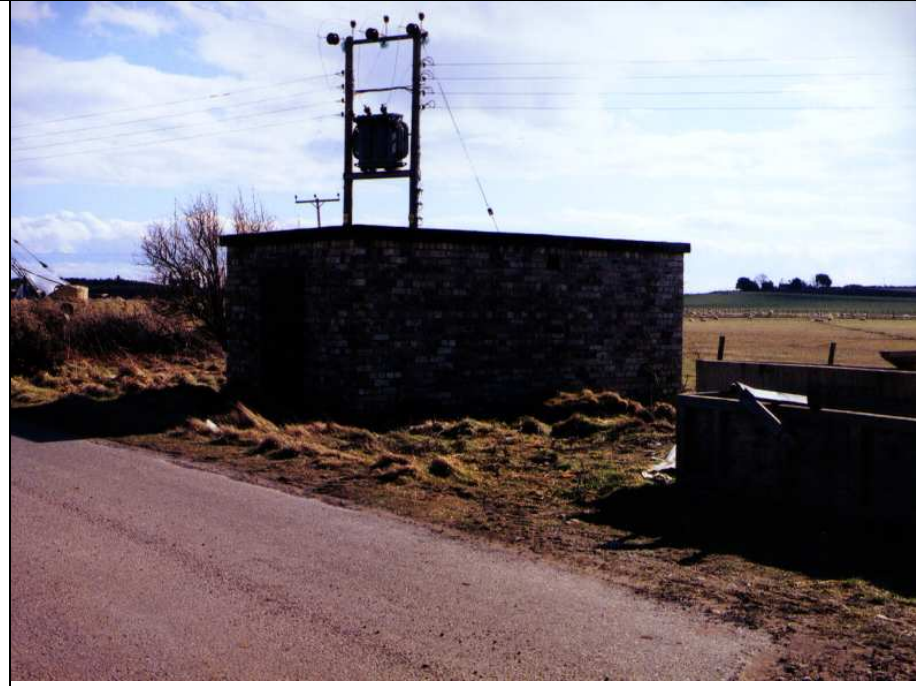
Photograph A14: munitions store

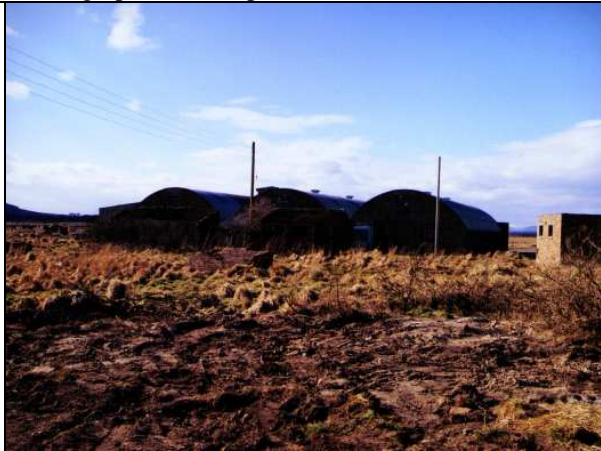
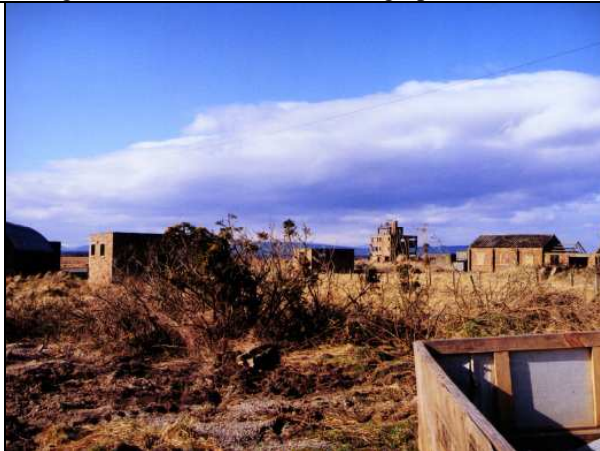
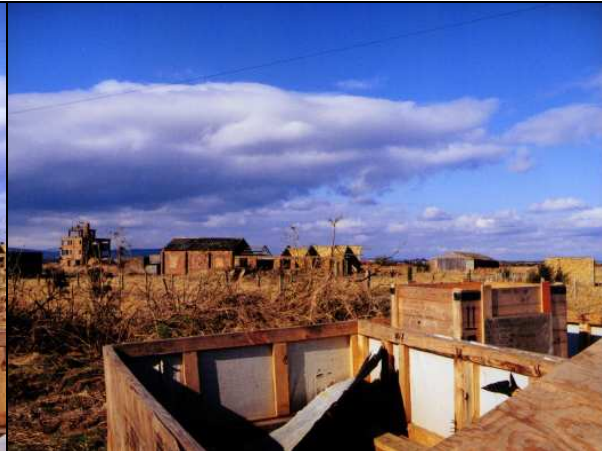
Panorama A15/A16/A17: General view over technical area from east of torpedo shed
FEARN AIRFIELD – PHOTOGRAPHIC SURVEY AREA A/G

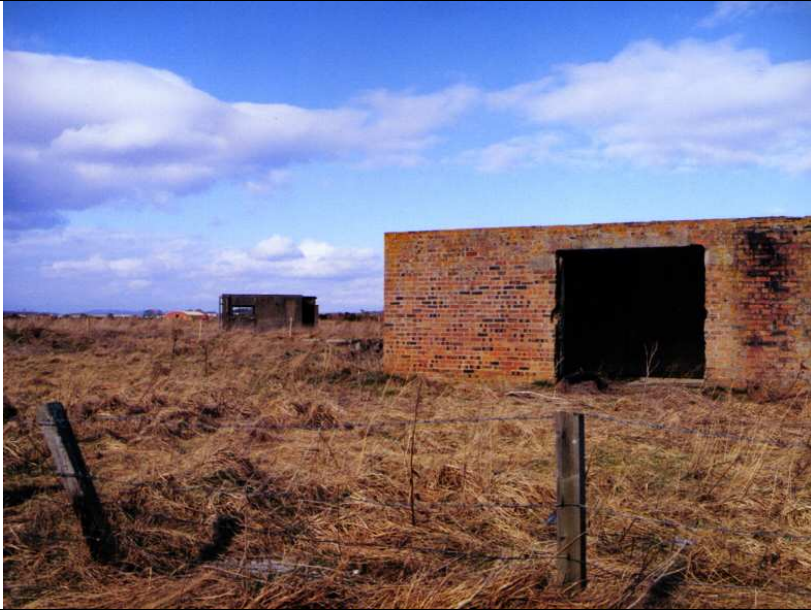
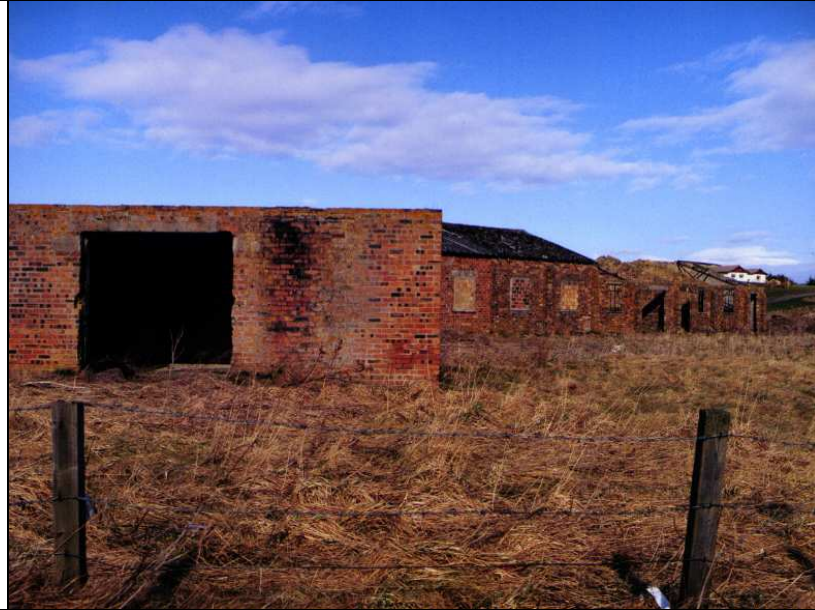
Panorama A18/A19: General view over technical; area from north of torpedo shed

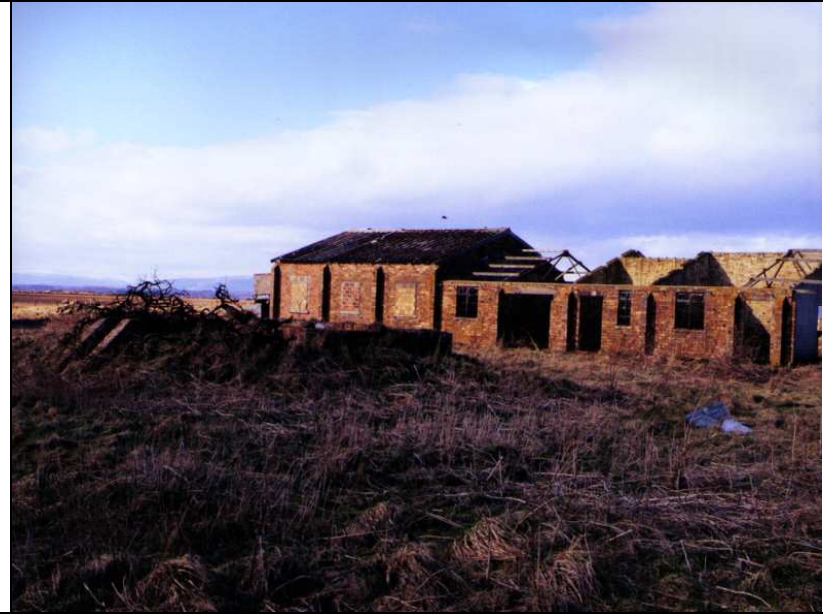
Photograph A21: View of technical building from the south

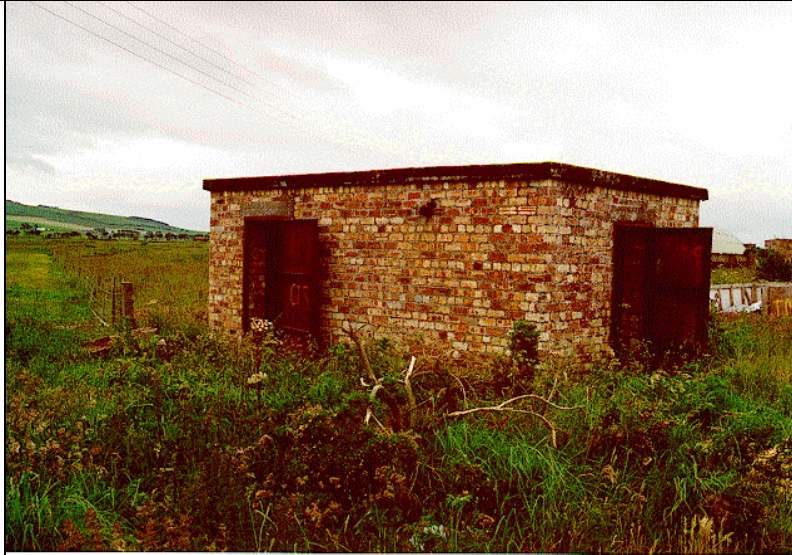
Photograph A22: munitions store

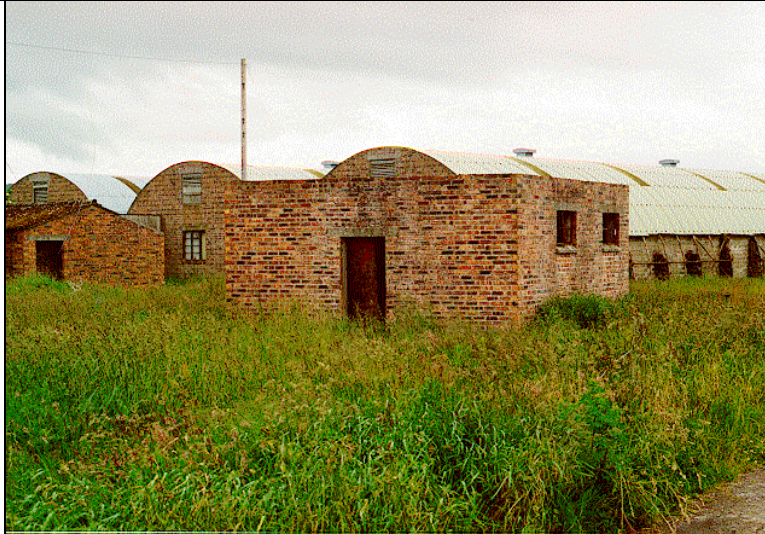
Photograph A24: Torpedo shed

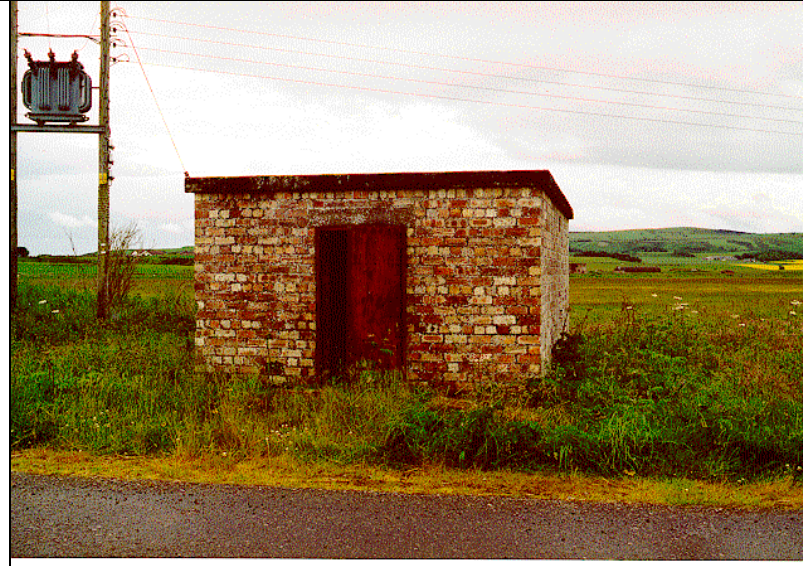
Photograph A25: Munitions store

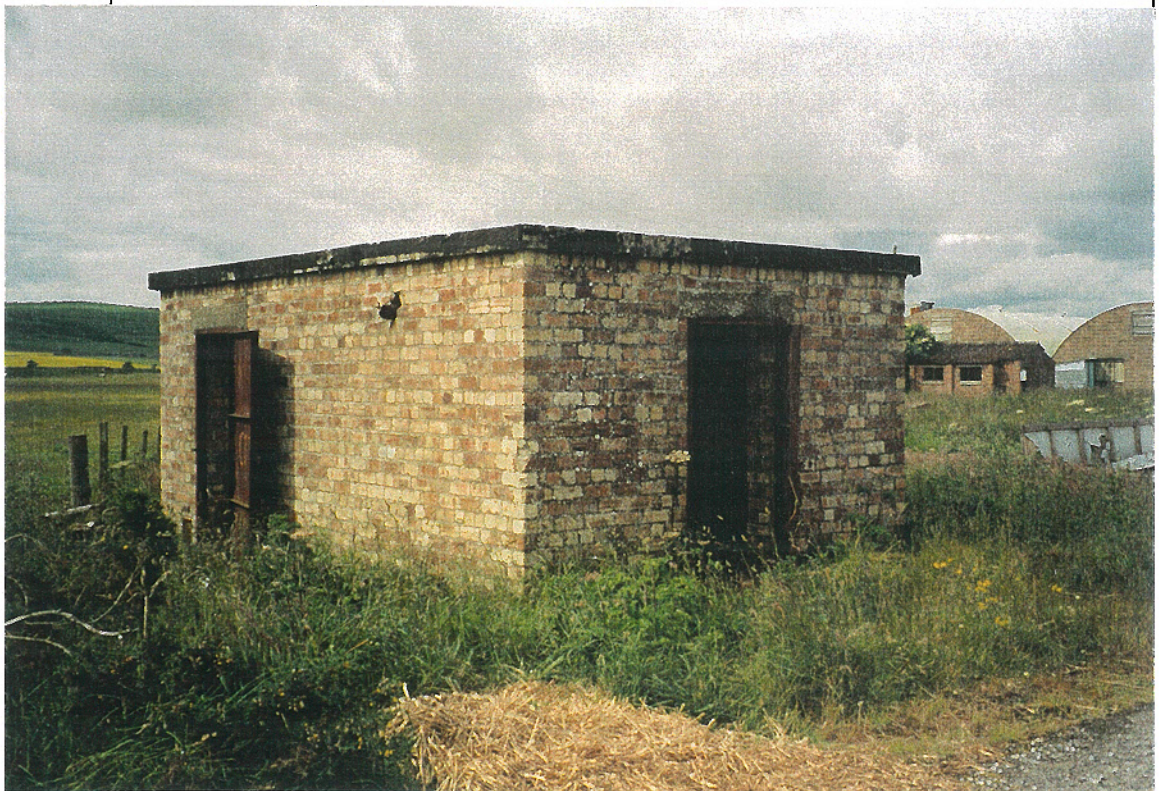
***Photograph No.***
Looking16A
W***Date*** 1/7/99

Low but could be included as part of a general interpretation of this area.

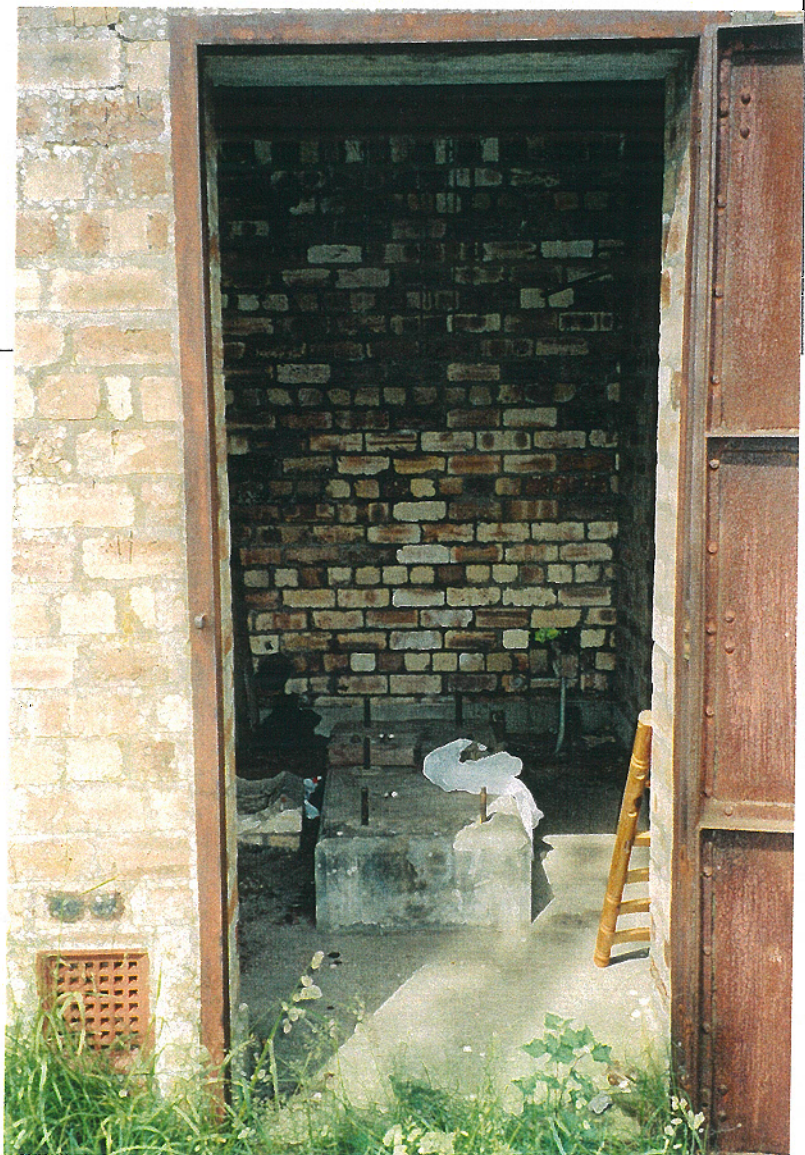
17A
WNW

6.5m by 3.5m and c2m high.
A low foundation 4.2m by 2.7 lies on the same axis to the E.

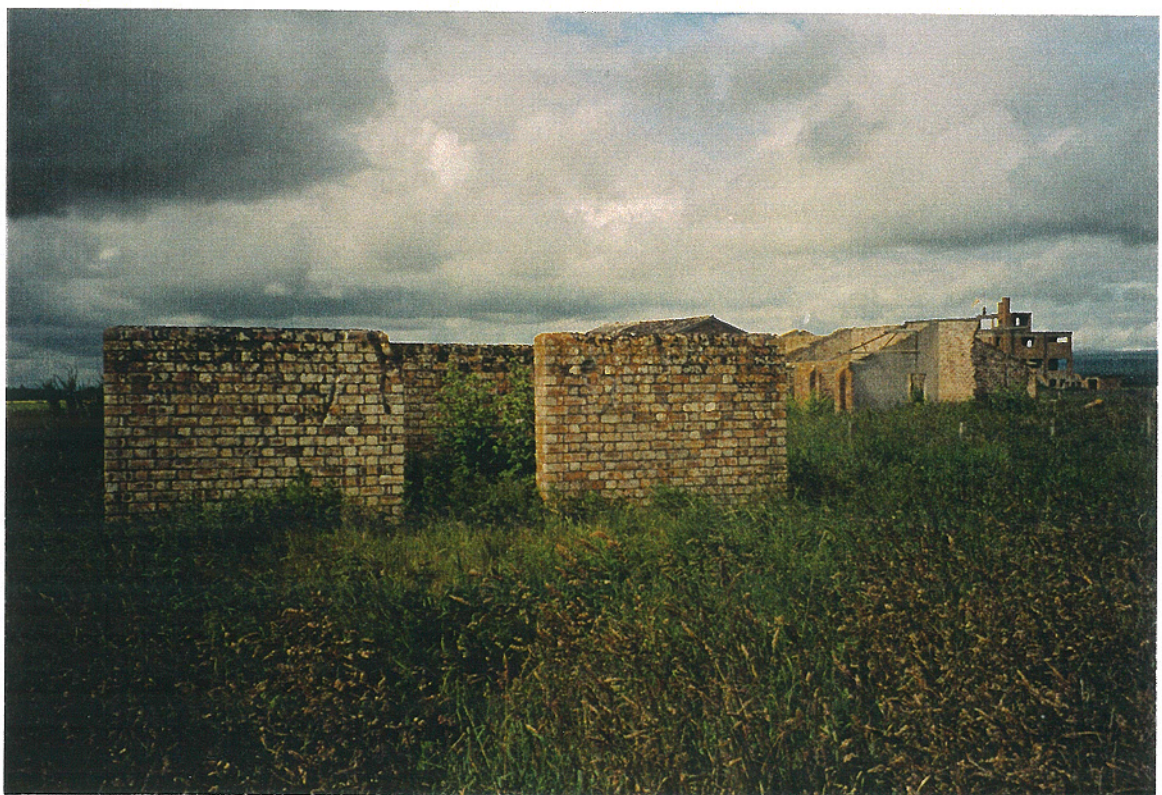
18A

It has been damaged on the E and has a quantity of rubbish within

Poor because of damage

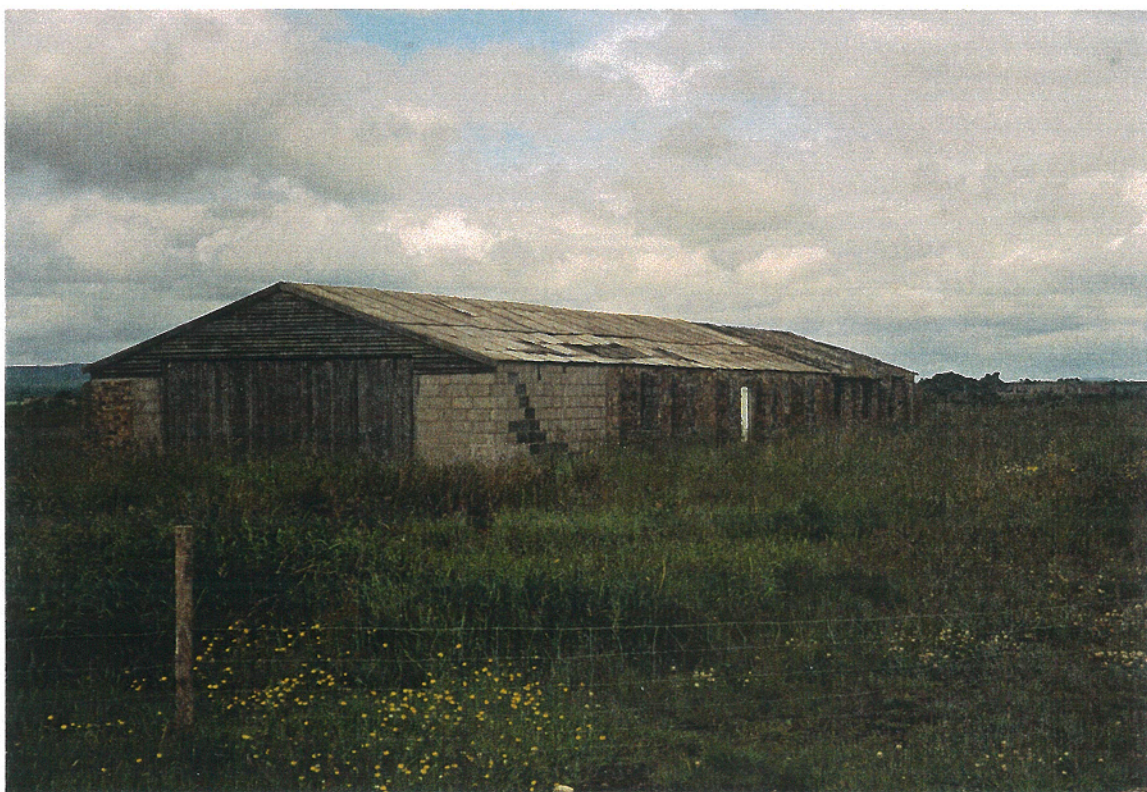
20A

If the main control tower is being preserved it may be relevant to retain this structure to demonstrate the development of the airfield.

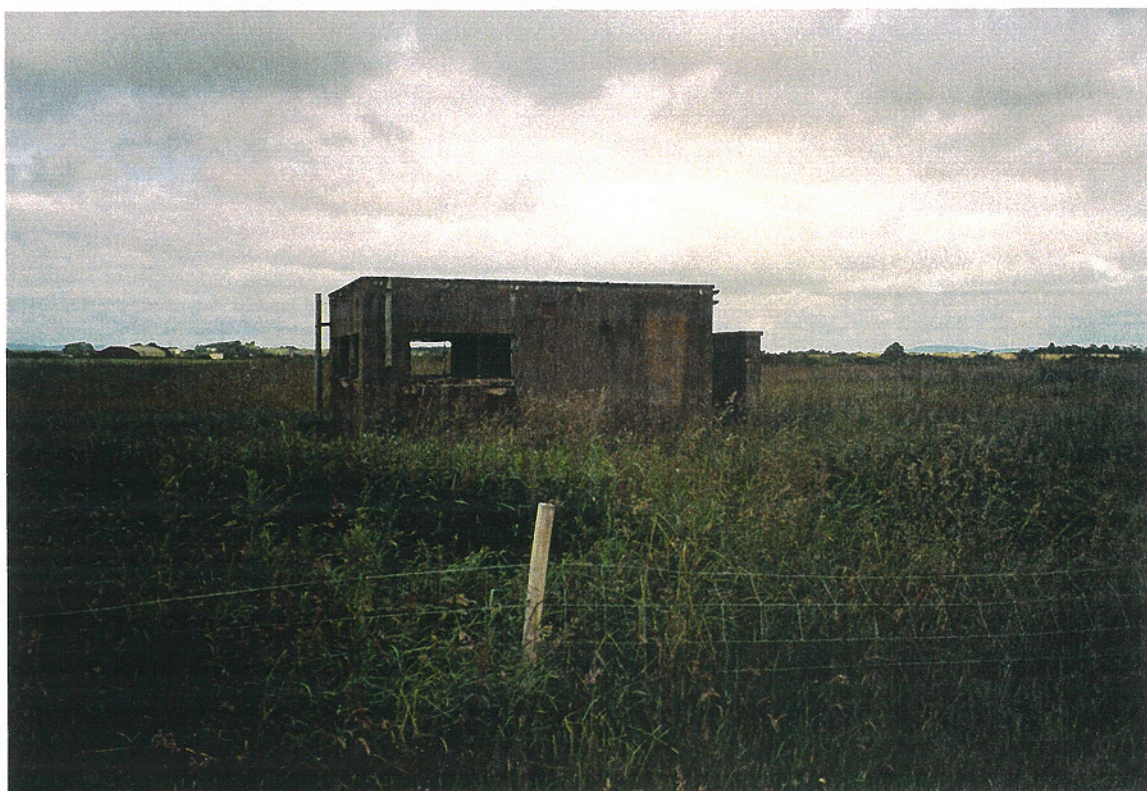
21A

Largely demolished and in a poor condition.

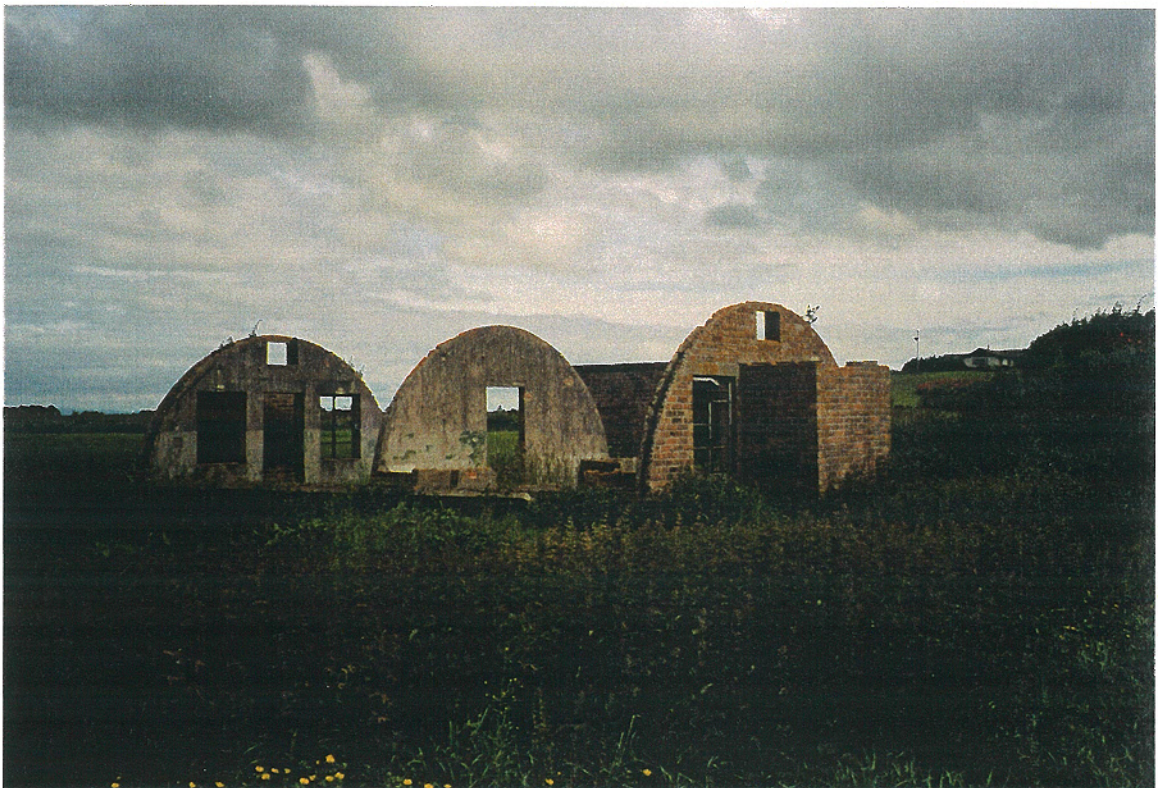
22A

The building is in poor condition and even in the part that has been maintained there are holes in the roof.

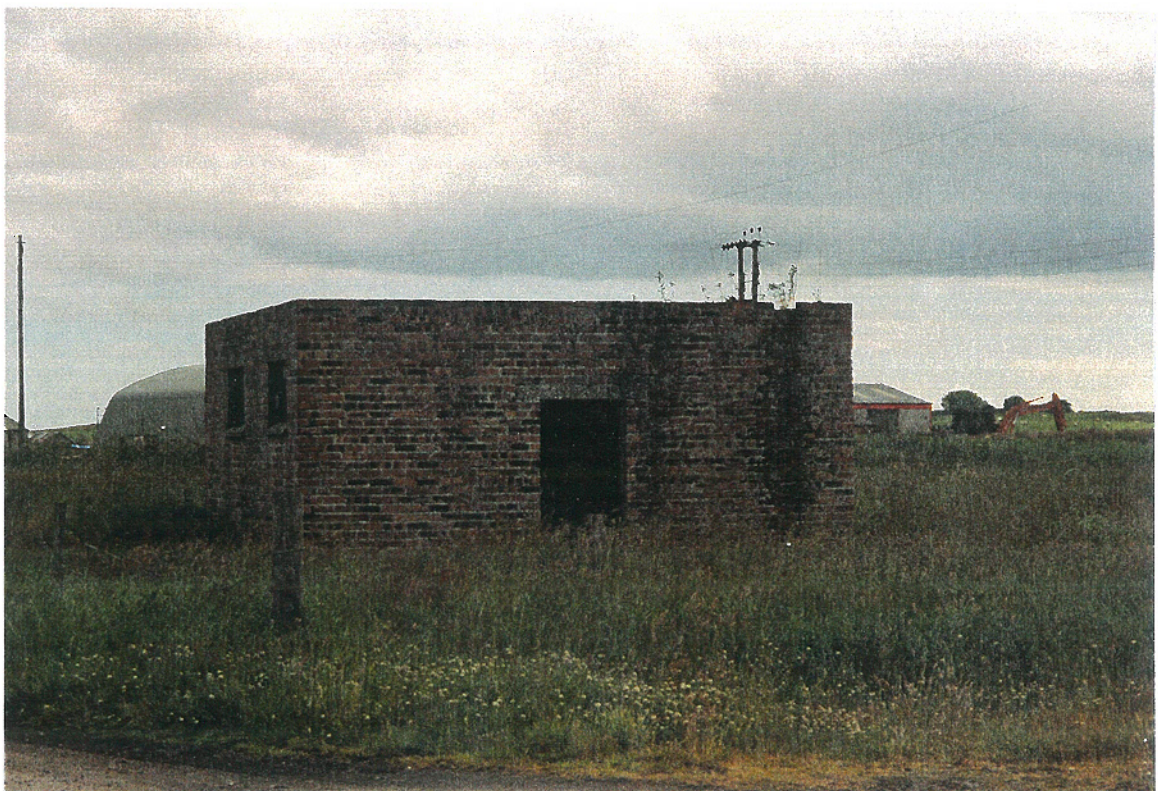
**Photograph No.**
Looking26A
E**Date** 1/7/99

Good, though some of the brickwork is beginning to decay

Bomb shelter of standard form

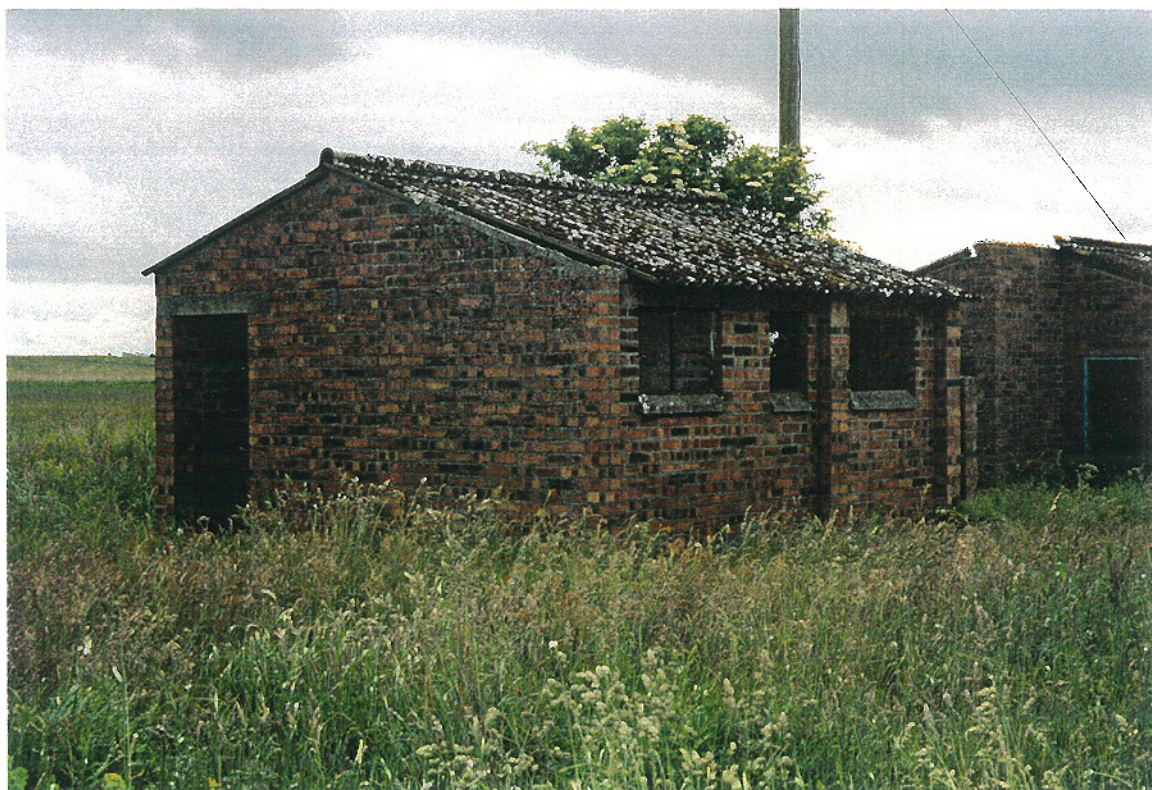
28A

FEARN AIRFIELD**Building Record****No. A.13****NGR NH****Dimensions** 7.8m by 5.2m aligned NE/SW**Description** Rectangular brick built structure with a ridged asbestos roof and porches at either end. It is similar to A.12 in both design and layout.**Condition** Poor**Interpretation** Toilet block**Importance** Low

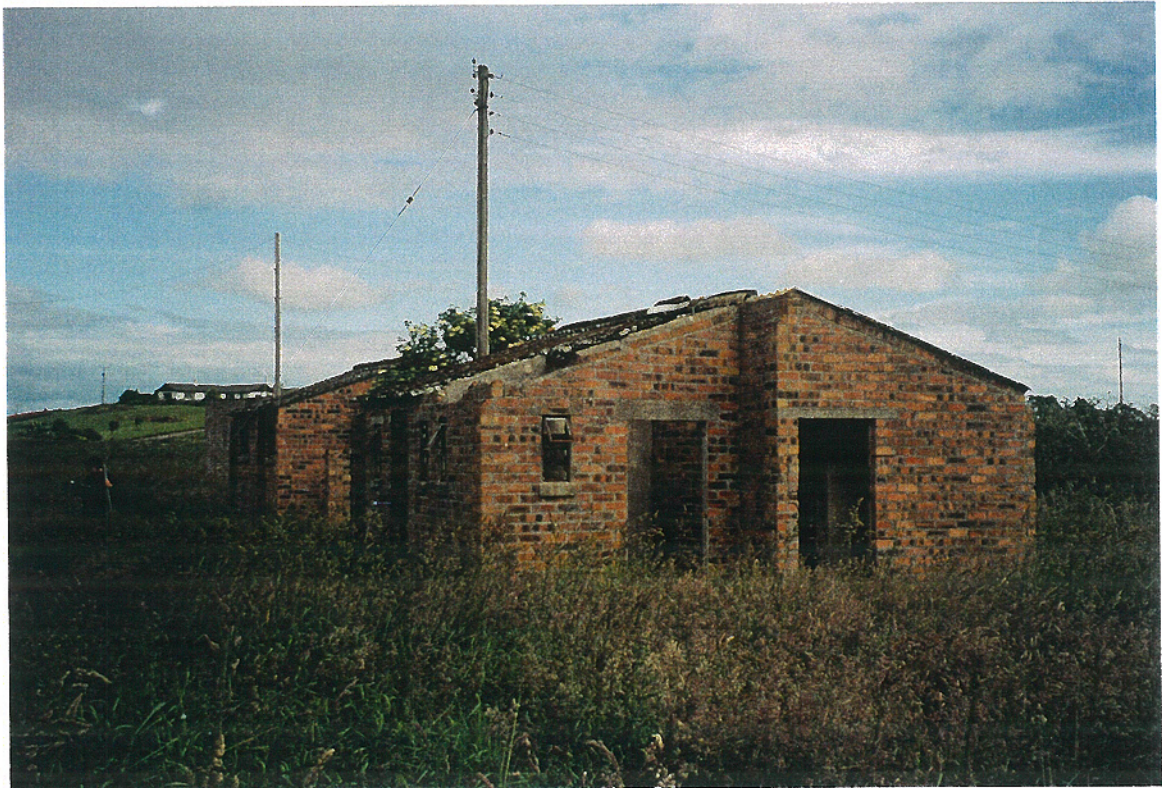
**Photograph No.** 29A
Looking NE**Date** 1/7/99

The concrete foundations survive of a building lying to the E of structures A.12 and A.13 on the same NE/SW alignment.

Demolished to foundation level

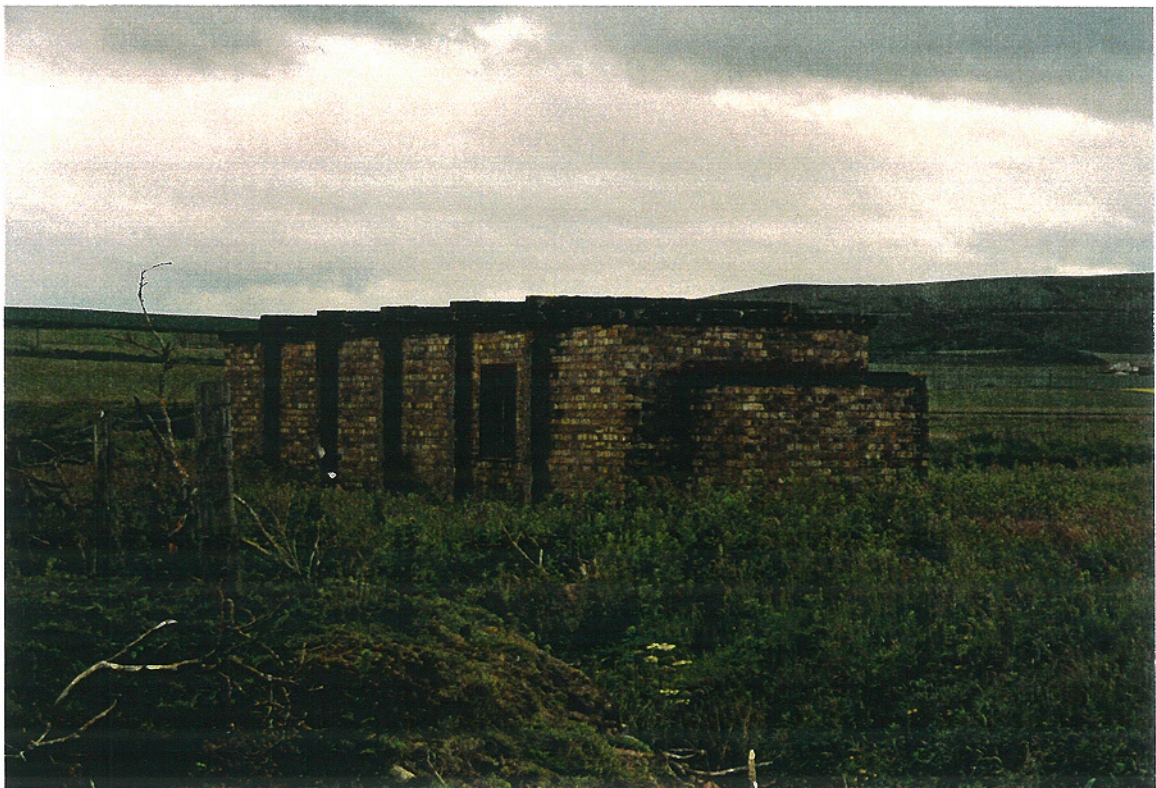
31A

Fair. Some cracking of the reinforced concrete has occurred

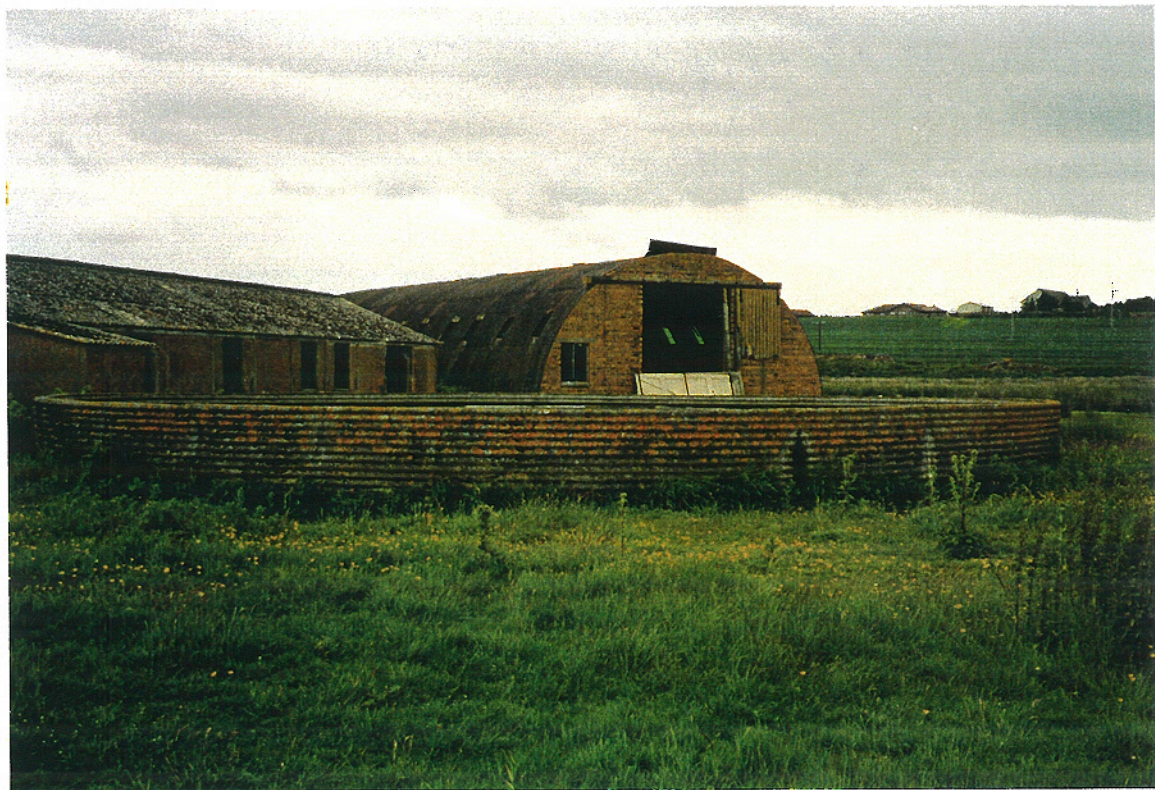
**Photograph No.**
Looking34A
NE**Date** 1/7/99

Poor with the roof unsafe and missing in places.

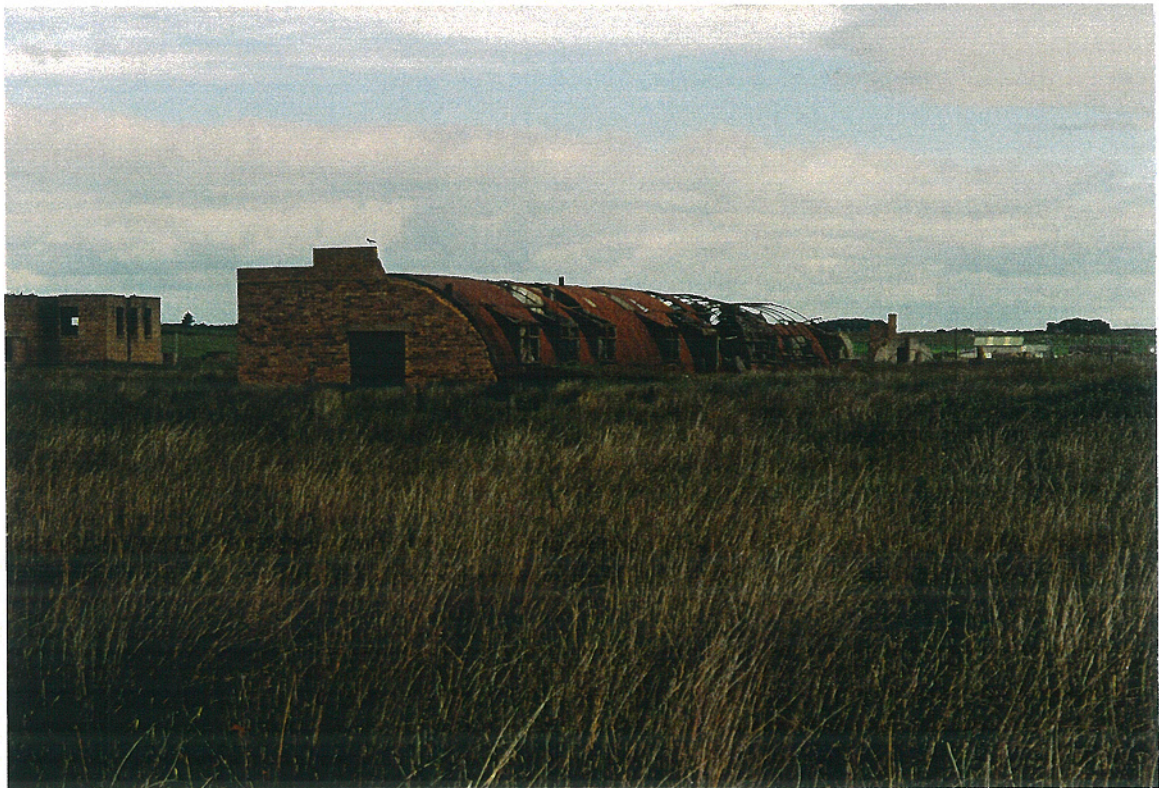
***Photograph No.***
Looking4B
SW***Date*** 1/7/99

Ruinous and unsafe

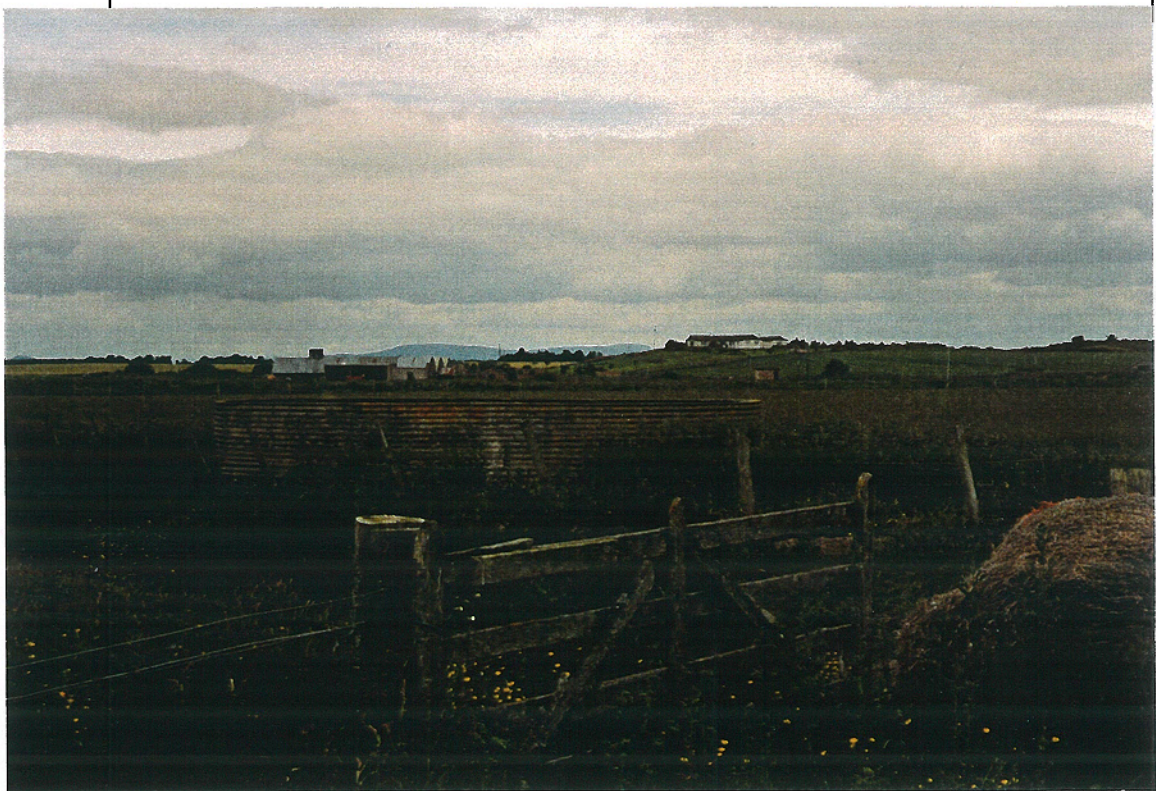
Photograph No.
Looking

The extension is poorly bonded with the original and the 2 structures have cracked apart. Rabbit burrowing at the N has also undermined this end cause serious cracks to appear.

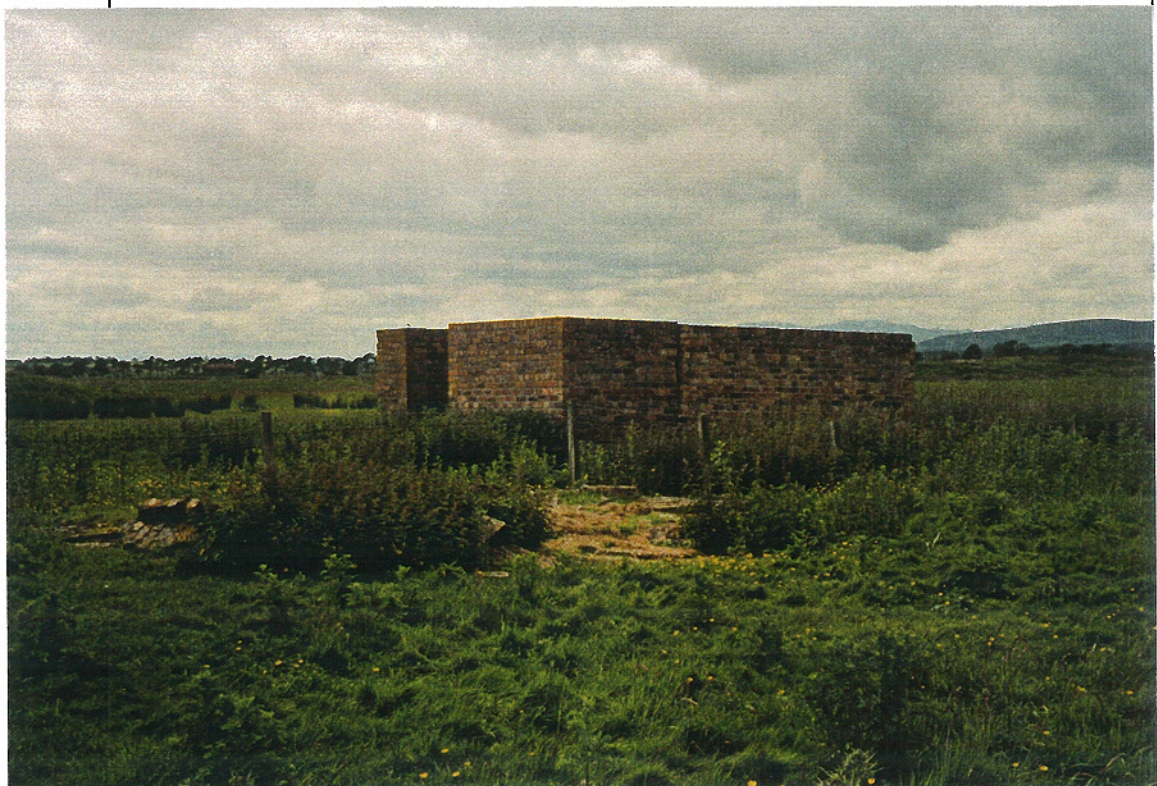
***Photograph No.***
Looking18B
WSW***Date*** 1/7/99

Brickwork in good condition but timber roof is quite rotten.

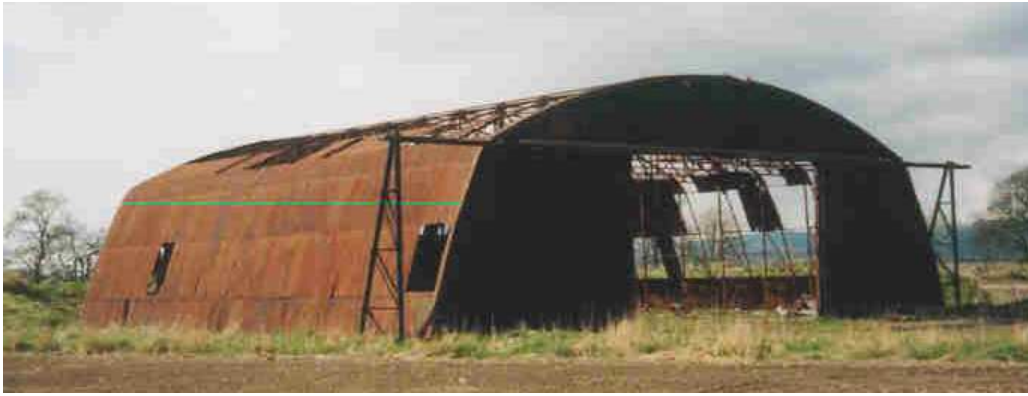
- 12.7 The hangar is in very poor condition with much of the cladding missing and evidence of a fire in one corner. The framework is locally damaged and twisted, and there is considerable corrosion of the vertical members where they enter the concrete floor slab.

- 12.8 No evidence of hazardous material was found in the construction of this hangar. However, the very dilapidated condition makes it a potential hazard, particularly in strong winds when the remaining cladding sheets could become airborne.

Photograph 11
Hangar NH 837 754 – view from east

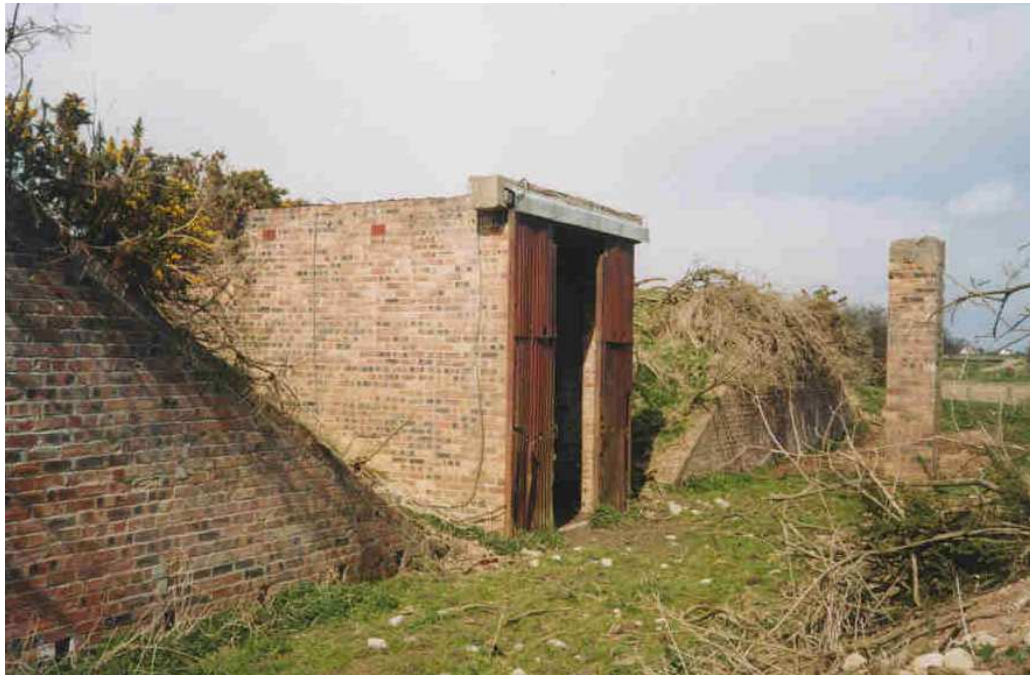
- 13.9 The brickwork walls were all in sound condition. Some minor spalling of the concrete roof slab was evident.
- 13.10 Most damage had been caused by removal of the steel overhead hoist beams for use elsewhere, and also by removal of the earth banks for use as fill. Only one store of each type remains in reasonably complete condition.

Photograph 14
Bomb store type 1

- 13.15 In the short term, it is recommended that the blast walls behind which soil has been removed be either backfilled with new material or demolished in the interests of safety. No other works are anticipated as being required to make the area safe for authorised public access. The two brick built stores are in fair condition and should be boarded up to ensure that they are wind and water tight until a future use can be determined.

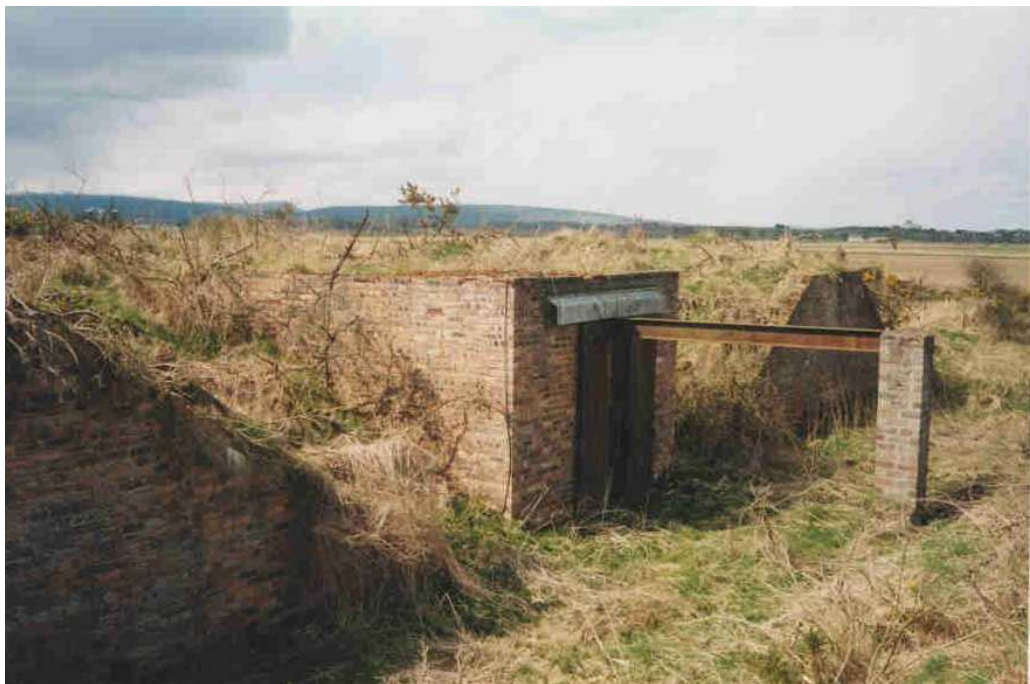
Photograph 15
Bomb store type 2

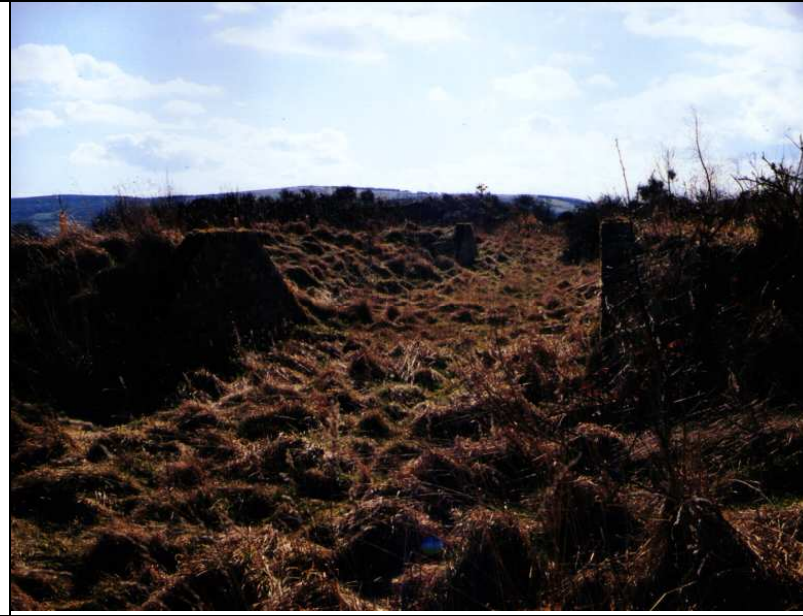
Photograph D45: remains of low level blast walls
