SECOND WORLD WAR AIRFIELDS AT TAIN AND FEARN, EASTER ROSS

A Report to Highland Council by the ASH Consulting Group

July 1999

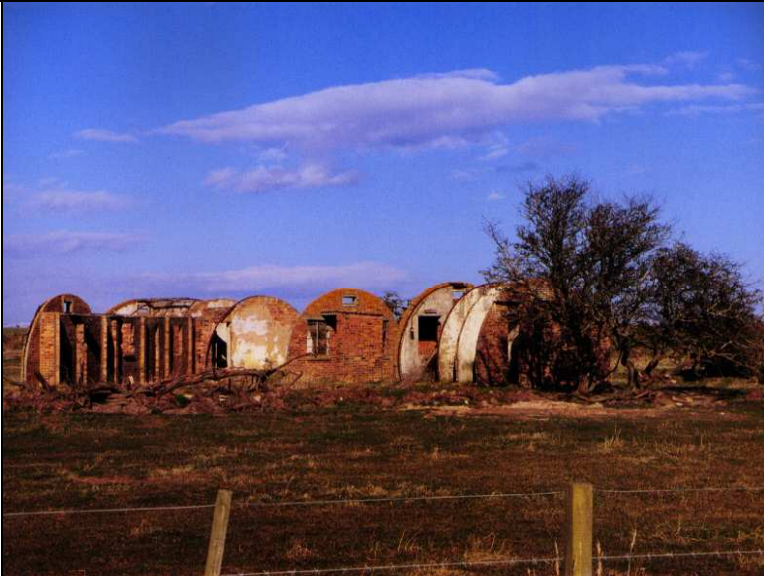
Photograph E 48 – remains of nissen huts

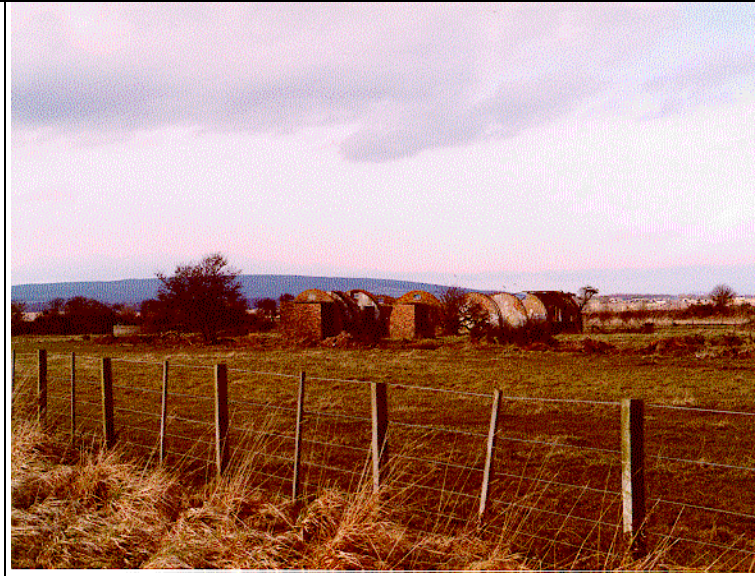
Photograph E51 – remains of nissen huts

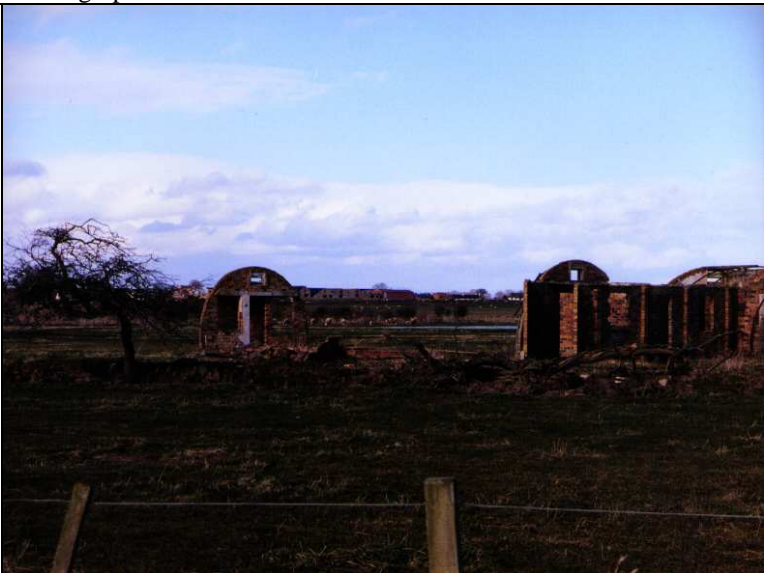
PANORAMA E/F49/50 – remains of nissen huts

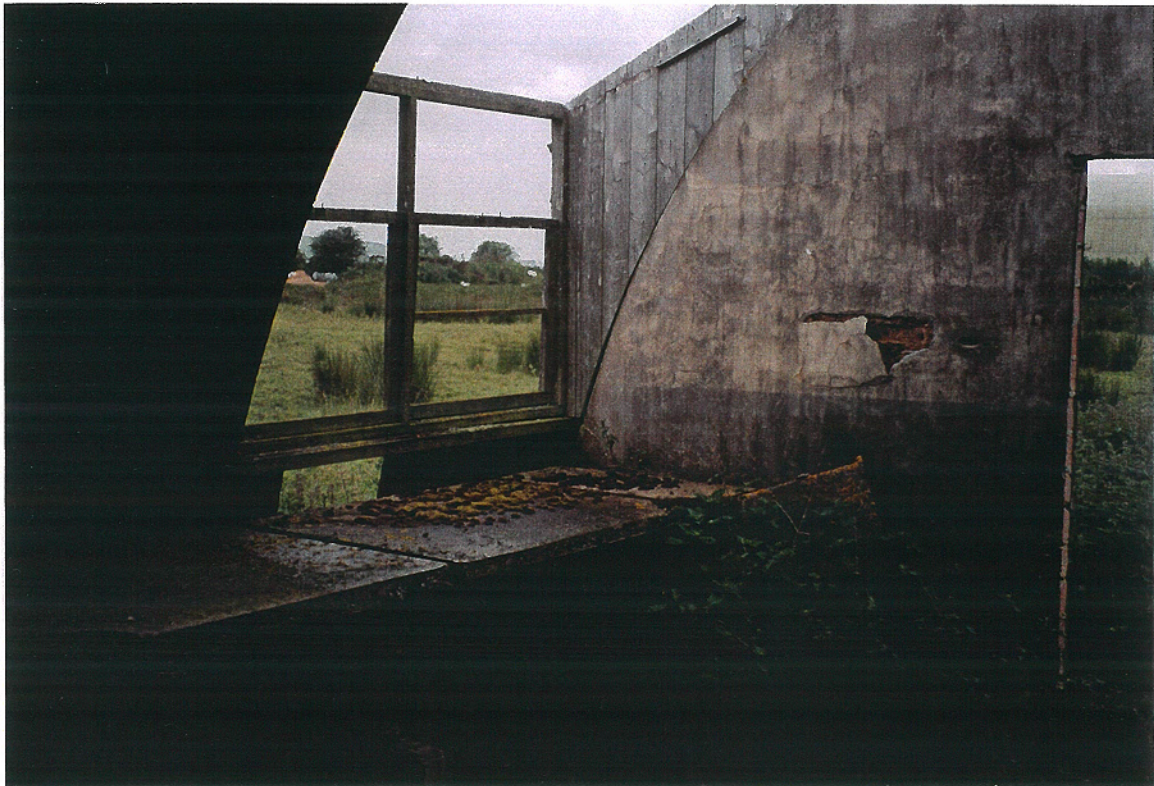
8
S (Interior view)

The brickwork is in good condition but the roof is poorly preserved.

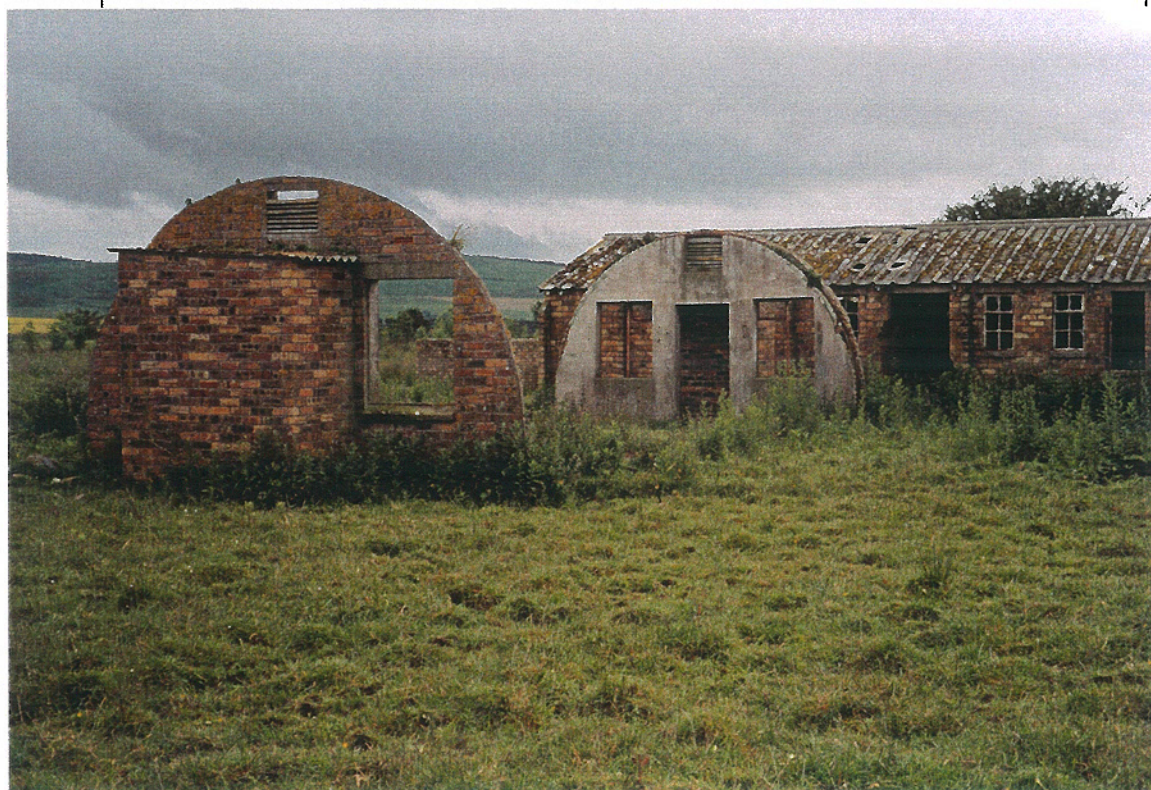
16

Stable but reinforced concrete is beginning to decay.

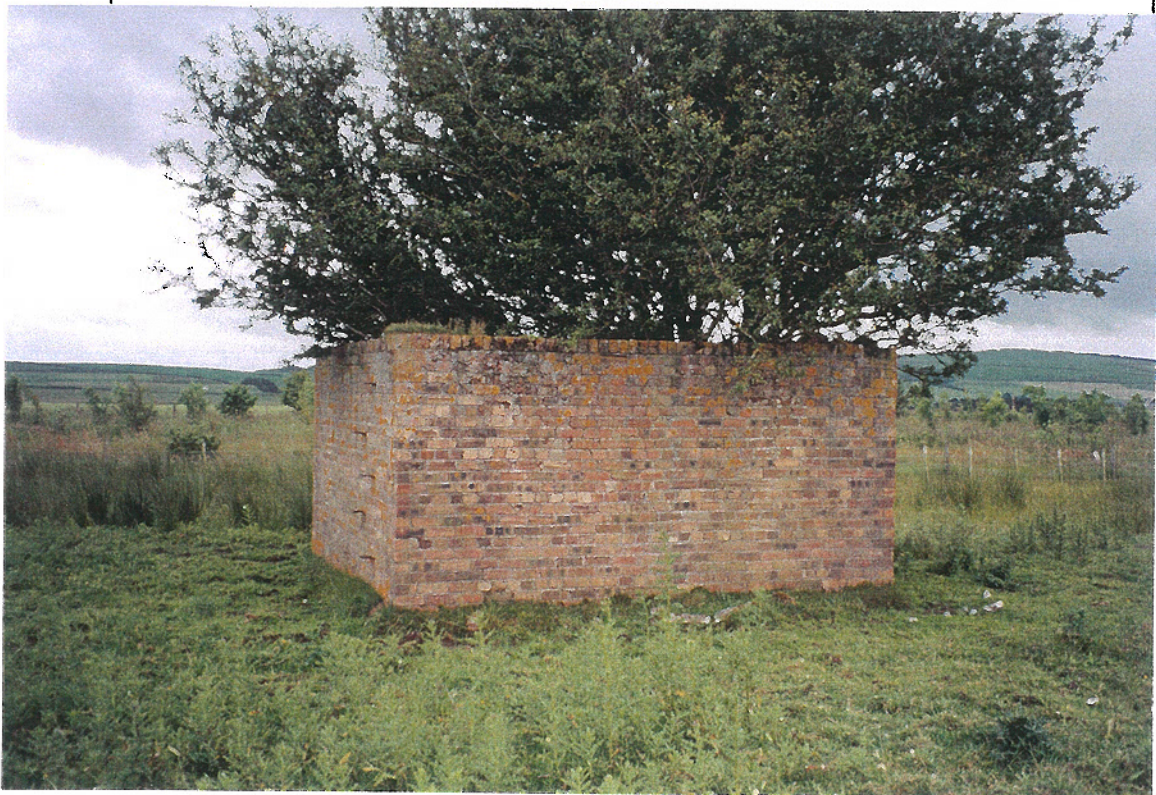
Photograph No. 21
Looking S

Fair but roof partly damaged especially on the SW

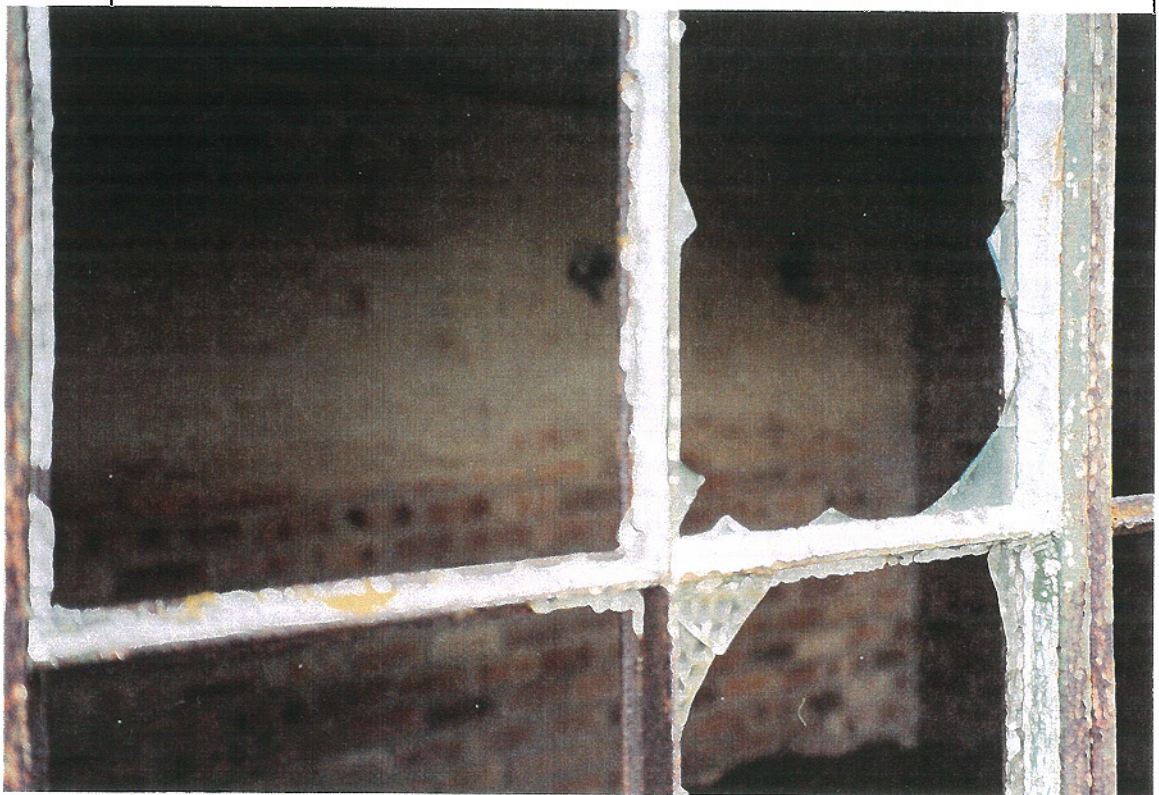
23

Fair. As elsewhere the reinforced concrete is beginning to decay

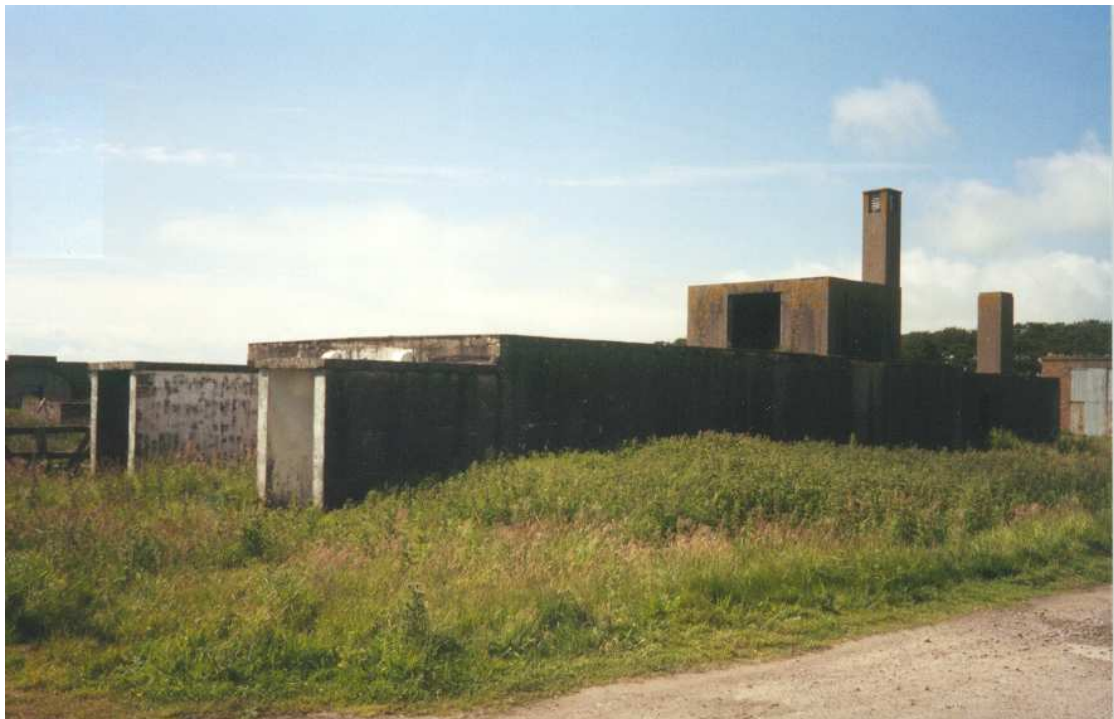
- 15.35 This building which was surveyed by AF Cruden Associates in June 1999 is located at NH 8565 7705 and is illustrated on photograph 20.

Photo No 20
Gas Decontamination Centre NH 8565 7705
N.W. elevation from the north

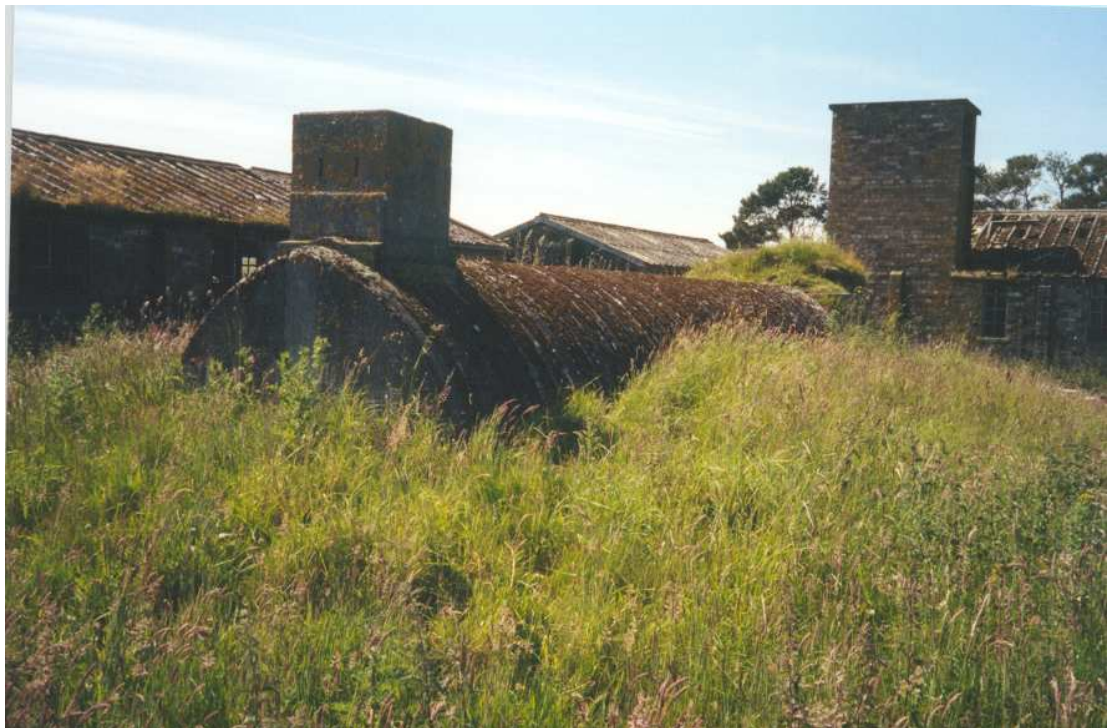
- 15.60 This structure is located at O.S. Ref: NH 8565 7695 and is illustrated on photographs 24 and 25. The survey by AF Cruden Associates was undertaken in June 1999.
- 15.61 A semi-buried reinforced concrete shelter some 30'0" long with a brickwork shielded entrance in the West gable. Internally the arched cross-section is 7'0" wide at the base and 7'0" high at the apex. There is a 2'0" square vent and emergency exit located in the roof at the end opposite the access doorway.

Photo No 24
Air Raid Shelter NH 8565 7695
View from the N.E.

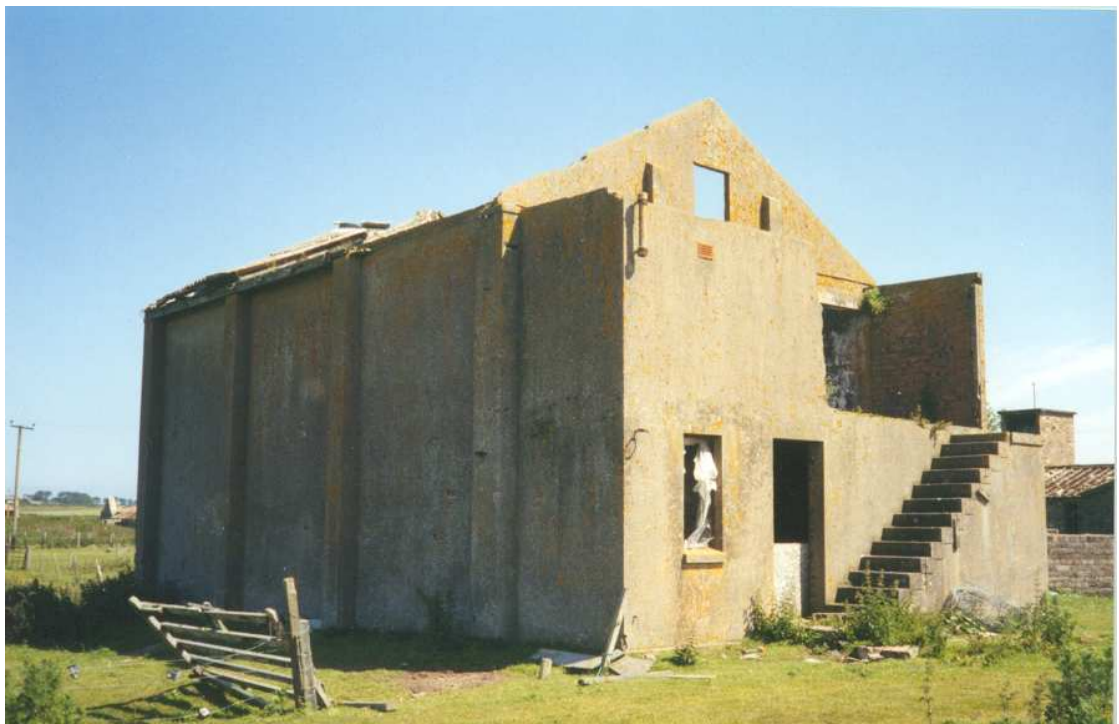
- 15.66 This building is located at O.S. Ref: NH 8562 7711, is illustrated on photographs 26 and 27 and was surveyed by AF Cruden Associates in June 1999.
- 15.67 This pitched roofed building is 22'0" wide by 34'0" long and is 15'9" high from floor to wallhead level.
- 15.68 Onto its western gable there is a flat roofed, two storey, full width extension some 5'6" long which provided an entrance foyer on the ground floor and a small balcony/projection area at first floor level. Access to the first floor was via a flight of external concrete steps. A very large opening has been knocked through the east gable wall to provide access to store a large vehicle (probably a combine harvester) within the building.

- 15.72 We are of the opinion that the building is in a dangerous condition and requires prompt action to make it safe. The east gable is unstable above the slapped out opening and we also consider the unpropped east gable above the balcony area to be unstable in high winds. These could be removed but this will then remove their propping action to the longitudinal walls which in turn will become unstable. In our opinion the building would be safest demolished to ground level.

Photo No 28
Cinema Building NH 8562 7711
General view from the West

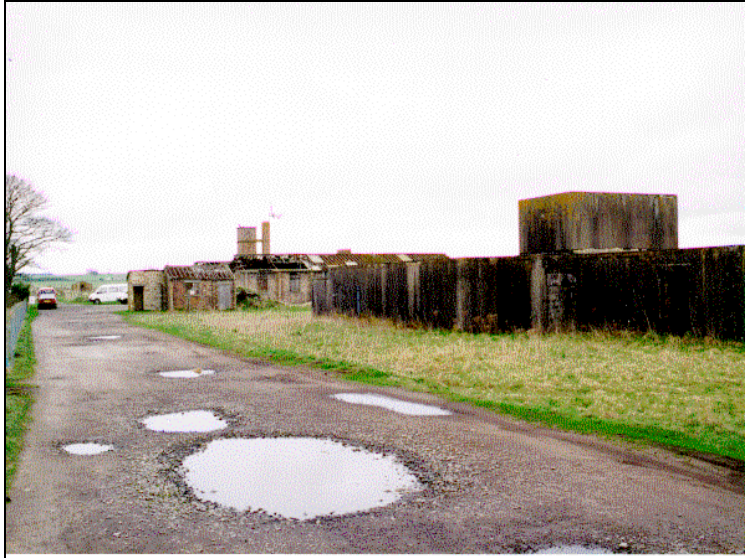
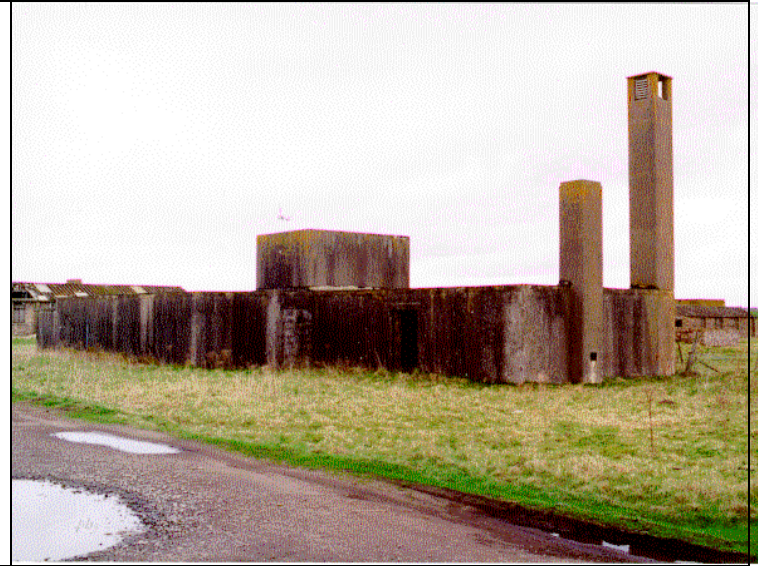
Panorama W30/W31: decontamination centre north and west elevations

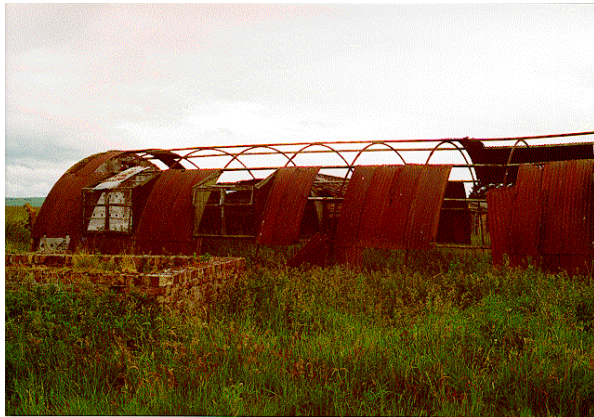
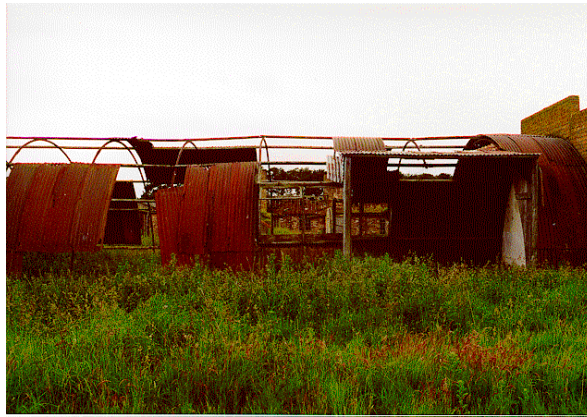
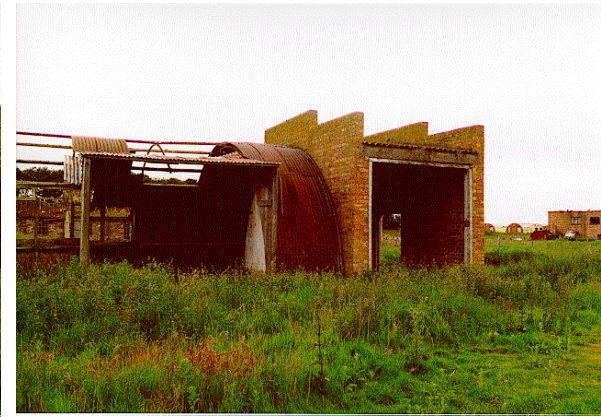
Panorama W41/W42/W43 remains of nissen structure

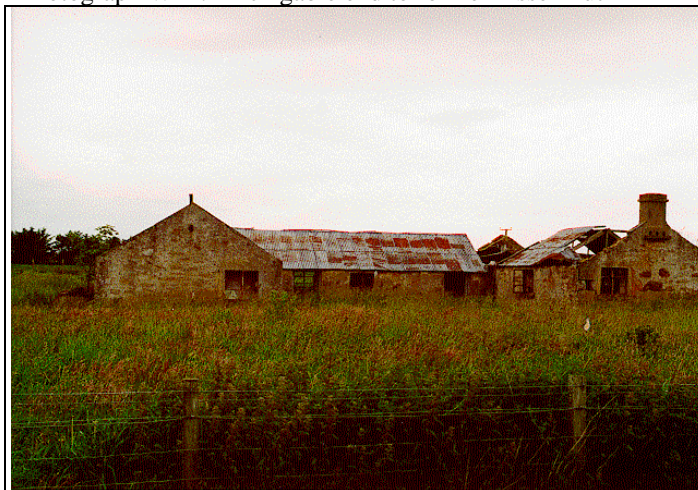
Photograph W46: derelict farm building adjacent to Loans of Tulloch

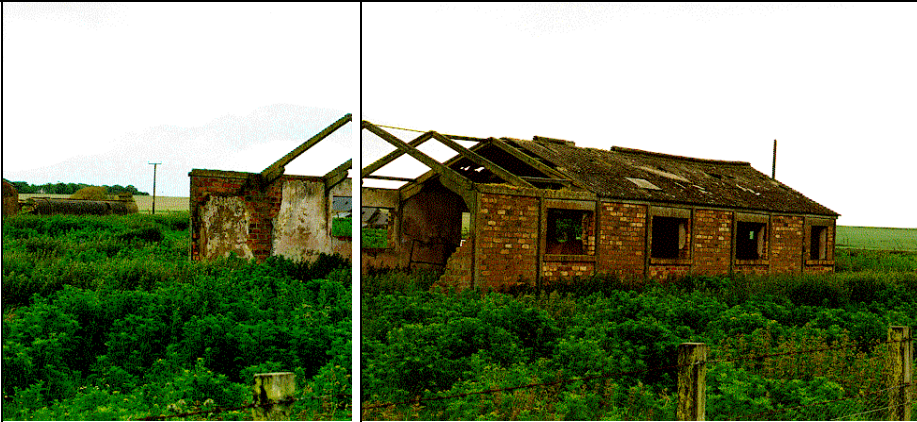
Panorama H6/H7– asbestos roofed building partially demolished

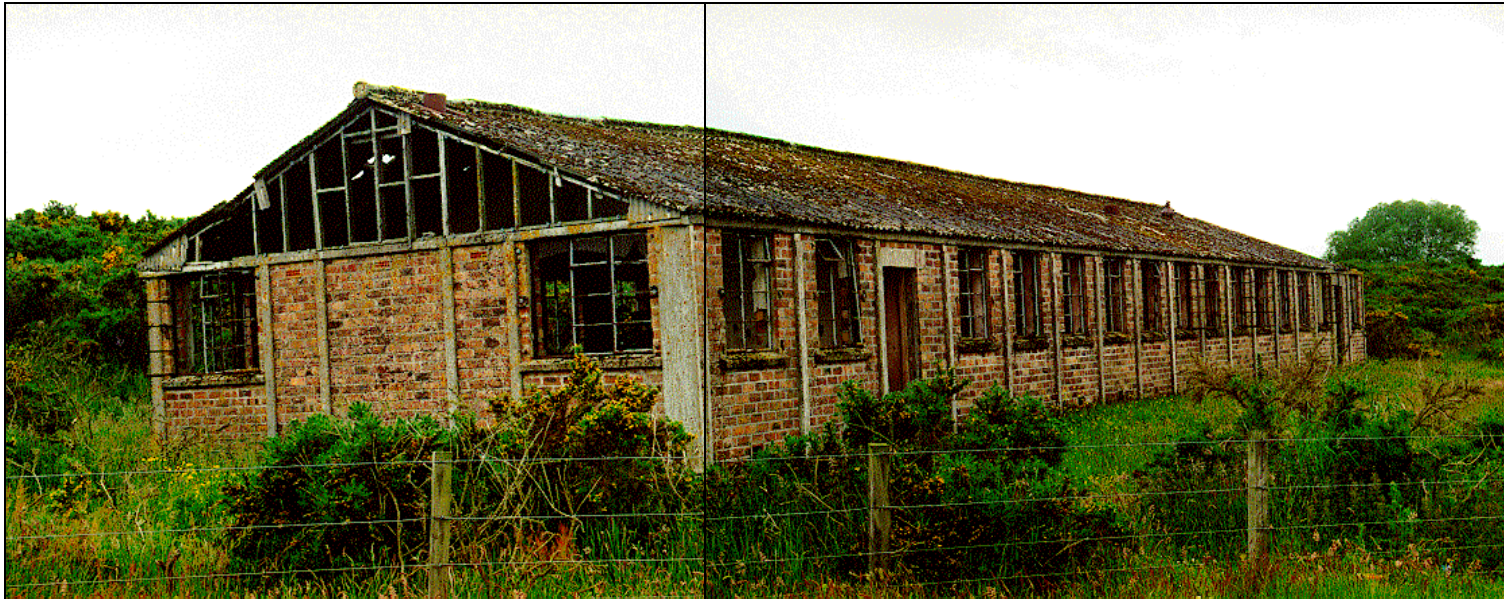
- 17.3 The other building is a long single storey brick storeroom which may have housed offices. The asbestos roof is in a poor state of repair and the building is surrounded by gorse and other vegetation. Part of the site on which this building sits has been quarried for sand and gravel and it can be assumed that the remains of other buildings and structures were demolished prior to or during quarrying operations.

Panorama J8/J9/J10: stores building northern elevation

Panorama J11/J12: stores

Photograph J13: stores building – east elevation

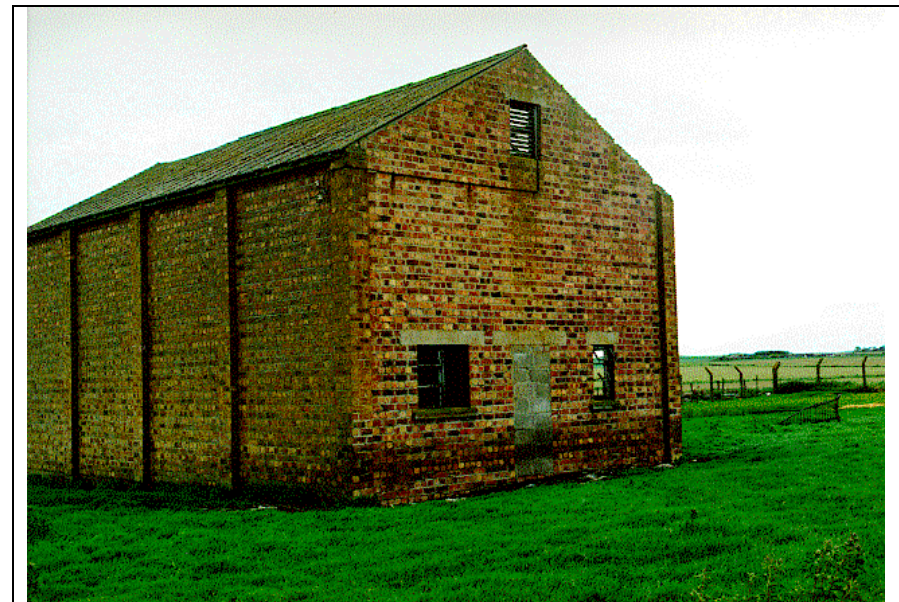
- 17.2 One of the two buildings which survive are a brick built fire engine house which lies near the access track which runs between this camp and the camp at Loans of Tulloch. This building is in a reasonable state of repair and is similar, although slightly larger than the one in area C.

Photograph J6: fire engine building view from north west

Photograph J7: fire engine building view from north west

Photograph J19: fire engine building

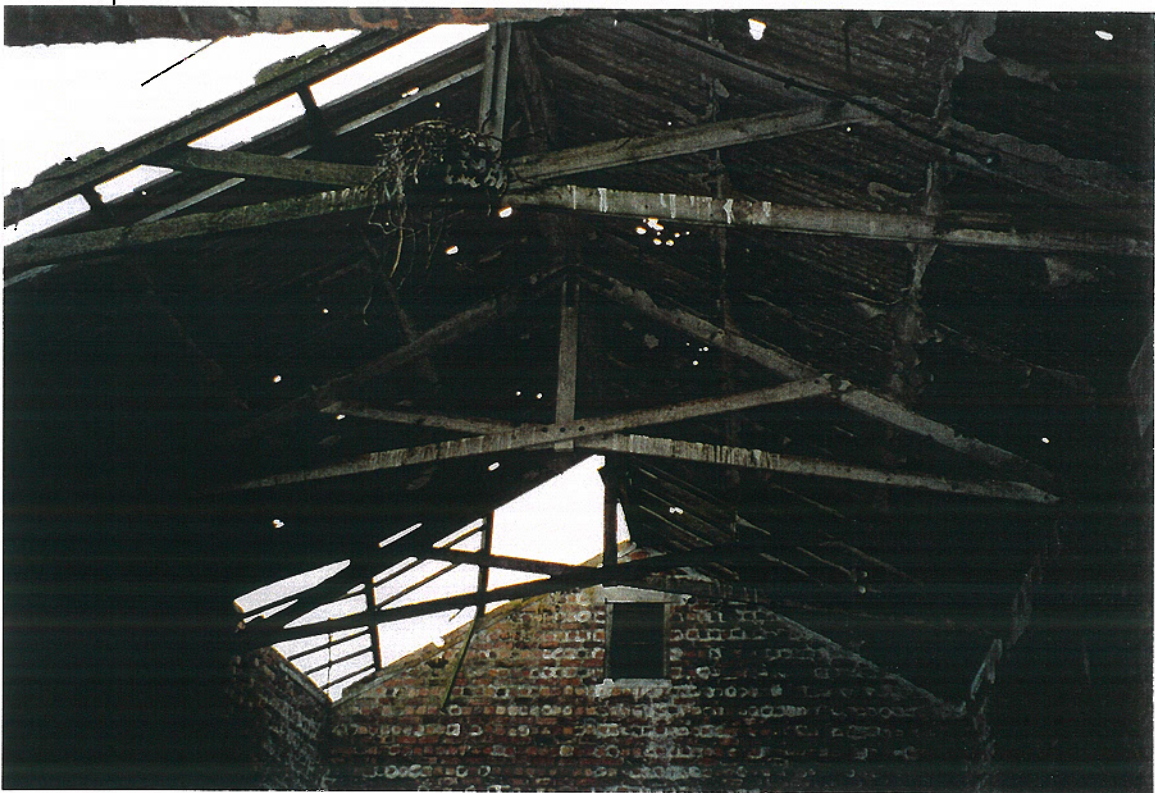
26B

Brickwork fairly good but roof in ruinous condition, making this building unsafe.

Low

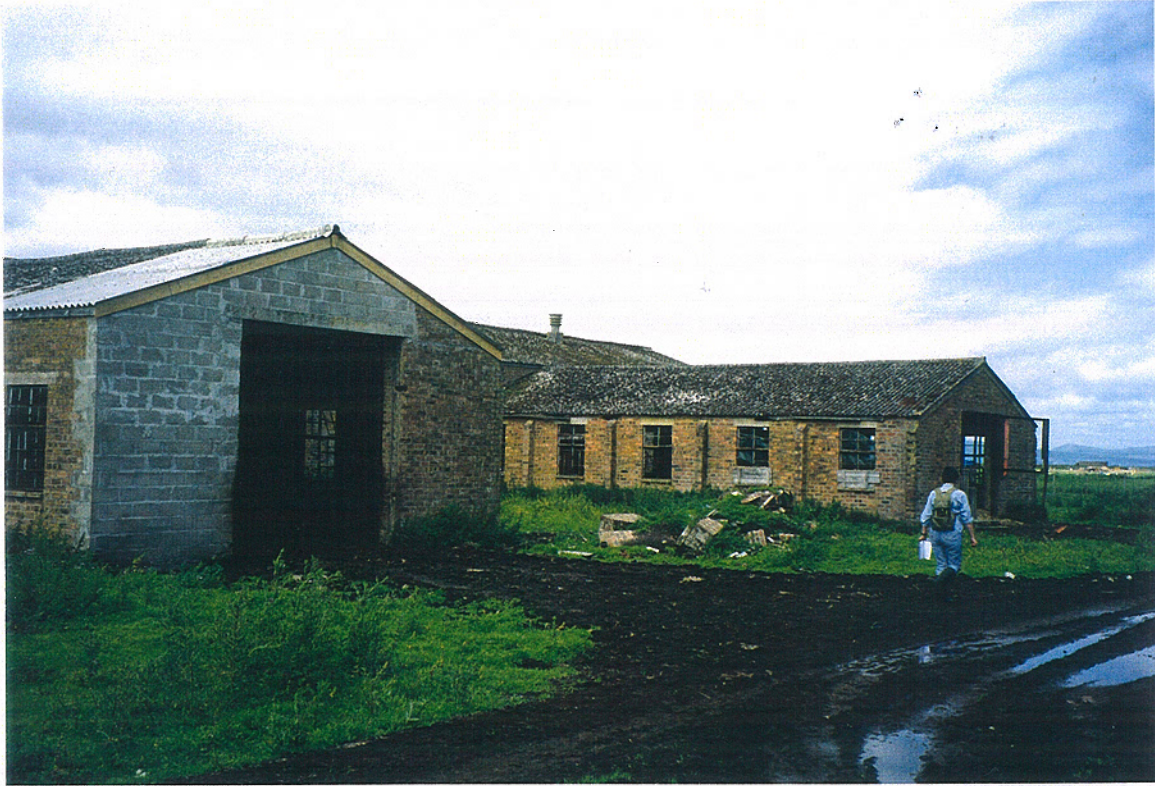
Photograph No. 22D

Looking N at E wings of Building A.6 with repairs and ?original door frame.

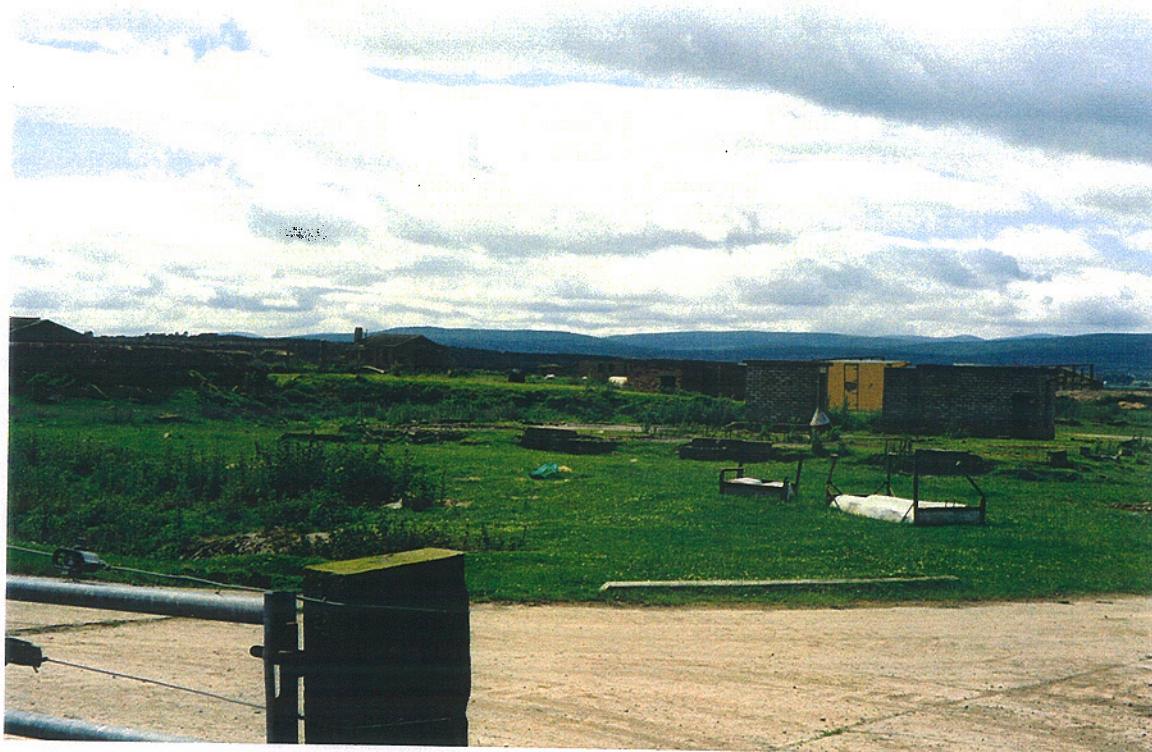
Foundations only

**Photograph No.****25D****Date 07/07/99****Looking****W across foundation A.7**

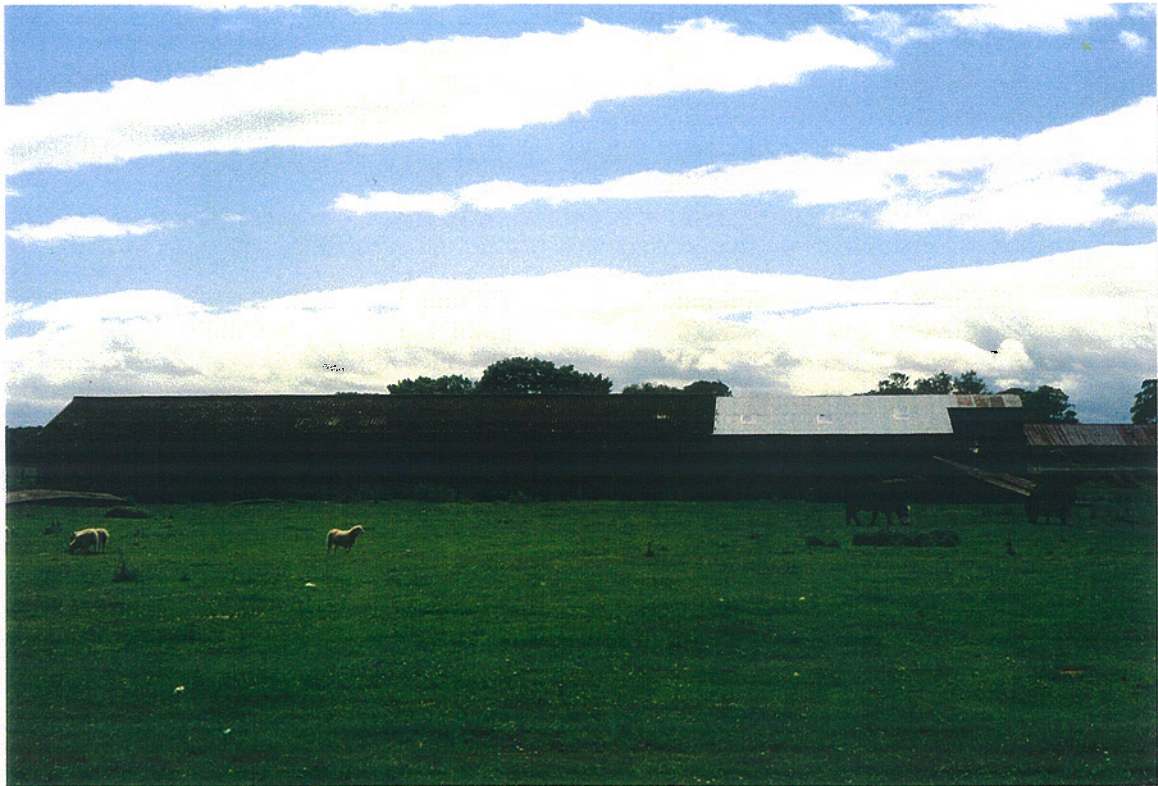
A substantial breeze block building with a pitched asbestos roof survives to the N of the entrance to this area. It is aligned NW/SE measuring 41m by 8m. The roof at the NW has been partially repaired with corrugated iron.

**Photograph No.****26D****Date 07/07/99****Looking****SW at Building A.8**

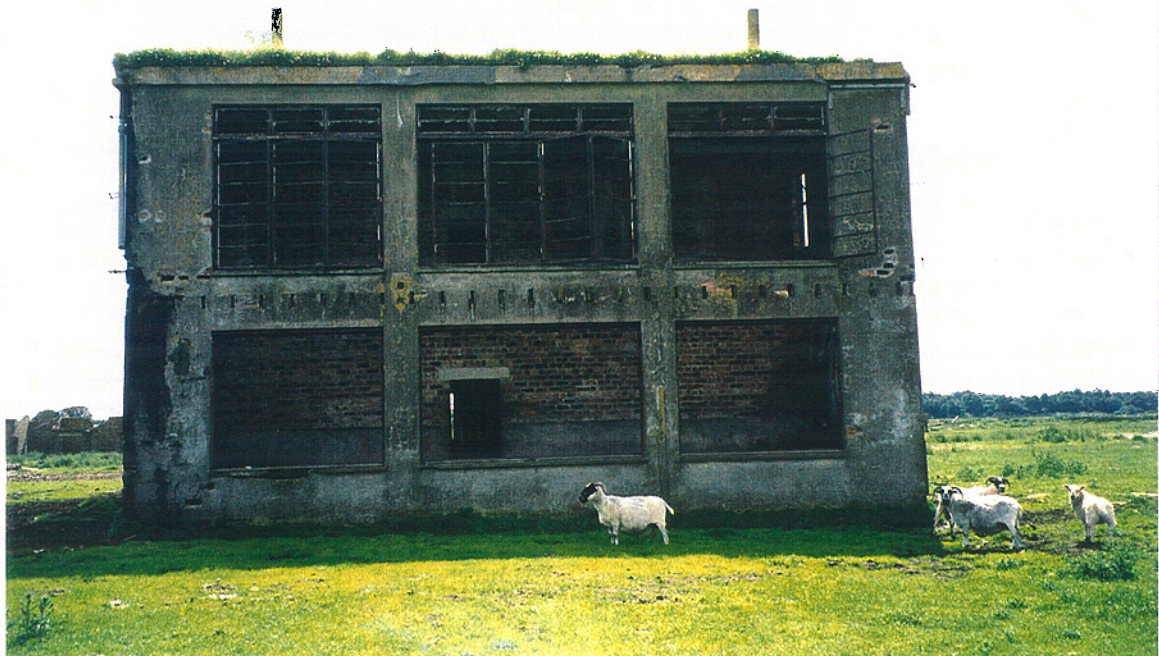
While the basic structure is sound, it is potentially hazardous to the public.

As similar examples survive in better condition elsewhere in the country this is not considered to be of major importance.

***Photograph No.*****28D*****Date*** 07/07/99***Looking******SW at front of control tower A.11***

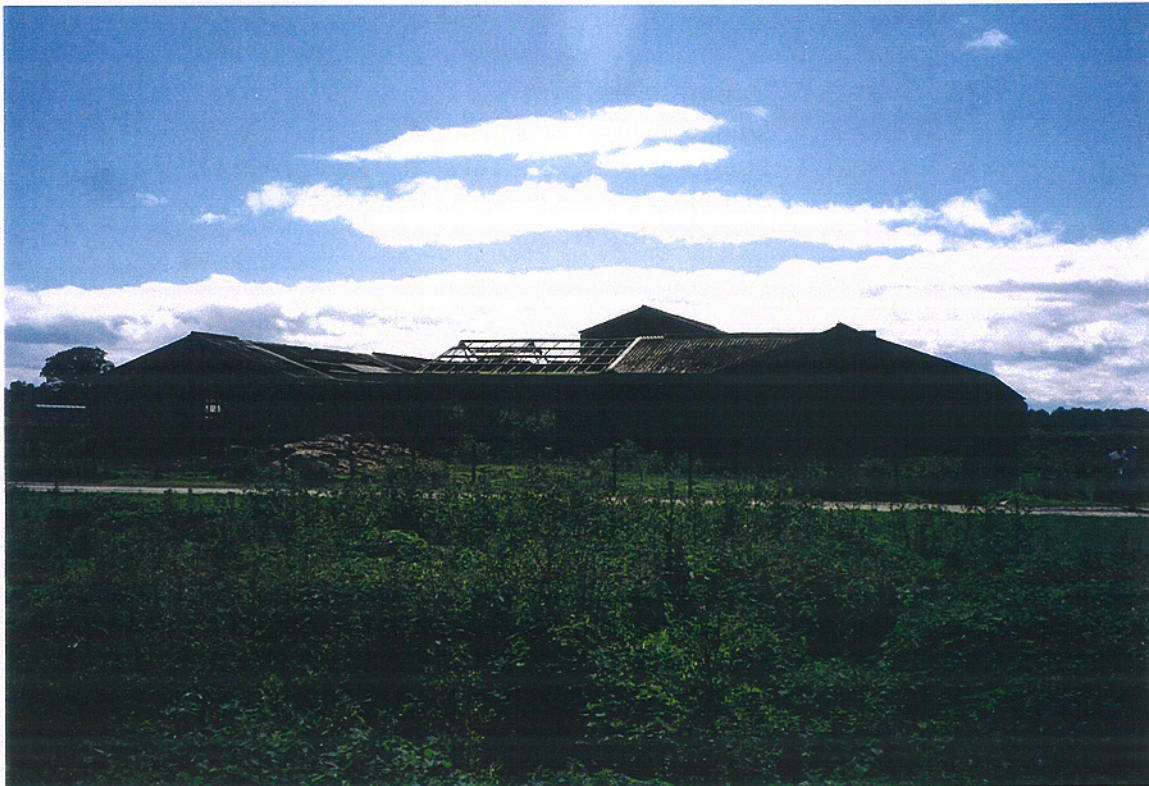
**Photograph No.****3E****Date 07/07/99****Looking****SW at Building A.14**

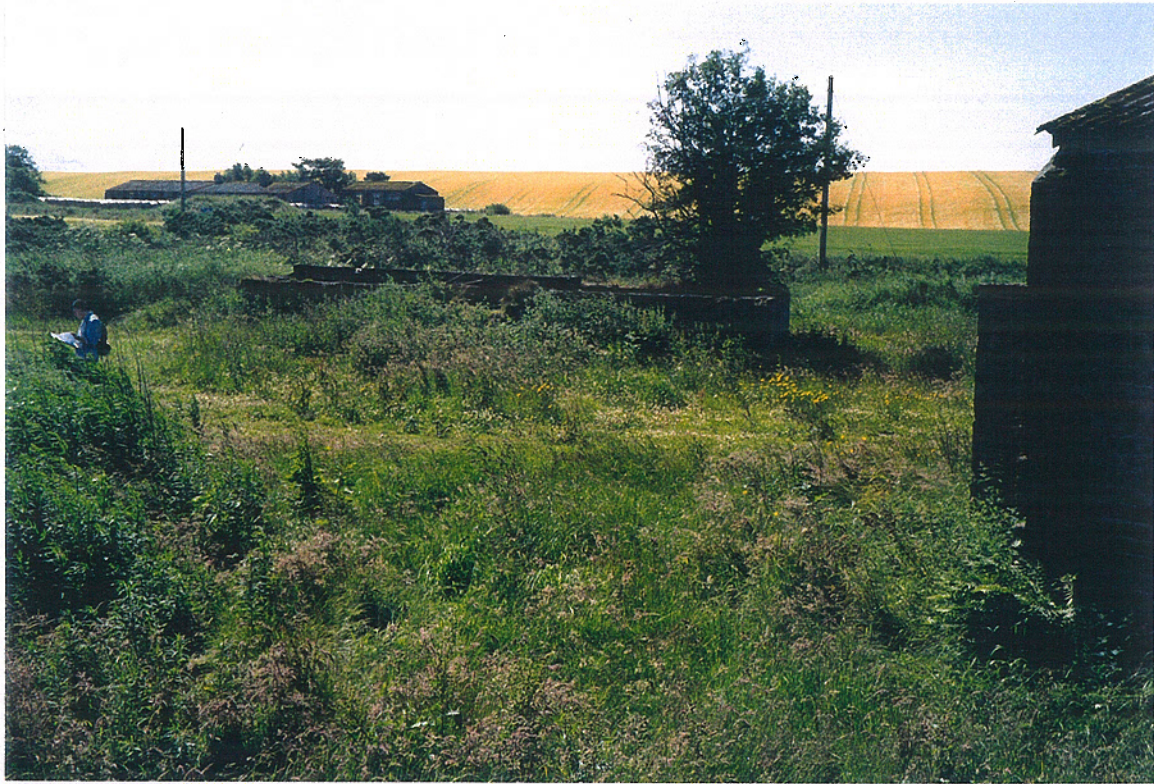
Photograph No. 17C

Looking W at bomb shelter b) built of red brick and SE corner of building B.1

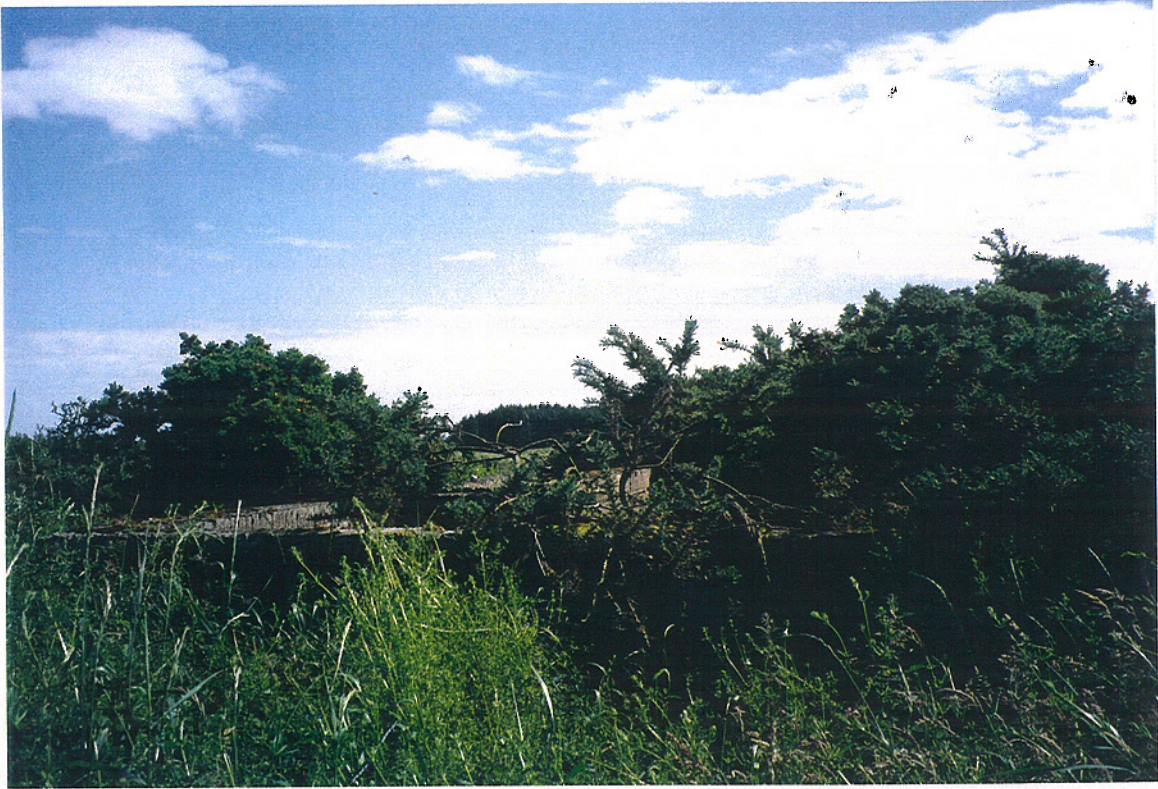
Photograph No. 16C

Looking E at bomb shelter d) built of grey brick

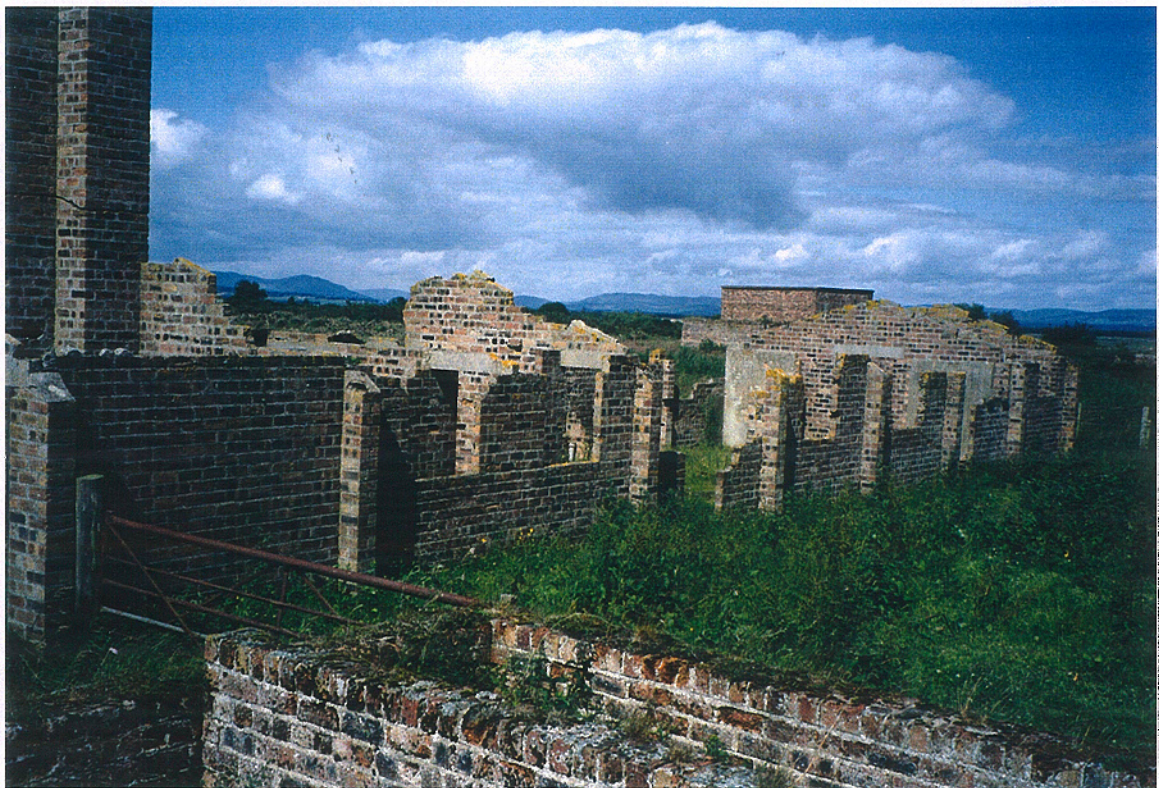
**Photograph No.** 25C**Date** 07/07/99

Looking NW across building B.3 with crack on tower visible on left of photo.
Photo taken from red brick bomb shelter to E.

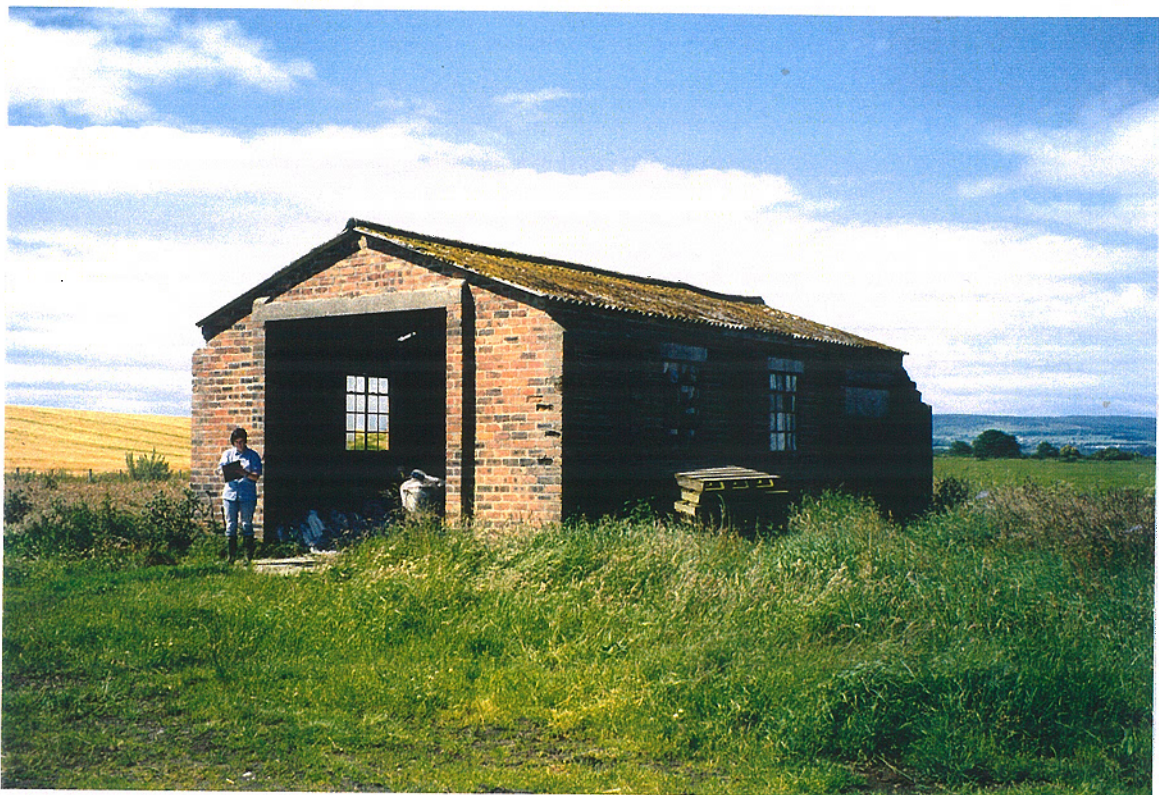
Good reflecting its continued use as a store. There is some evidence that replacement asbestos sheets have been inserted in the roof.

**Photograph No.****33C****Date 07/07/99****Looking****W at entrance of Building C.1**

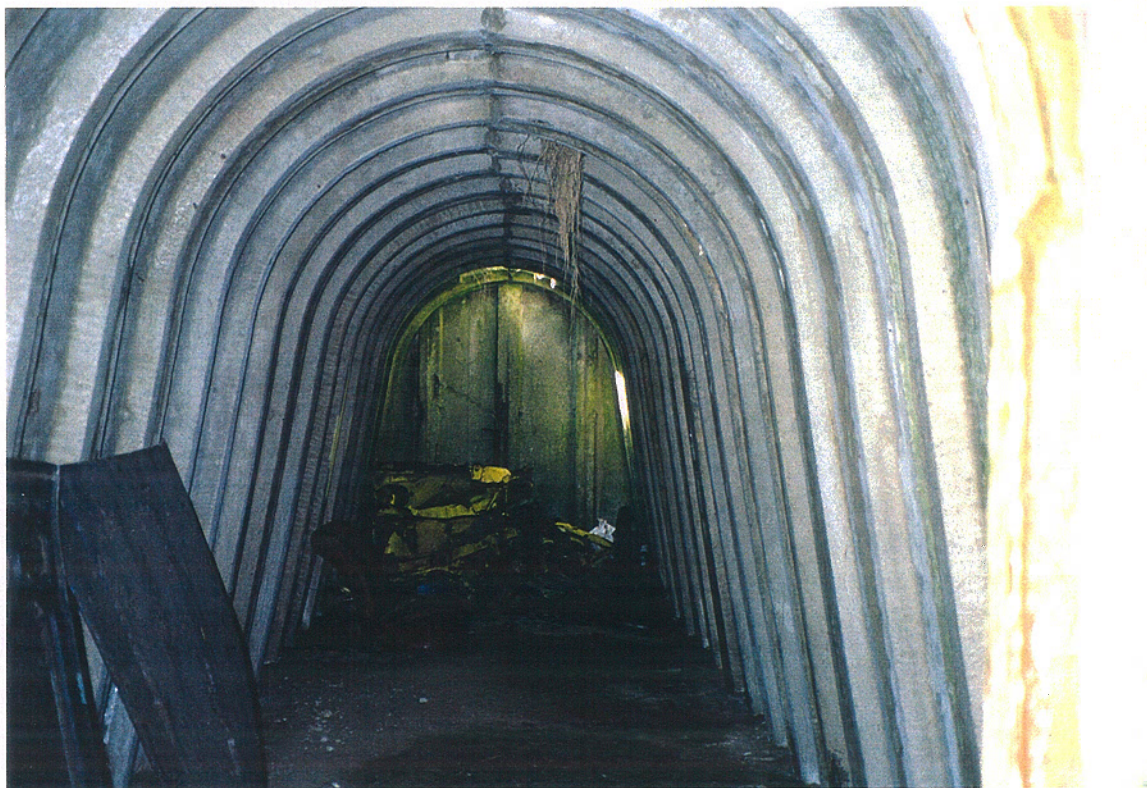
Low but a good example of its type.

**Photograph No.****34C****Date 07/07/99****Looking****WSW down interior of underground shelter C.2**
