SECOND WORLD WAR AIRFIELDS AT TAIN AND FEARN, EASTER ROSS

A Report to Highland Council by the ASH Consulting Group

July 1999

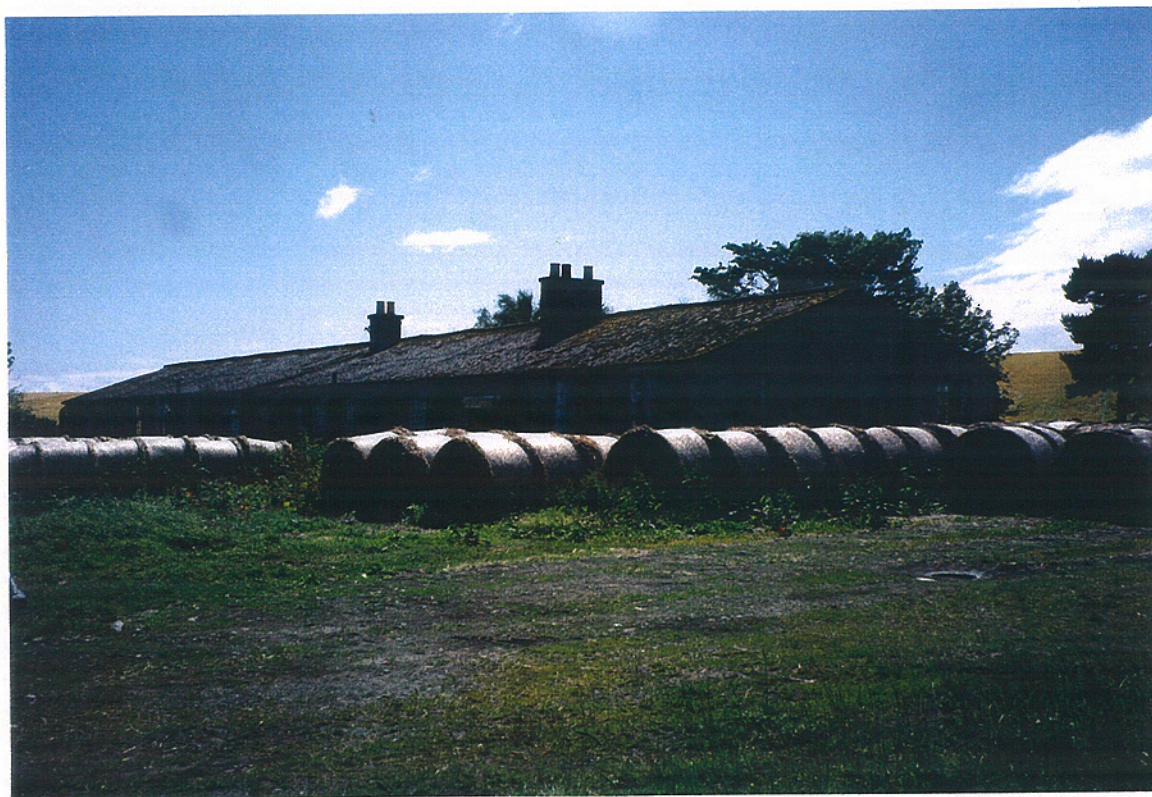
Low. Will probably continue in agricultural use

**Photograph No.****36C****Date 07/07/99****Looking****SE along E side of Building C.3**

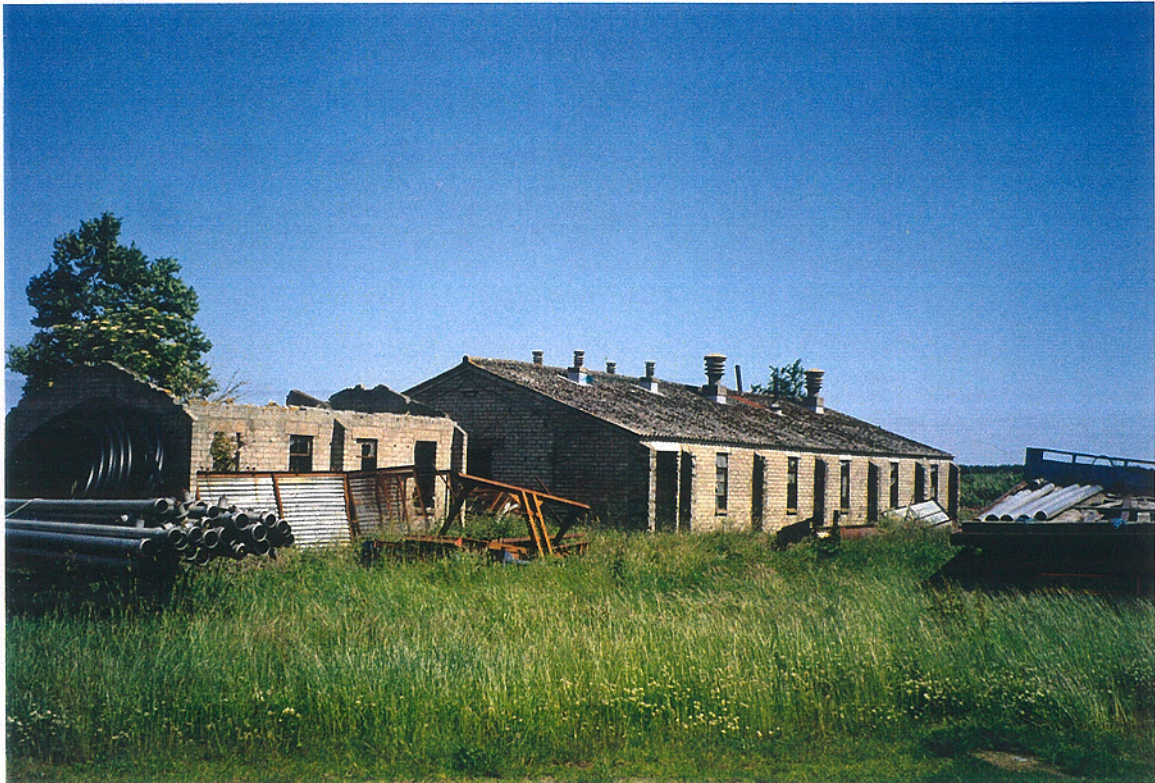
Photograph No. 2D
Looking NW at Building 4

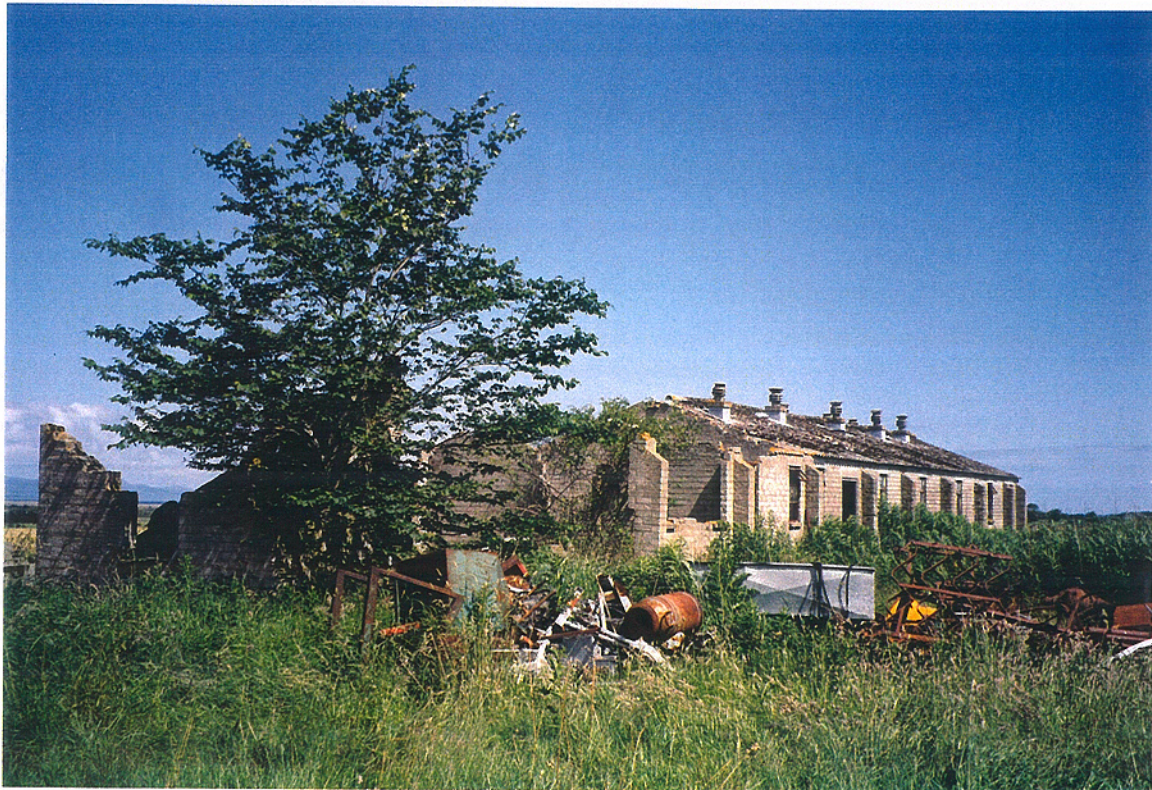
**Photograph No.****4D****Date 07/07/99****Looking****NE at Building C.4**

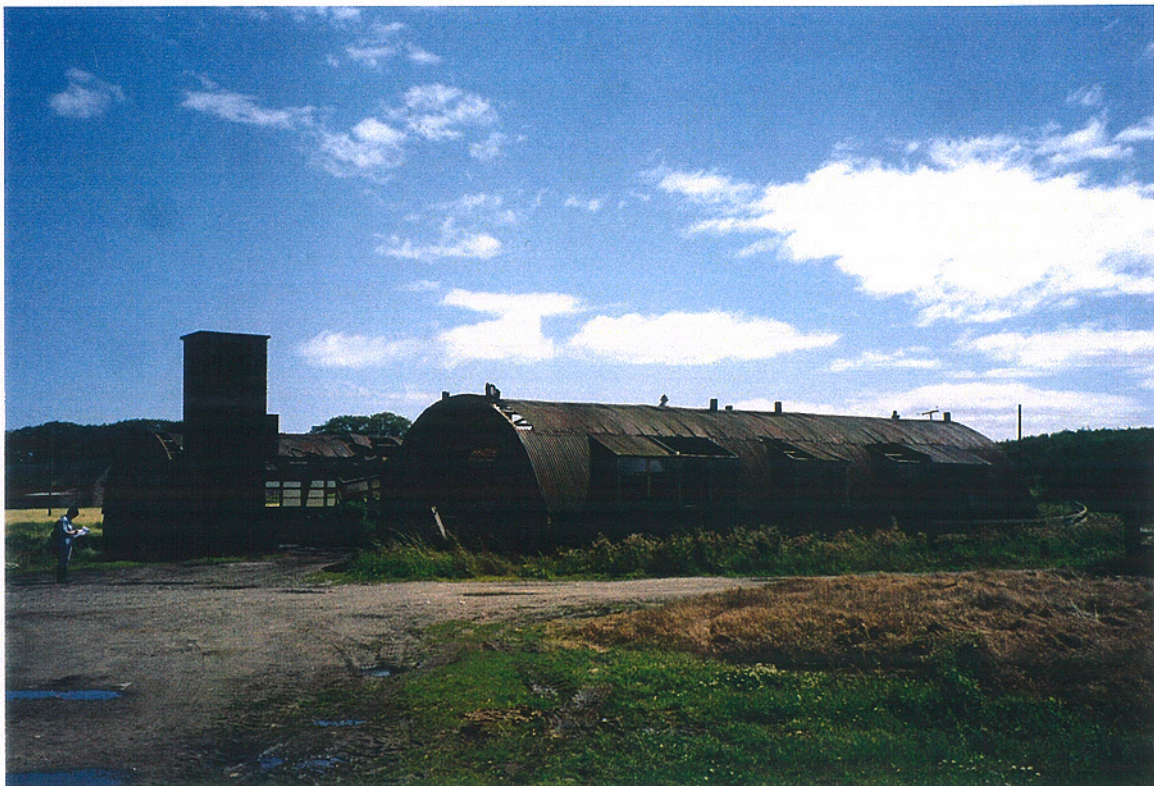
Both buildings are in a very poor state of repair and are potentially dangerous

**Photograph No.****5D****Date 07/07/99****Looking****SE towards ruinous nissen huts C.5**

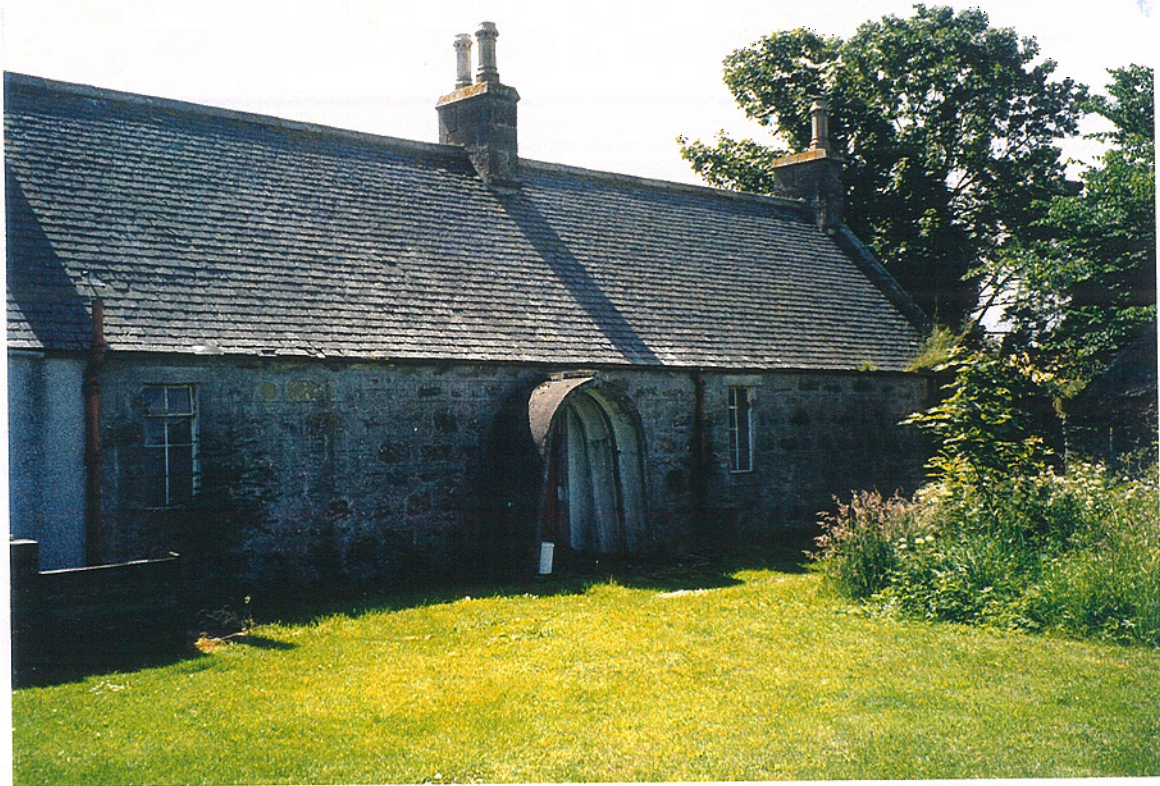
1D

SW at blast shelter sections reused as a porch for farm cottage

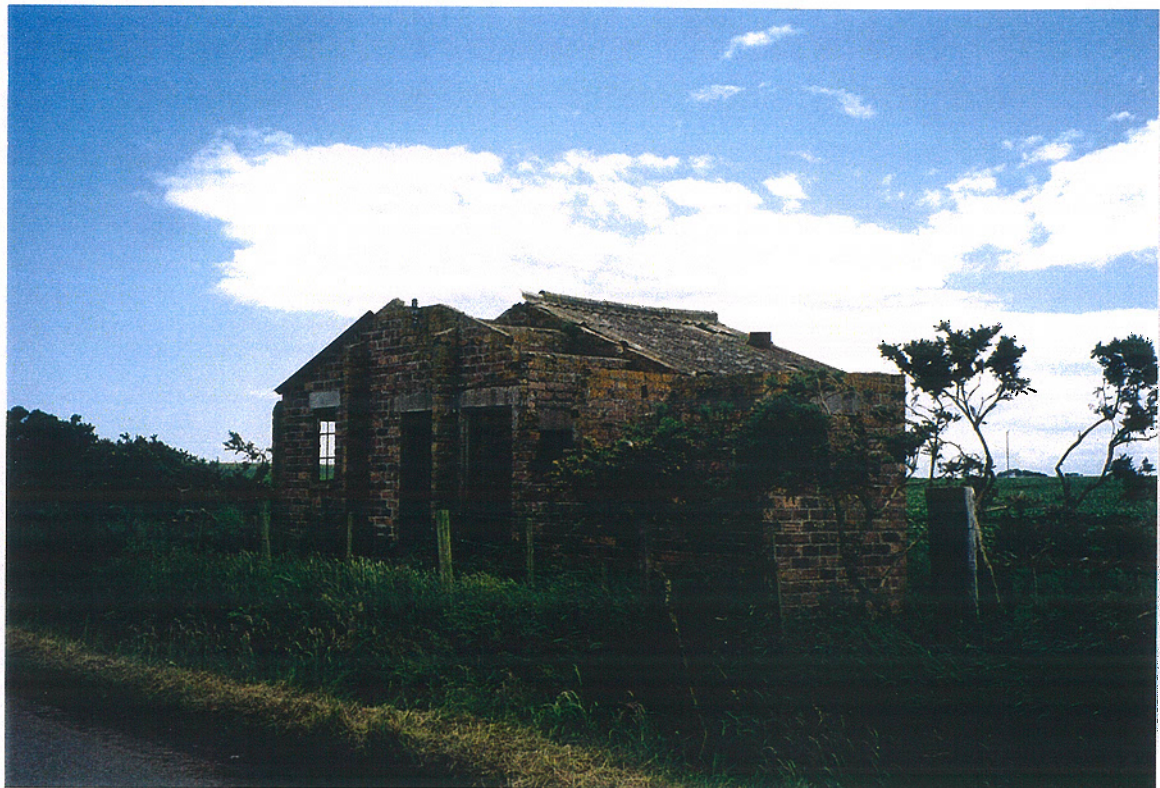
**Photograph No.****6D****Date 07/07/99****Looking****SE at front of Building D.1**

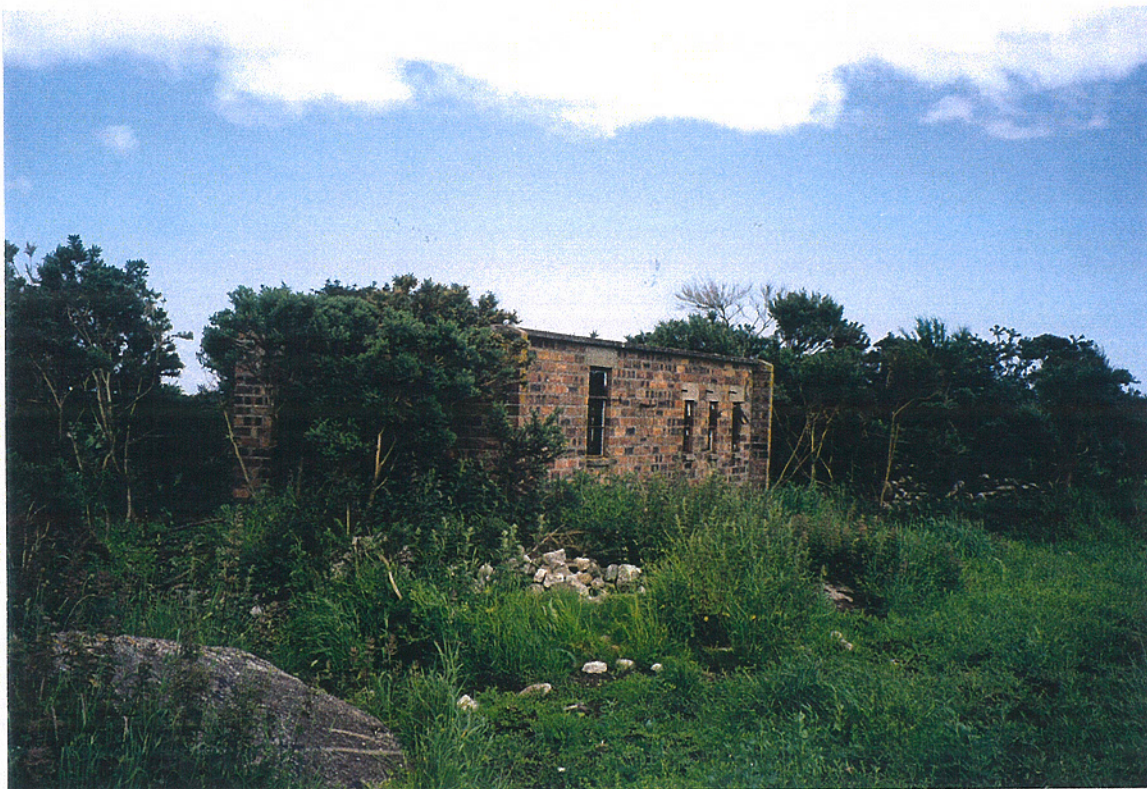
7D

NE at Building D.2

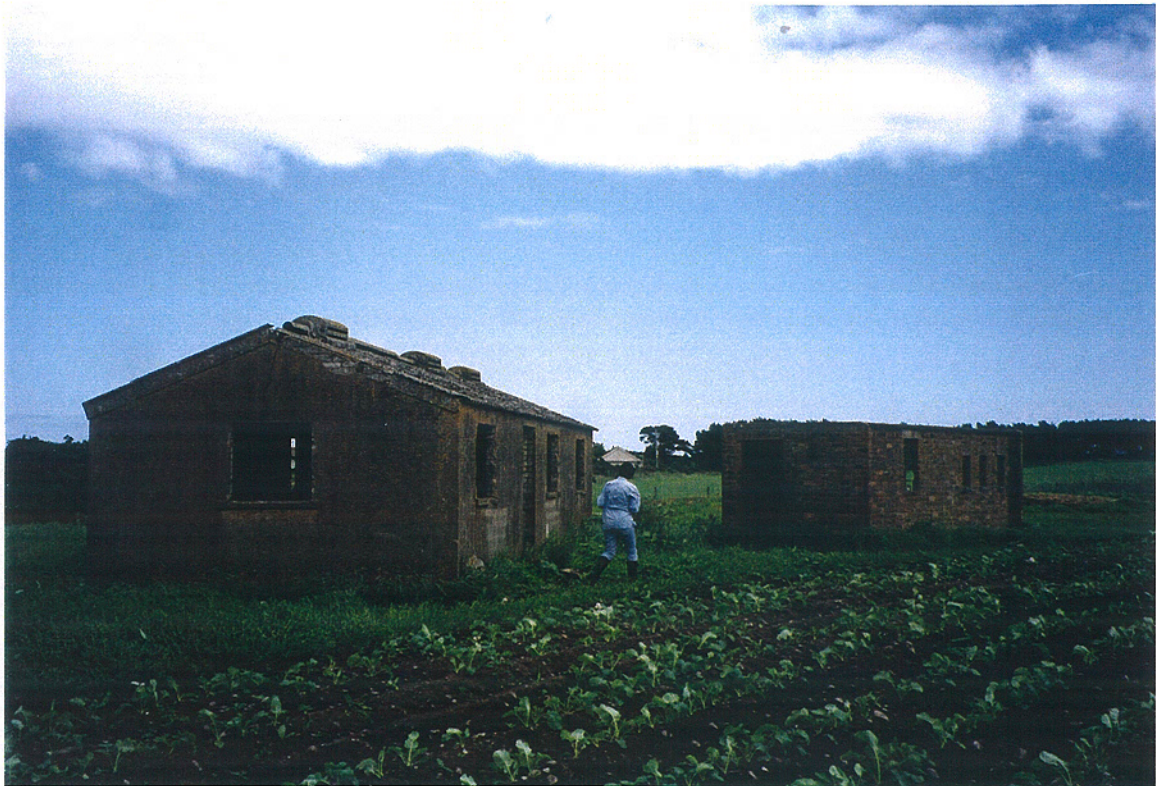
**Photograph No.****9D****Date 07/07/99****Looking****NE at Buildings D.4 and D.5**

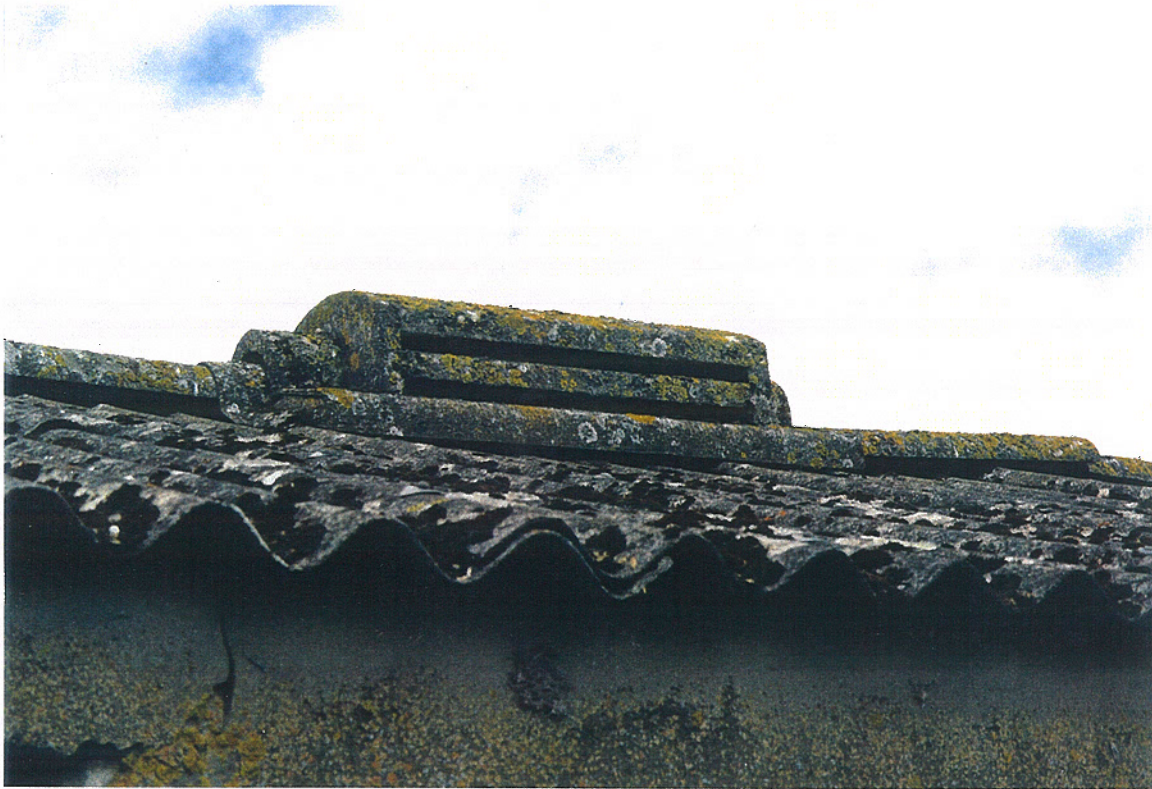
10D

NE at detail of roof vent in Building D.4

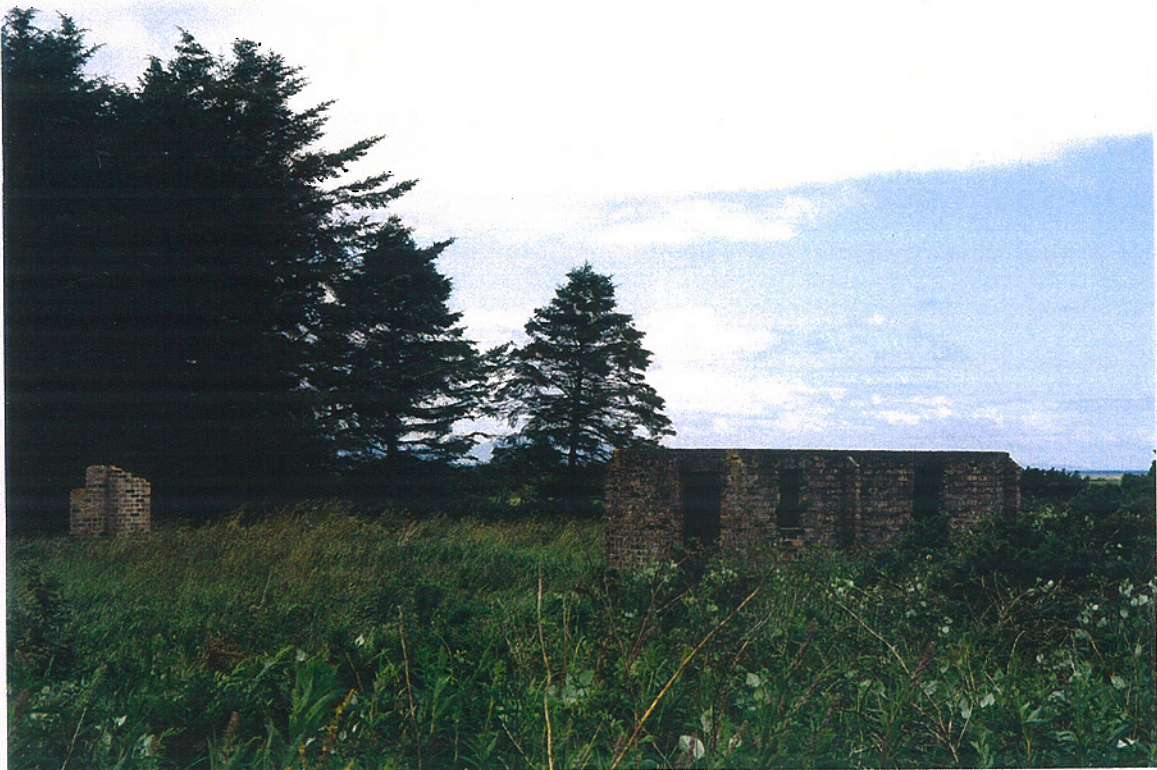
**Photograph No.****12D****Date 07/07/99****Looking****NE at Building D.7 and other fragmentary remains.**

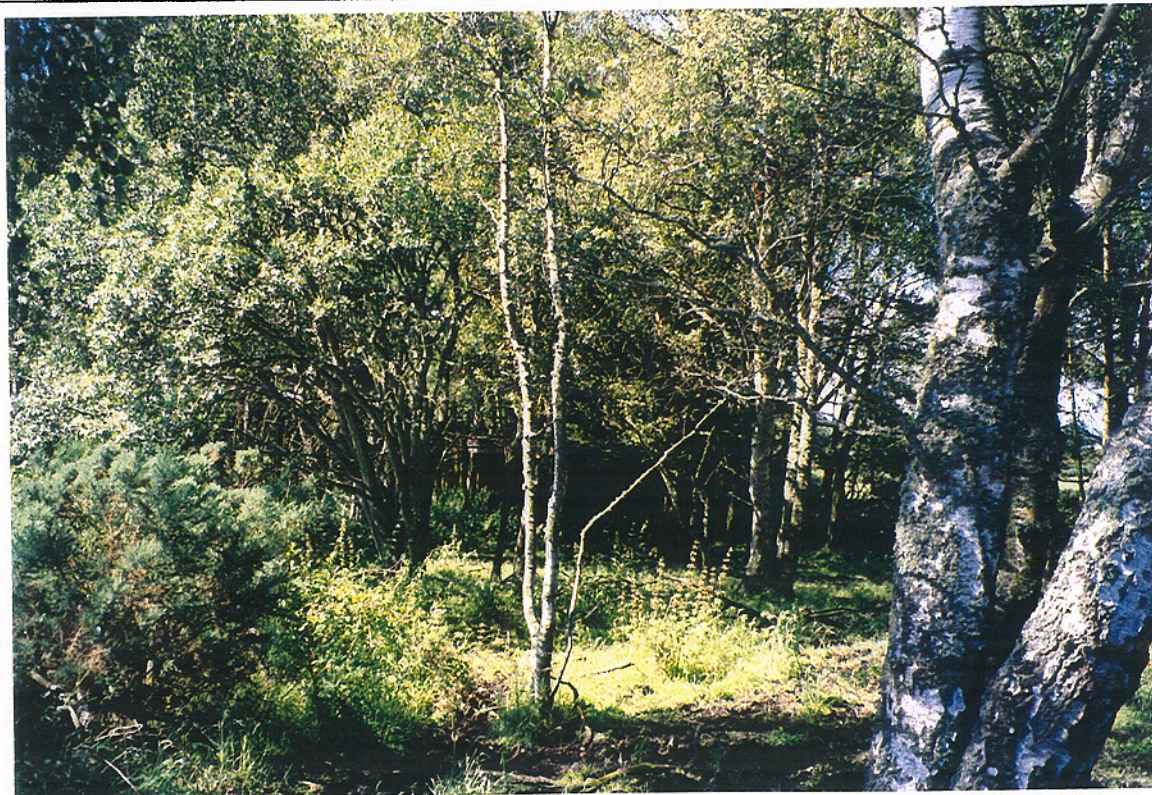
F3 Both buildings here are in poor condition with the walls partly demolished.

12E
N at derelict structures at F.3

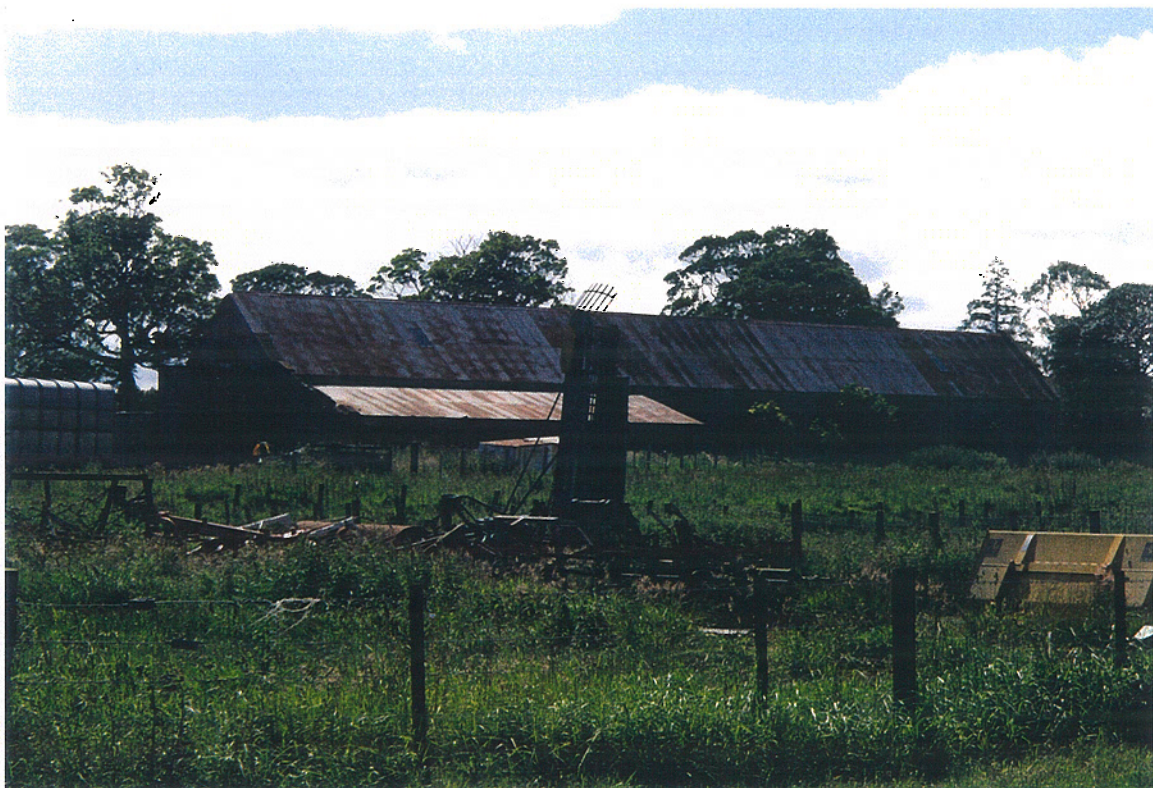
Condition The barn is in active use as part of Balnagall Farm and is in good condition.

**Photograph No.****7E****Date 07/07/99****Looking****SW at Barn H.1**

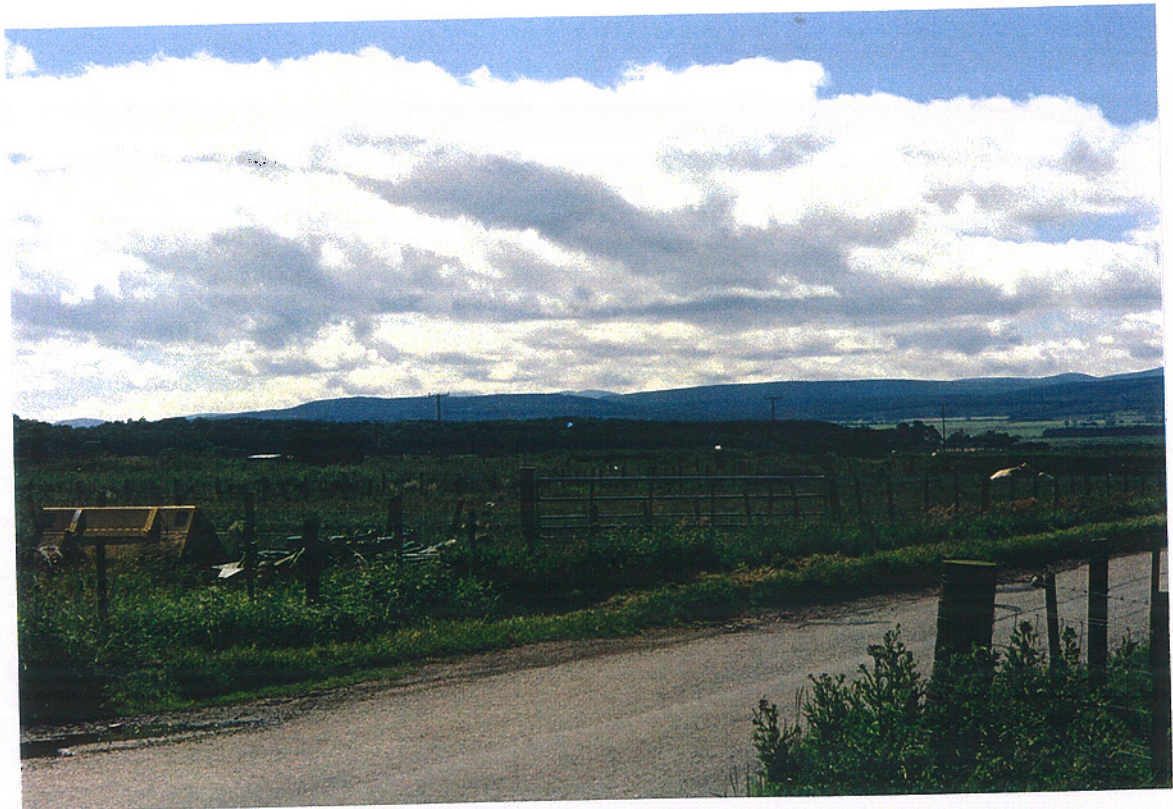
**Photograph No.****9E****Date 07/07/99****Looking****W at Sheds H.2 to the E of Barn H.1**

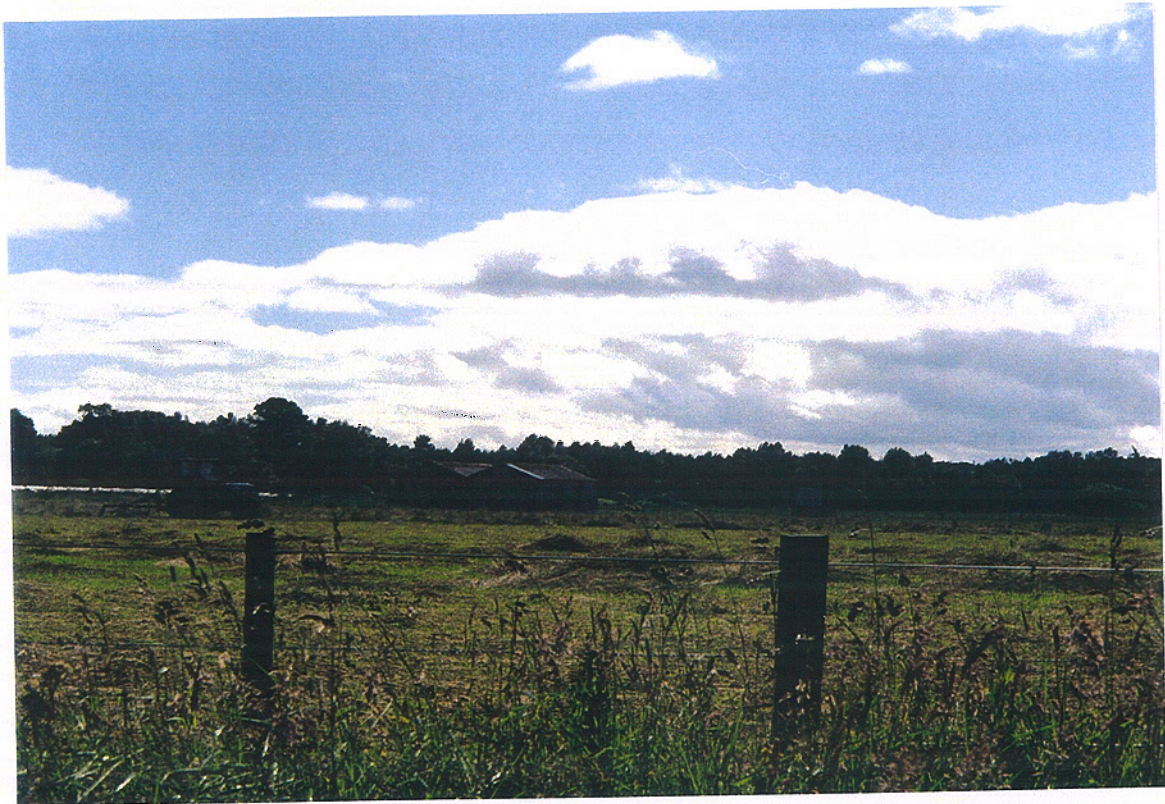
**Photograph No.****9E****Date 07/07/99****Looking****S to Sheds I.1**

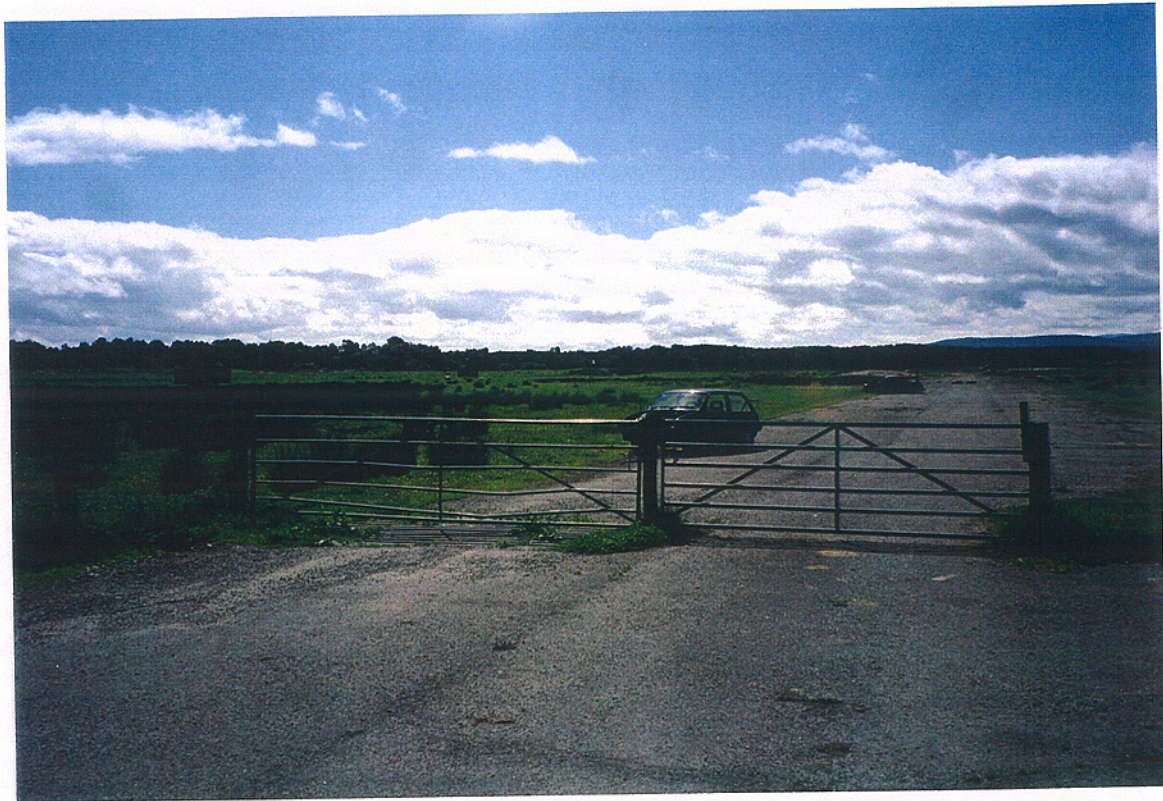
**Photograph No.****8E****Date 07/07/99****Looking****SW to small Sheds I.2**

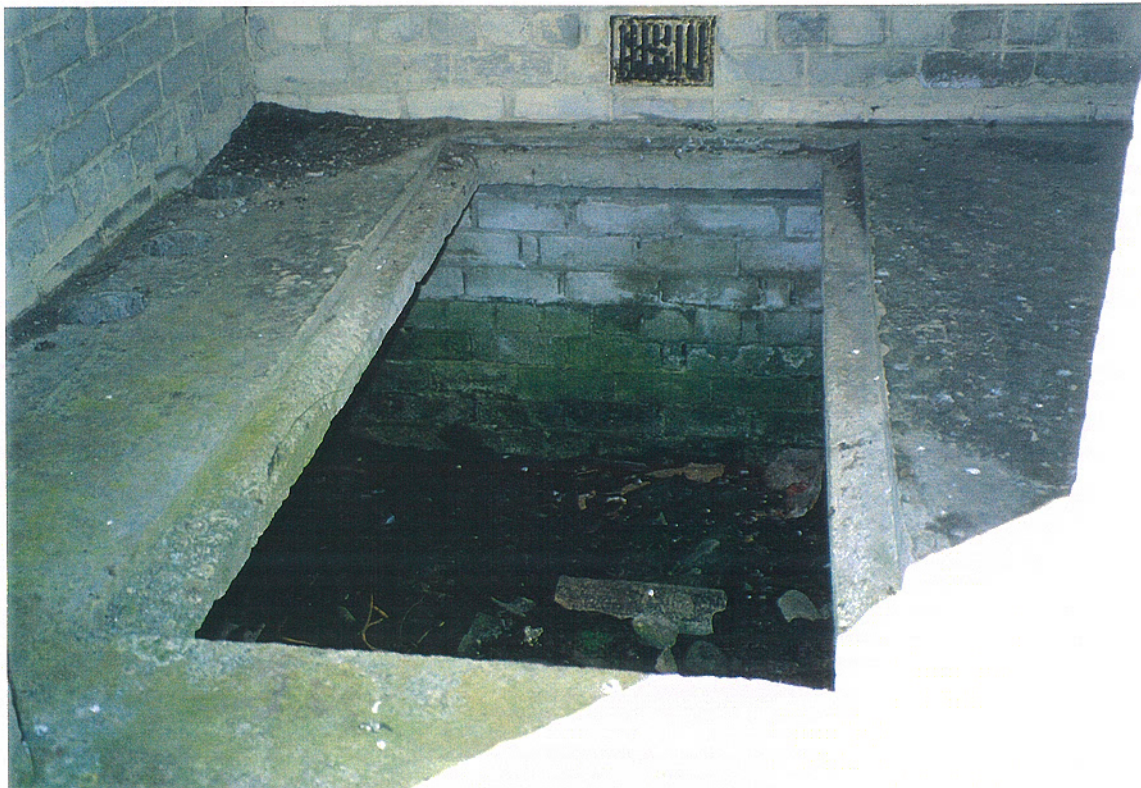
6C
Nw at interior of ?Ground Post J.2

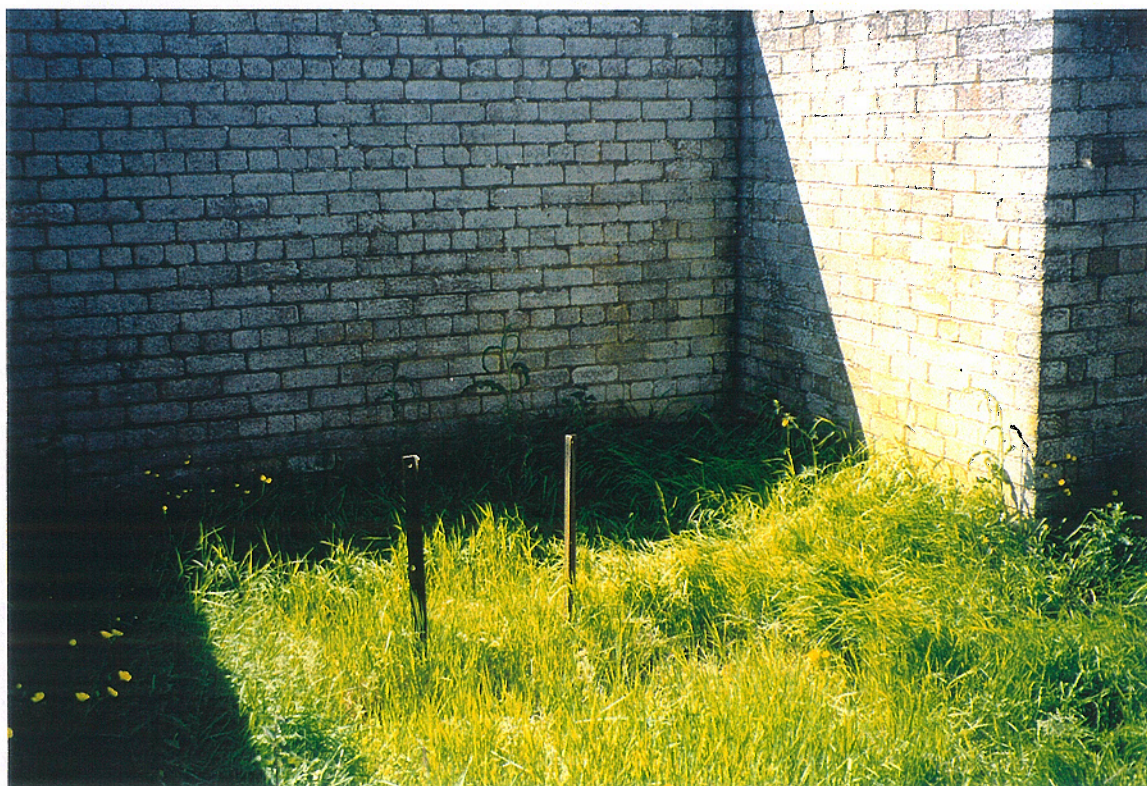
7C
SW at interior supports in ?store to NE of J.2

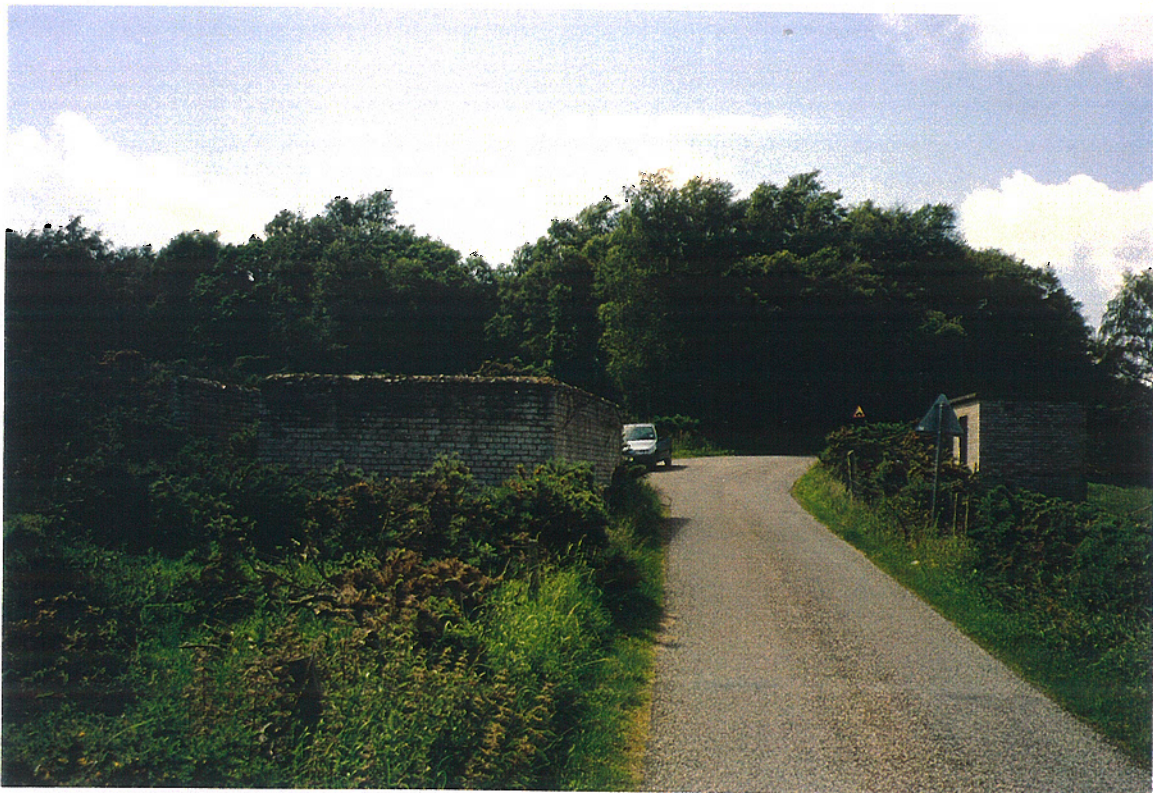
**Photograph No.****36B****Date** 02/07/99**Looking****SW towards both K.1 & K.2**

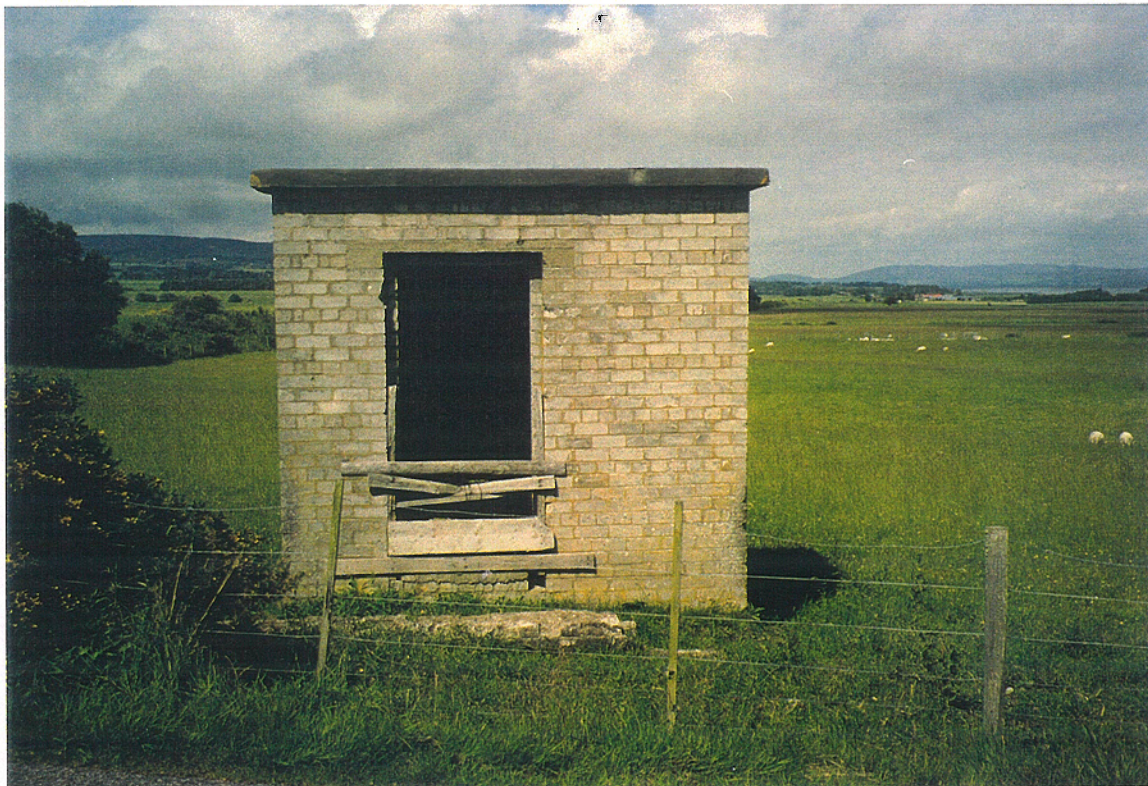
34B
NW at entrance to K.1

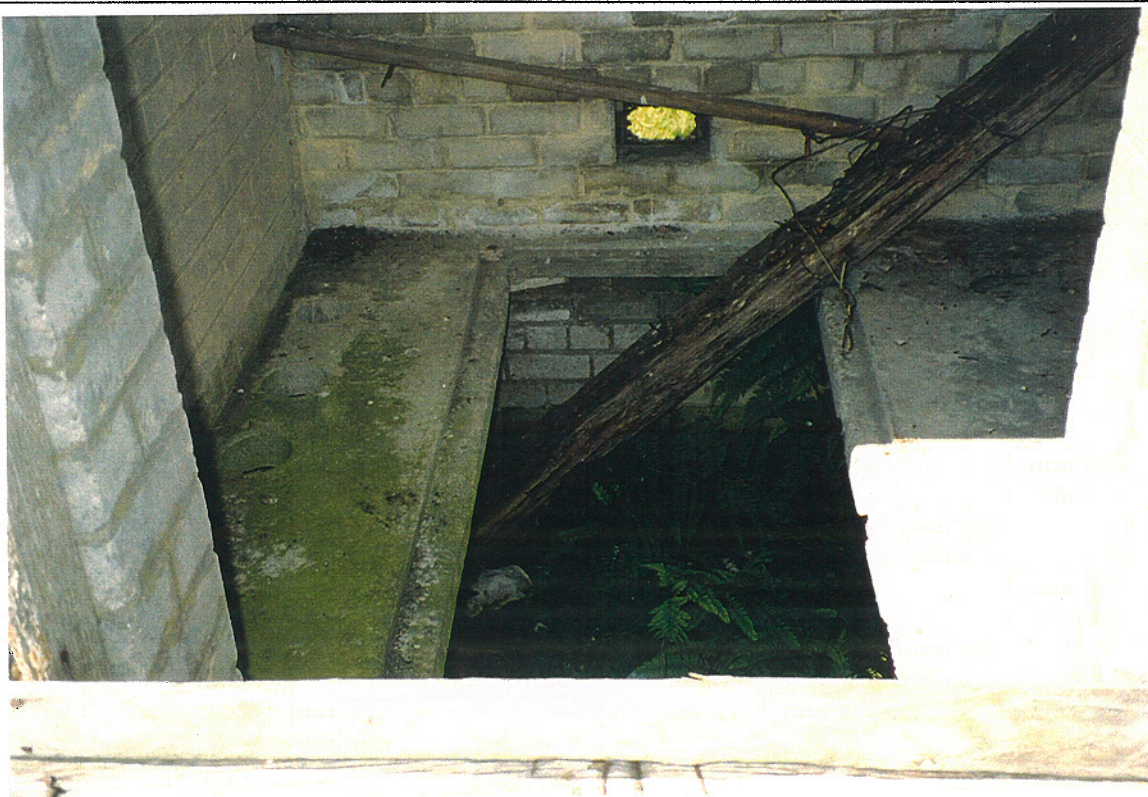
35B
at interior of NW of K.1

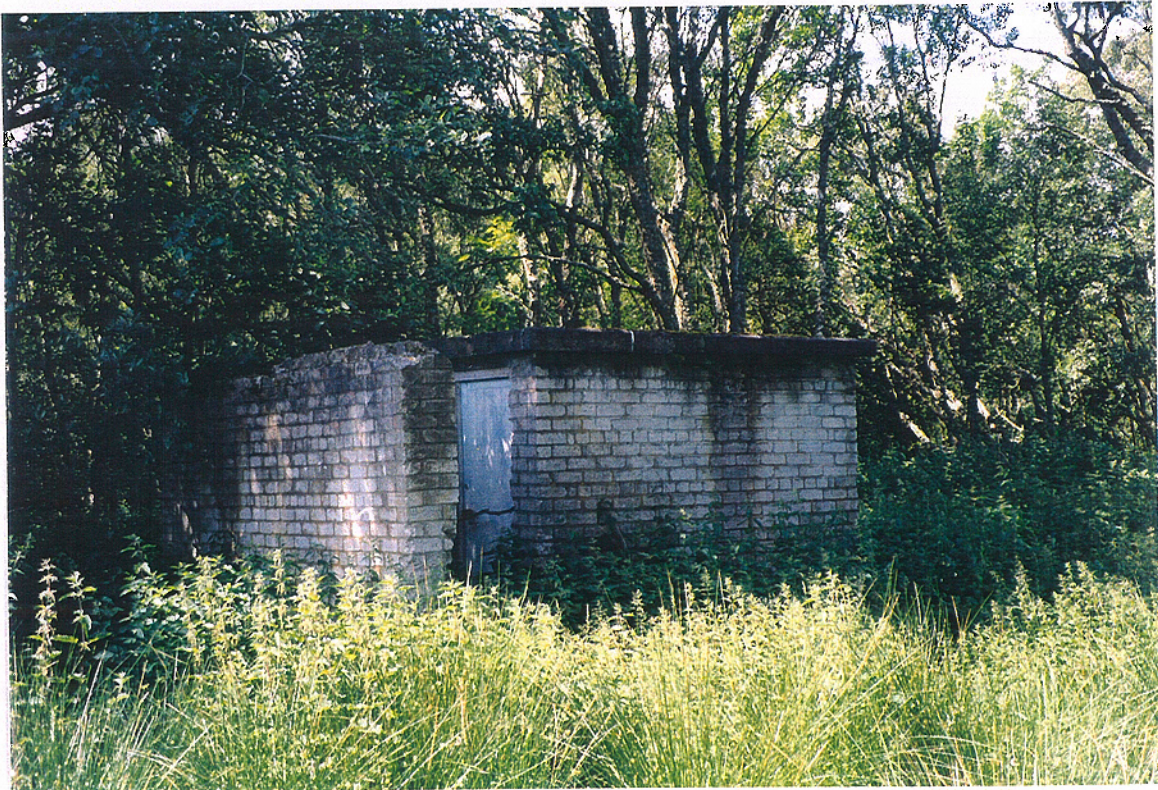
This building is in excellent condition with the marks of shelving and a probable desk visible in the paintwork of the interior.

**Photograph No.****1C****Date 02/07/99****Looking****SE at entrance to K.3**

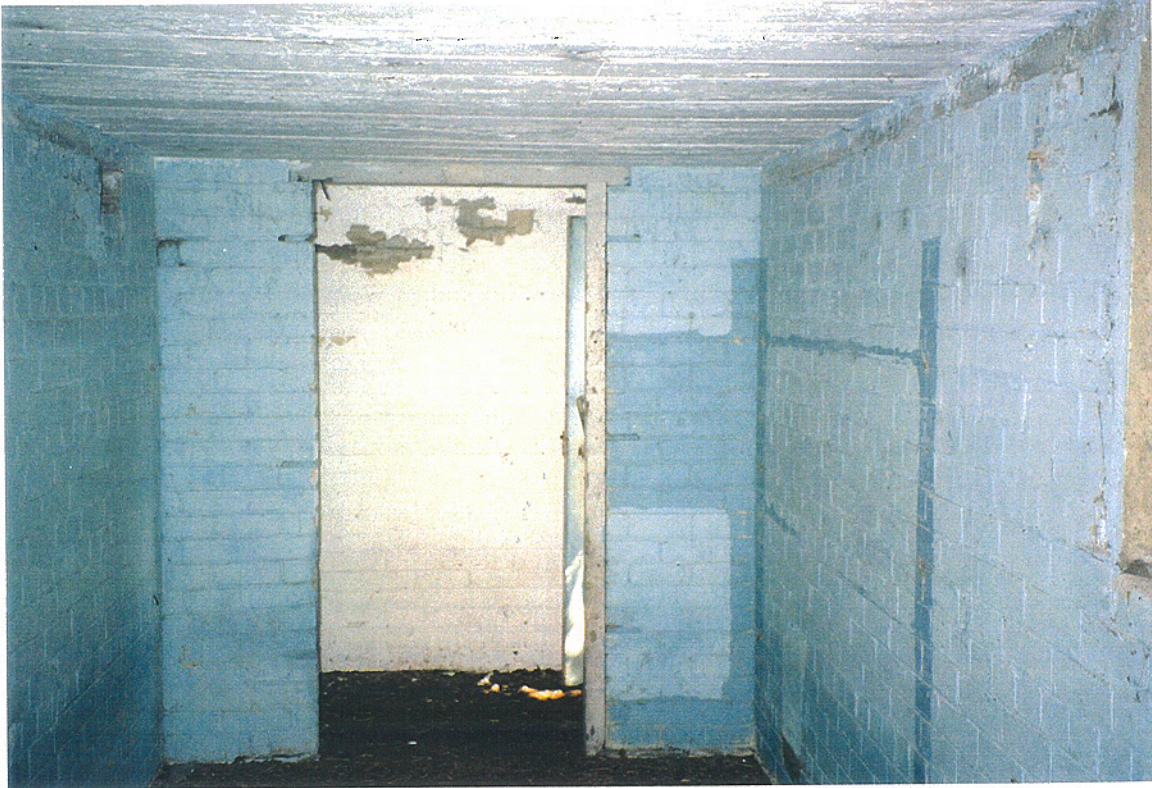
Photograph No. 6C

NW at interior of ?VHF post K.3

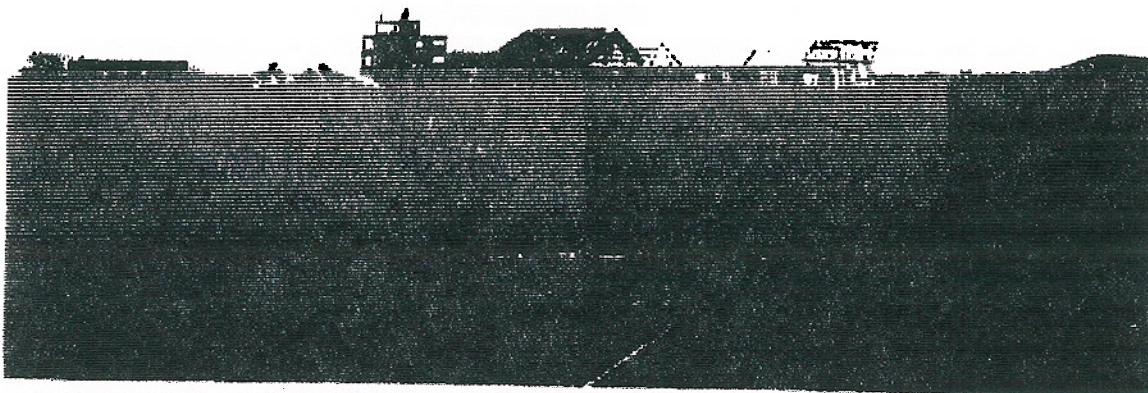
One or two of these buildings have been converted into workshops. The majority, however, remain derelict.

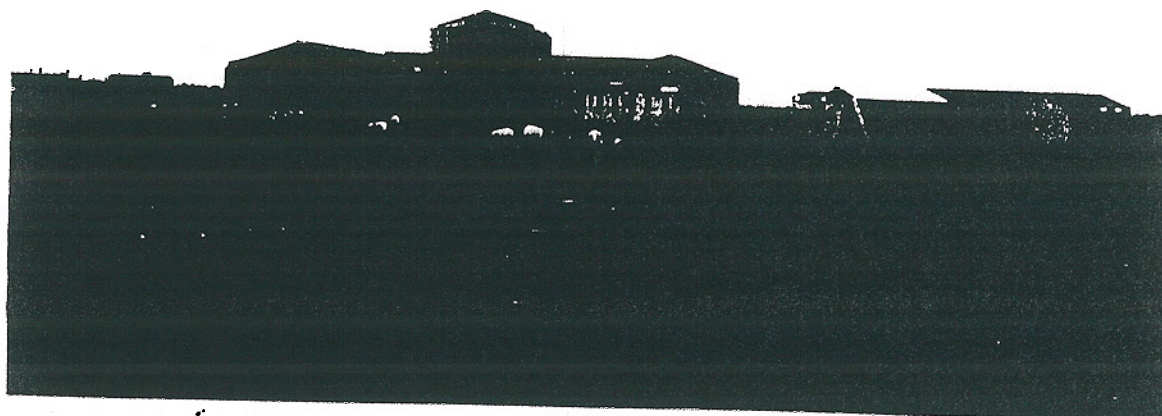
The buildings are being used for storage and as animal shelters.
